Derwent River Wall Repairs Matlock, Derbyshire

Photographic Recording and Archaeological Watching Brief

Ref: 281330.04
August 2023

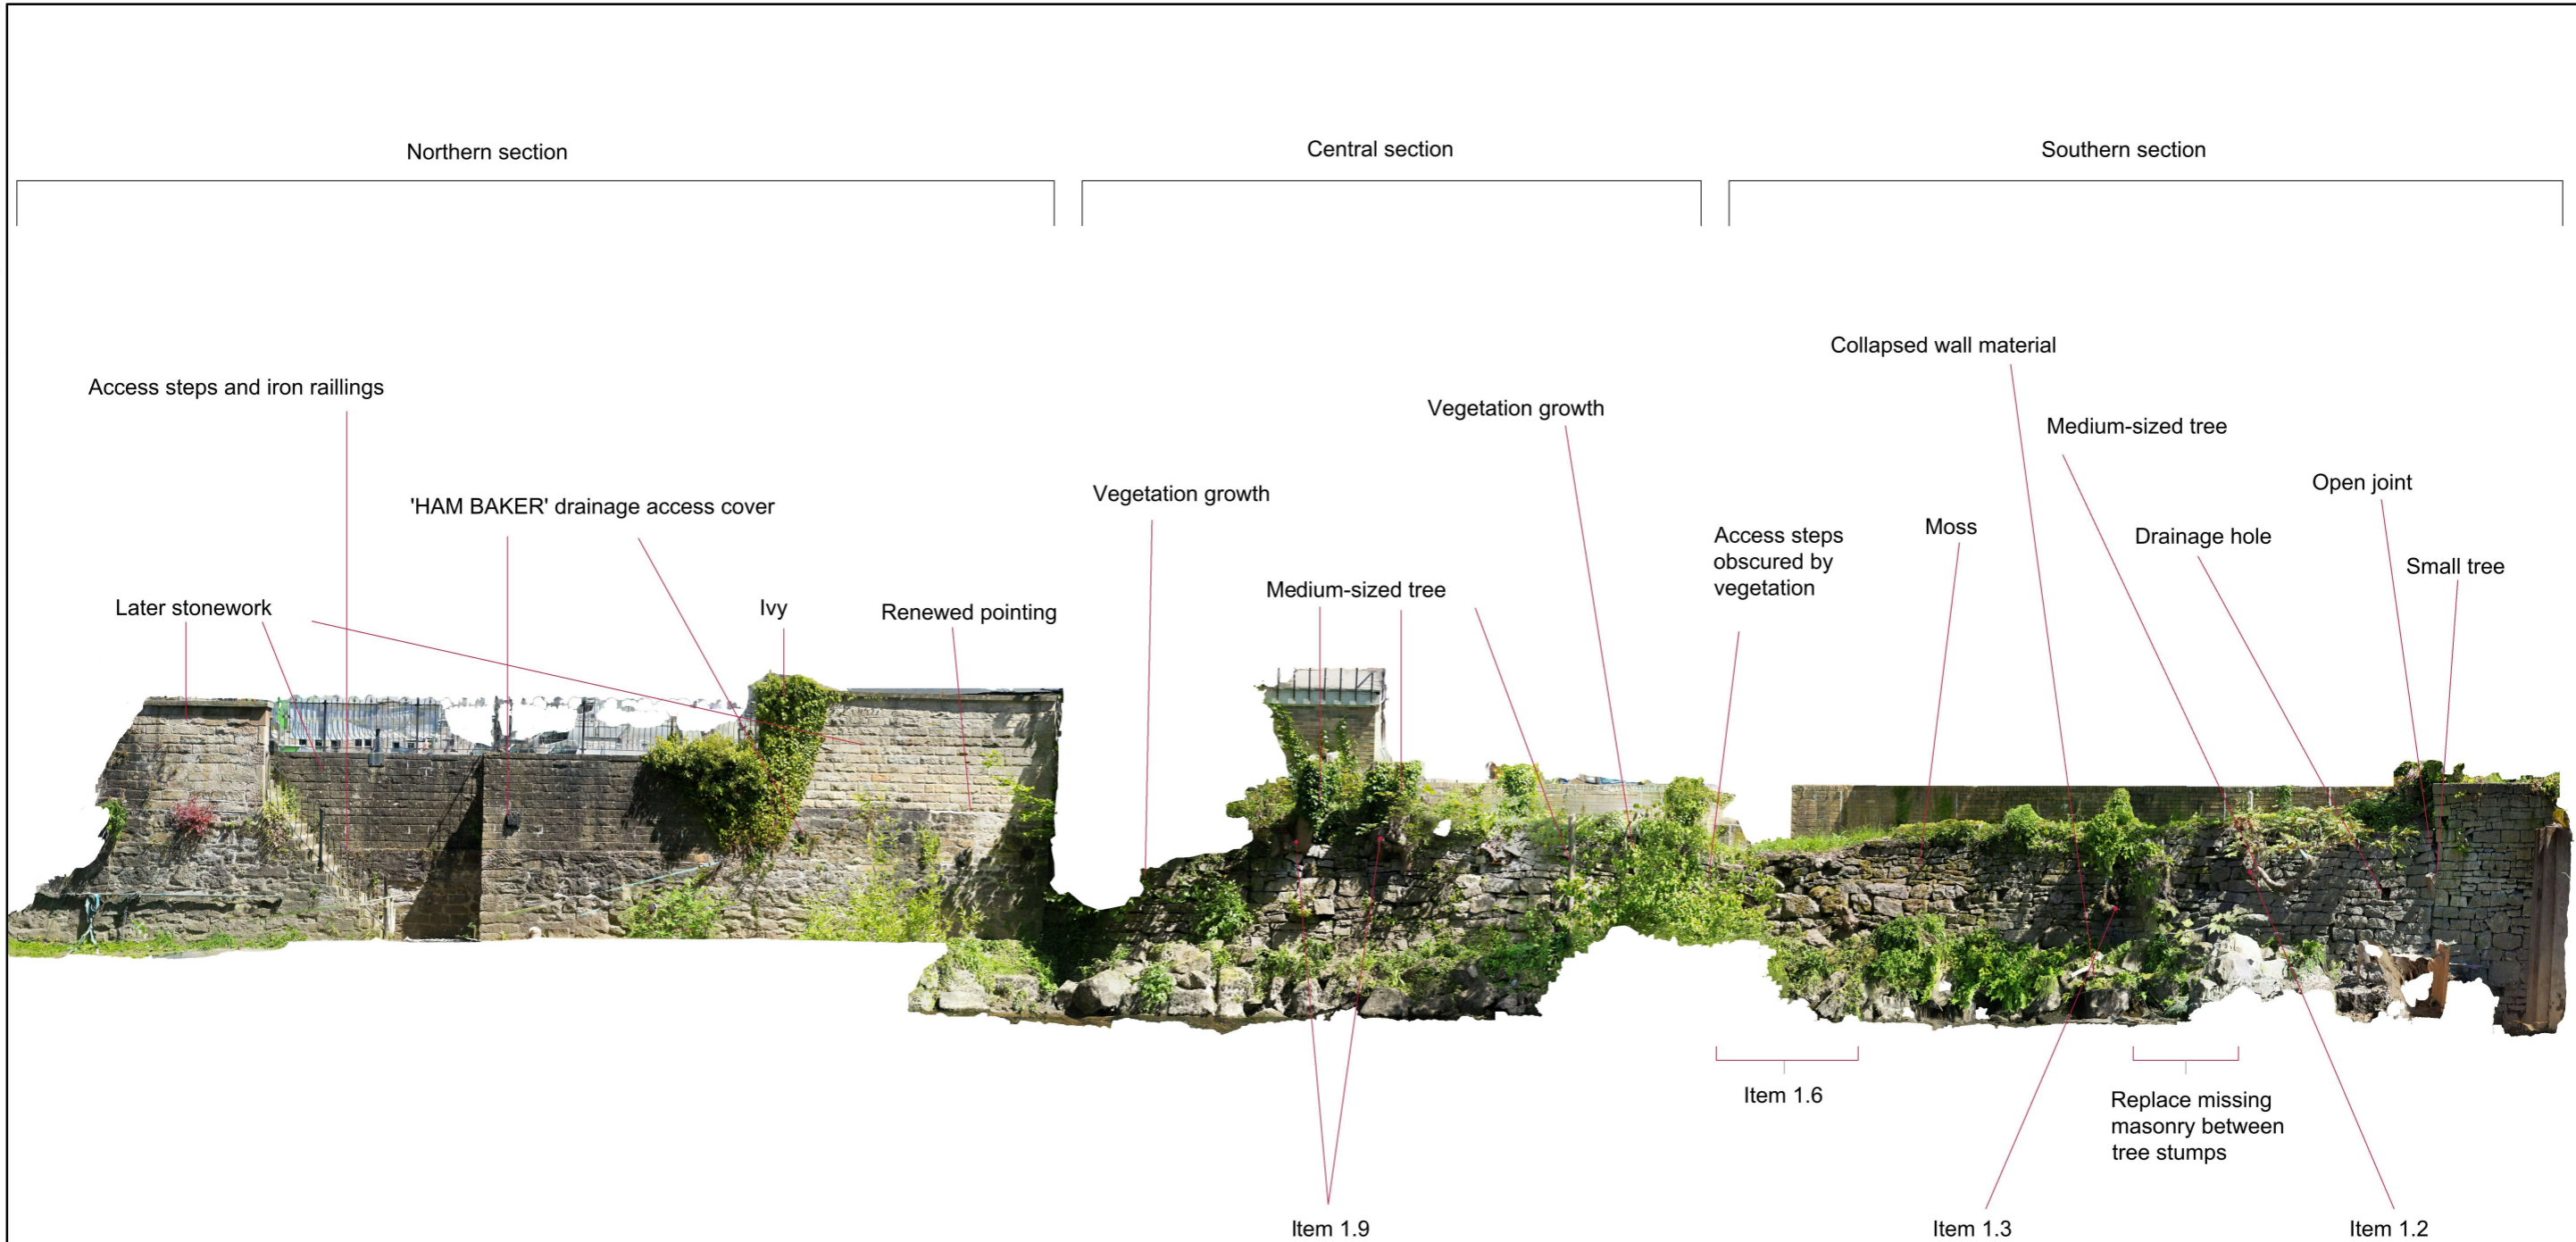
Figure 2: Matlock River east bank wall, west facing elevation

5.1.1 The recorded section of riverside wall measured approximately 2.5 m in height and approximately 54 m in length (Fig. 2). The wall comprised a mixture of local gritstone and limestone, which appeared as regular coursed rubble at the northern end and uncoursed and coursed random rubble stonework in the central and southern sections. At the northern end of the relevant section of riverside wall, a small flight of steps provided pedestrian access down from the upper bank to the riverside (Fig. 5).

Items 1.2, 1.3 and 1.9
 Masonry disrupted and wall compromised by tree growth
 Repair = dismantle the wall around tree stumps, cut back the tree stumps and rebuild; and replace small amount of masonry missing between tree stumps at 1.2 and 1.3

Item 1.6
 Wall downstream of obscured access steps in very poor condition with a considerable amount of loose masonry present.
 Repair = dismantle and rebuild this part of wall

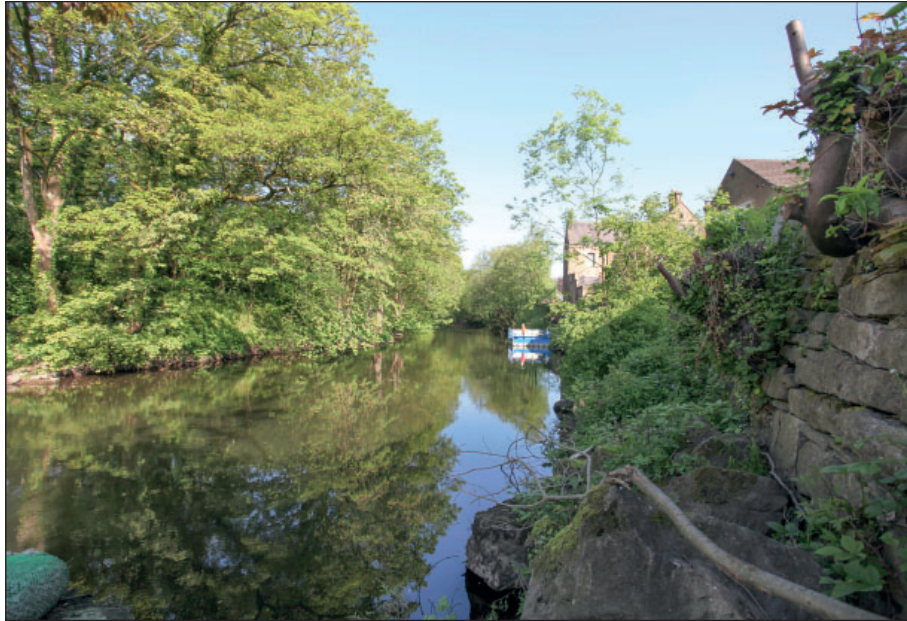
Figure 3: River wall, view from the south-east

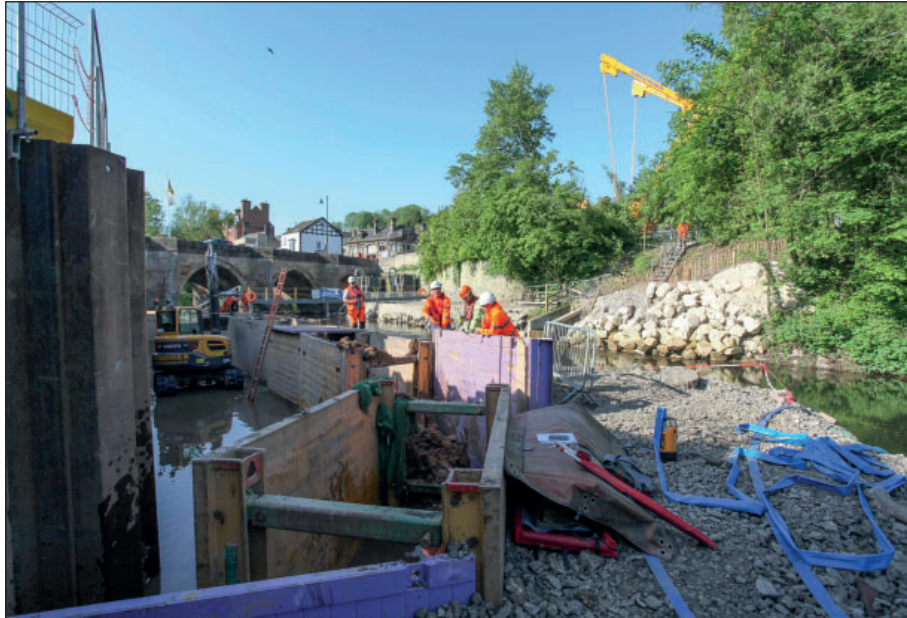
Figure 4: River wall in proximity to Matlock Derwent Bridge, view from the north-west

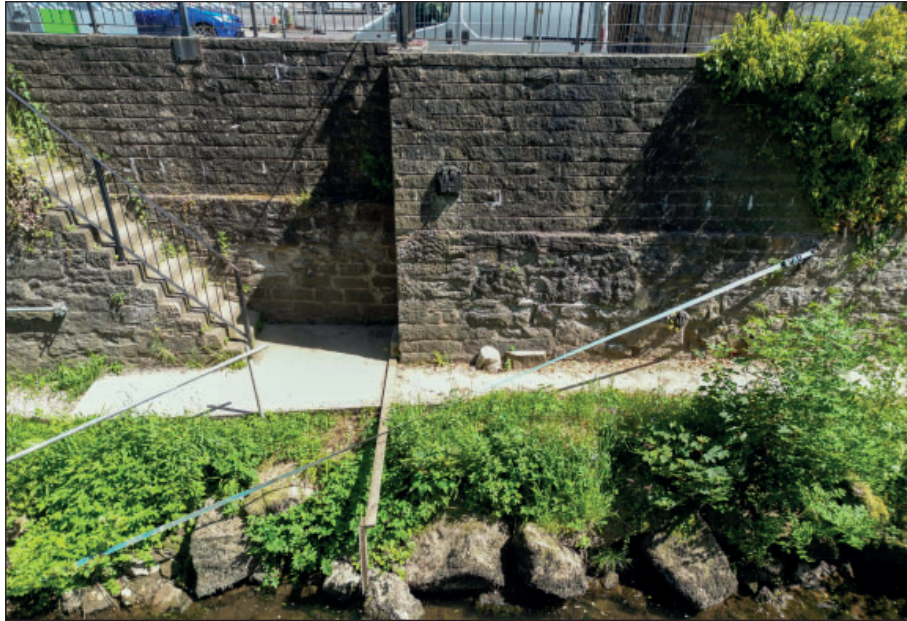
Figure 5: Access steps and iron railings in northern section of the river wall, view from the south-west

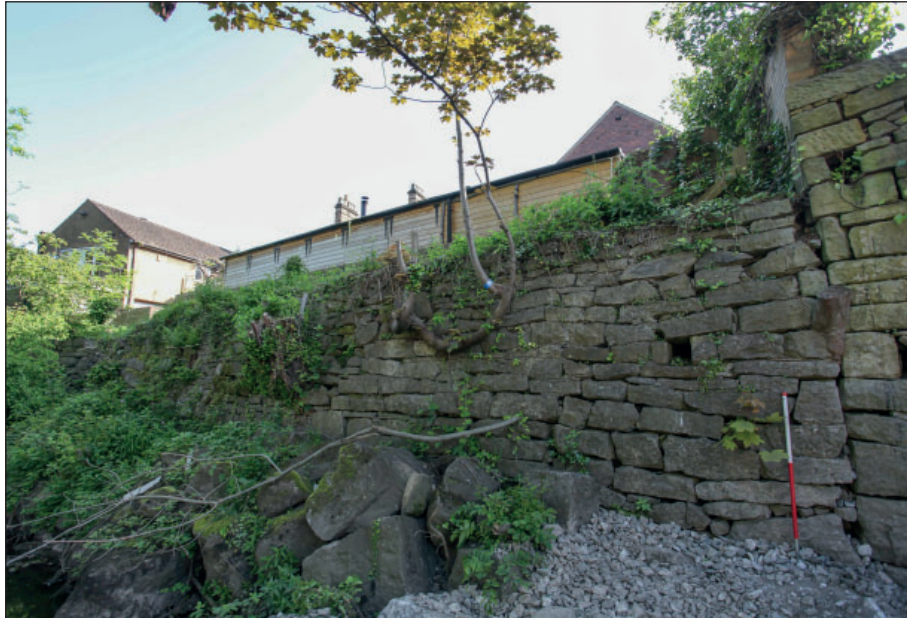
5.1.3 The southern section of the wall consisted of approximately 13 courses of coursed rubble of varying sizes that appeared in relatively poor condition with missing pointing throughout and evidence of localised collapse and vegetation growth. Some remnant pointing, which was mid-grey and appeared to be hard and cementitious in nature, was visible between some of the stones.

Figure 6: Southern section of the river wall, view from the south

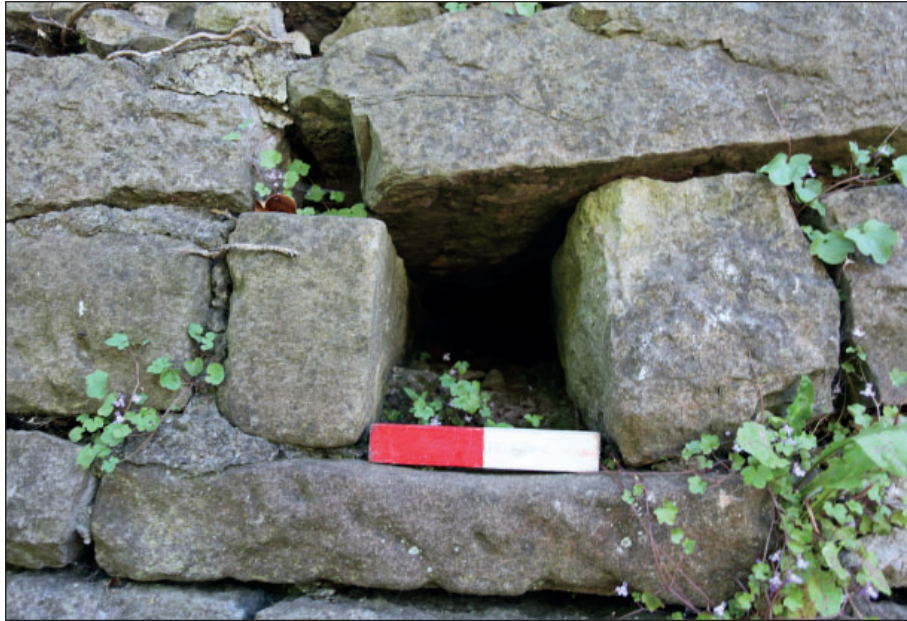
5.1.4 Extensive rubble wall material from previous collapse episodes was present within the river and at the base of the wall. A remnant drainage hole 0.2 m in width was observed in the southern section approximately seven courses up from the base (Figs 6–7). Several young trees had established themselves throughout the upper part of the wall and resulted in disruption of the masonry (Figs 8–9). There were no apparent signs of repair, although visibility was partial due to vegetation. The wall abutted a taller wall of 15–17 courses in the neighbouring property beyond the watching brief area to the south (Fig. 6), from which it was separated by an open straight joint measuring 0.05 m in width.

Figure 7: Drainage hole in the southern section of the river wall, 0.2 m scale

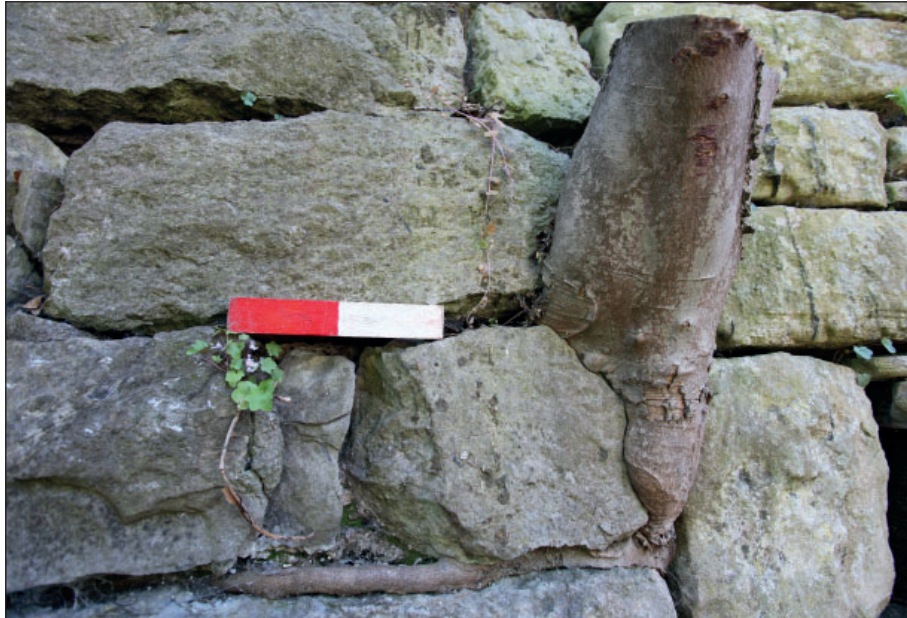
Figure 8: Small tree in the open joint of the southern section of the river wall, 0.2 m scale

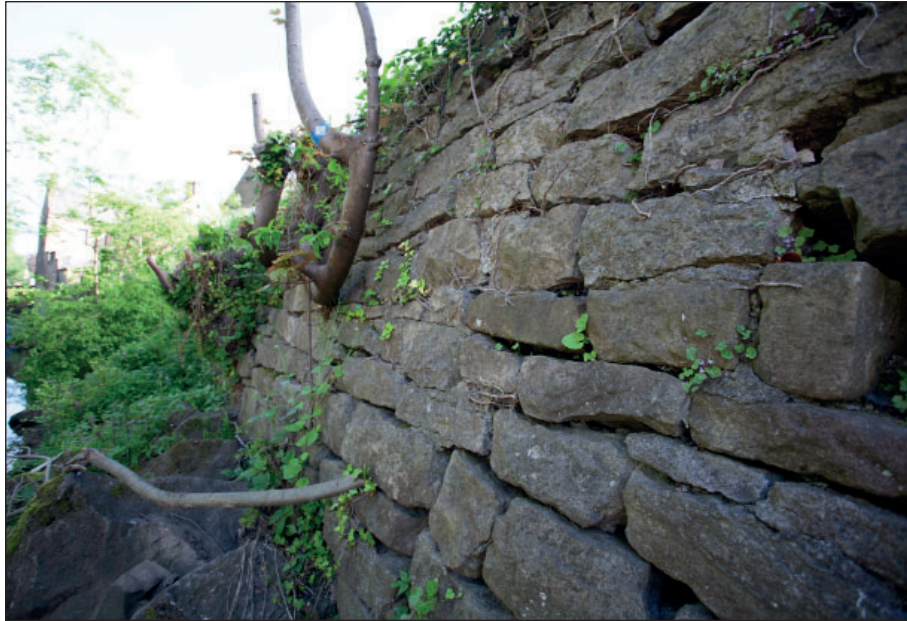
Figure 9: Medium-sized tree in the southern section of the river wall

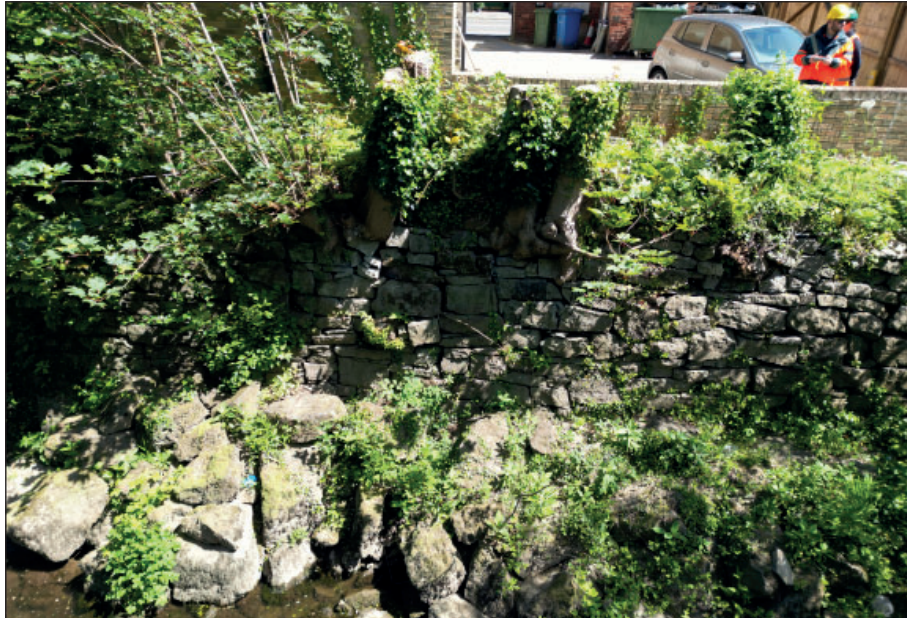
uncoursed random rubble, although of more varying sizes, with larger stones and some areas of collapse that appeared to have been repaired. There were two medium-sized trees growing out of the top of the wall and one medium-sized tree at the bottom that had created structural issues in the form of missing masonry (Figs 10–11). Despite the trees, there was less vegetation growth and moss throughout this section of the wall.

Figure 10: Two medium-sized trees and vegetation growth at the middle section of the river wall, view from the south-west

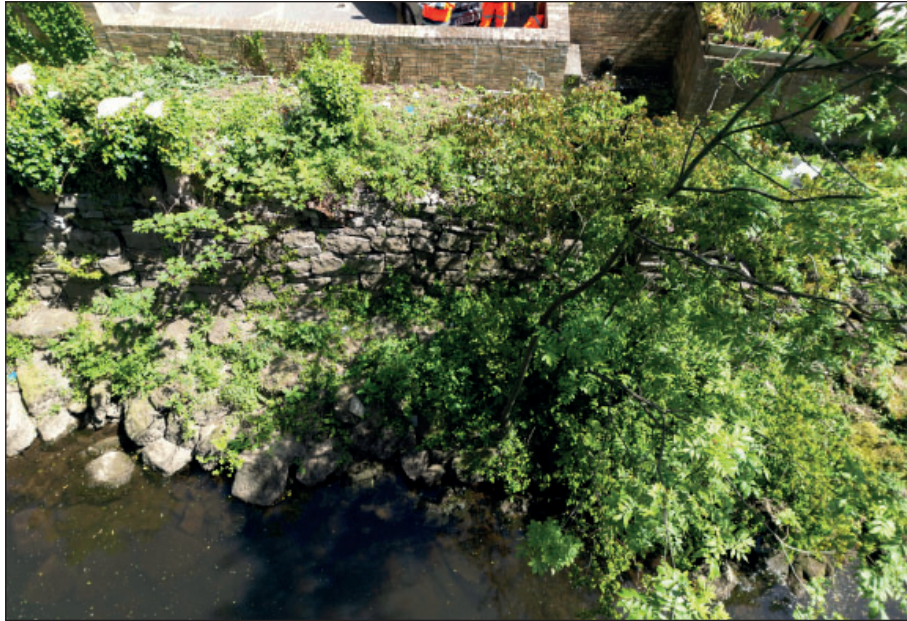
Figure 11: One medium-sized tree and vegetation growth at the middle section of the river wall

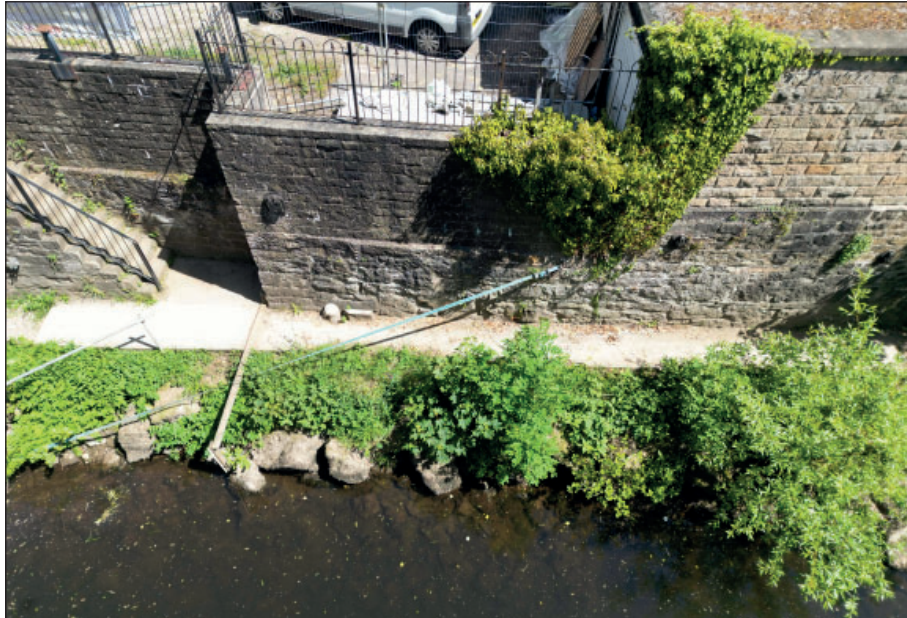
Figure 12: Access steps and ivy at the northern section of the river wall

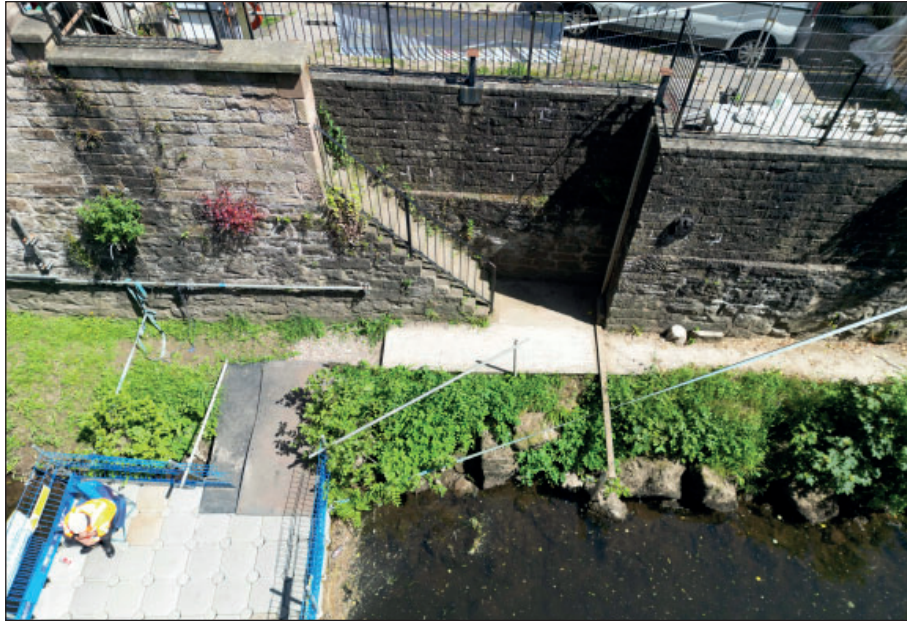
Figure 13: Access steps and vegetation growth at the northern section of the river wall
