Survey of Timber Marks and Fabric Analysis on HMS *Victory*

Technical Report

Ref: 88310.02

June 2014

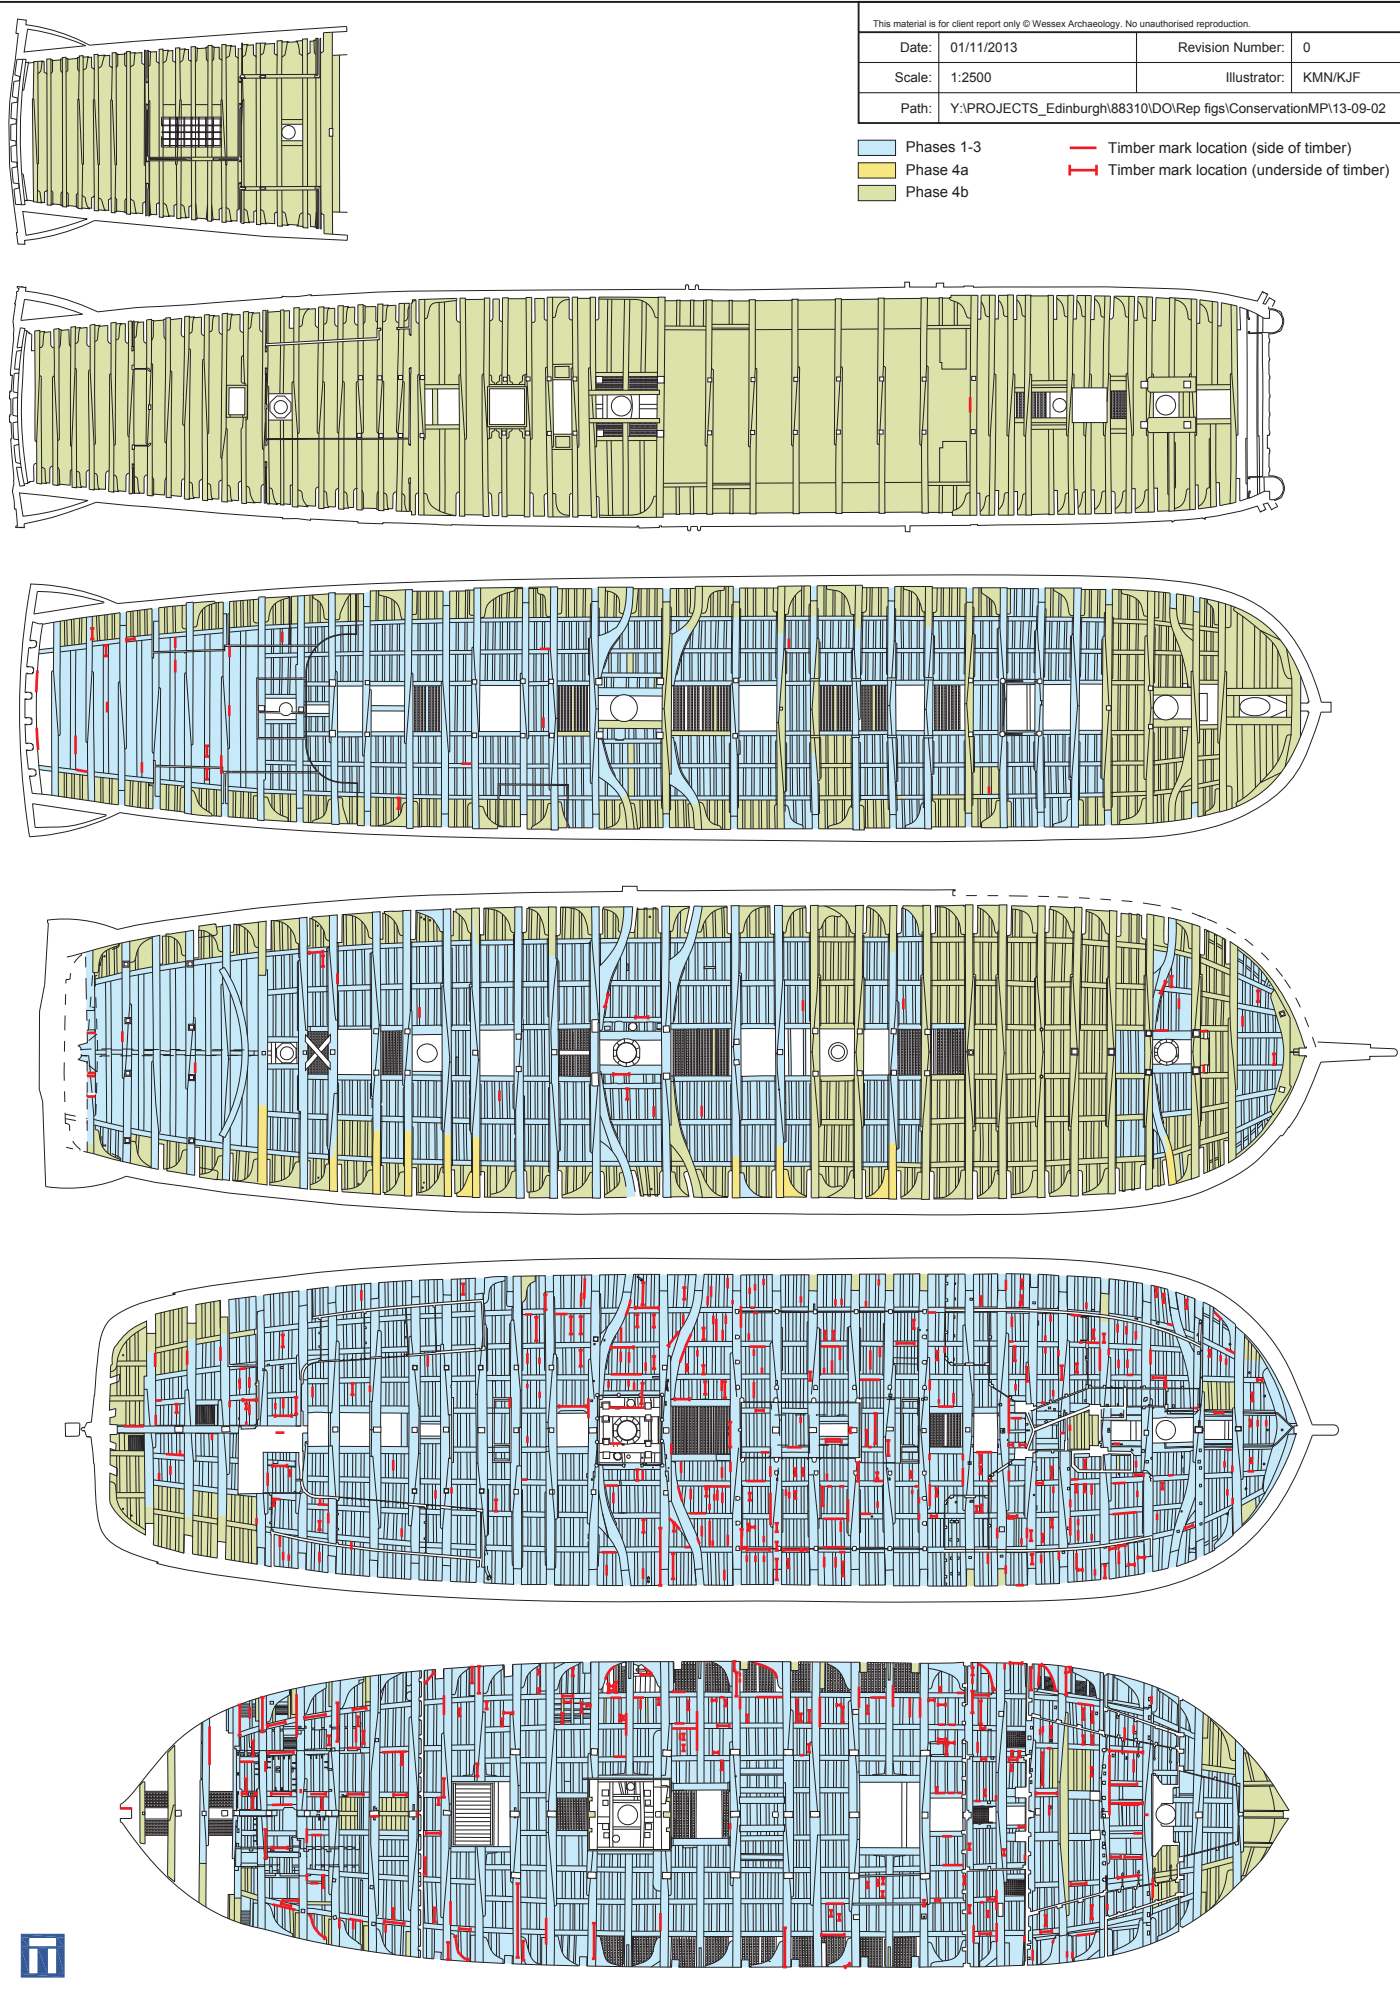
Figure 8

Deck plan showing phasing identifying modern replacement timbers

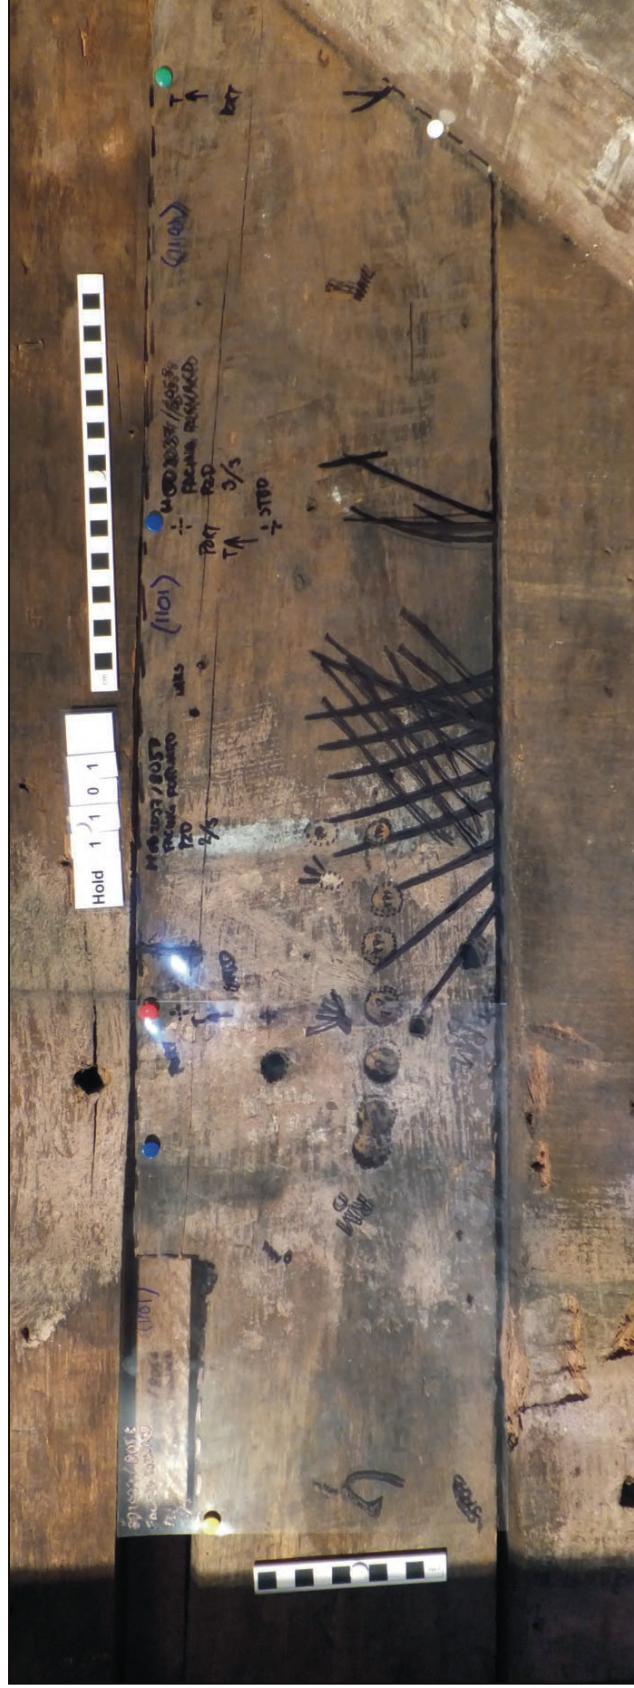
Figure 9

- 6.7.3 One of the more exciting discoveries during the on-board survey was the presence of stamps noted on timber mark 1100, 1101, 2007 and 2043, located on lodging knees (2007 and 2043) and bulkhead planks (1100 and 1101) in the area of the Grand Magazine in the hold (Figure 9). Both stamps comprised the capital letters **RMD** and are likely to relate to the initials of Richard Mosebury, the Timber Master at Portsmouth between 1801 and 1824, as already indicated in the arisings survey described above. This discovery confirms the presence of such stamps on *in situ* components on-board *Victory* and offers tangible insights into the individuals responsible for the works in Portsmouth Dockyard in

Rase marks and stamps on bulkhead planking - 'RMD', probably Richard Mosebury, Timber Master, 1801-24

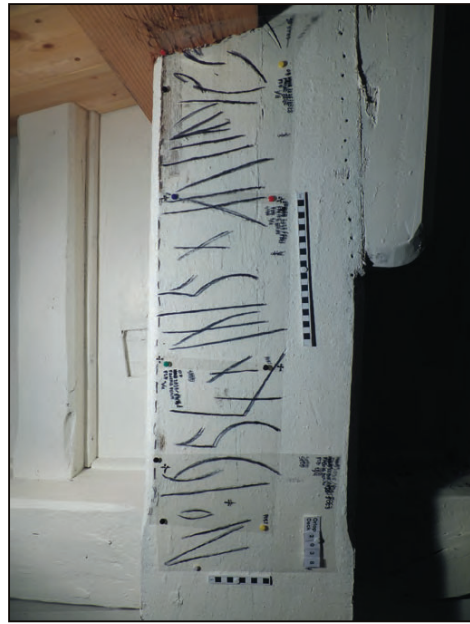
Rase mark on a lodging knee from the Orlop Deck - No. 9052, 1812 date; shown with OHP tracing in place

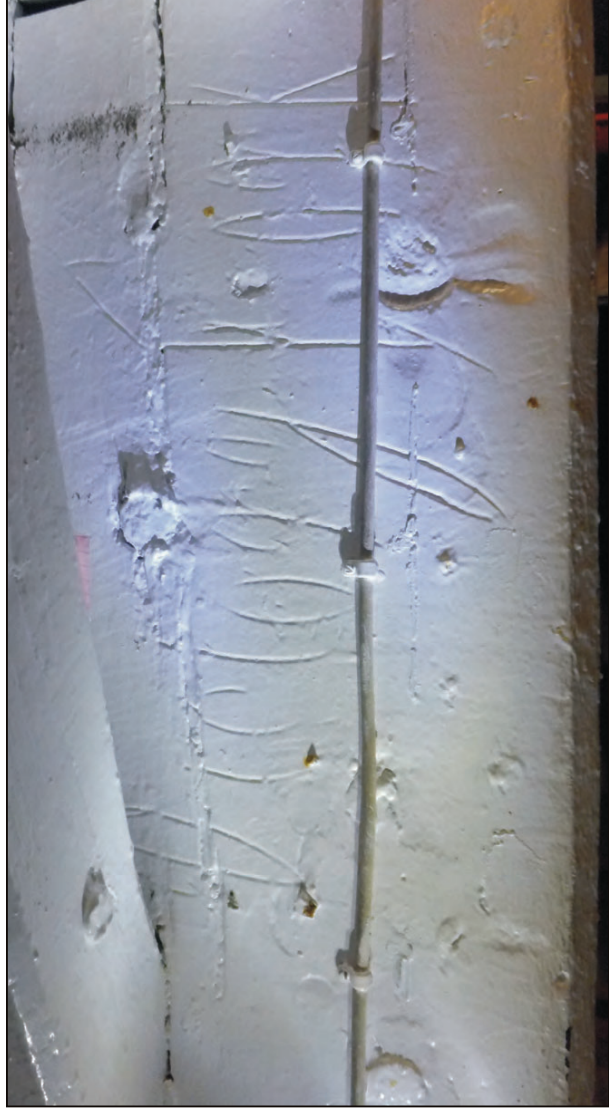
Figure 12

- 6.7.6 Further interesting observations relate to the groups of letters, or initials, associated with the syntax. As outlined above, these almost certainly relate to the individuals who marked the timbers during the various working processes within the dockyard. What is clear is that a spatial analysis of the initials show dominant forms (also noted in the arisings survey); particular examples include **YC** or **YCC**, and **BA**, all of which are represented throughout the deck structure on the Orlop and Lower Deck in particular (Figure 12).

Underside of carling from the Lower Gun Deck showing the standard syntax including the 1815 date and the common letters YC. The syntax has been struck through, indicating that the information given was perhaps incorrect at the time the timber was received into the dockyard.

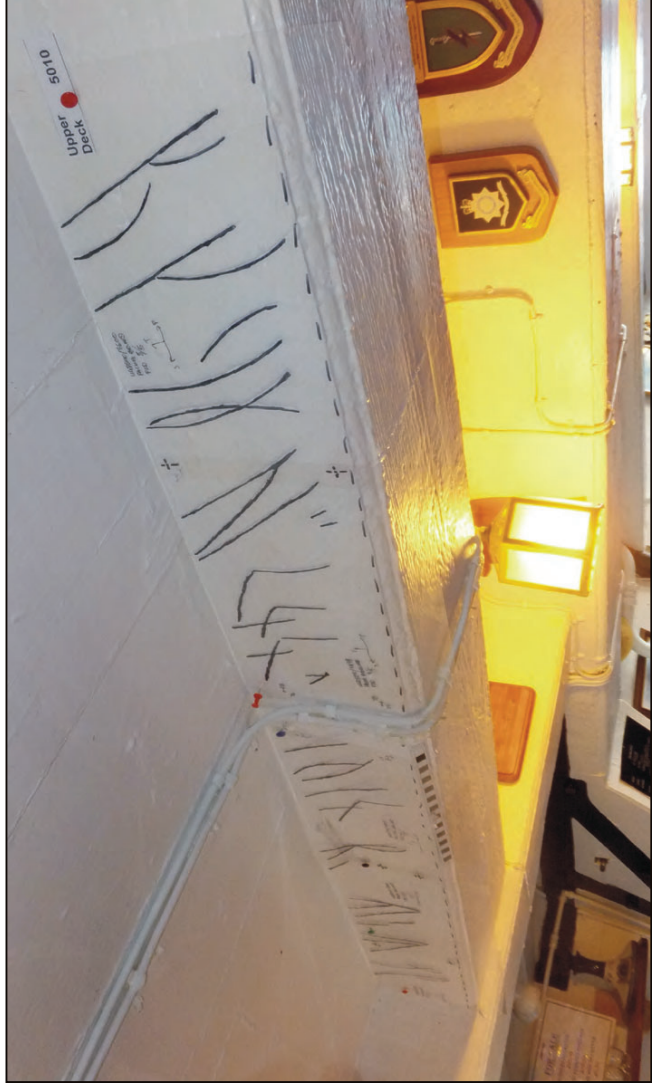
Figure 13

- 6.7.8 The evidence for timber marks containing plain language within the on-board assemblage is well represented. The majority of the plain language relates to deck structure such as carlings and ledges (in addition to the abbreviated marks for elements such as deck beams). In addition to beams, carlings and ledges, examples were noted on other elements. A particularly nice example was noted on a beam arm (Fork) from the forward end of the Lower Deck which read **Victory Fork** (Figure 13).

Lower deck rase mark on a beam arm - 'Victory Fork'

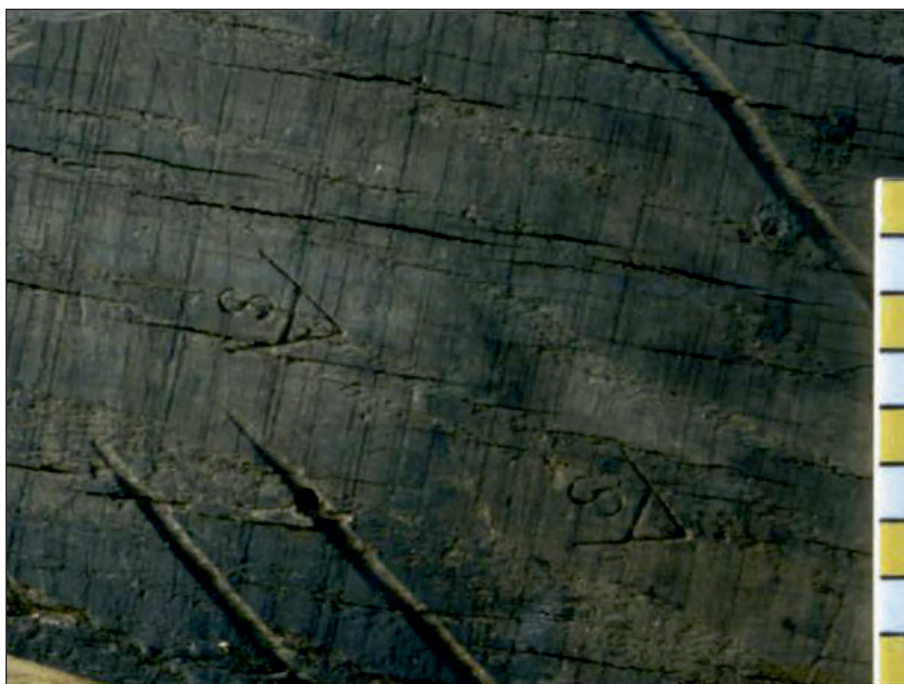
- 5.2.13 Although parts of these marks have been cut out during the cutting of the checks on the side faces of the timber, it is still possible to recognise the basic format of the 'syntax'. The discovery of the stamps on the end grain of this timber also helps to translate these reduced marks. Apart from the distinguishing number, the basic information is the same. The date for the timber is 1814 similar to the other two examples noted above, as is the inverted 5 in Roman numerals. This is particularly prevalent in supporting the interpretation of this mark as pertaining to the cubic contents in square feet of both timbers. This is also supported by the almost exact similarities in the dimensions or scantlings of the two components which are undoubtedly from the same area of the orlop deck. The letters **YC** are also represented and the further capital letters **SW**, more than likely the initials of an artisan. Also of interest is the presence of the word **Carling** in plain language, indicating the type of ship component the timber represents (Plate 2).

Plate 2: Examples of the rase marks and carvings on the end grain of Timber Number 99

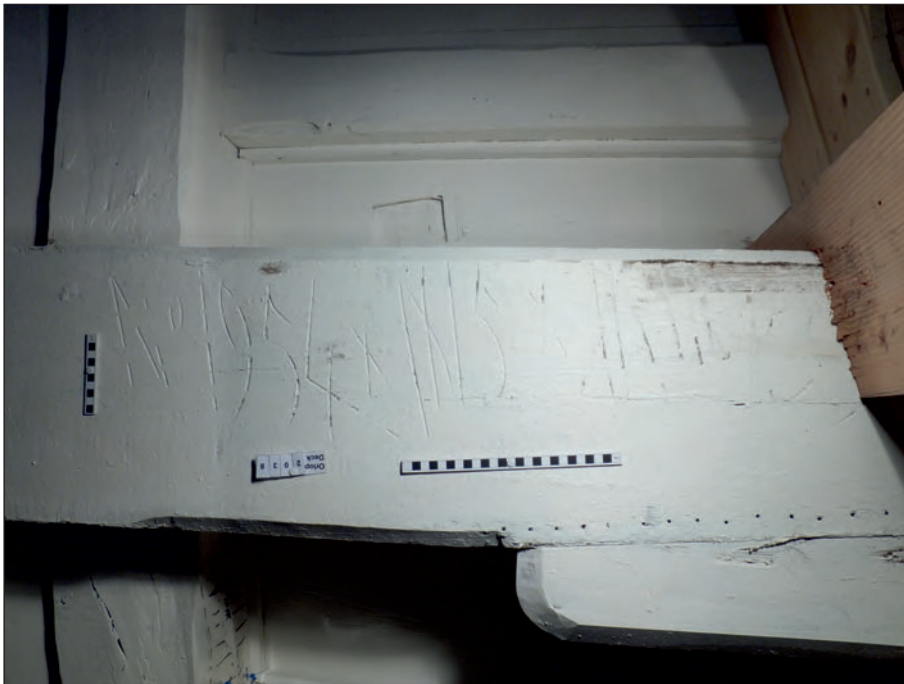
- 5.6.1 With the exception of *HMS Unicorn* the rase marks among the assemblage, such as that noted above, indicate a rare occurrence where we see the name of a vessel (*Victory*) rased on a large percentage of ship timbers (Plate 4). The practice of marking the name of the vessel on the timber was to indicate to which vessel the timber article was destined. This was particularly important if there were a large number of vessels or works carrying on at the dockyard at the same time. The aim was to avoid confusion among the shipwrights when moving the timber from one location to another, for example from the storage berths to the requisite building way. In addition to the name of the vessel, names of individual shipwrights are also represented among the timber assemblage. While examples have already intimated the initials of individual shipwrights or officers, other instances present names written in full, plain language. Examples include the name 'I Procter' on Timber No. 407; the name 'Hill' on Timber No. 416; and the name 'R Sells' on Timber No. 443. Of interest is that all the marks appear on frame timbers and highlight similar styles of marking. It may be the case that the timbers may have all been marked during the same phase by different individuals. Timber No. 443 also gives a date of 1820, possibly indicating a repair episode to *Victory* some time shortly after this date. The question as to the identity of these names is often difficult to establish. In the case of 'R Sells' however, the identity of the individual is intimated in a letter from Portsmouth to the

Plate 4: An example of the name Victory rased on a a section of futtock from the arisings
