HMS/M A1, BRACKLESHAM BAY, WEST SUSSEX

DESIGNATED SITE ASSESSMENT: ARCHAEOLOGICAL REPORT

Ref: 53111.03jj

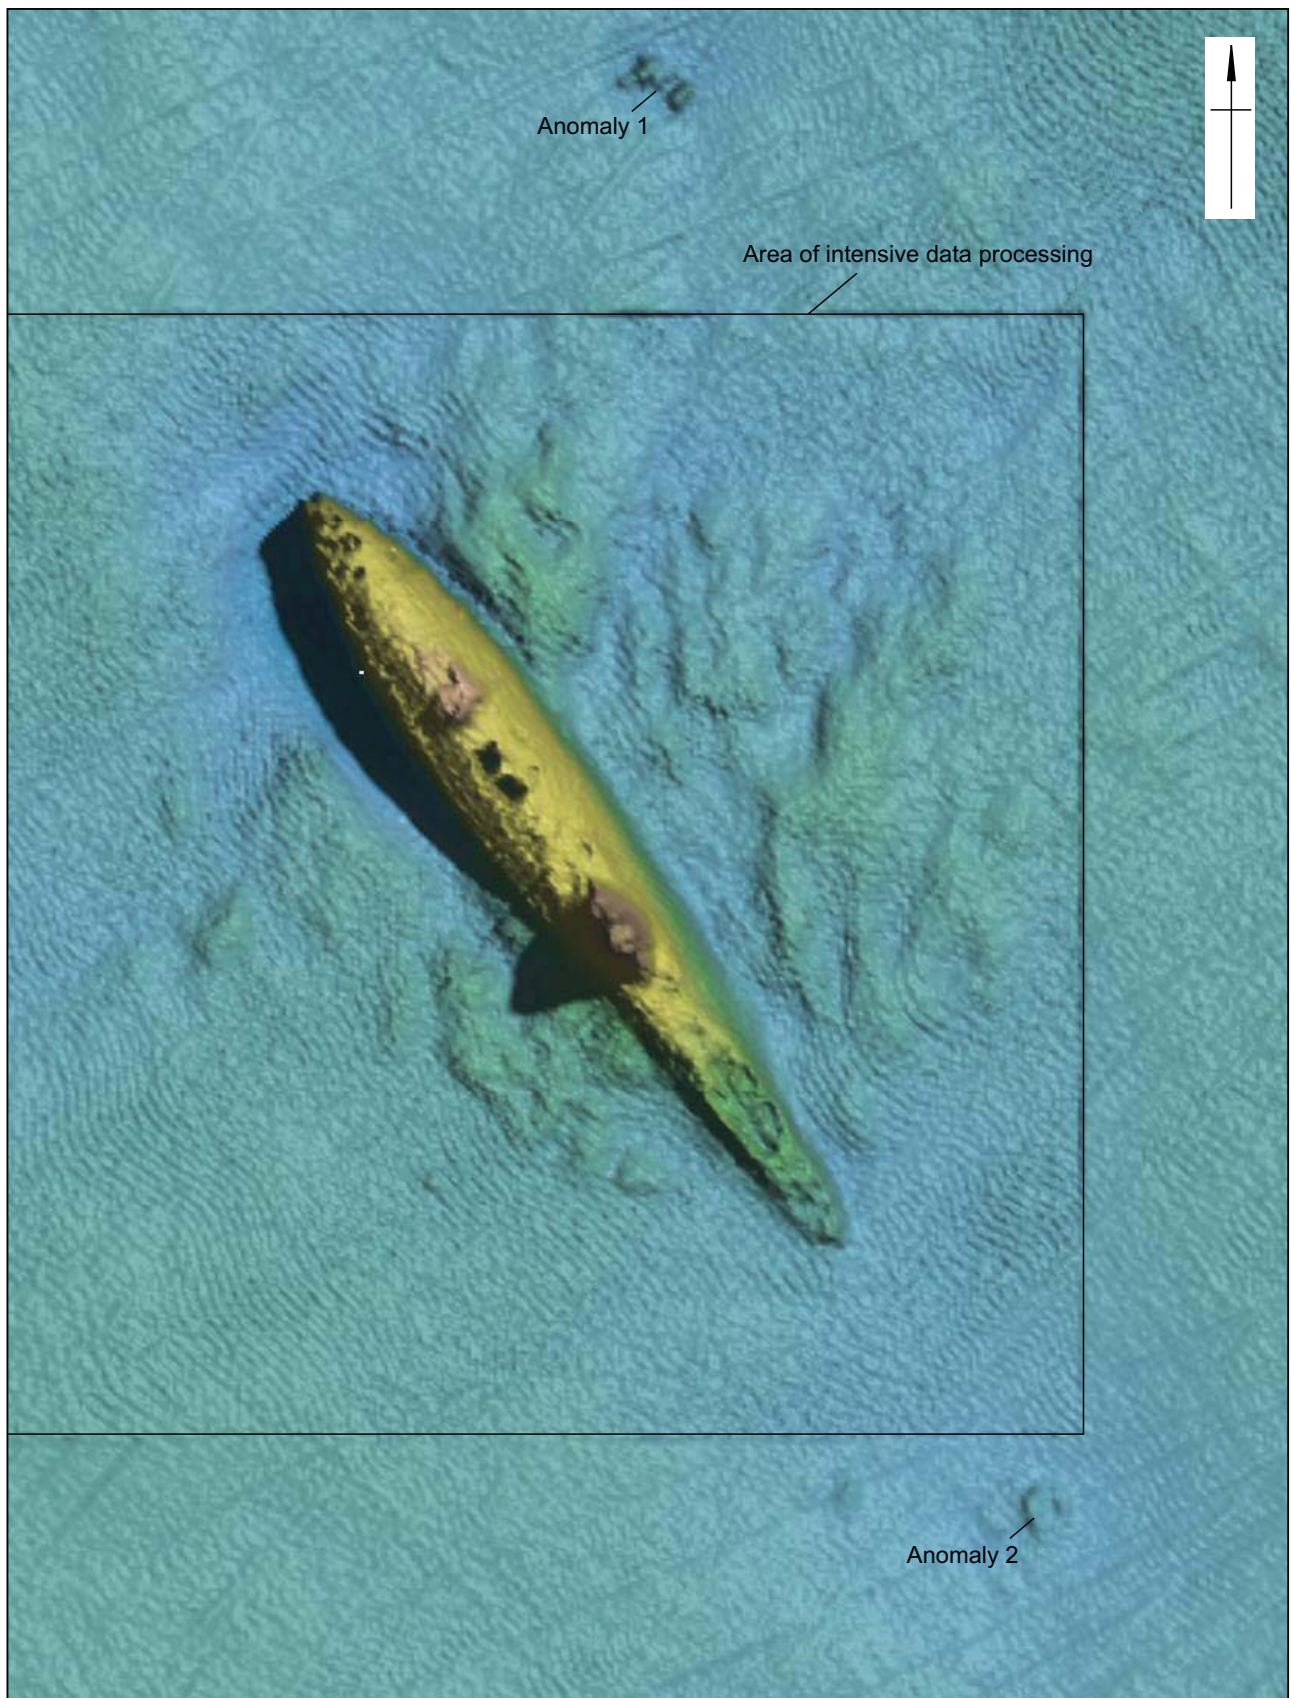
- 5.3.3. There is a small scour toward the bow of the wreck which exposes the under side of the bow cap. This scour is evident on the multibeam image in **Figure 2** and on the section drawing with multibeam insert in **Figure 5**.

- 5.4.3. The outer casing is suffering from severe corrosion pitting along the entire exposed section of the outer, upper casing. This pitting is even visible from the multibeam images of the site, as shown in **Figure 2**.

- 5.4.7. Also in this area a small amount of corrosion pitting was observed during the diving investigation. These small holes on top of casing are visible in the multibeam images, as shown in **Figure 2**. Diver measurements of these areas of corrosion match measurements taken from the geo-referenced images.

- 6.2.4. The rate of corrosion of all elements of the wreck must be monitored annually, ideally using an underwater multiple echo ultrasonic thickness gauge. Using this gauge on selected areas of the wreck structure will show the thickness of metal at each selected point. This will provide an accurate and quantifiable record of corrosion rates on the wreck.

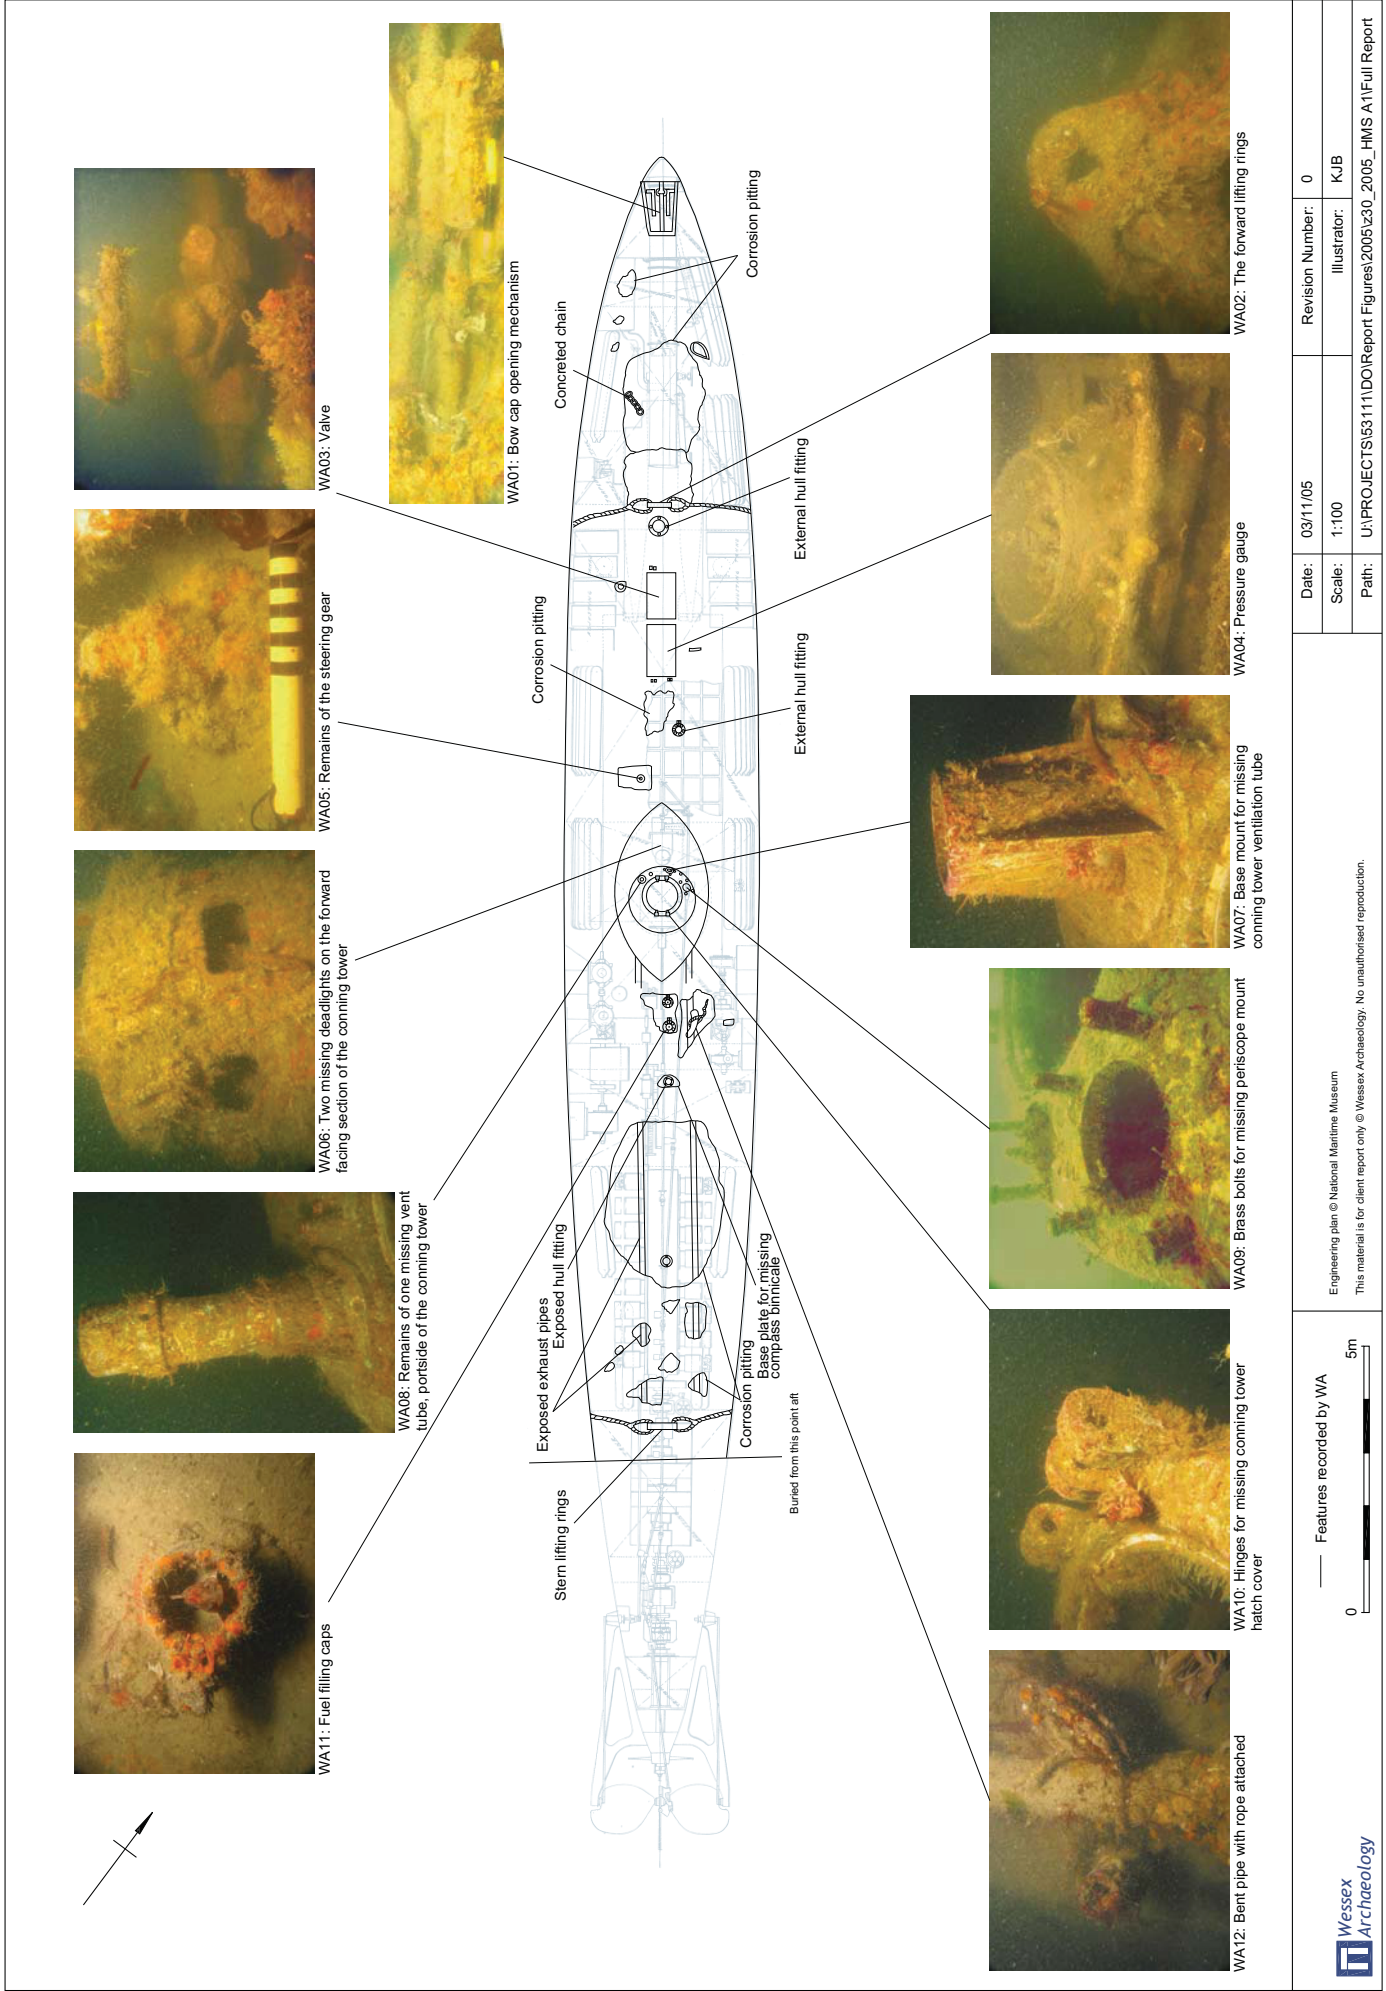
Plan showing areas of damage Figure 4

- 5.4.6. A large amount of the upper casing on top of the hull is missing and as a result the bow cap opening mechanism is now visible, **WA 01** in **Figure 4**.

- 5.4.9. Moving aft toward the conning tower the next feature observed was the forward lifting rings – a unique feature and found only on *HMS/m A1* as a result of her use as a submerged target. They are located 1m forward of the forward torpedo hatch and appear to be intact, with the associated cables that run underneath the hull still in position. The rings are depicted in **WA 02** in **Figure 4**.

- 5.4.18. Just aft of the aft torpedo loading hatch is another area of corrosion to the uppercasing. 1m aft of this corrosion on the port side a break in the casing exposes the remains of the surface steering gear linkage. This is depicted on the contemporary elevation drawing, just forward of the leading edge of the conning tower, **Figure 3** and **WA 05** in **Figure 4**.

5.4.26. Immediately behind the conning tower are the two fuel filling points for the petrol engine. As is clear from **WA 11** in **Figure 4** the caps for these fuel filling tubes are now missing, probably illegally removed by divers. During a recent visit by WA divers to the designated wreck HMS/m Holland 5 a similar fuel filling point was observed, but in this instance the fuel filling cap is still in position.

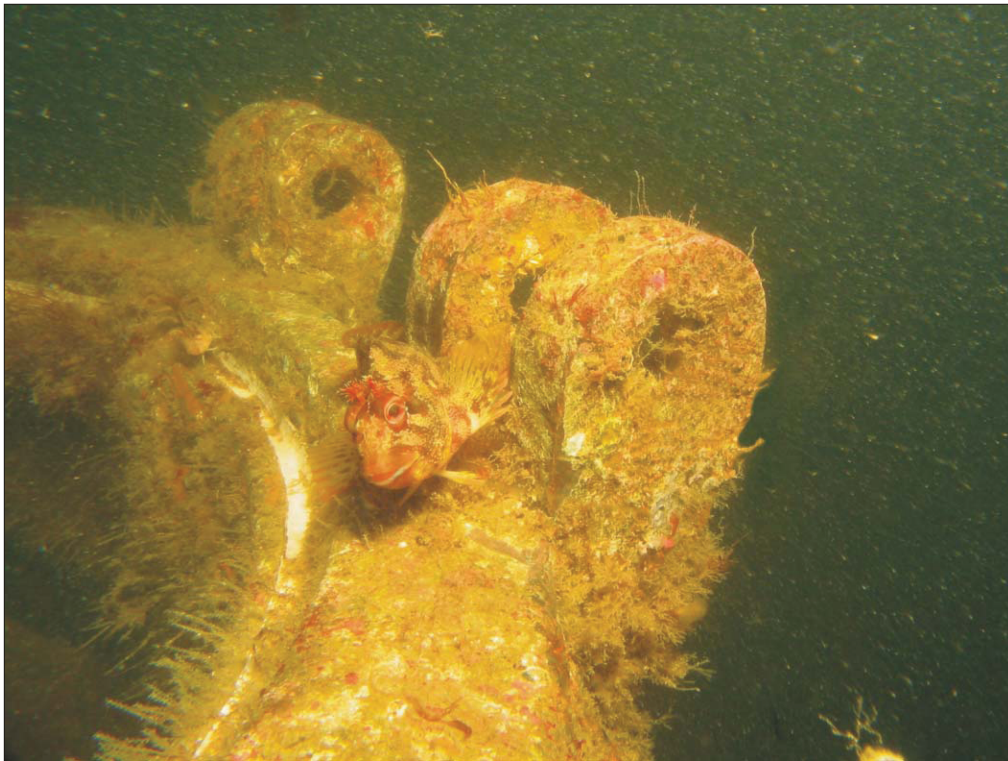
- 5.4.24. On top of the conning tower itself the hatch is now missing. This was removed by the Licensee to prevent its theft. The hinges for the hatch are still in position and are shown in **WA 10** in **Figure 4**. As the hatch cover is missing it is possible to look into the tower, but given the amount of loose pipe work that is contained within the tower diver access is impossible.

Plate 1: Hinges for missing conning tower hatch cover

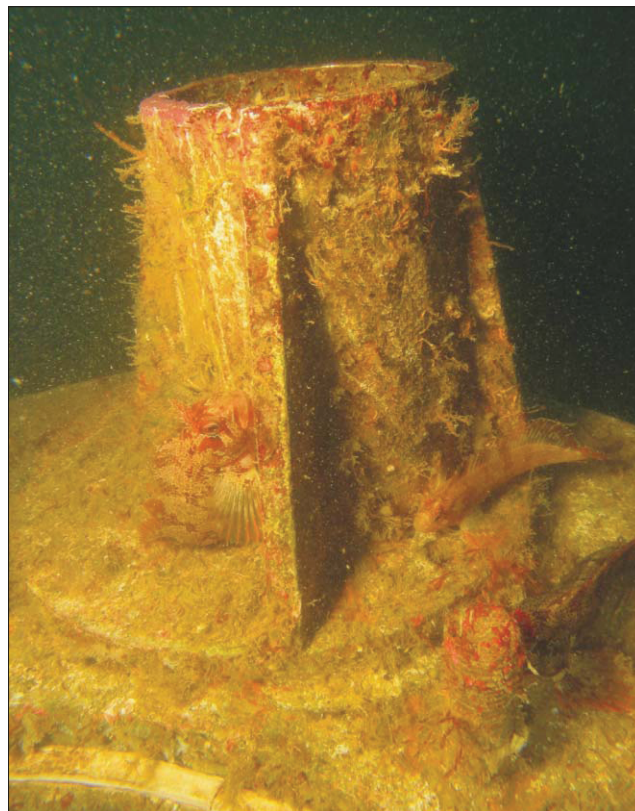
- 5.4.22. All brass ventilation tubes have been removed from the wreck and this is illustrated in **WA 07** and **WA 08**, **Figure 4**.
- 5.4.23. The periscope mount is also missing; all that remains of any periscope fittings are the four brass bolts that would have attached the mount to the top of the conning tower. This was either removed prior to the vessel being used as an unmanned target or removed by illegal diving activity, **WA 09** in **Figure 4**.

Plate 2: Base mount for missing conning tower ventilation tube

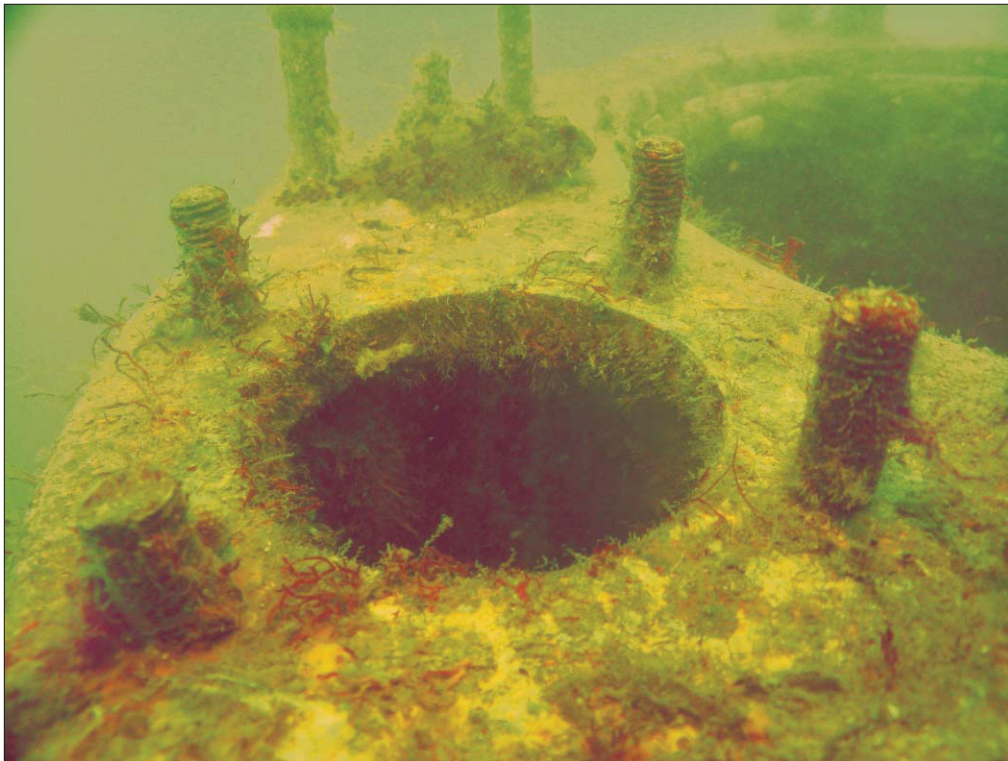
Plate 3: Brass bolts for missing periscope mount

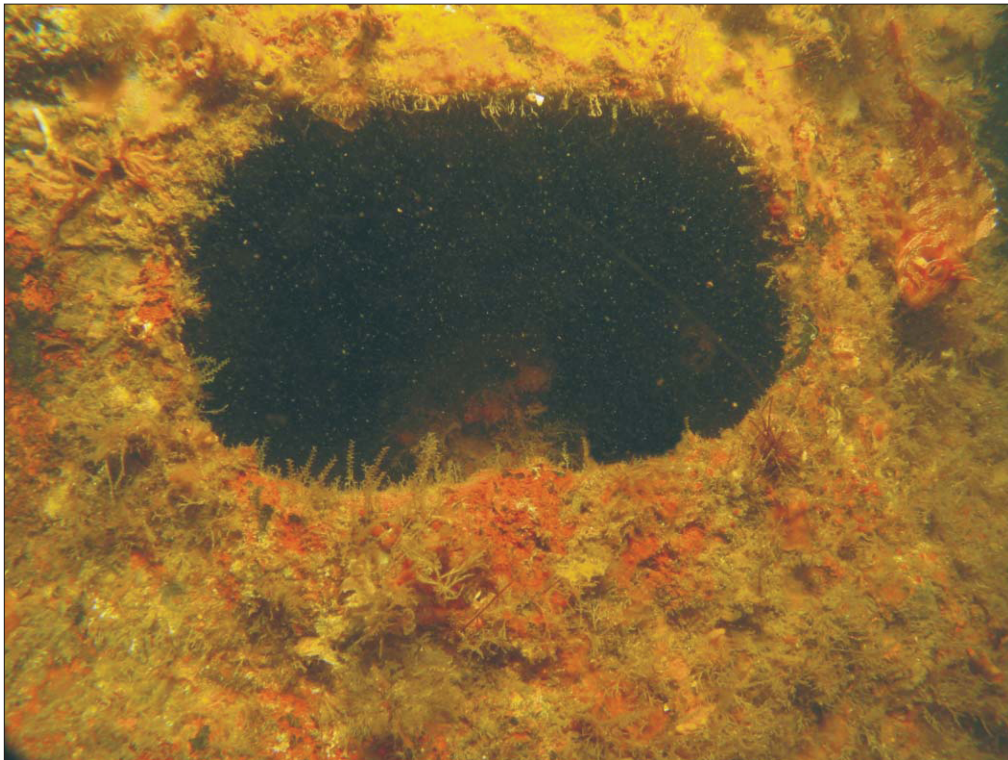
- 5.4.19. The conning tower is the high point and is roughly the centre point to the wreck. An initial survey of the exterior surfaces of the tower was quick to show that all the glass deadlights are now missing, leaving empty voids in the tower, **WA 06** in **Figure 4**.

Plate 4: Missing deadlight

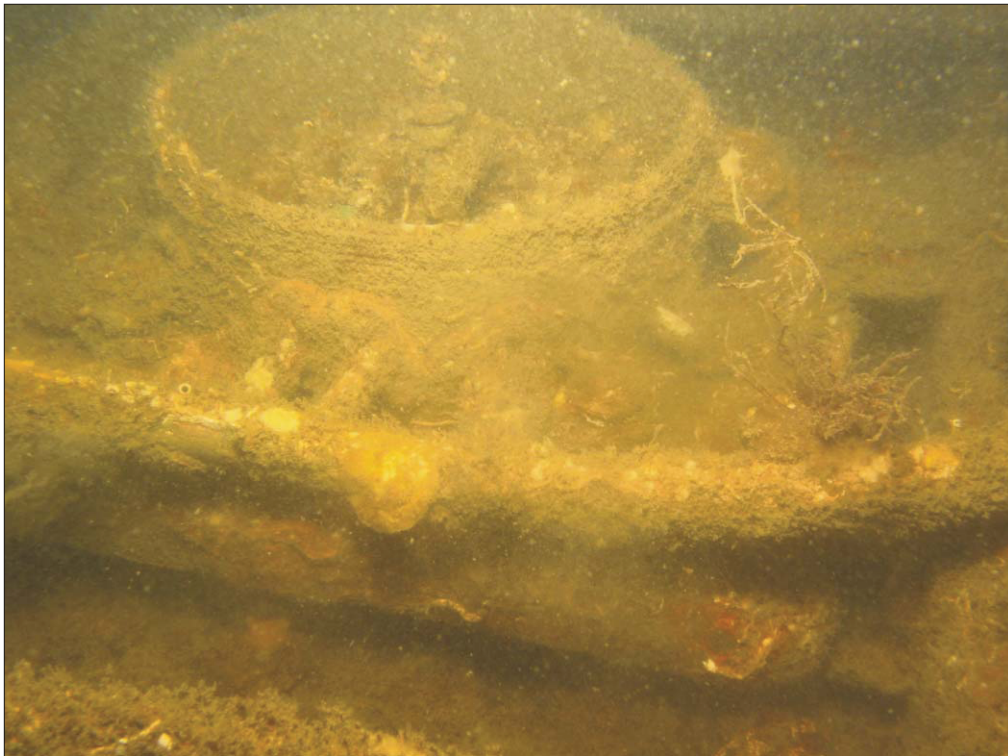
- 5.4.17. Also observed in this internal survey were the remains of a pressure gauge. **WA 04** in **Figure 4** shows this gauge, but it is apparent that the glass cover and graduated backing to the gauge are no longer in position. This is probably a result of illegal diving activity.

Plate 5: Pressure gauge

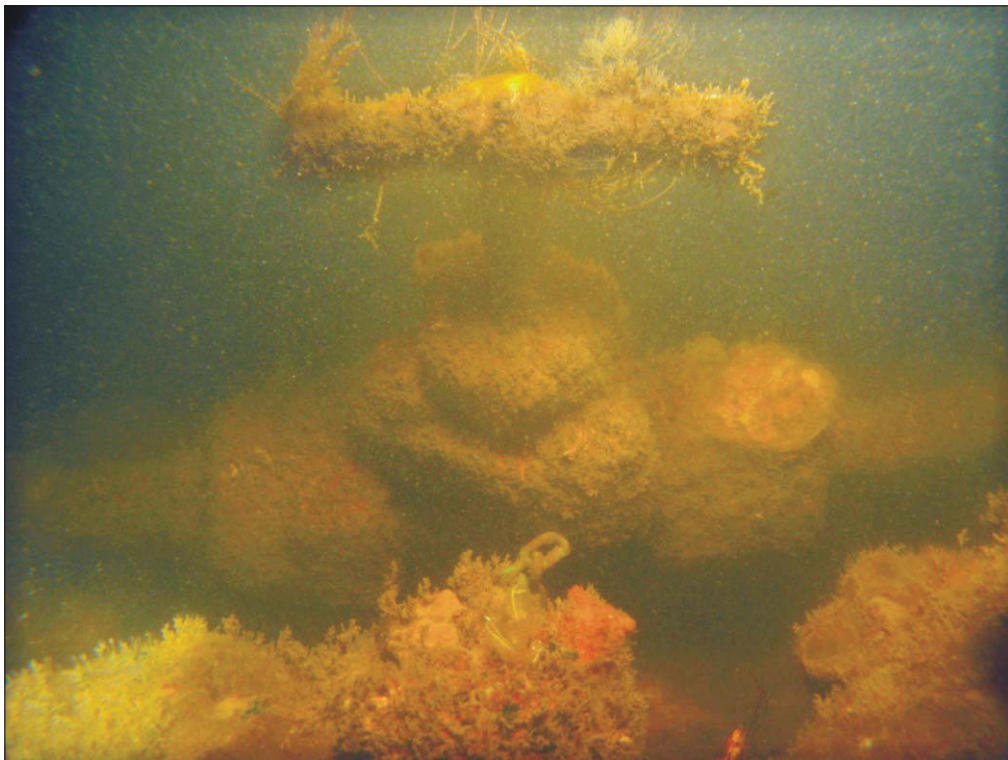
- 5.4.16. A number of high pressure lines, presumably for compressed air were observed running along the sides and ceiling of the hull interior. At least two quarter turn valves fitted to these pressure lines were also observed, with an example of one being depicted in **WA 03** in **Figure 4**.

Plate 6: Valve
