Area A3, Castleward Phase 2, Derby

Archaeological Post-excavation Assessment

Ref: 209420.1
November 2018

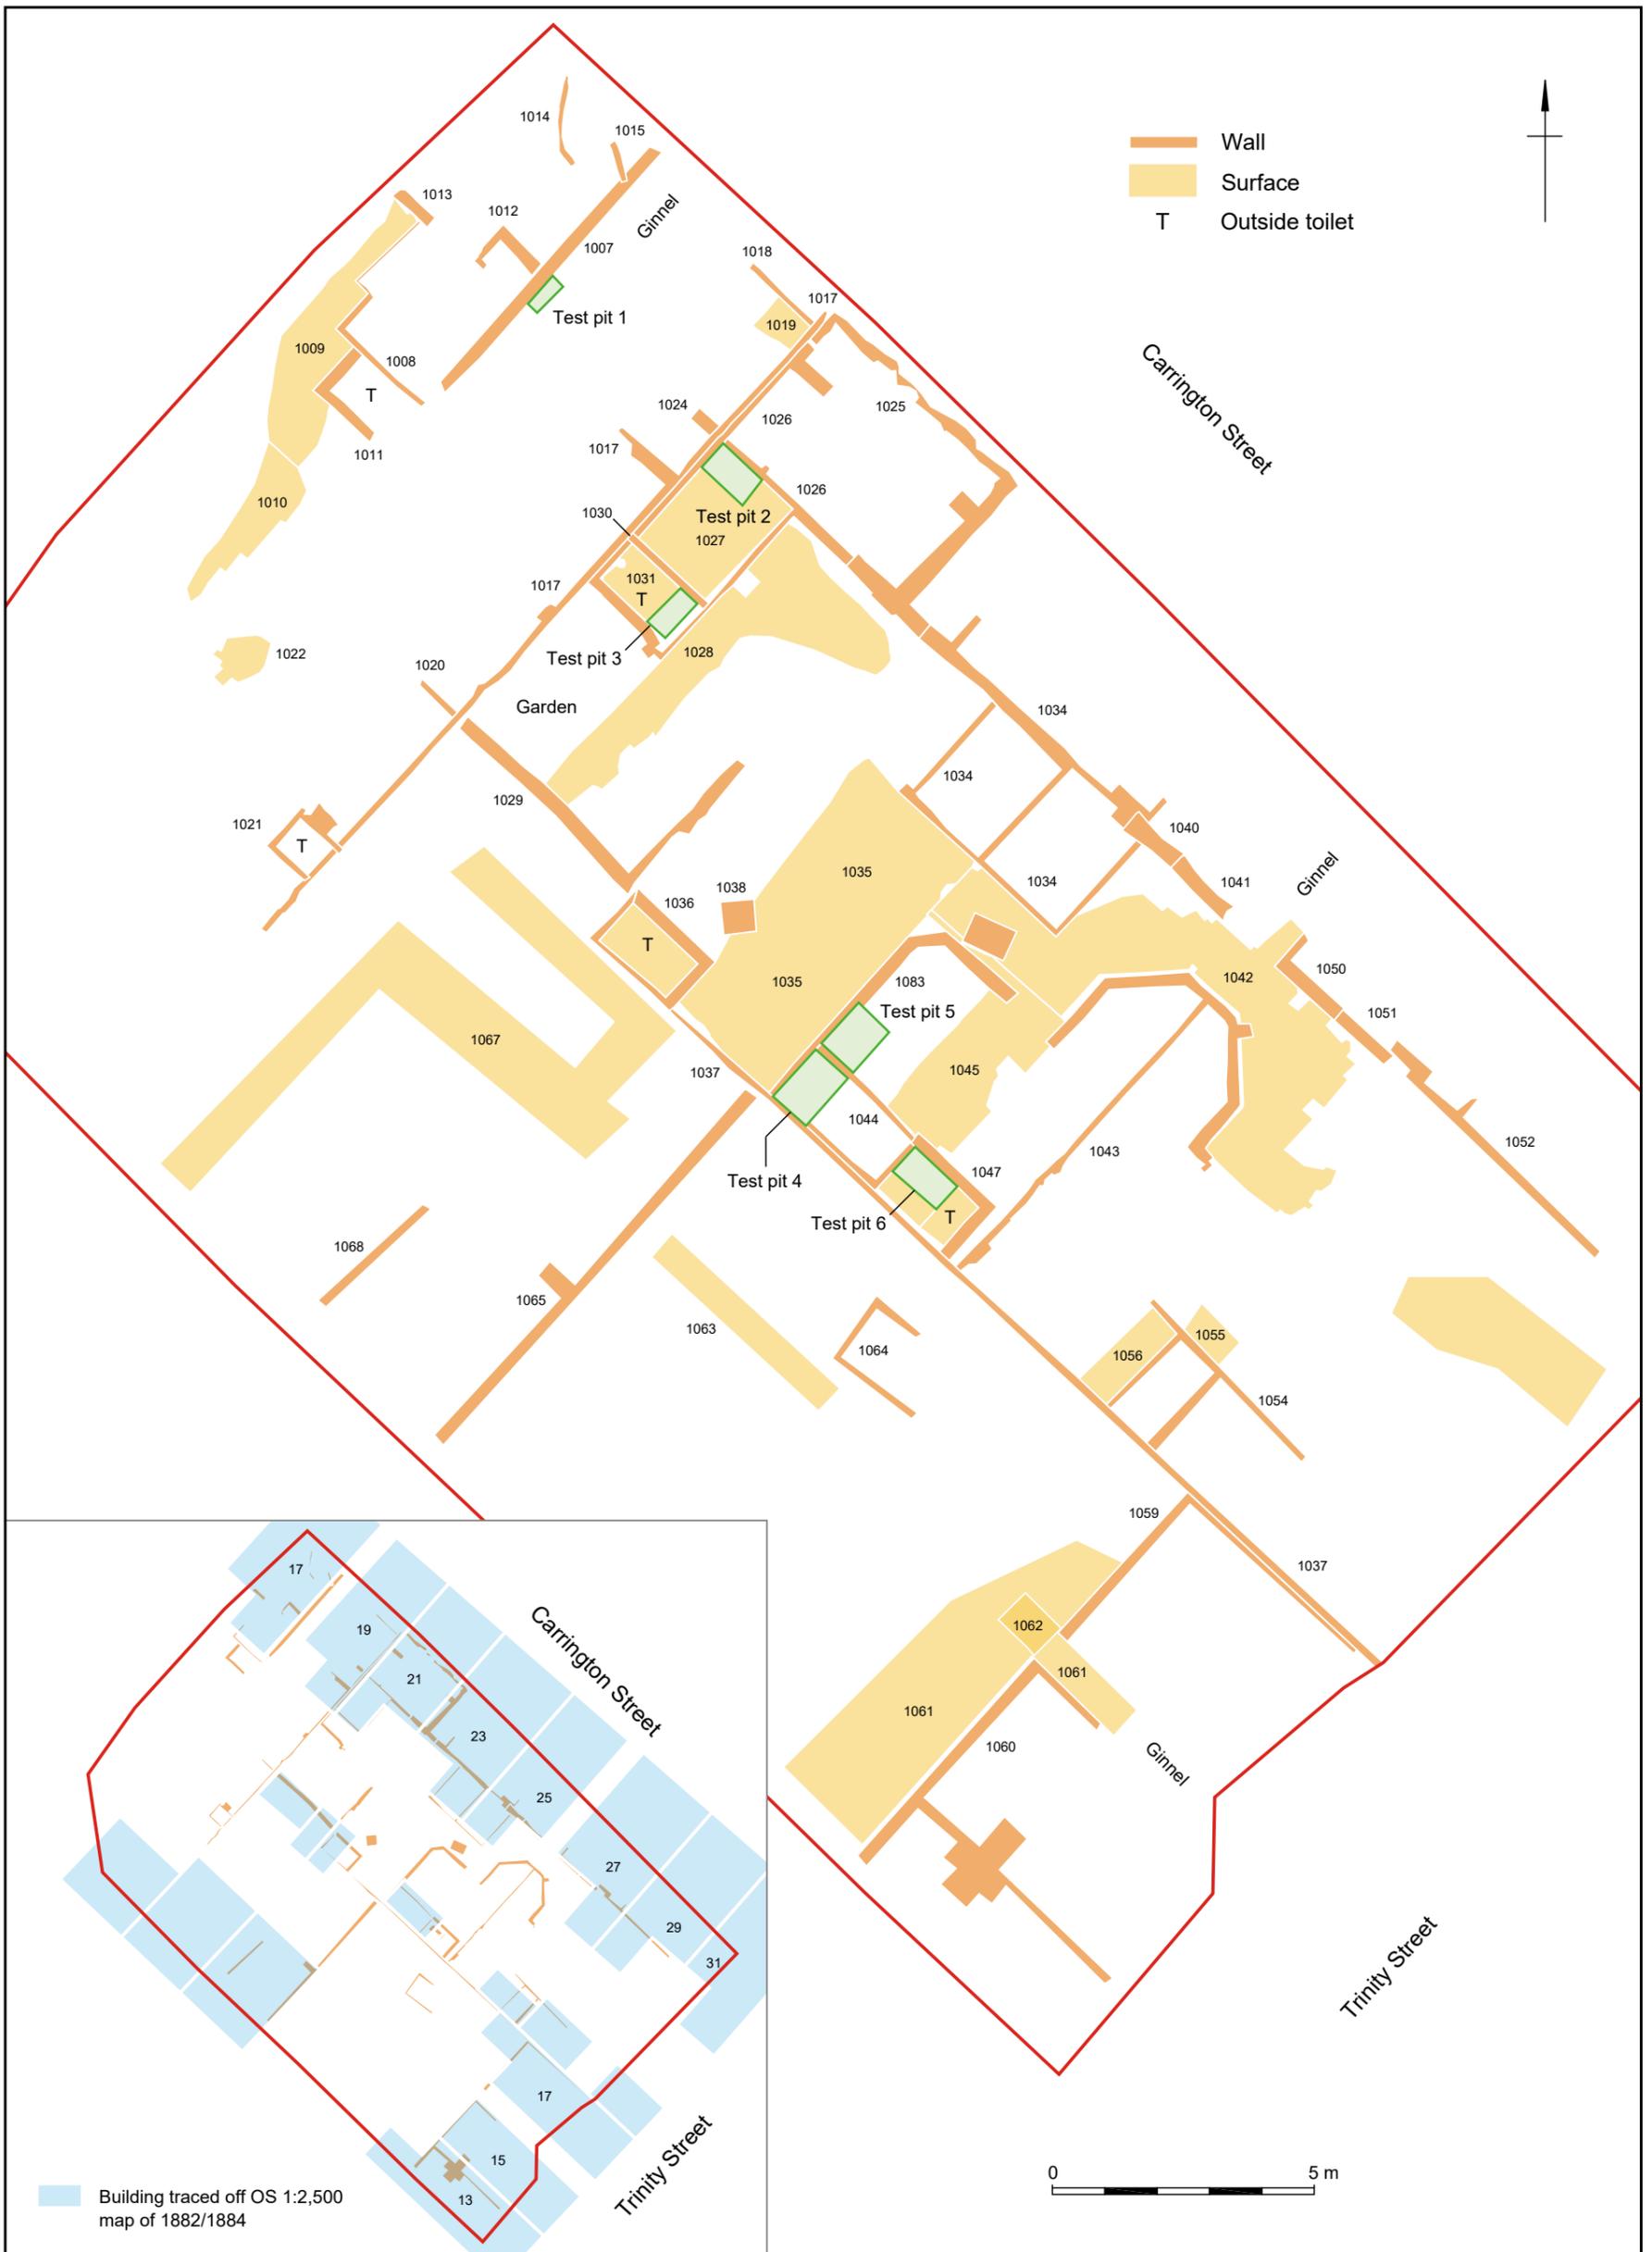
Figure 2

Building traced off OS 1:2,500 map of 1882/1884

Site plan

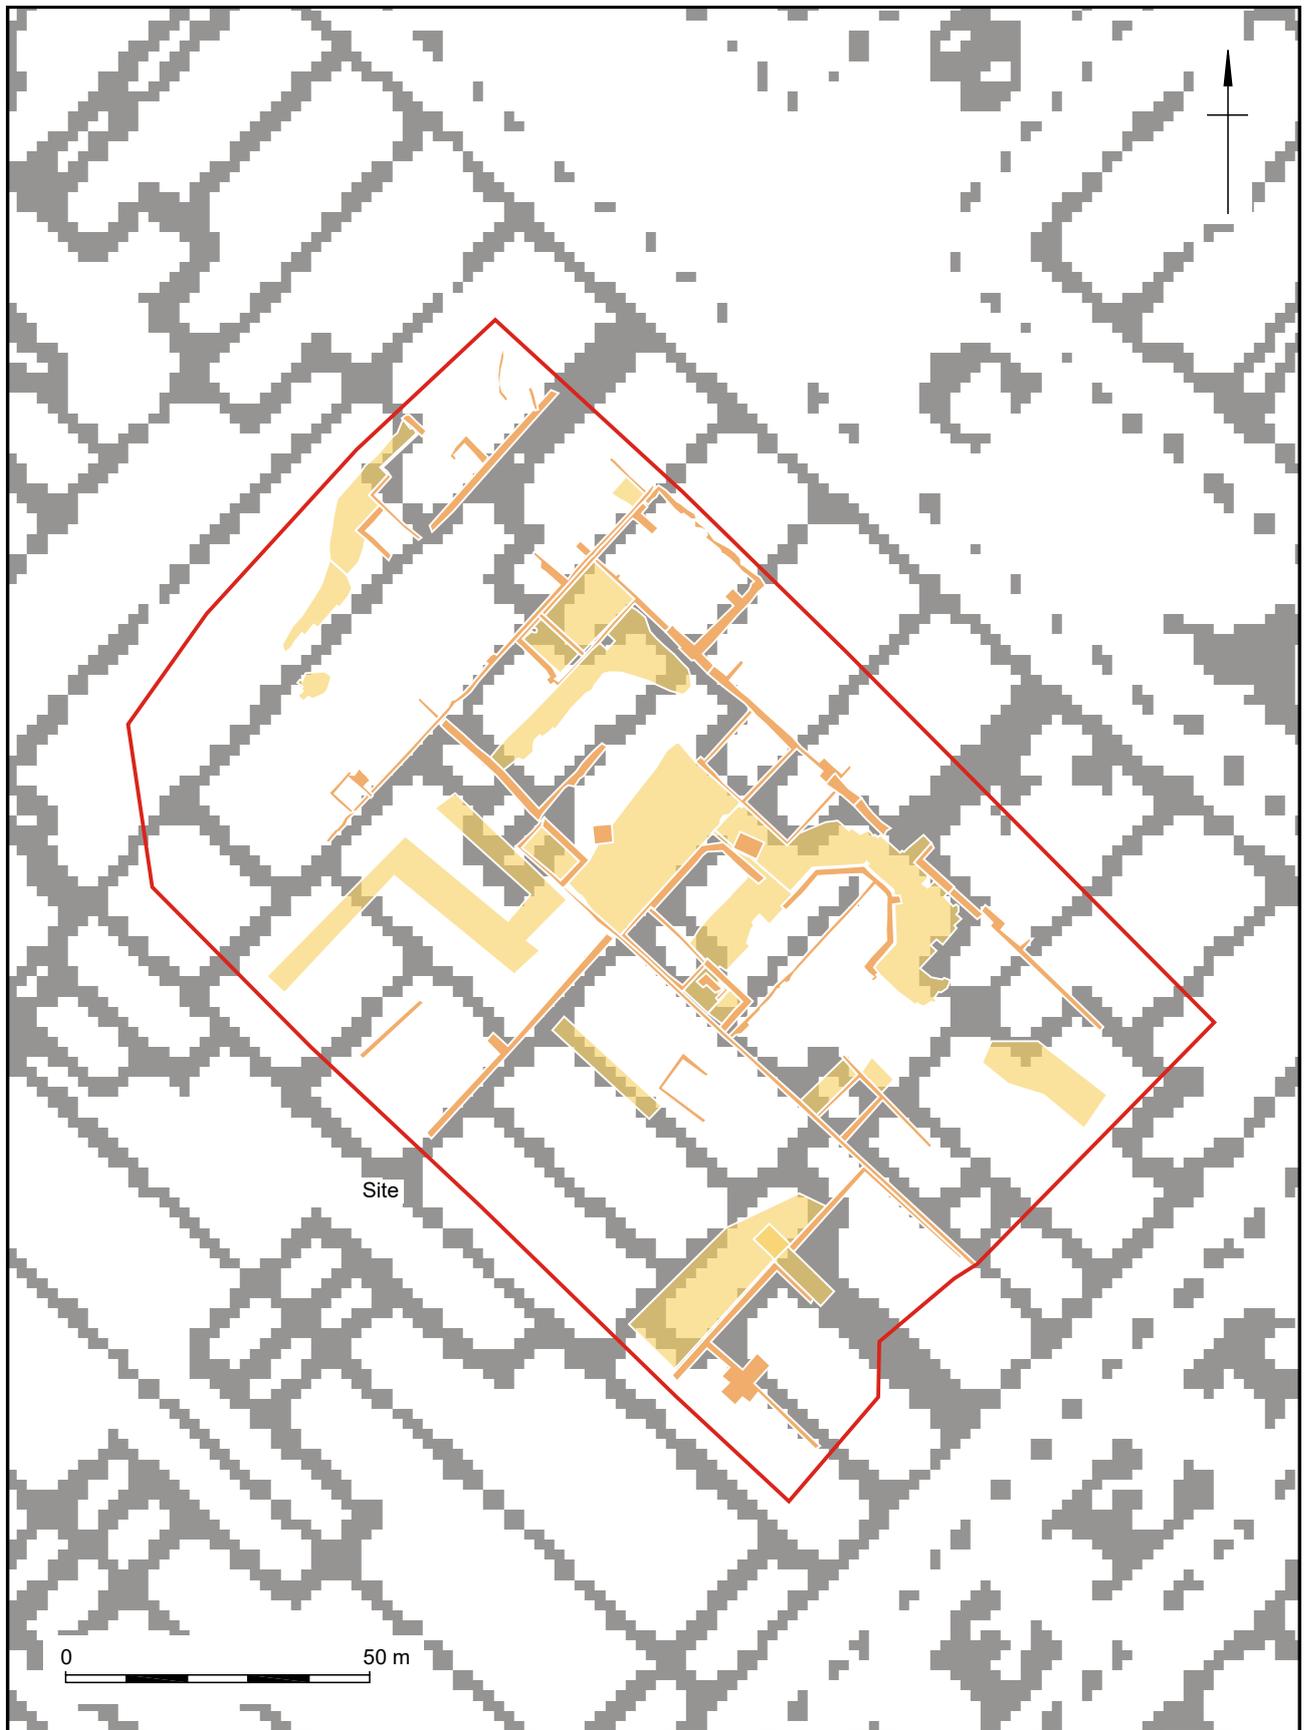
Figure 3

Exposed remains overlain onto 1882/84 Ordnance Survey 1:2,500 map

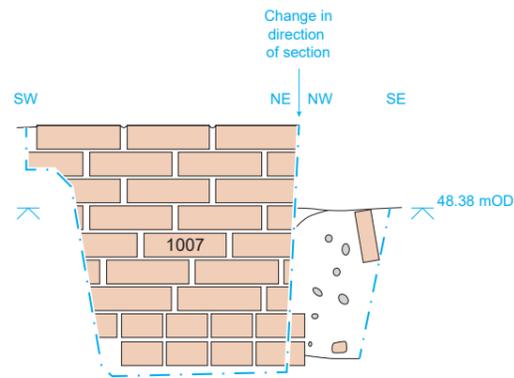
Testpit 1: section drawing

- 5.3.6 A hand-dug sondage (test pit 1: 0.7 x 0.3 m) was dug in the ginnel between 17 and 19 Carrington Street, up against wall 1007 (Fig. 4; Pl. 2). This revealed nine courses of wall 1007, with the bottom two courses comprising a stepped-out foundation of bricks laid on a header course on bed. The footings were abutted by a brown sandy clay levelling layer/fill with stone and brick rubble that was hard to distinguish from the modern crush that sealed the demolished remains across the Site.

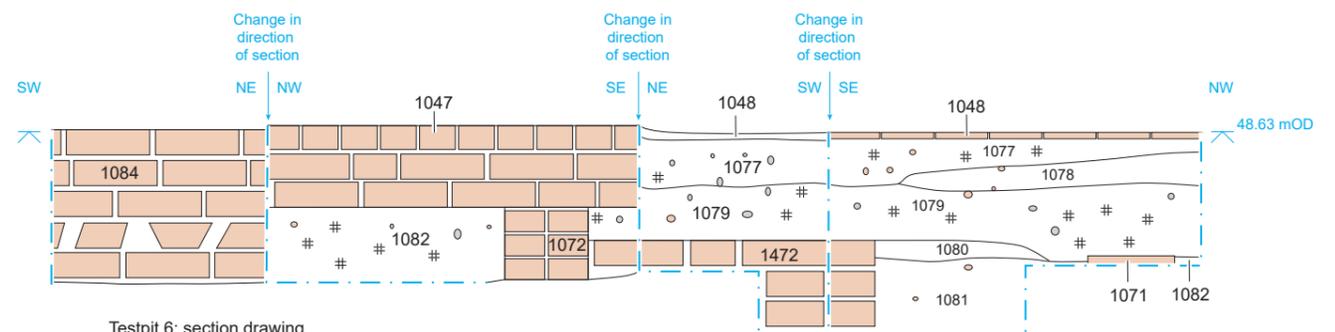
Testpit 6: section drawing

- 5.3.18 Test pit 6 (1.1 x 0.6 m) was excavated through the cheque-tiled floor in the northern corner of the toilet (Fig. 4; 9–10). Beneath the tiled floor, the remains of two earlier walls (1072 and 1084) were exposed. Both walls were aligned north-east to south-west, and lay 0.9 m apart. Wall 1072 was constructed of handmade red brick (230 x 110 x 70 mm) set on bed on a stretcher course and bonded with a mid-brown grey lime mortar. Three courses were seen and the wall was one skin thick. Wall 1084 was of a similar build to 1072, although a stepped-out foundation course was seen. A stack of bricks, two skins thick and laid on bed on a stretcher course, lay between the two walls, and continued to the north-east underneath the later blue brick wall and the limits of the test pit.

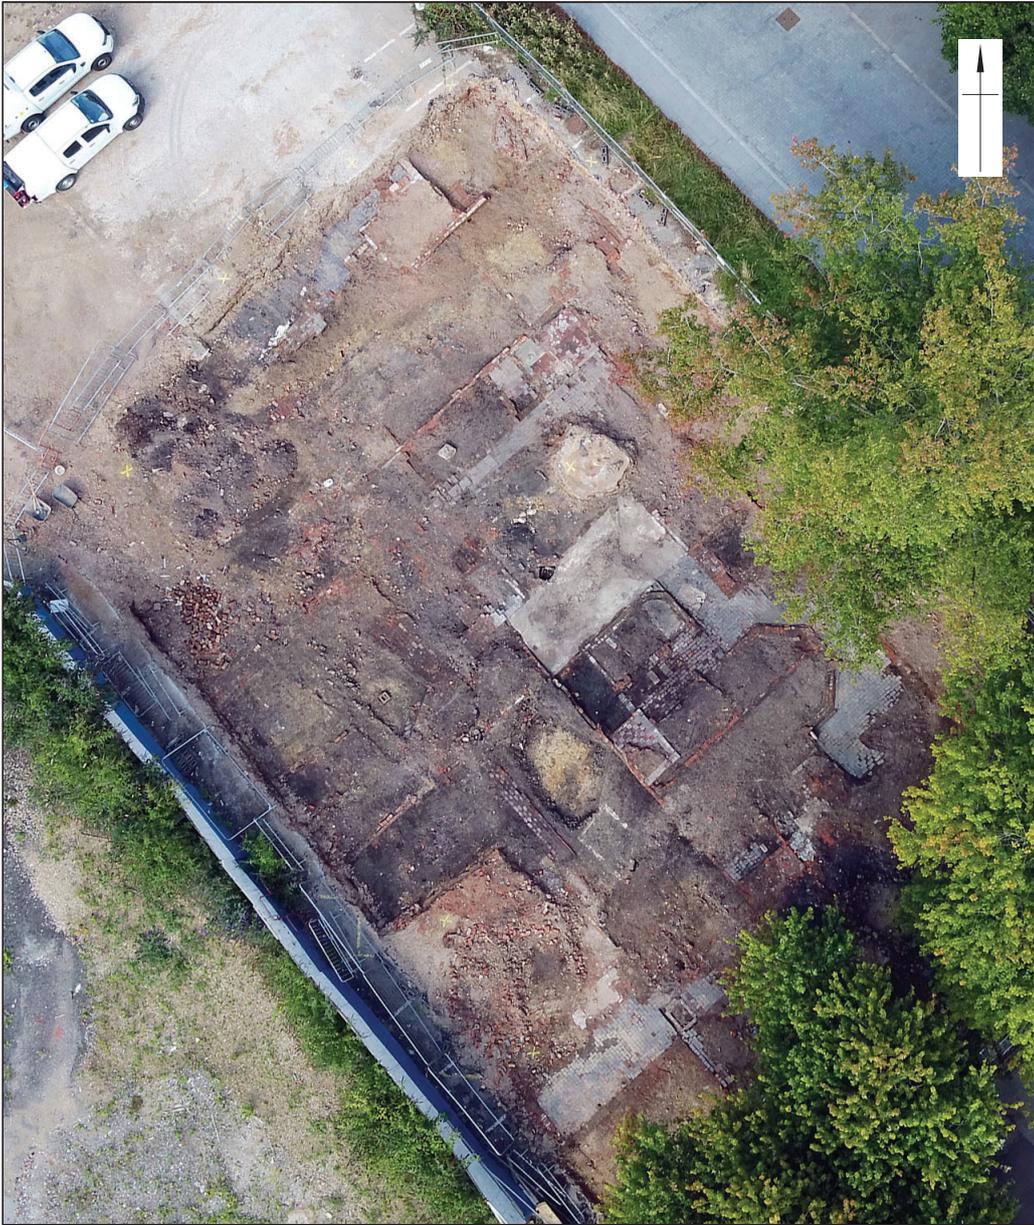
Plate 1: Aerial view of remains

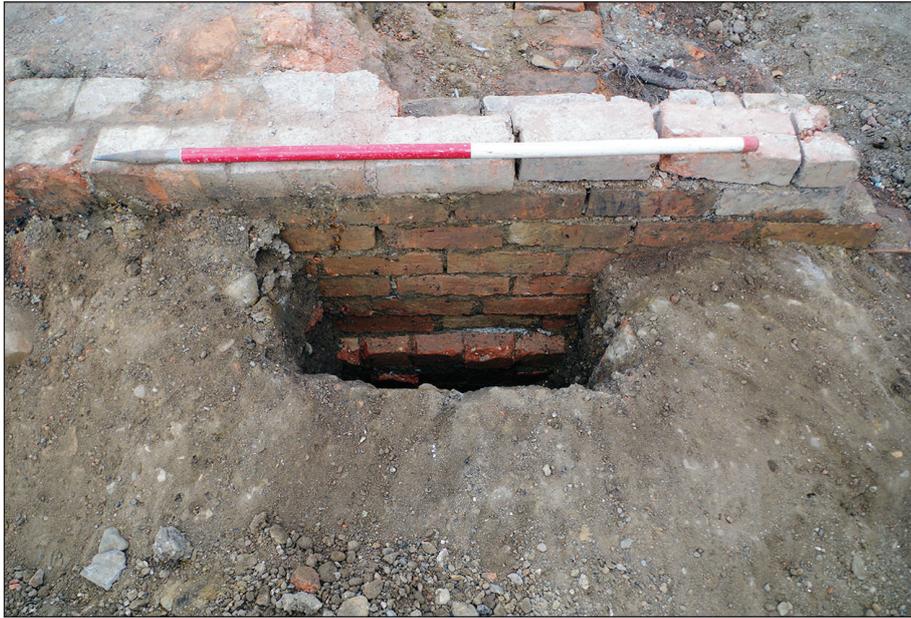
Plate 2: Test pit 1: camera facing north-west

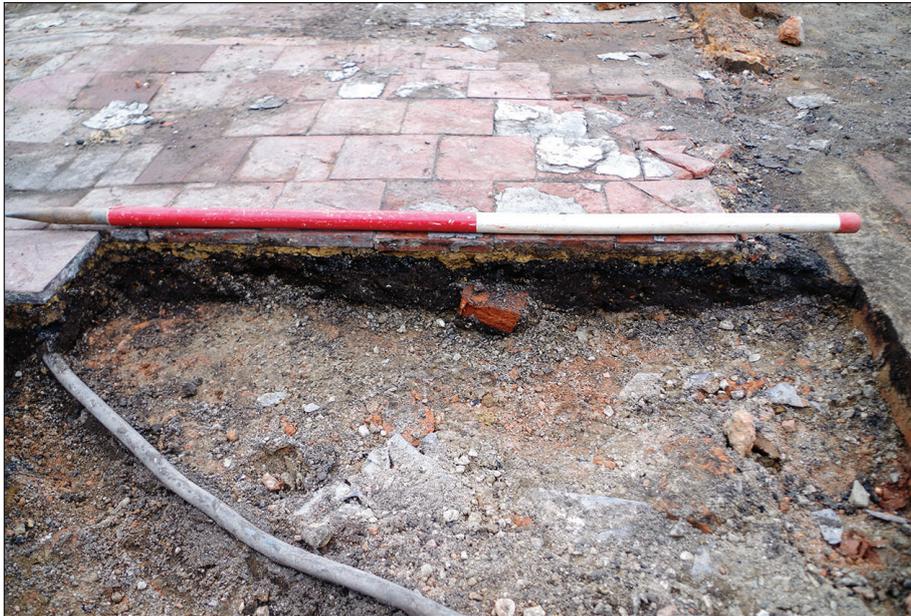
Plate 3: Test pit 2: camera facing south-west

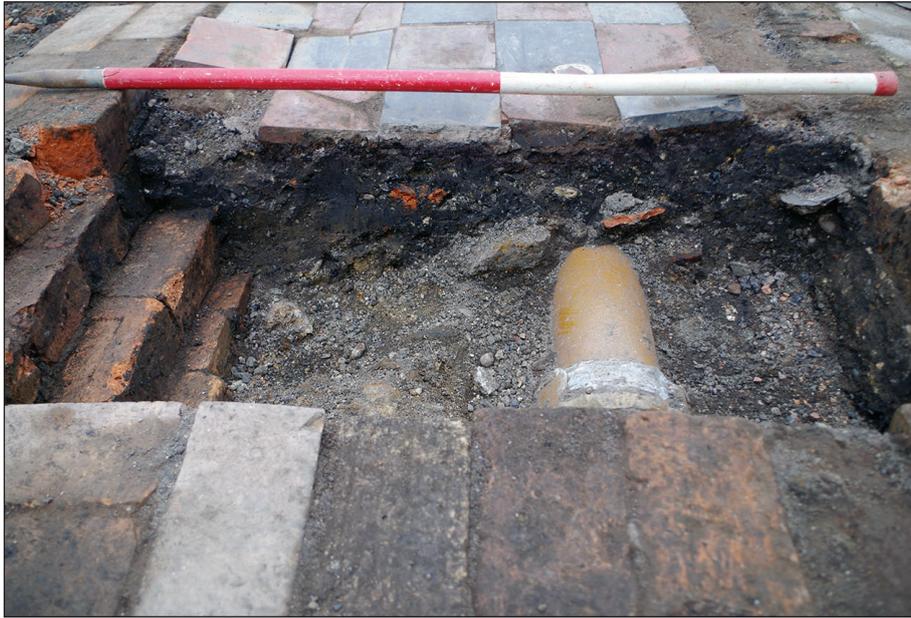
Plate 4: Test pit 3: camera facing north-west

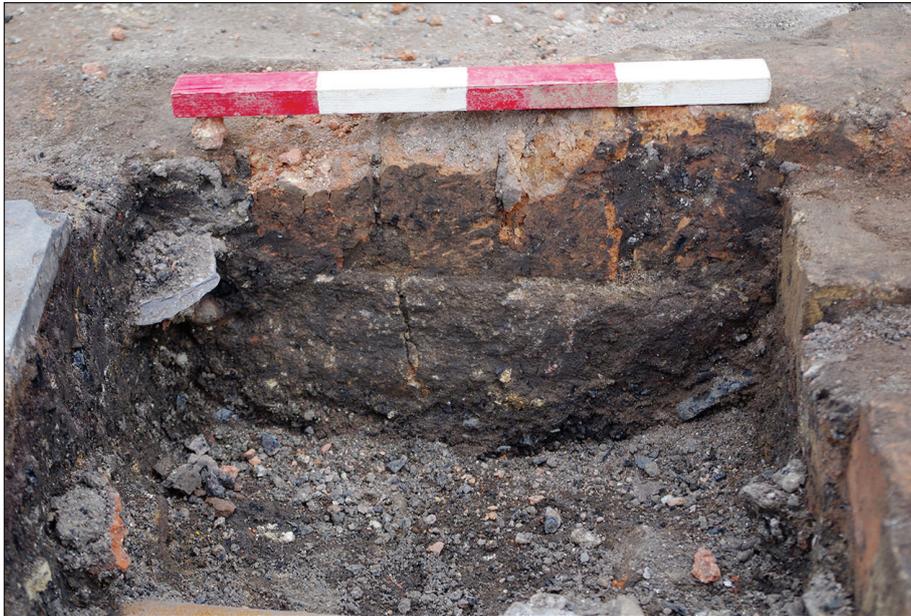
Plate 5: Test pit 3: detail of sandstone footing beneath wall 1030

have a foundation course of yellow sandstone blocks supporting a rowlock course of red handmade bricks (Pl. 5).

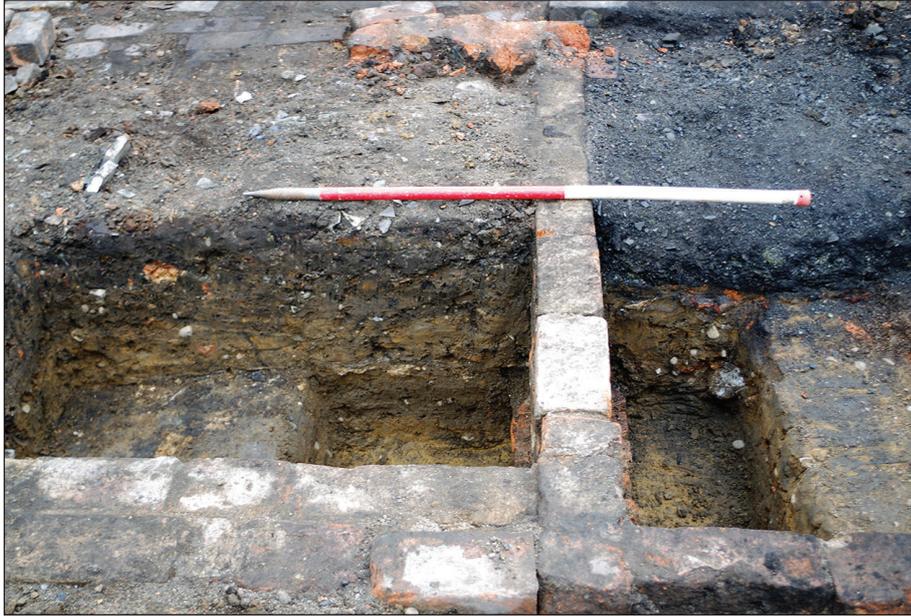
Plate 6: Test pits 4 and 5: camera facing south-east

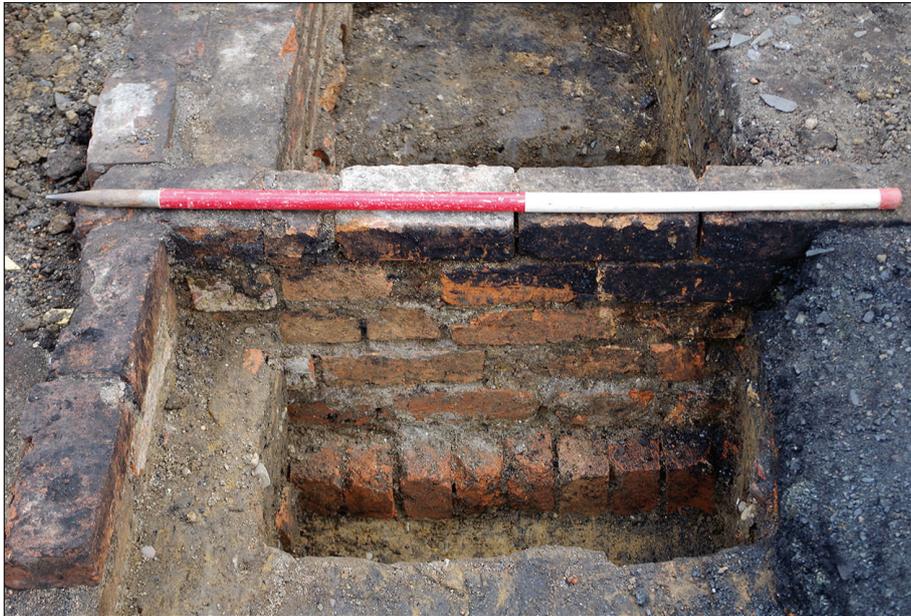
Plate 7: Test pit 4: camera facing north-east

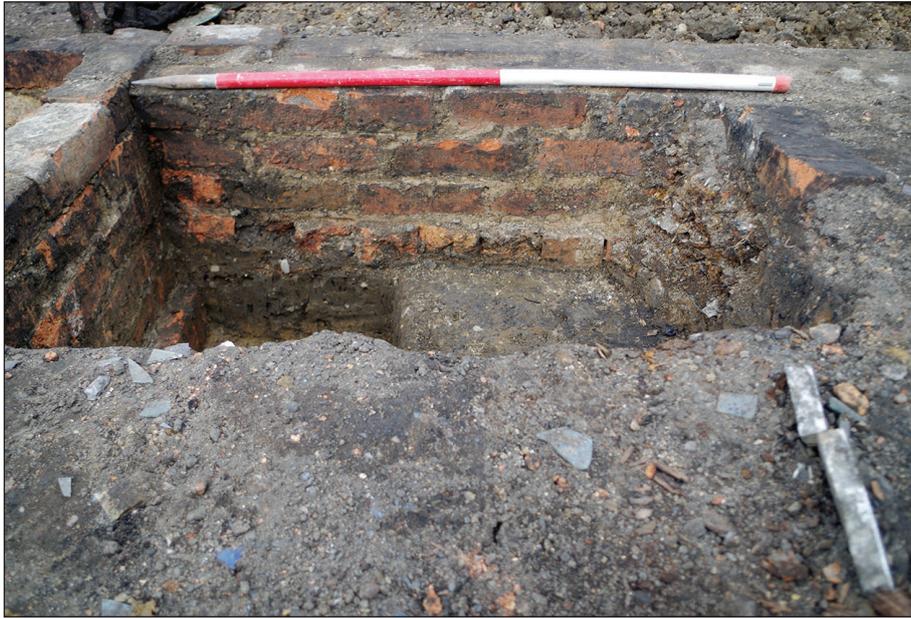
Plate 8: Test pit 5: camera facing north-west

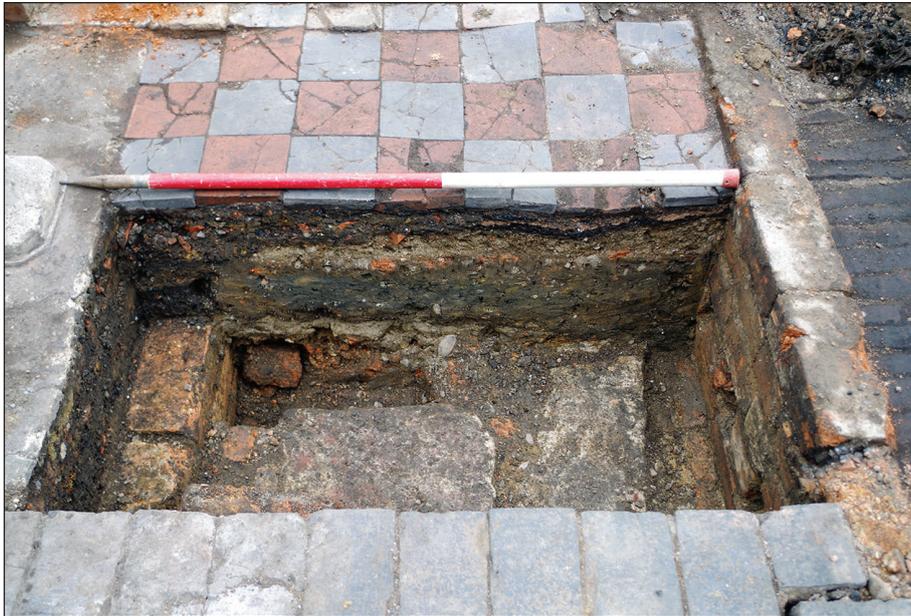
Plate 9: Test pit 6: camera facing south-west

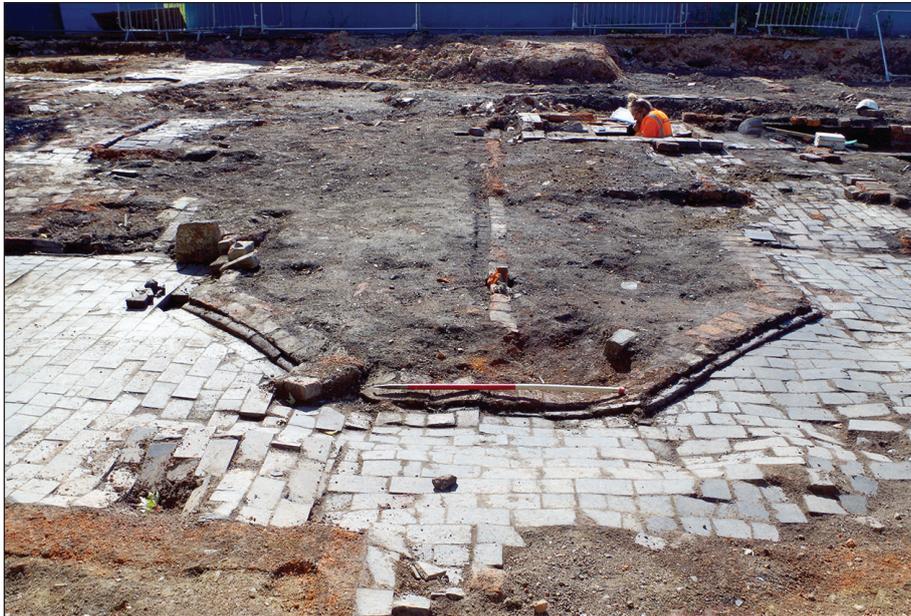
Plate 11: General view of area to rear of numbers 25 and 27 Carrington Street (camera facing south-west)

- 5.3.22 Other remains noted to the rear of 25 Carrington Street include north-east to south-west garden walls separating it from neighbouring properties (1083 and 1043) and an expanse of external yard surface, comprising a mixture of brick types bonded with black ash mortar (1045).
