Sylvester Gardens, Sheffield South Yorkshire

Post-excavation Assessment and Updated Project Design

Planning Ref: 06/01918/FUL/17/00604/FUL
Ref: 118762.2
November 2019

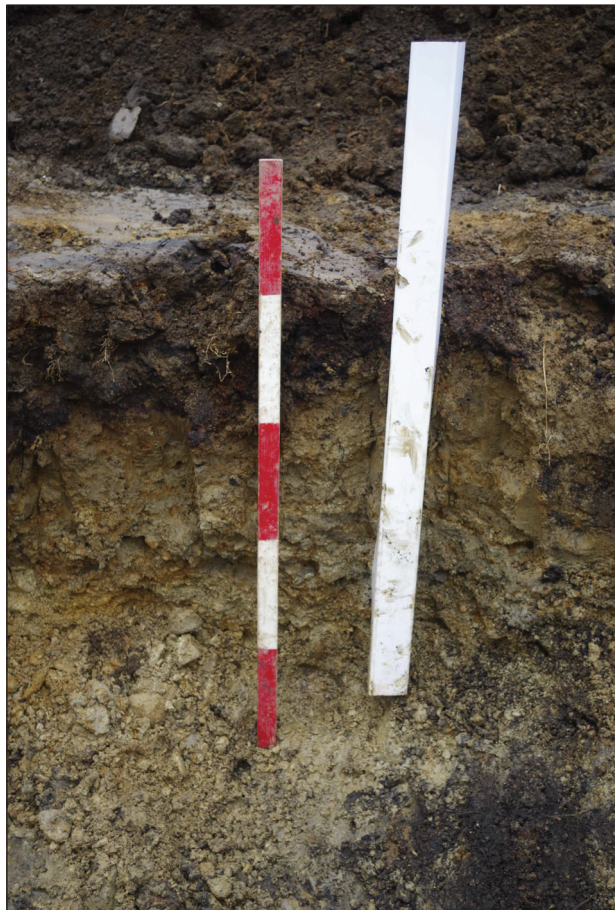
Plate 1: East facing section of sondage showing monolith in situ.

- 7.4.3 In monolith sample 101 we have evidence of episodic depositional events. High energy fluvial gravels, overlain by lower energy finer grained deposits of clay, silt and sand. The variable fine to coarse nature of the sediments indicates that alluvial deposition alternated between high and low energy, incorporating localised lithic inclusions. Iron staining and concretions observed within the alluvial deposits indicate the effects of redoximorphism caused by repeated post-depositional waterlogging of the deposits over an extended period.

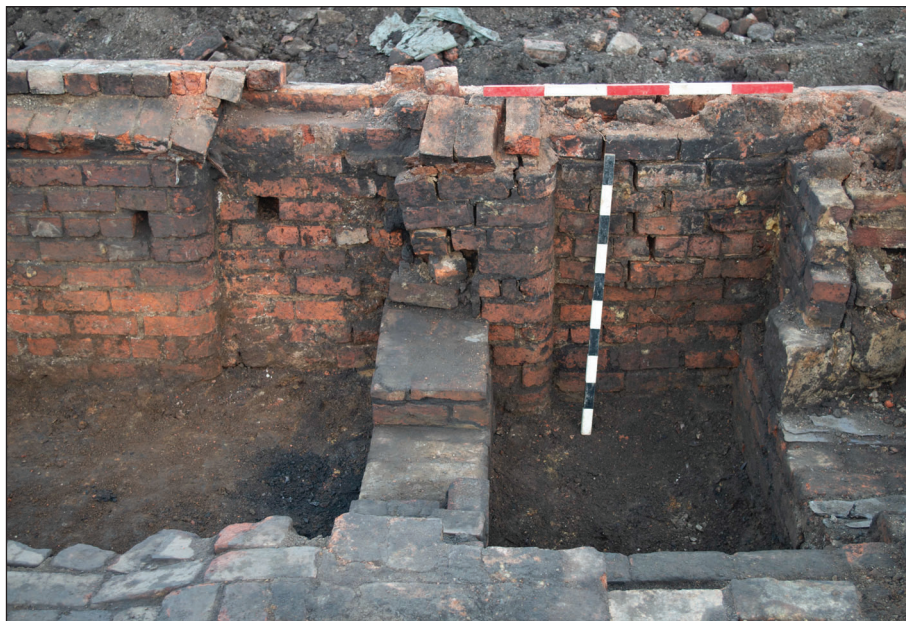
Plate 2: South facing elevation of 1014.

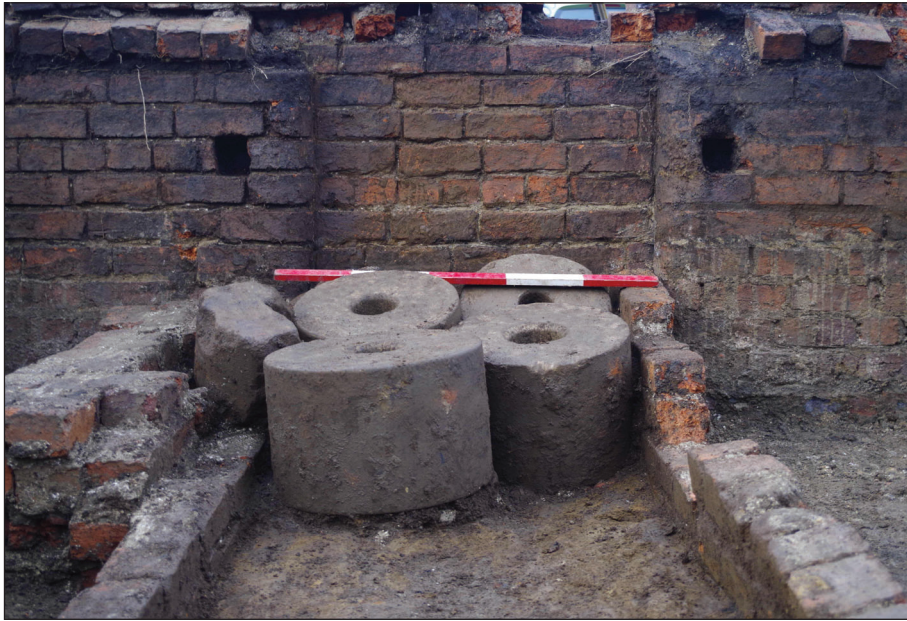
Plate 3: South facing elevation of 1014, 1185 and 1186.

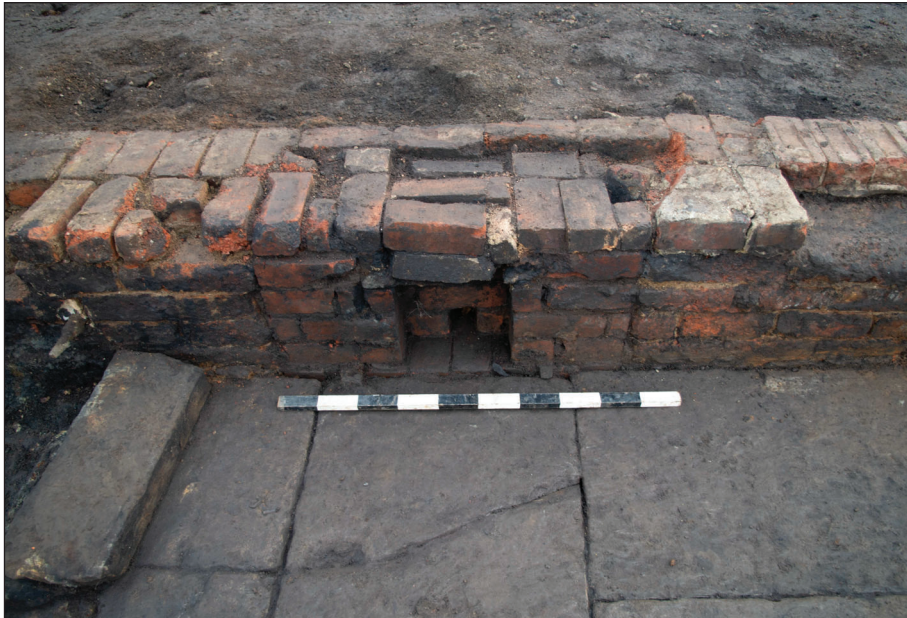
Plate 4: North facing elevation of 1209.

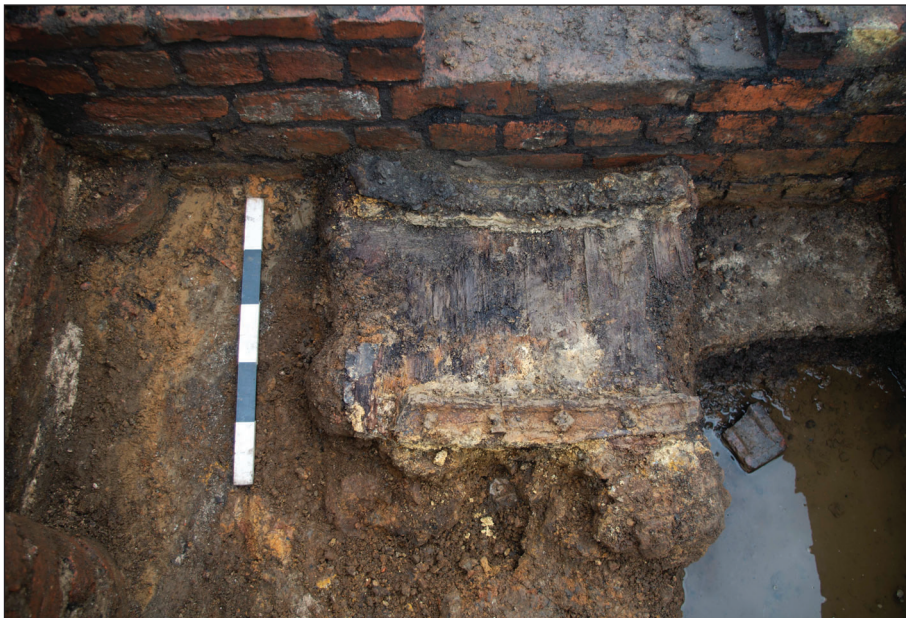
Plate 5: Plan photo of wheel 1228 from the west, showing leather belting.

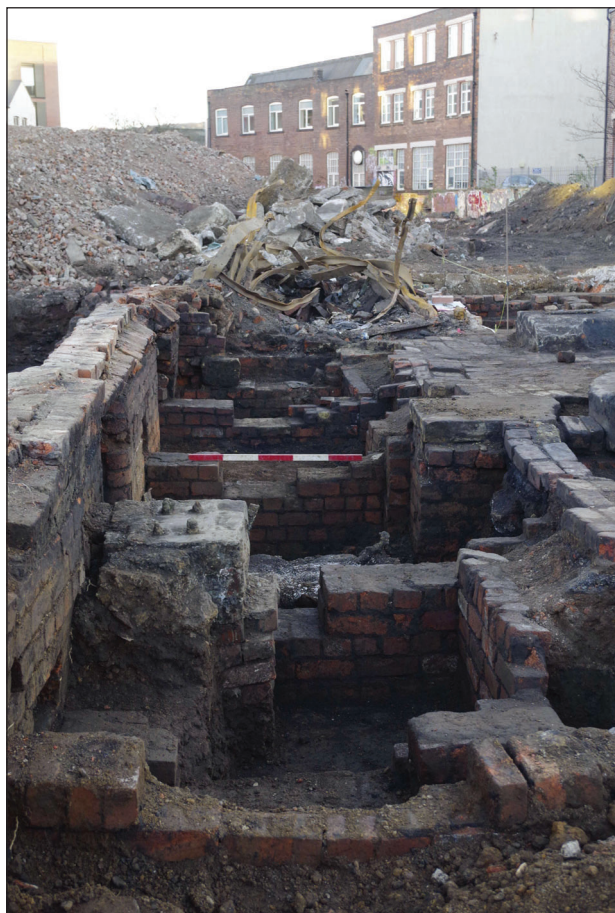
Plate 6: Looking east along drive shaft 'notch' along north wall 1014.

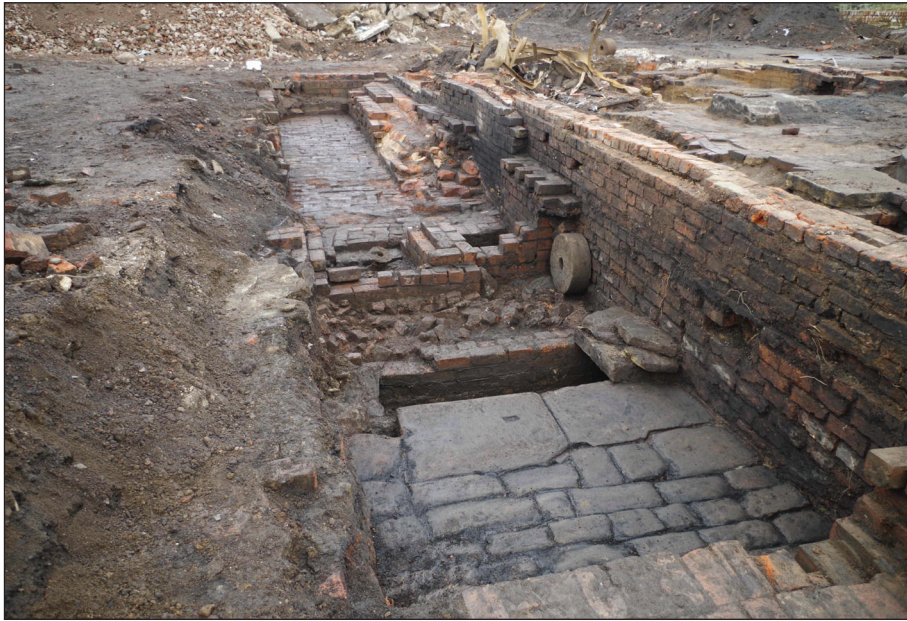
Plate 7: Phase one boiler house showing internal features, facing south-east.

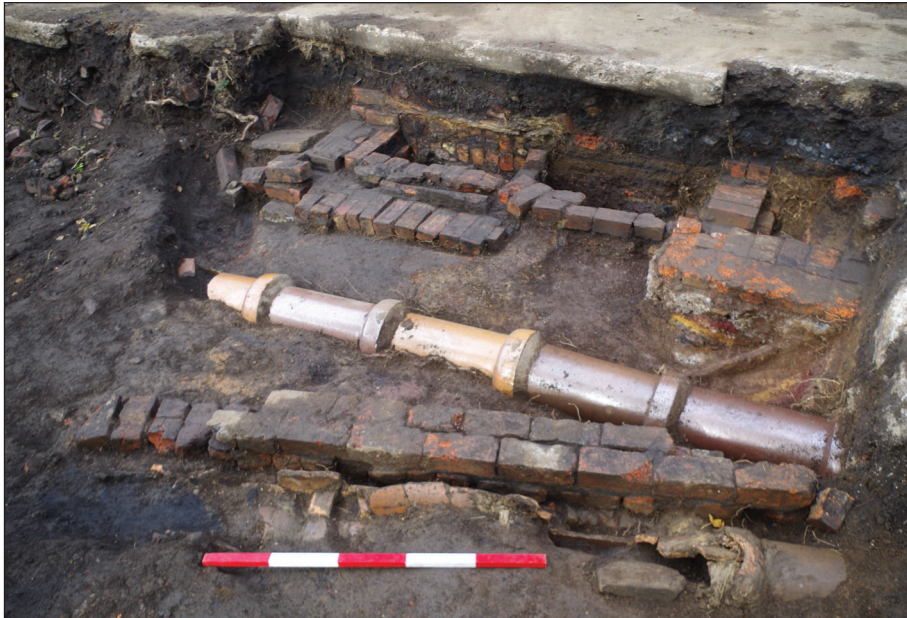
Plate 8: South facing elevation of brick-built furnace boxes 2093 and 2100.

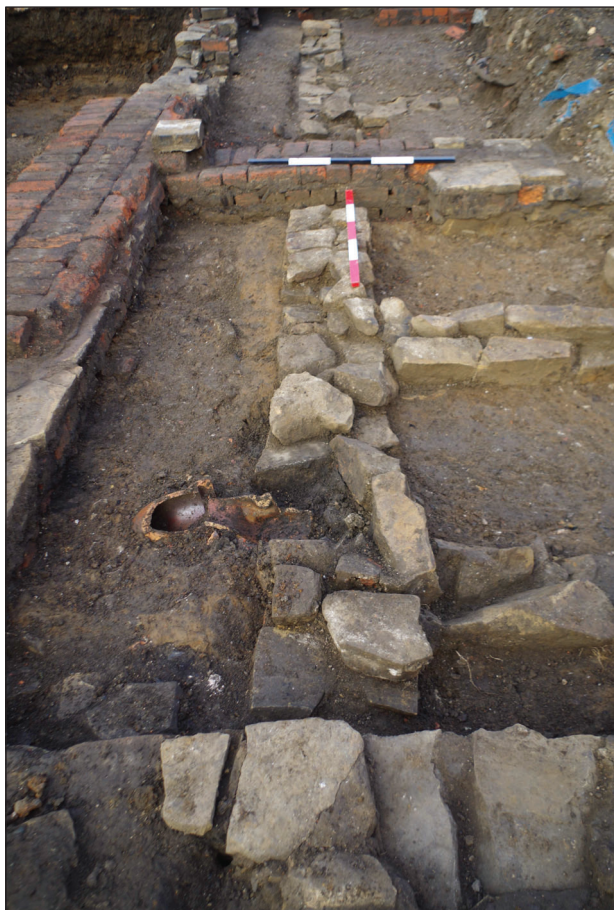
Plate 9: Structure groups 2156 and 2155 looking west.

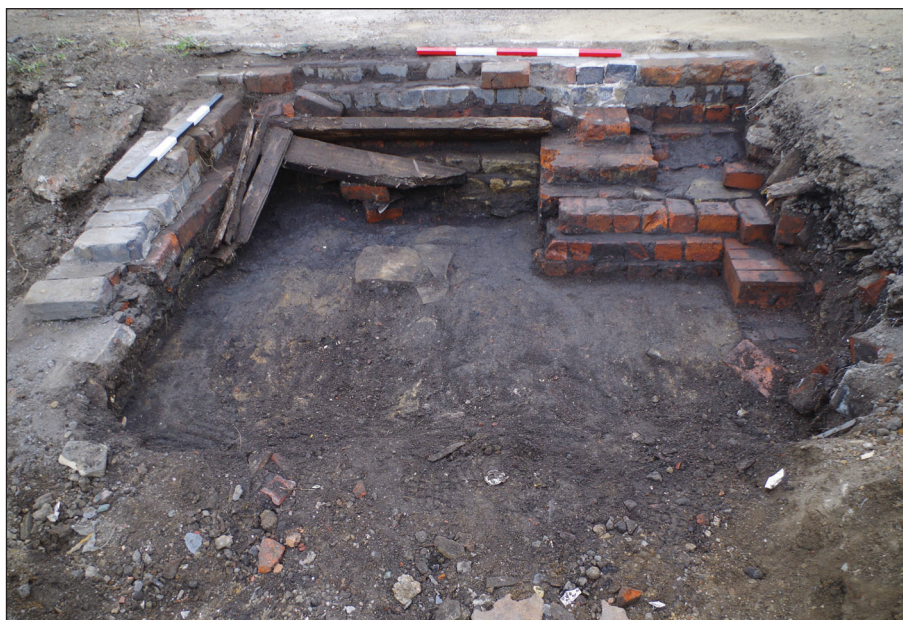
Plate 10: Structure 2155 looking west.

- 5.4.14 The early housing (group 2156) was cut by a stone and brick built structure (group 2155). Structure 2155 consisted of a 9.30 m long, 0.50 m wide sandstone foundation (2068) irregularly coursed and bonded with black ash mortar which ran east to west, with three shorter walls (2037, 2074 and 2077) running at right angles to the north. On top and bonded to the sandstone with black ash mortar was a red brick wall. The main east to west aligned wall (2068) carried a single course of up to five skins of a fragmentary wall (2075). The bricks were of mixed types, including handmade bricks with remnants of lime mortar indicating re-use and frogged and unfrogged machine bricks. The structure was bonded with black ash mortar. The wall (2037) atop the westernmost foundation (2070) survived with four courses and four skins wide at its base, with a step in to three skins after the first course. This step provided a ledge for supporting wooden floorboards 2036 (**Pl. 10**).

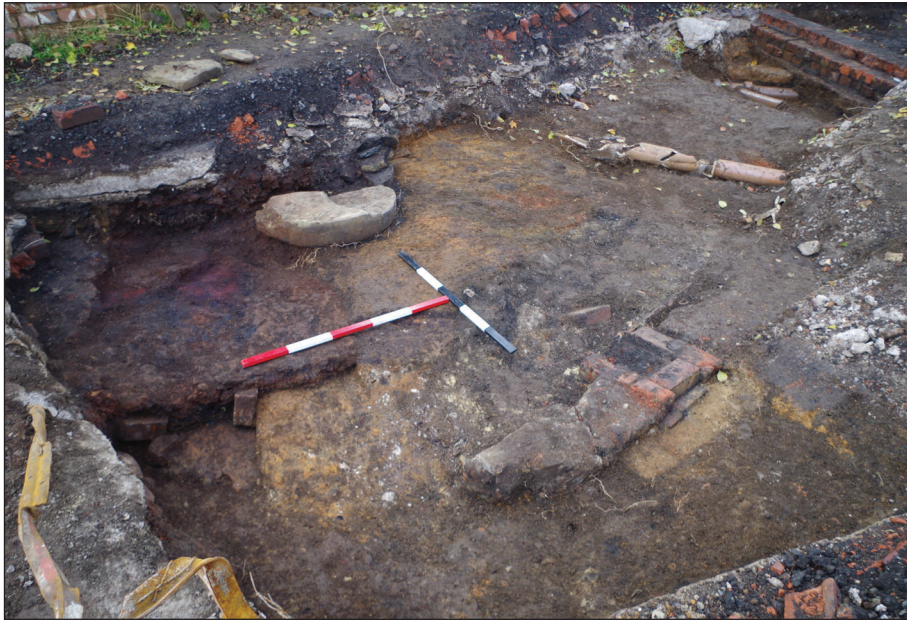
Plate 11: Clay lined channel 2045 and associated modern drainage truncations, looking south-west.

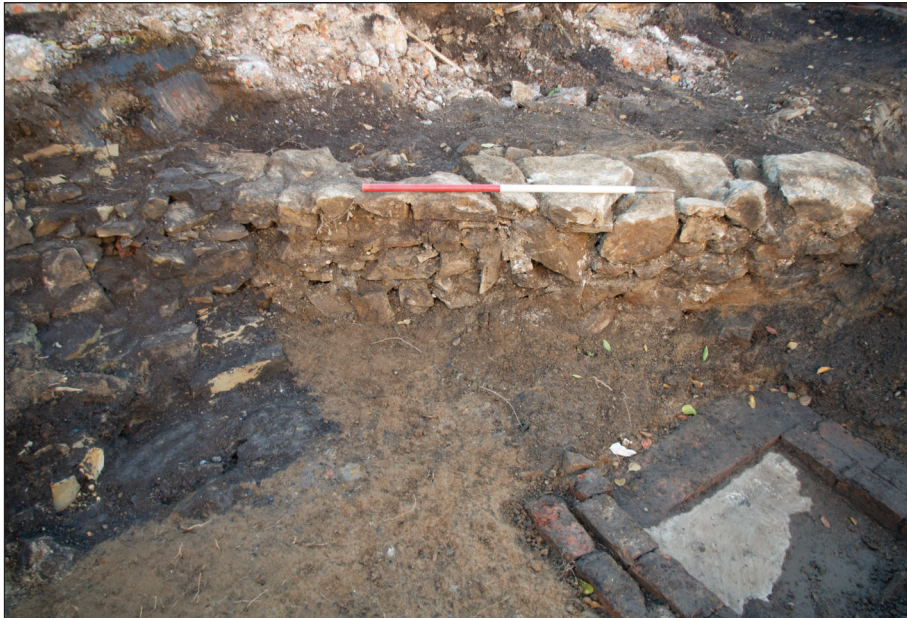
Plate 12: Walls 3031, 3032 and later drainage, looking south-east.
