Hollis Croft, Sheffield South Yorkshire

Strip, Map and Record, Evaluation and Watching Brief

Planning Ref: 16/02910/FUL/
Ref: 116361.09
June 2019

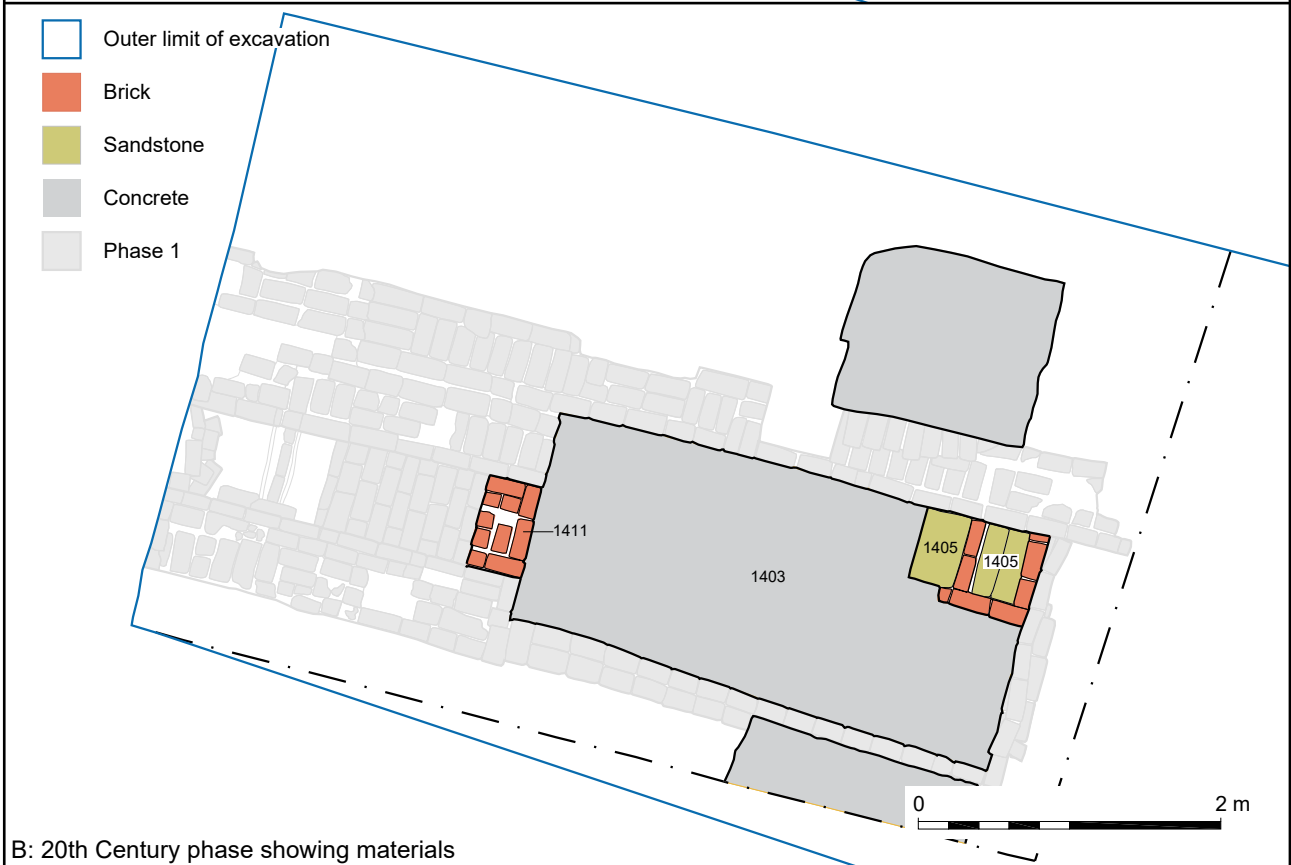
B: 20th Century phase showing materials

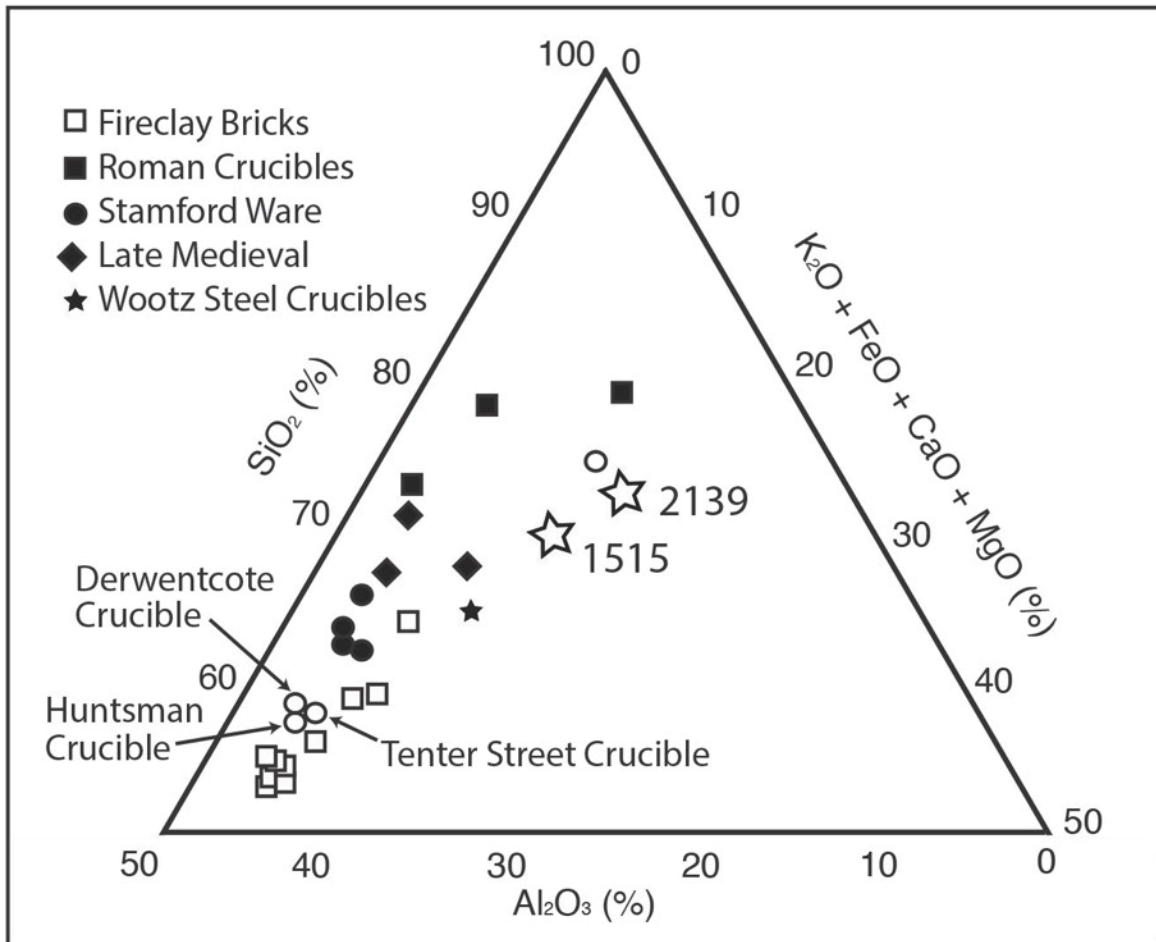
Figure 64

Chest furnace samples 2139 and 1515. Analysed from Hollis Croft compared with those of a Sheffield Huntsman crucible and other earlier metalworking crucibles (Freestone and Tite 1986), plus 18th century steel making crucibles from Sheffield (Quinn 2013b) and Derwentcote (Andrews et al. 2017). Modified from (Andrews et al. 2017, fig. 9, p. 61).

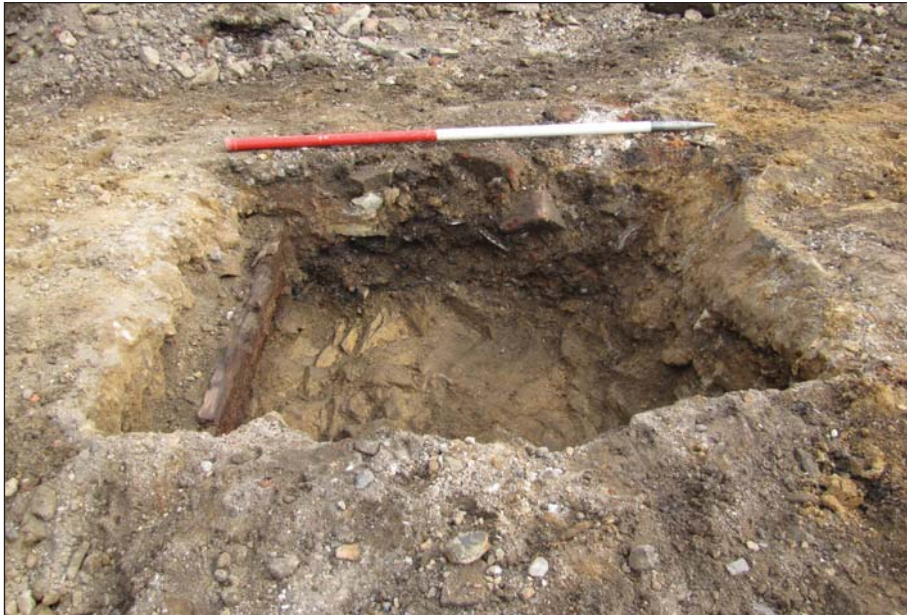
Plate 6: Wooden beam or plank shoring 912 within foundation cut 910 from the north

- 5.2.11 An approximately 1 m wide foundation cut was recorded during the evaluation running east to west (906) before returning to the north at the west end (910). The foundation cut was filled with tightly packed rubble and industrial waste (907 and 911), forming a hardcore base, presumably to support a removed wall. Deposit 911 contained pottery dating to the mid- to late-19th century. Cut 910 was supported along its western edge by shoring comprising a narrow wooden beam or plank (912; **Plate 6**). Pottery and clay tobacco pipe indicate a mid- to late-19th century date for made ground 916 through which these features were cut. These foundation trenches do not correlate with anything shown on any consulted historic map, although they are parallel with the boundaries of the plot which persisted from the 18th century throughout the 19th (**Fig. 4–6**). Foundation trenches 906 and 910 are contained within the area of the rear range of buildings shown on the 1787–9 Fairbank Plan (**Fig. 4**), however they do not correlate exactly with the walls of that building, and, on the strength of the artefacts recovered from associated made ground 916, are likely later in date.

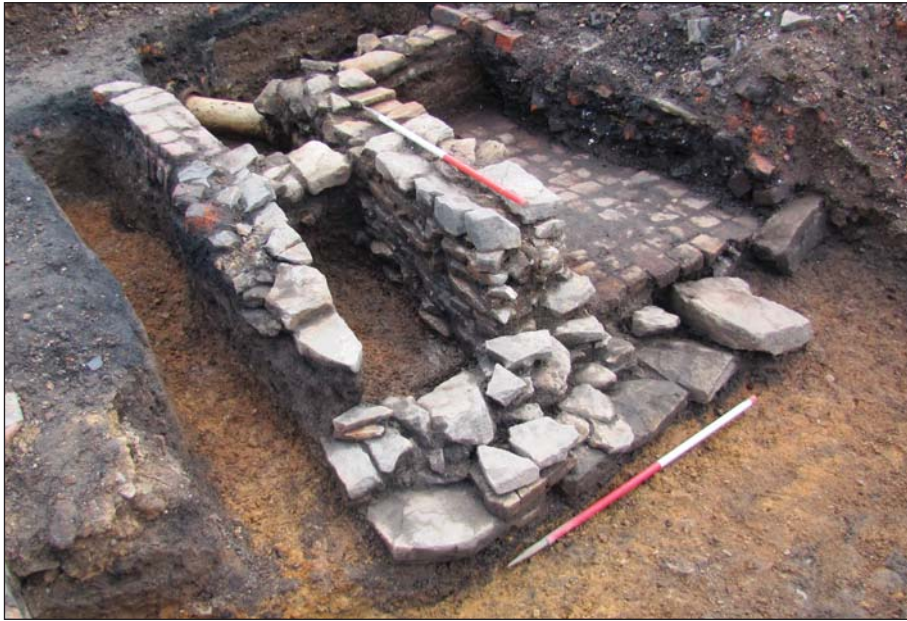
Plate 7: Overview of eastern end of Area A from the south-west

- 5.2.12 The strip, map and record excavation revealed a group of structures (923–928; **Plate 7**) to the east of wall 913/914. The structures occupied an area 2.6 m by 2 m, and continued beyond the limit of excavation to the east. Structures 926, 927 and 928 comprised sandstone and black ash mortar foundations each around 0.36 m wide. In one place, an overlying handmade red brick and black ash mortar wall of headers (923) survived. A possible grindstone had been re-used as masonry in wall 926. A waste sewage pipe (929) 0.25–0.29 m in diameter ran to the north-west and was built into sandstone foundation 927, although the pipe did not appear on the south-east side of foundation 927, perhaps suggesting an undetected phase of repair decommissioning the pipe. Made ground layer

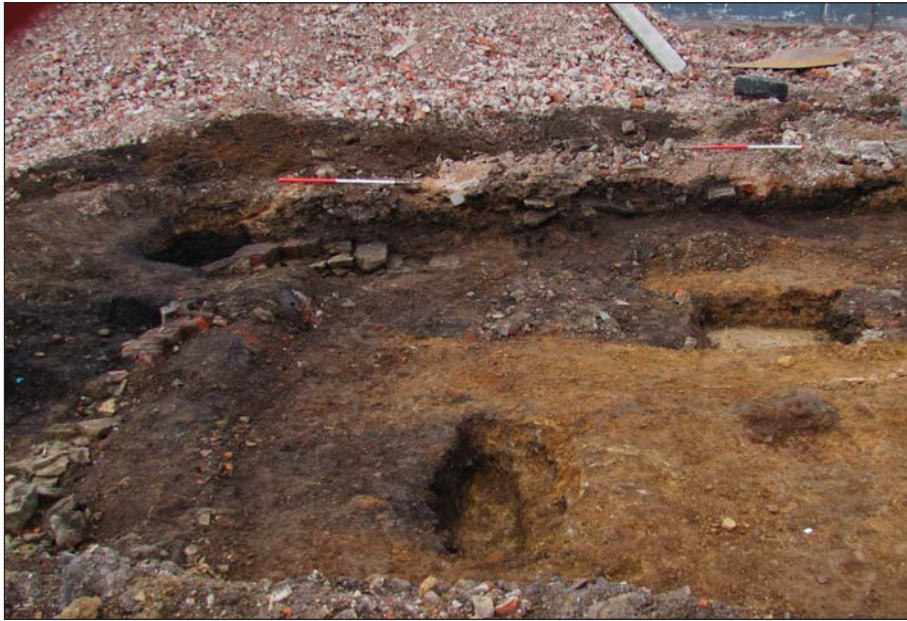
Plate 9: Western end of Area A with possible pit 908 at bottom right. From the north

- 5.2.8 A second small possible pit (908; **Plate 9**) may have been associated with pit 904. Pit 908 was 0.5 m in diameter and 0.57 m deep with a dark fill. Possible feature 908 did not contain any artefacts and it was not certain that pit 908 was a genuine anthropogenic feature.
- 5.2.9 During the evaluation, an unmortared wall comprising a sandstone foundation (913) overlaid with handmade red bricks in a rowlock bond (side-on headers; 914) ran predominantly north to south with a return to the west at both ends (**Plate 5**). The structure correlates with the east end of the rear range of buildings depicted on the Fairbank Plan (**Fig. 4**). By 1853 this building had been removed (**Fig. 5**).

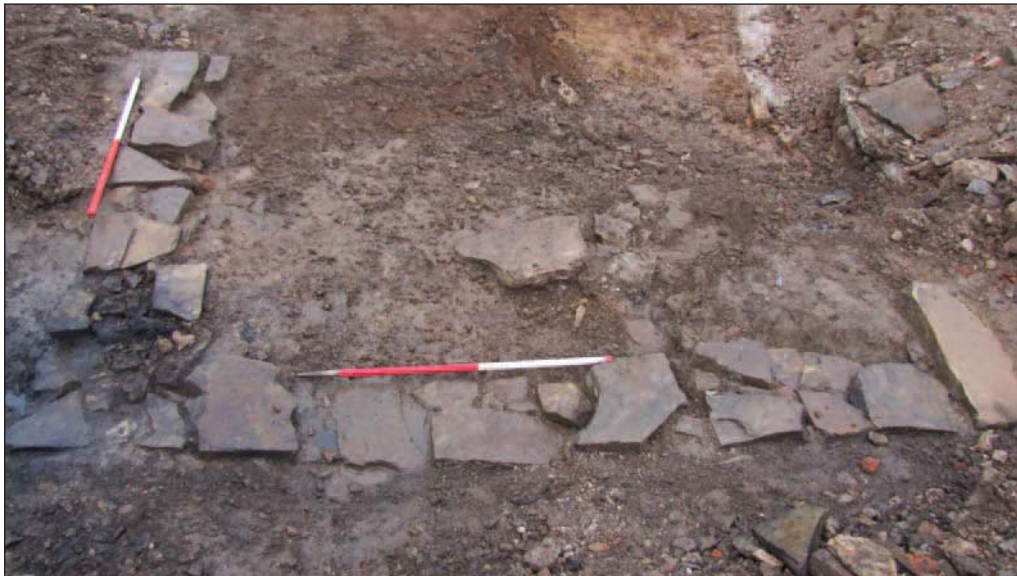
Plate 10: Wall 1017 from the east

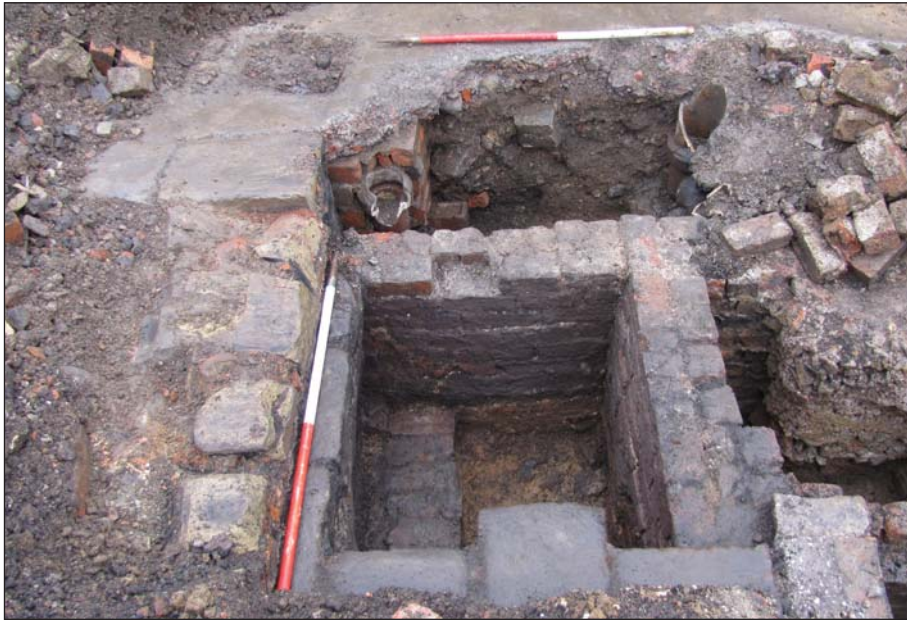
Plate 19: Wall 1723 and associated contexts from the east

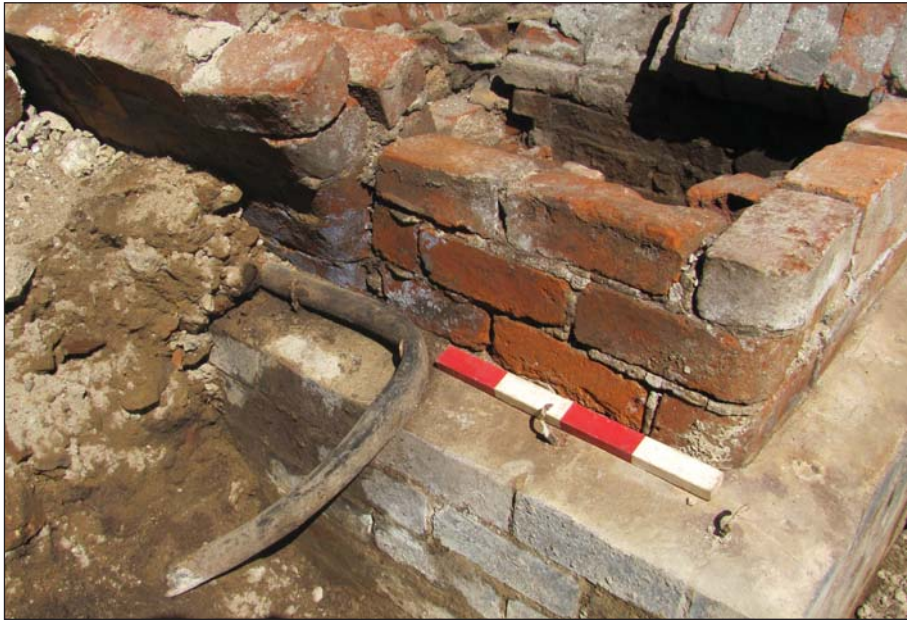
Plate 21: Bull nosed bricks ends on wall 1736 and vault 1735 and modern wall 1753 from the south-east

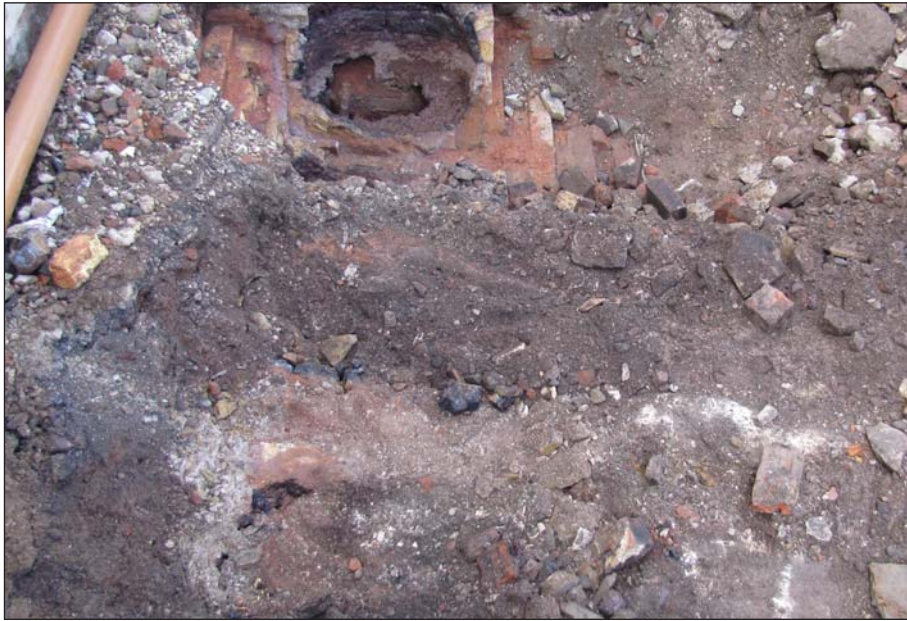
Plate 23: Potential additional crucible hole associated with furnace 1757–1764 from the south

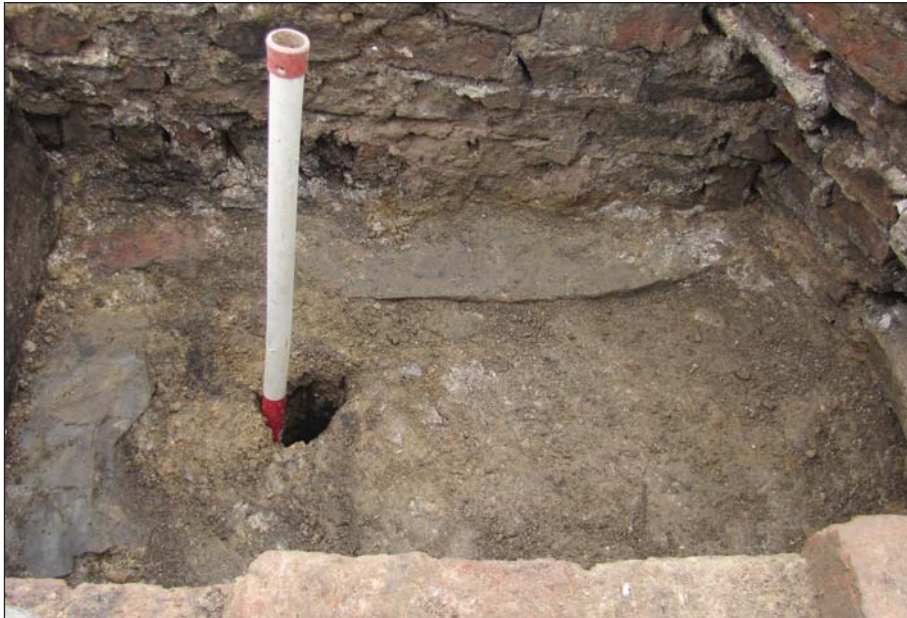
Plate 26: Stakehole 2166 and foundation 2165 from the west

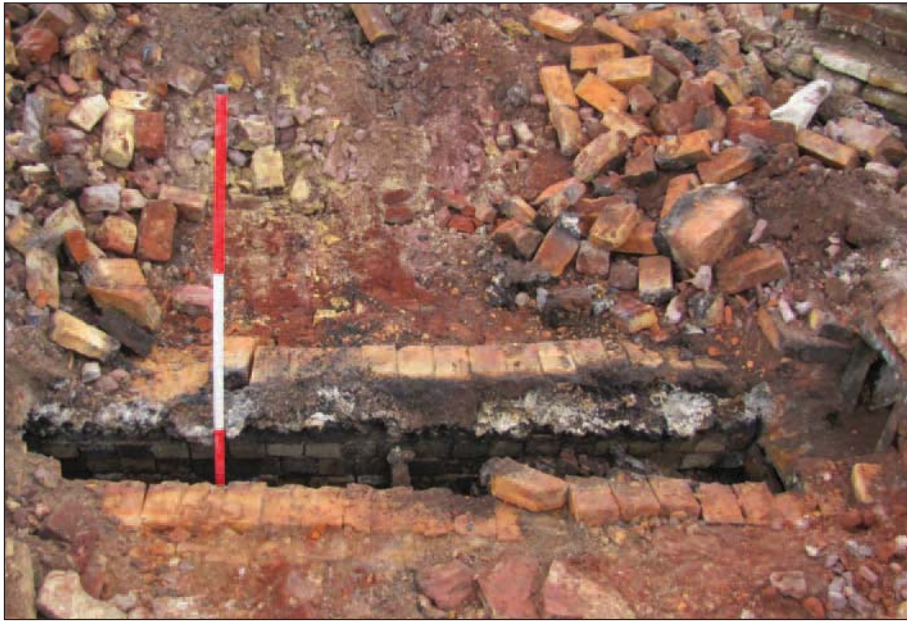
Plate 33: Fire pit of north cementation furnace (3007) revealed during watching brief from the north

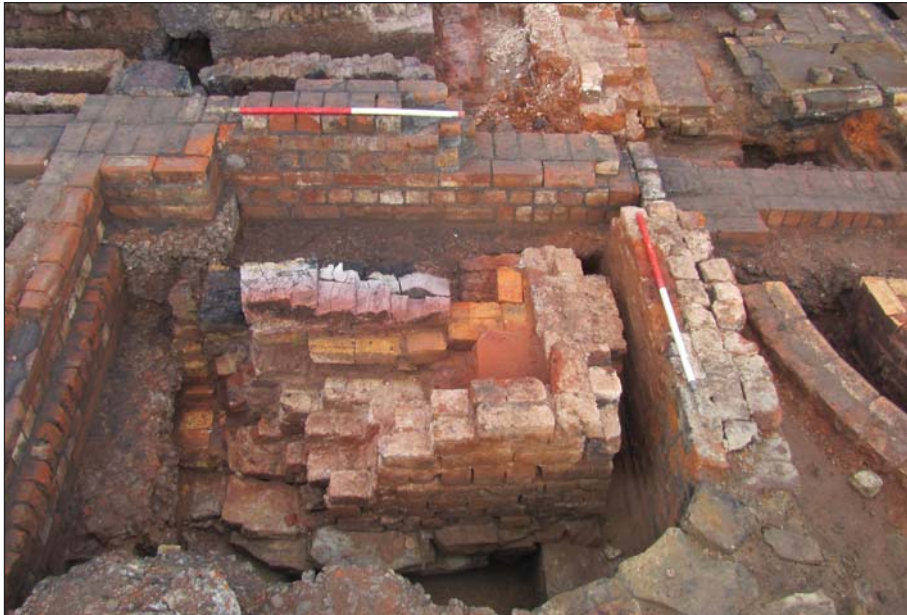
Plate 36: North-east part of northern furnace separated from rest of furnace by truncation showing foundation 2036 from the east
