Bristol Digital Futures Institute 65 Avon Street, St Philip's Marsh, Bristol

Archaeological Watching Brief

Planning Ref: 21/02496/F, 21/076439/X
Accession Number: BRSMG 2021.34
Ref: 223262.3
April 2023

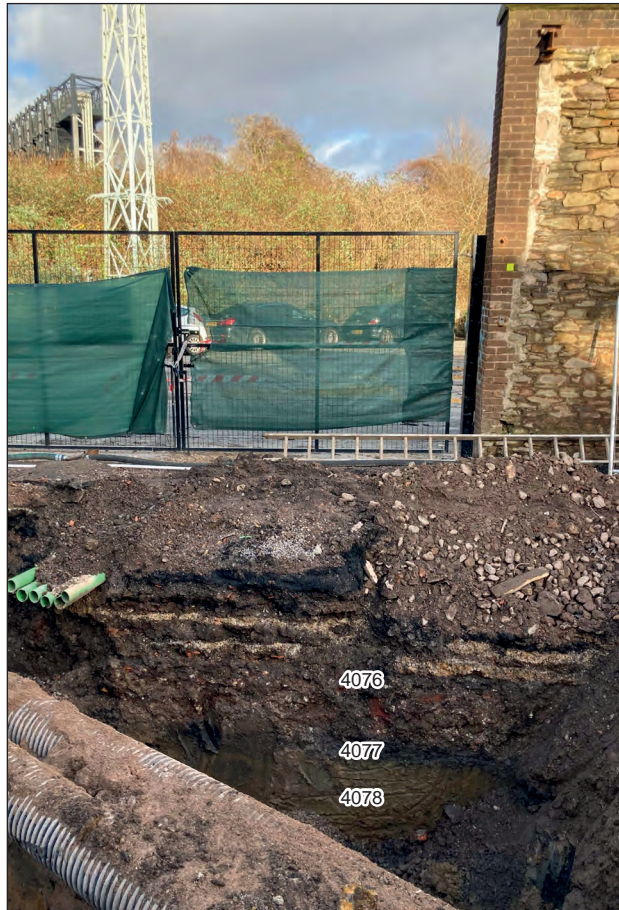
Figure 36: Alluvium 1078, buried topsoil 1078, and made ground layer 4076, looking north-east towards Gas Lane, (photograph by C. Mason).

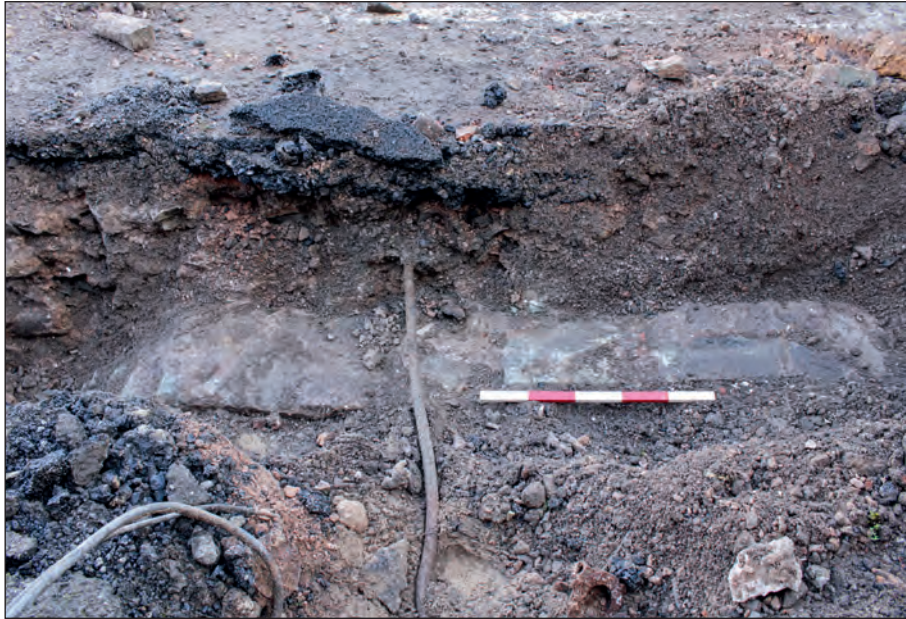
Figure 38: Stone wall foundation (2027) north-east of Avon Street, looking north-east. Scale: 0.5 m (photograph by C. Sabato).

5.3.2 Remains of the gasworks office comprised a series of sandstone rubble footings, all bonded with grey lime mortar (group 2046; Figs 16, and 38–9). This group of structures included foundations of the building's Avon Street frontage (2027; Figs 16 and 38), which was 0.47 m wide; and the 0.85 m wide footings (2039; Fig. 16) that defined the south-east side of the covered way. A parallel brick wall foundation (2025 and 2040; Figs 16 and 39) would have supported a row of piers that separated the pedestrian walkway from the vehicle passage.

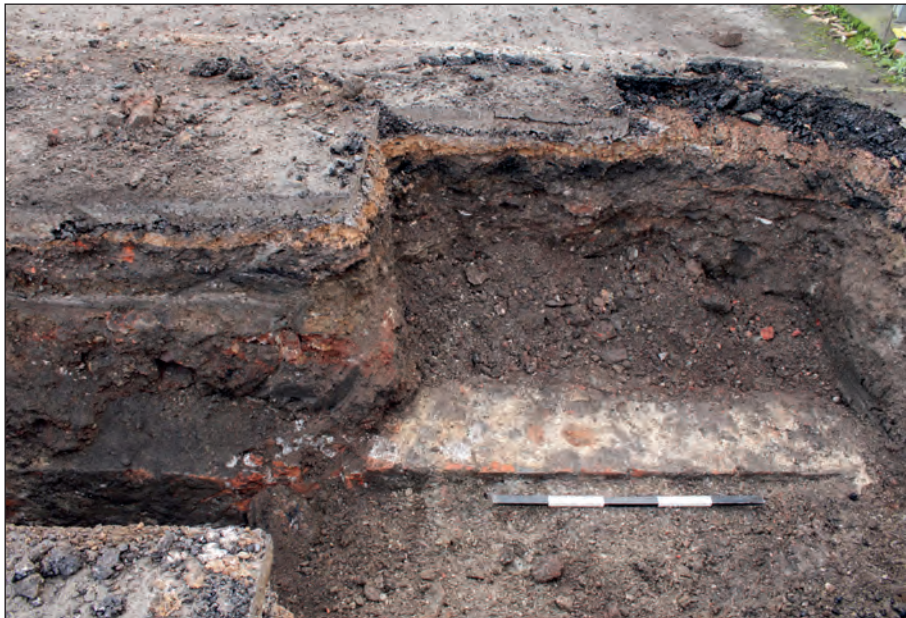
Figure 39: Brick wall foundation (2025) north-east of Avon Street, looking south-east. Scale: 1 m (photograph by C. Sabato).

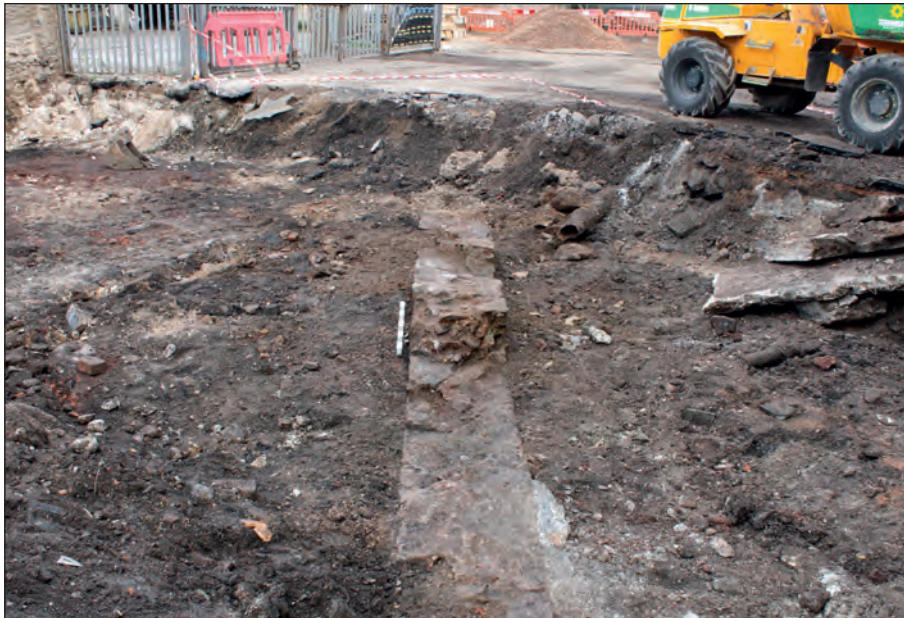
Figure 40: Stone wall foundation (4048, group 1083) on north side of retort house, looking east. Scale: 1 m (photograph by C. Mason).

- 5.3.7 The foundations of the retort house (group 1083; Figs 16–17, 40–1, and 54) and lean-to coal stores (group 1085; Figs 16–17 and 42–6) were abutted by a 1.4 m thick ground raising deposit (group 1091). The upper surface of this deposit, which comprised a compacted surface of crushed clinker, was recorded at 8.4 m OD (0.6 m bgl): this is interpreted as the floor of the original gasworks yard. Within the north-west range of the retort house, there was a similar ground raising deposit (4025), which also abutted the foundations of the building.

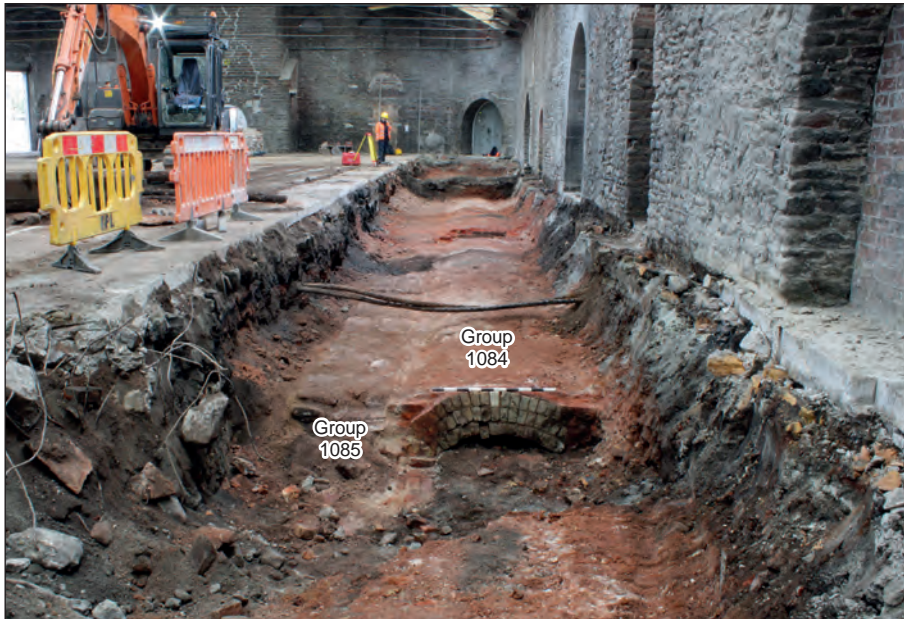
Figure 42: Stone wall foundation (group 1085) and brick flue (group 1084) in coal store, looking north-east. Scale: 1 m (photograph by C. Mason).

- 5.3.8 The foundations of the lean-to coal stores (group 1085; Figs 16–17 and 42–6) were 0.6 m wide and 0.8 m deep. The height and angle of the lean-to coal store roof was evident from a line of angled coping stones on the sides of the coal store chimney (Figs 45–6). A course of coping stones with the remnants of lead flashing below, were also evident to the sides of the chimney and along the inner south-east and north-west elevations of the coal store.

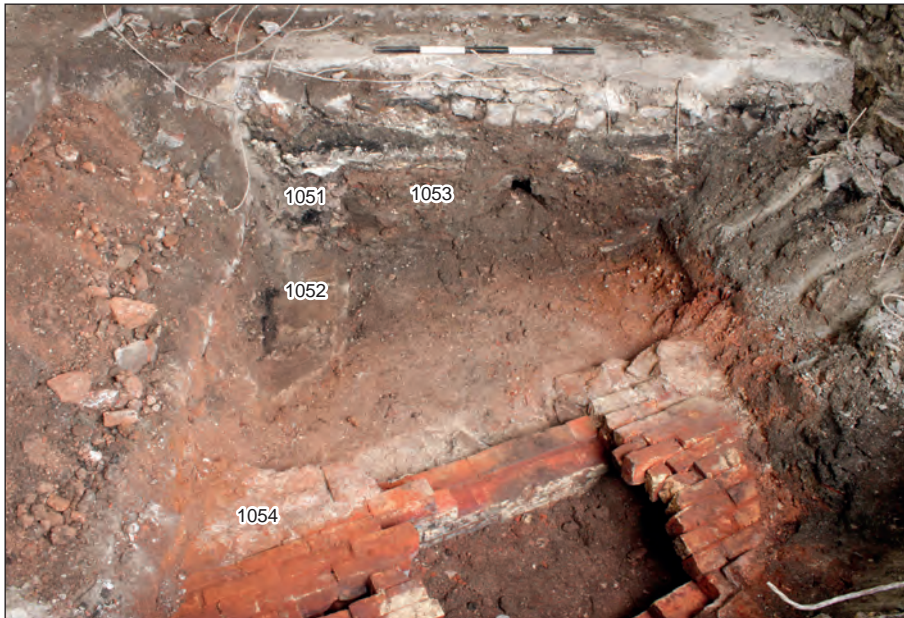
Figure 43: Stone wall foundation (1052, group 1085), made ground (1053, group 1091), robber cut 1051, and brick flue (1054, group 1087). North corner of coal store, looking south-west. Scale: 1 m (photograph by C. Sabato).

- 5.3.13 The flue (group 1087; Figs 17, 43, and 56–8) in the north corner of the coal store appears to have respected the foundations (group 1085) of the 1821 lean-to coal store, which suggests that the flue was built while the lean-to was still standing (i.e., before the mid-1850s). Flue 1087 had an oval internal profile that measured 0.6 m wide and 0.74 m high. Externally, the flue was 1.4 m wide and over 1.1 m deep. The south-eastern terminus of the flue was truncated by modern disturbance, but it is likely to have originally had a rectangular opening at floor level, with an above-ground brick or iron flue that linked it to the high-level opening in the side of the adjacent chimney.

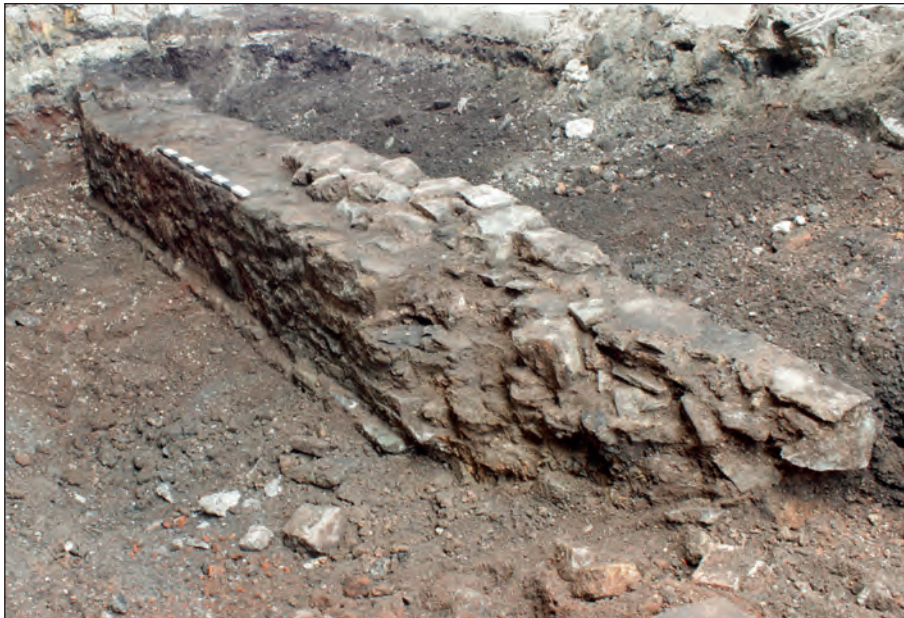
Figure 44: Stone wall foundation (group 1085), in south corner of coal store, looking west. Scale: 1 m (photograph by A. Pannell).

- 5.3.6 The foundations of the retort house were over 2 m deep. It is unknown if the lower parts of the foundations were constructed in trenches, or if they were built directly on the underlying alluvium. Given the size of the retort house, and the soft nature of the underlying deposits, it is possible that the building is founded on timber piles, though there is no evidence to confirm or refute this suggestion. Remains of the original lean-to coal stores were recorded in the coal store (group 1085; Figs 16, 17, and 44–6) and rear yard (4040; Figs 17, and 48–9).

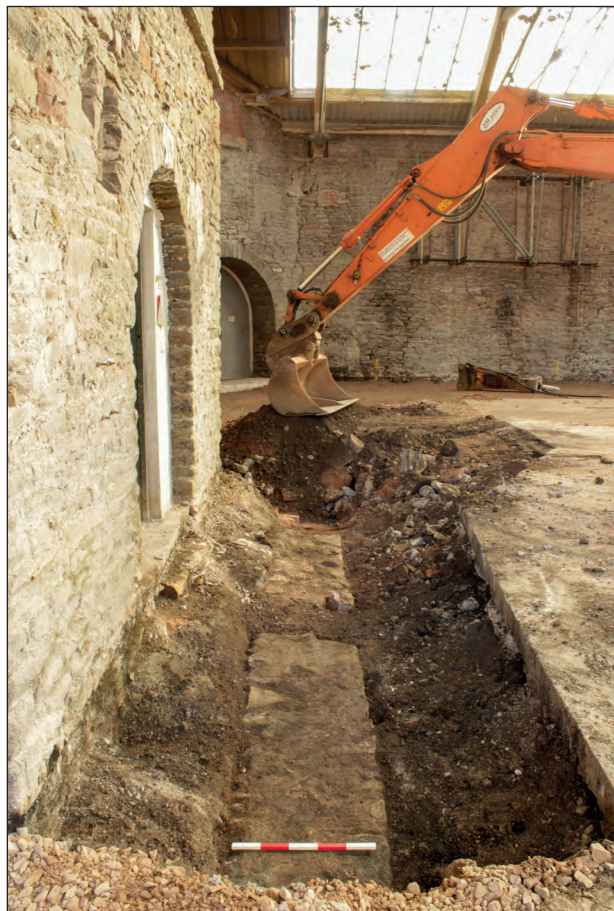
Figure 45: Stone wall foundation (1048, group 1085) and upstanding chimney in coal store, looking south-east. Scale: 0.5 m (photograph by C. Mason).

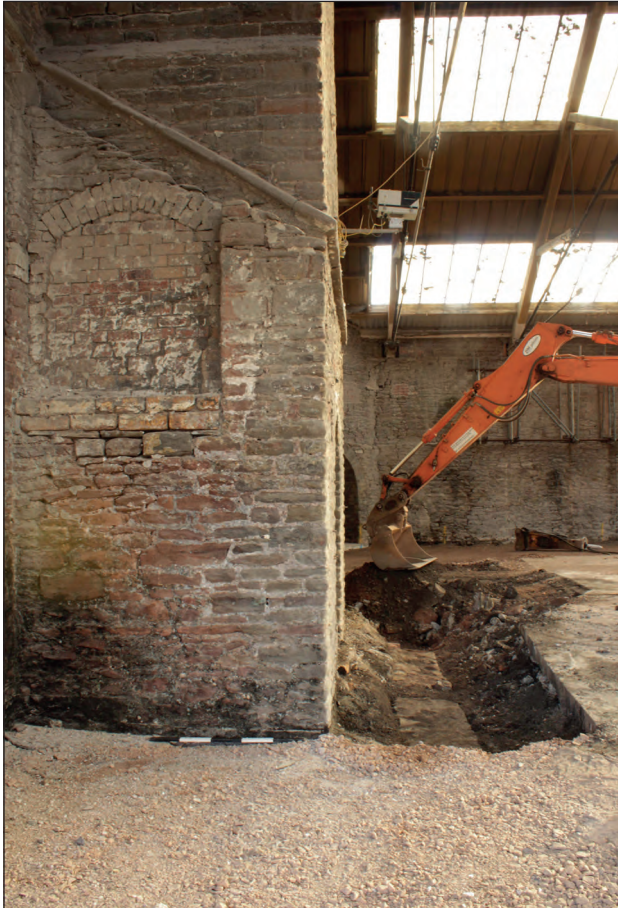
Figure 46: Stone wall foundation (1048, group 1085) and upstanding chimney in coal store, showing line of coping stones and opening into north-west side of chimney. Looking south-east. Scale: 1 m (photograph by C. Mason).

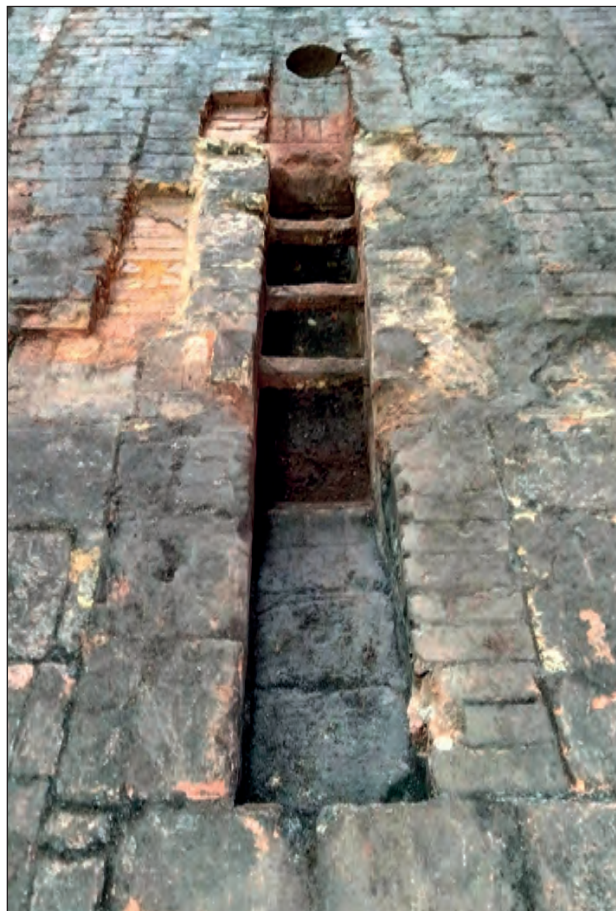
Figure 51: Ash pit in retort bench (group 3058) at the north-east end of the north-east range of the retort house. Looking north-east (photograph by A. Pannell).

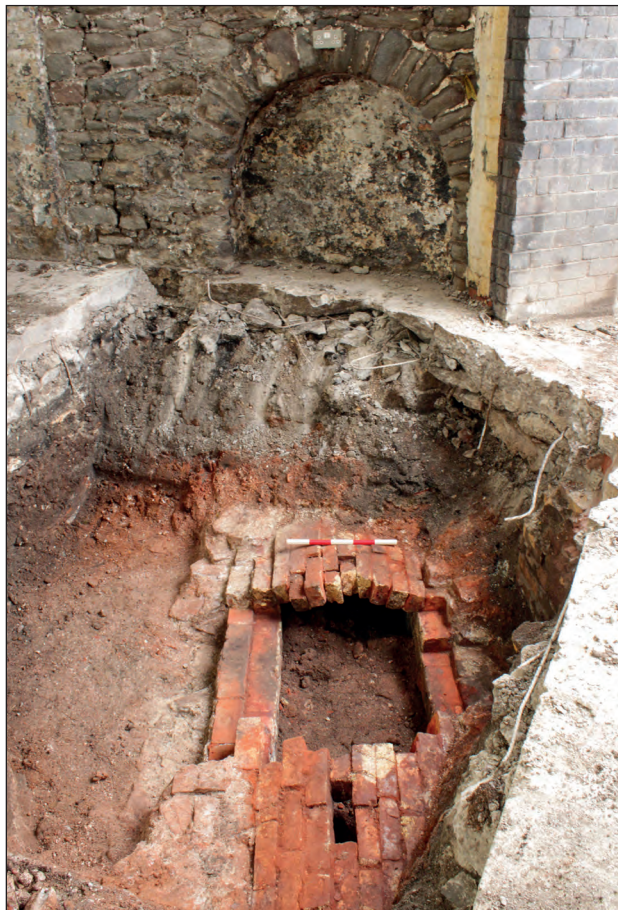
Figure 56: Brick flue (1054, group 1087) in north corner of coal store, looking west. Scale: 1 m (photograph by C. Mason).

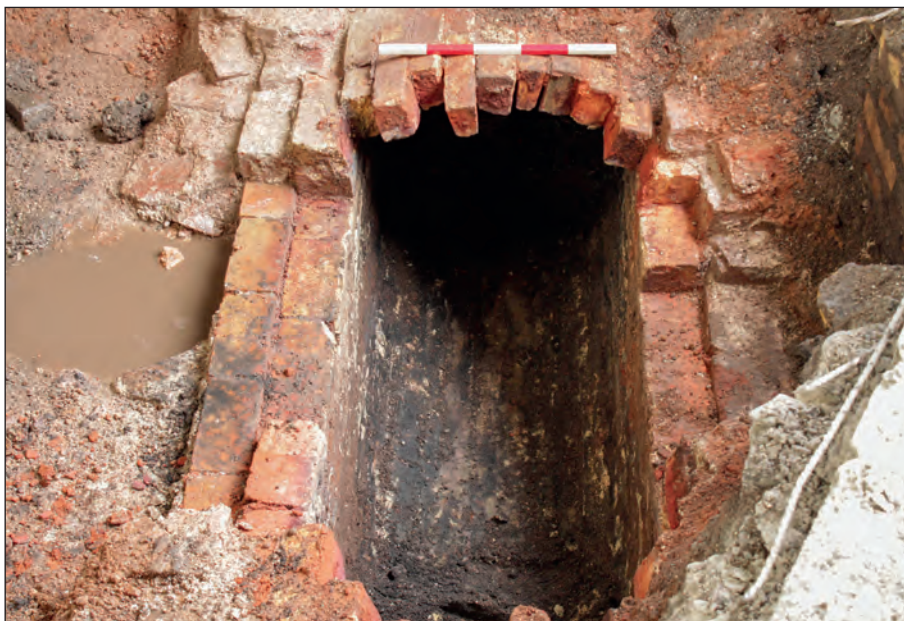
Figure 57: Detail of brick flue (1054, group 1087) in north corner of coal store, looking west. Scale: 0.5 m (photograph by C. Mason).

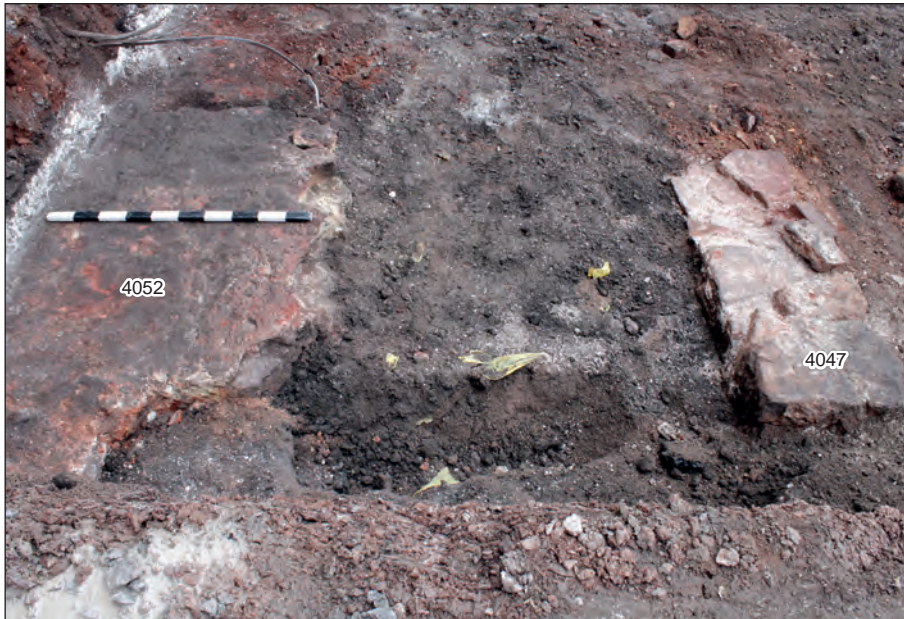
Figure 60: Foundations 4047 and 4052 at the north-east end of the north-west range of the retort house. Looking north-east. Scale: 0.5 m (photograph by V. Jerjotoma Ortin).

- 5.3.14 To the north-east of retort bench group 3058, there were various heavily truncated stone foundations (4015, 4047, 4050, 4051, and 4052; Figs 17, 52–3, and 59–61) of uncertain function. These structures are tentatively interpreted as foundations for gas purification equipment. This suggestion is supported by the fact that there are no external condensers, washers, or scrubbers, shown on any of the pre-1854 mapping (Figs 3–4), which suggests that purification processes were probably undertaken in the north-east range of the retort house (the other two ranges were filled with retort benches).

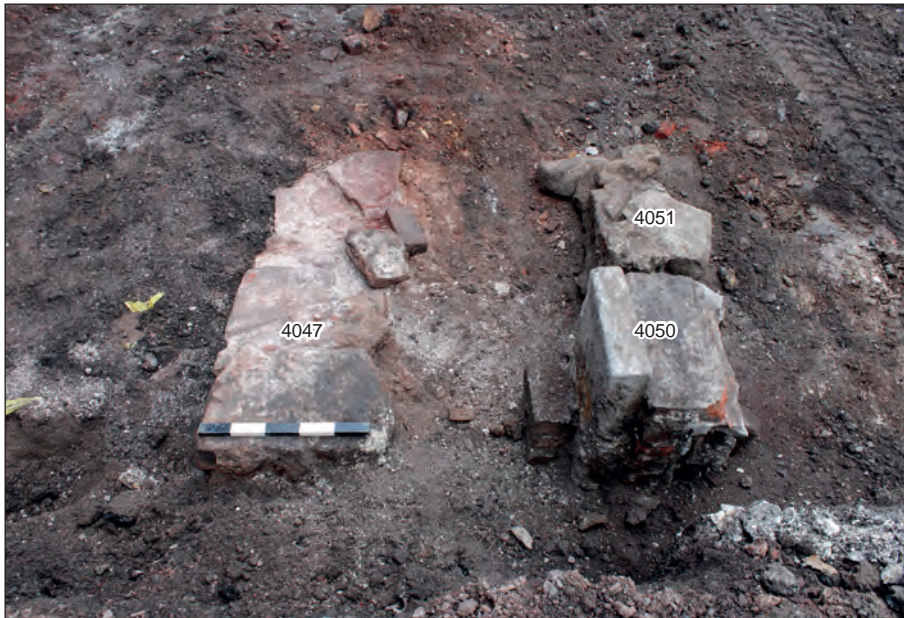
Figure 61: Foundations 4047 and 4050–1 at the north-east end of the north-west range of the retort house. Looking north-east. Scale: 0.5 m (photograph by V. Jerjotoma Ortin).

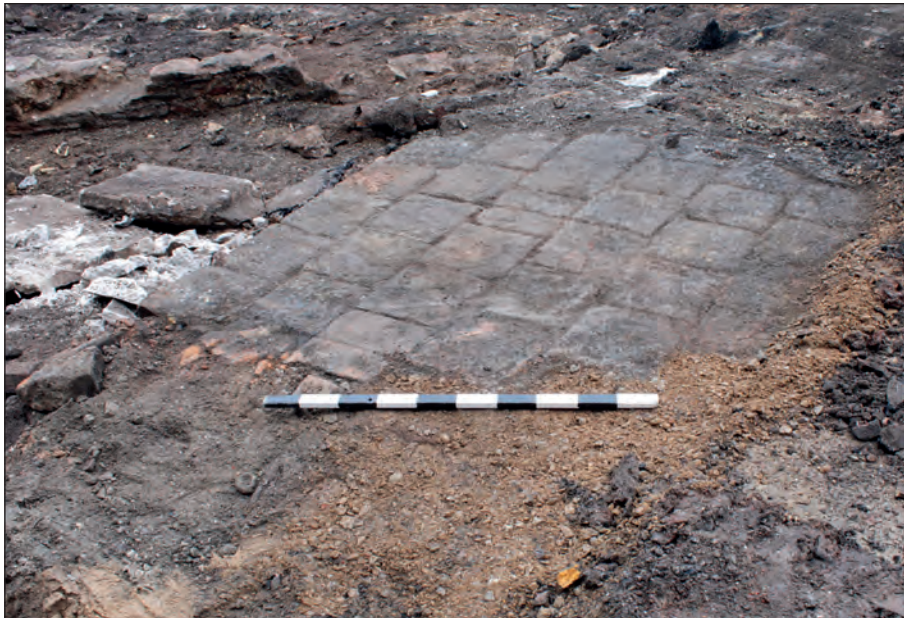
Figure 62: Floor surface 4049 in the north-east range of the retort house. Looking north. Scale: 1 m (photograph by C. Sabato).

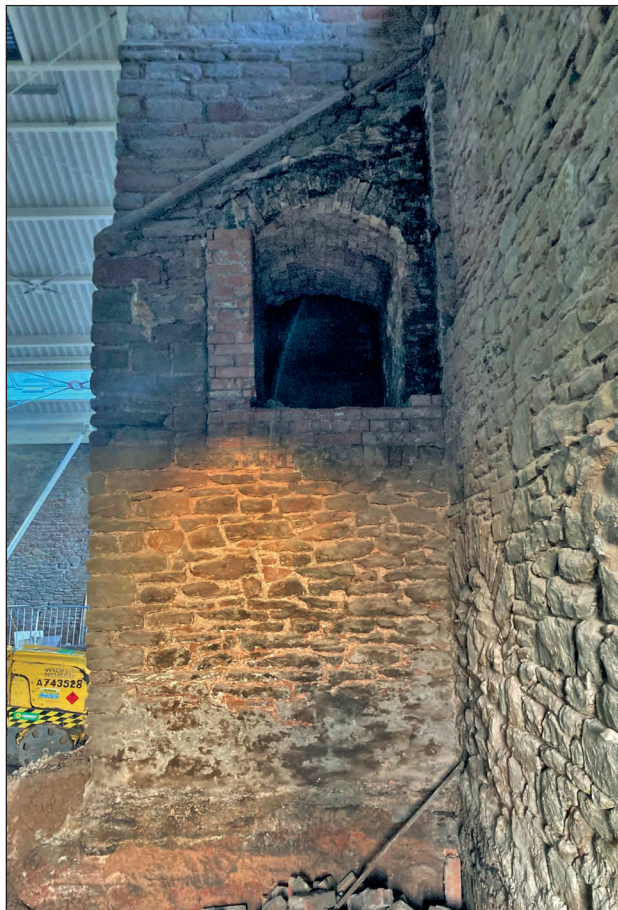
Figure 74: High level flue opening into the coal store chimney, looking north-west (photograph by C. Mason).

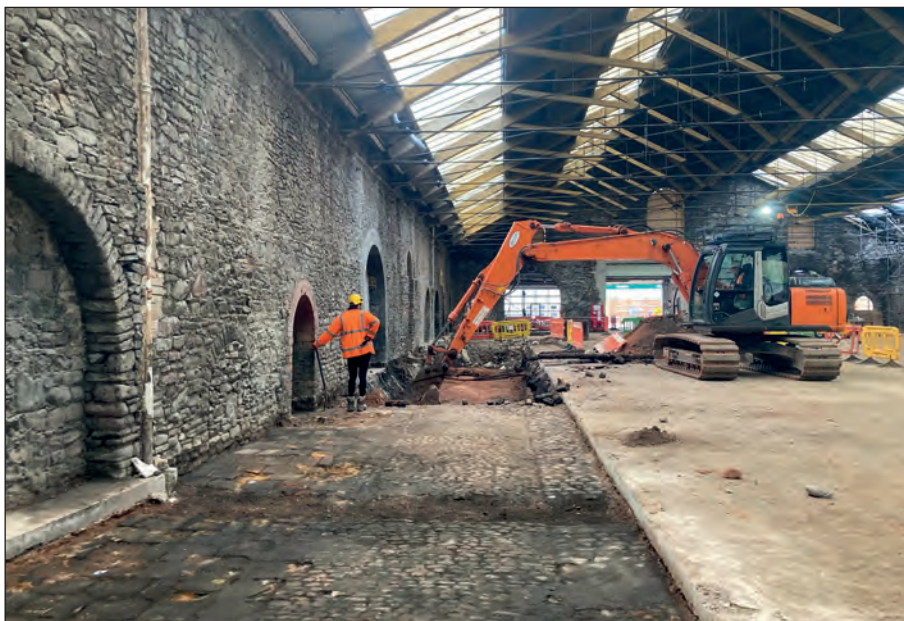
Figure 75: Fireclay slab and sandstone sett floor (group 1082) on the south-east side of the coal store, looking south-west (photograph by C. Mason).

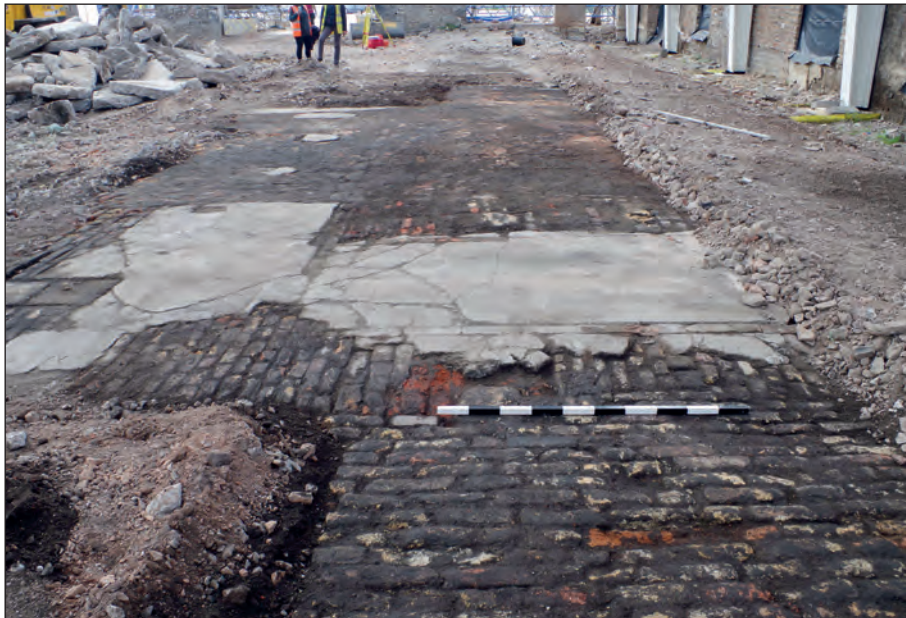
Figure 79: Sandstone sett floor (group 1082) and modern concrete repairs (group 1086). Scale: 1 m (photograph by C. Sabato).

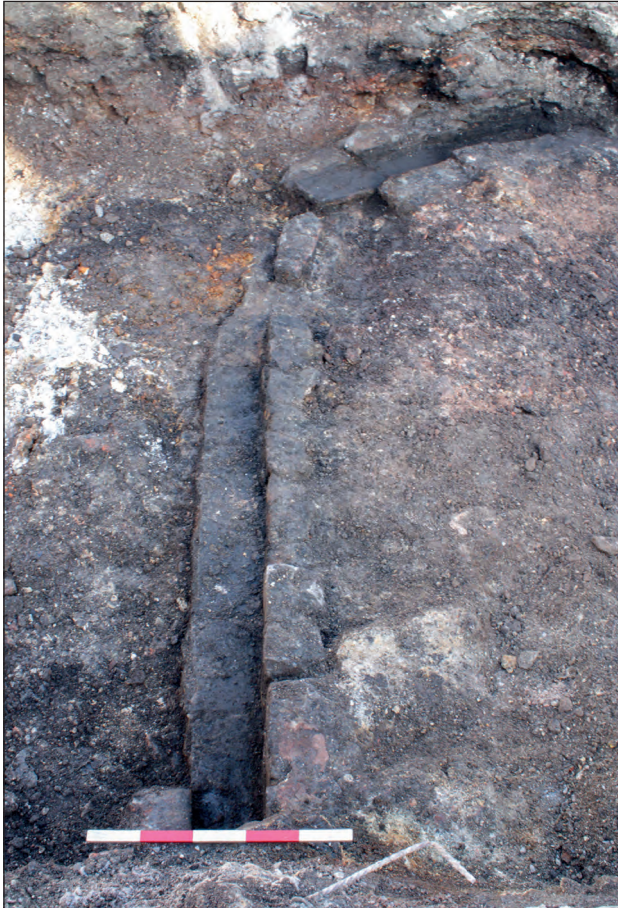
Figure 80: Brick- and stone-lined drain (group 1088), looking north-east. Scale: 0.5 m (photograph by C. Sabato).

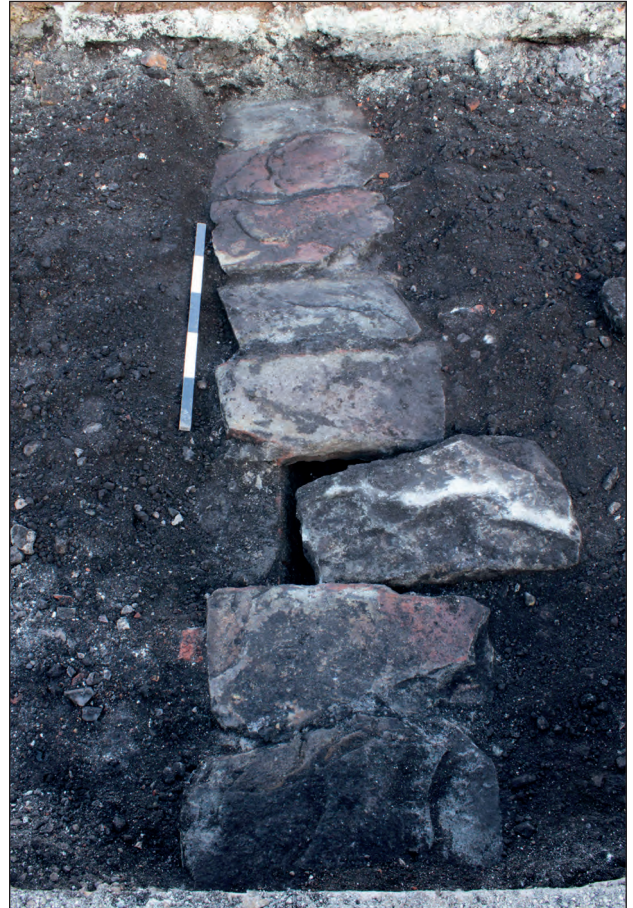
Figure 81: Brick- and stone-lined drain (group 1088), showing in-situ capstones. Looking north-east. Scale: 1 m (photograph by C. Sabato).

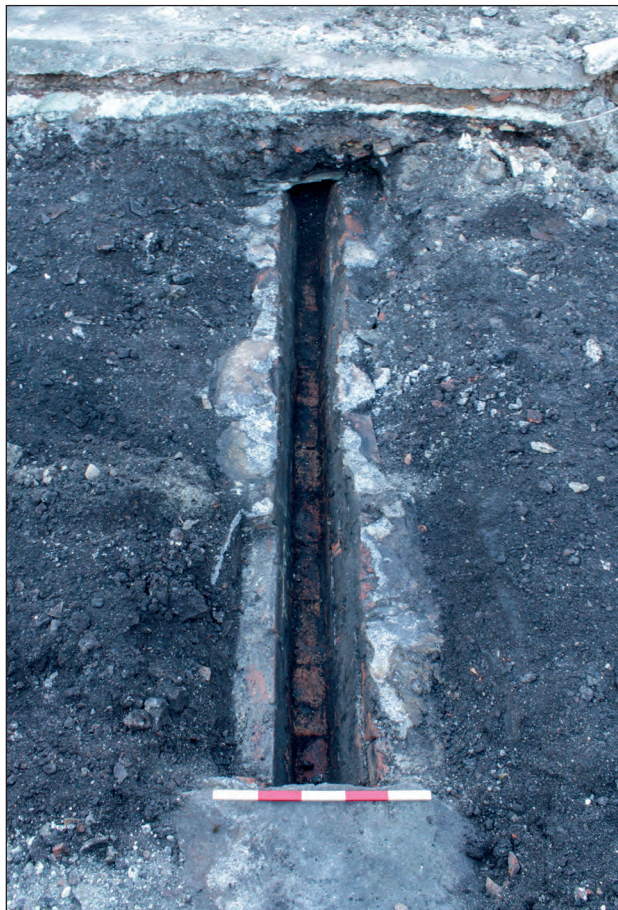
Figure 82: Brick- and stone-lined drain (group 1088), after removal of capstones. Looking north-east. Scale: 1 m (photograph by C. Sabato).

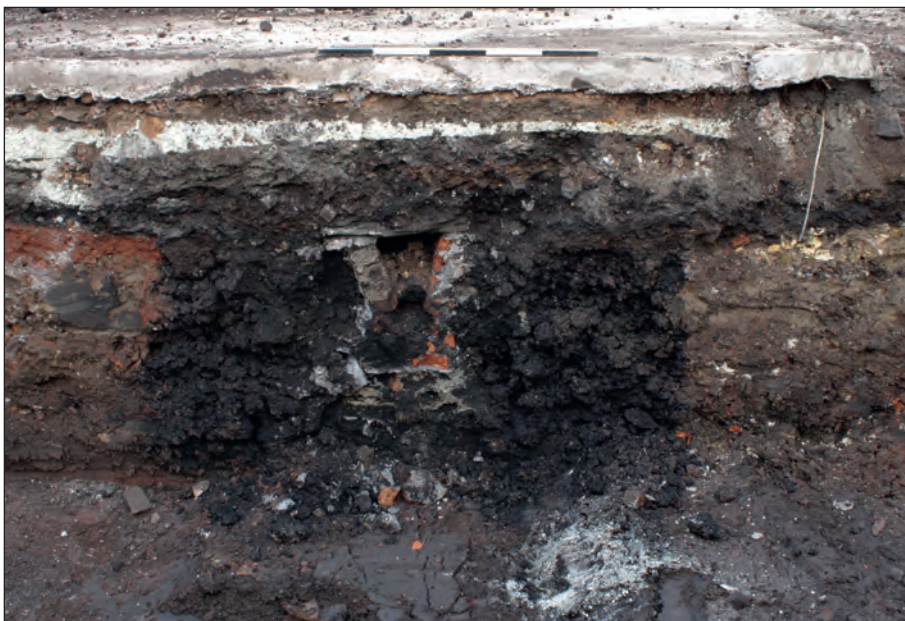
Figure 83: Brick- and stone-lined drain (group 1088), showing oversized construction cut. Looking north-east. Scale: 1 m (photograph by C. Sabato).

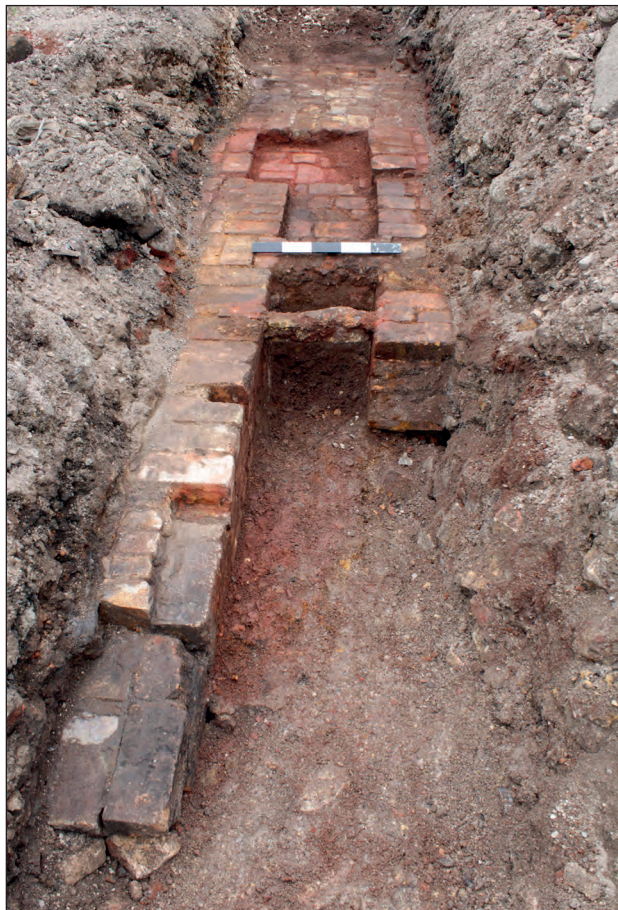
Figure 86: Ash pit on south-east side of retort bench (group 4080) in north-east range of the retort house, looking north-west. Scale: 0.5 m (photograph by L. Jervis).

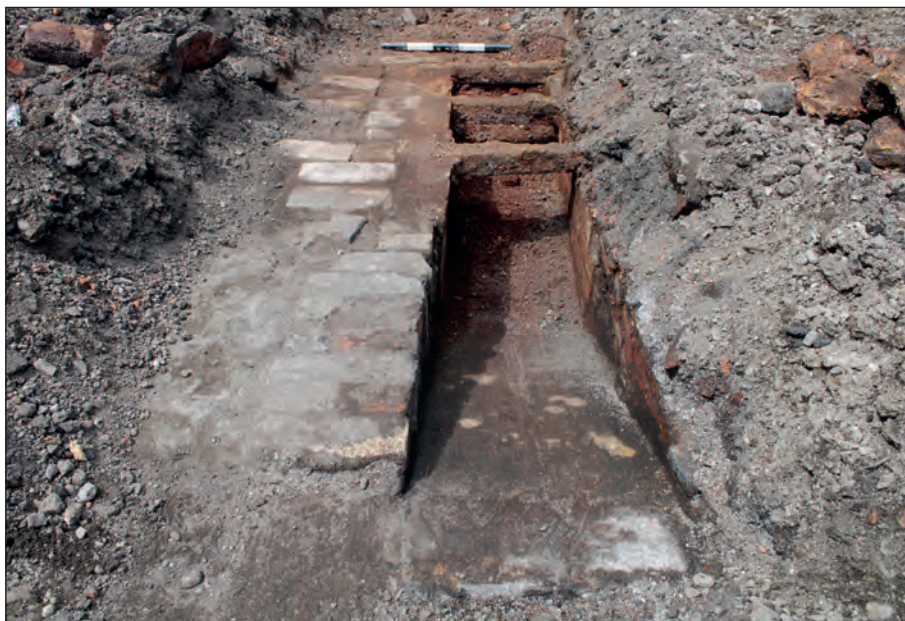
Figure 87: Ash pit on south-east side of retort bench (group 4080) in north-east range of the retort house, looking north-west. Scale: 0.5 m (photograph by C. Sabato).

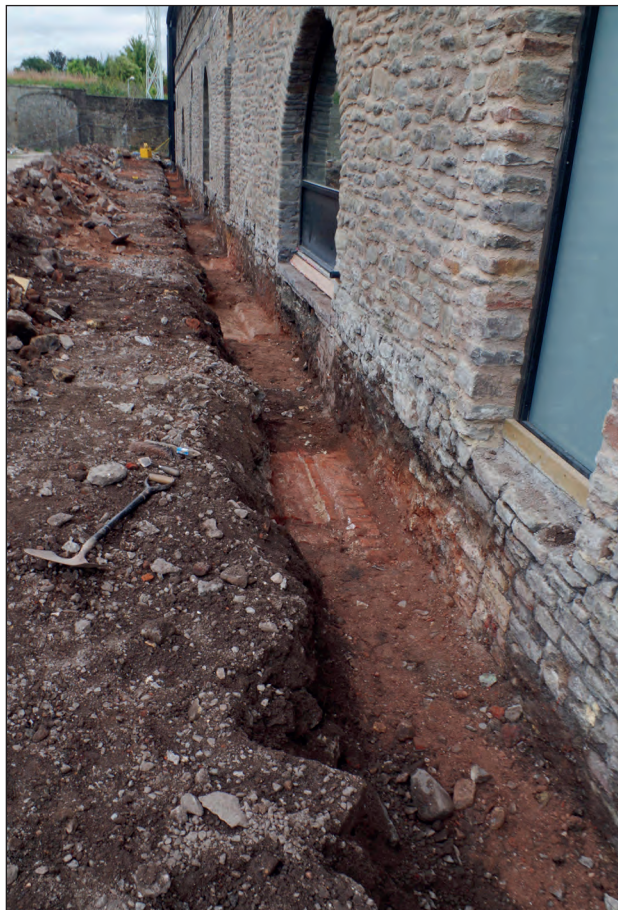
Figure 98: Brick flue (2041) to the north-west of the retort house, looking east (photograph by L. Jervis).

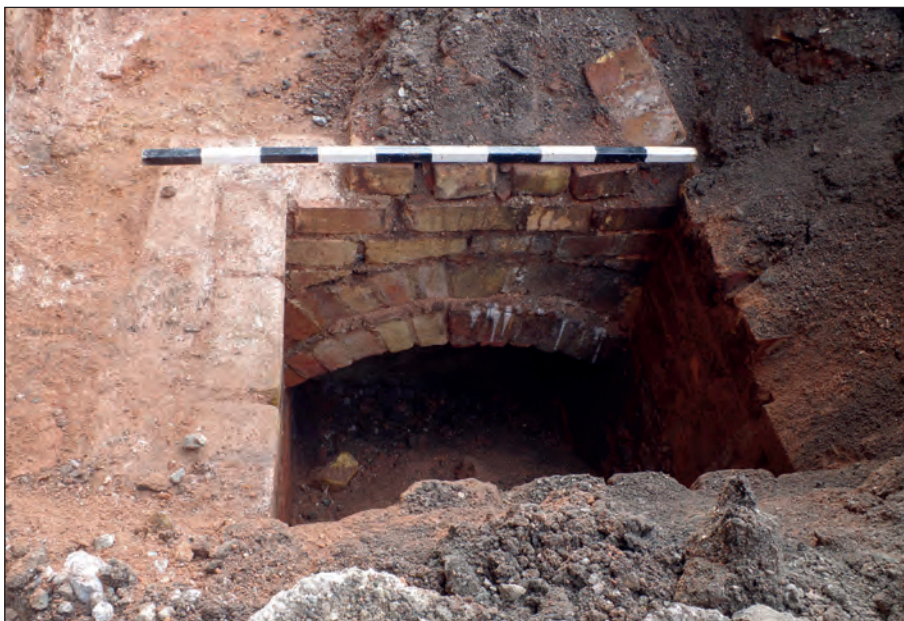
Figure 99: Opening at north-east terminus of brick flue (2041) to the north-west of the retort house, looking south-west. Scale: 1 m (photograph by L. Jervis).
