Garston Street Culvert Shepton Mallet, Somerset

Historic Structure Record

Document Ref.: 287010.01
November 2023

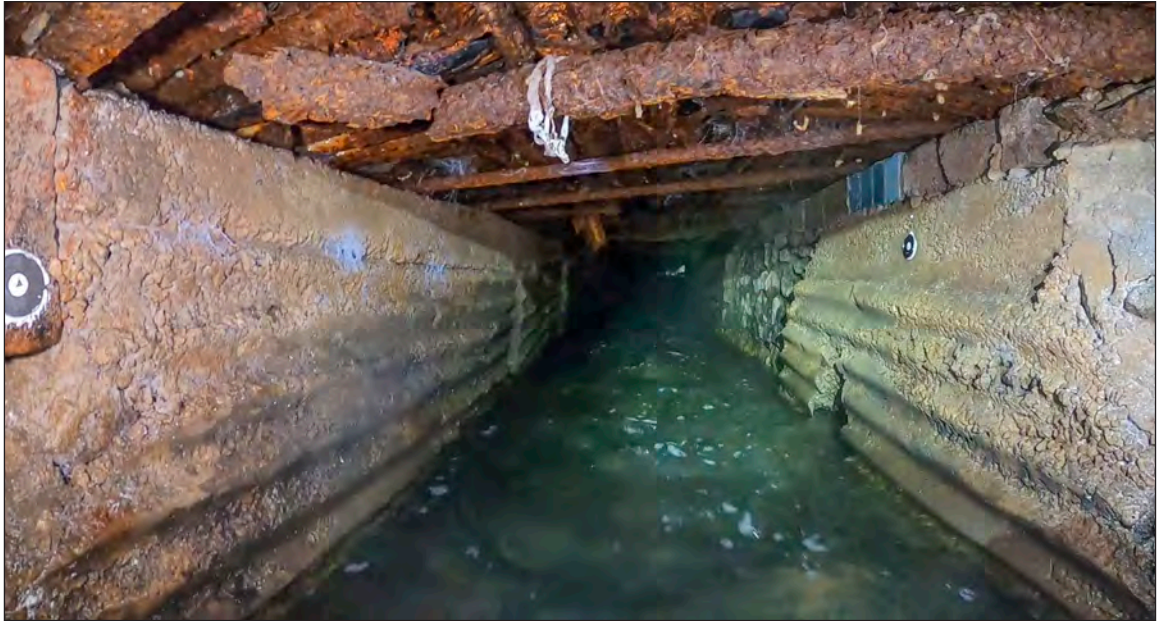
- 6.1.4 Starting at the inlet, the historic southern channel measures c. 55 m in length to the junction, and it is this section of the culvert to be lined. The westernmost 23 m were inaccessible due to restricted space, although the metric survey indicates there is a stone masonry arch 11.38 m long by 1.630 m wide x 0.97 m high, which then narrows to 1.25 m wide and between 0.90 and 1.02 m high. The majority of this narrow section has been modified with a corrugated concrete lining to the walls and a flat corrugated steel soffit but there is a short 1.9 m long section where the earlier stone arch remains (**Photograph 1**).

Photograph 1: Inaccessible concrete lined and re-roofed part of the southern channel from the inlet

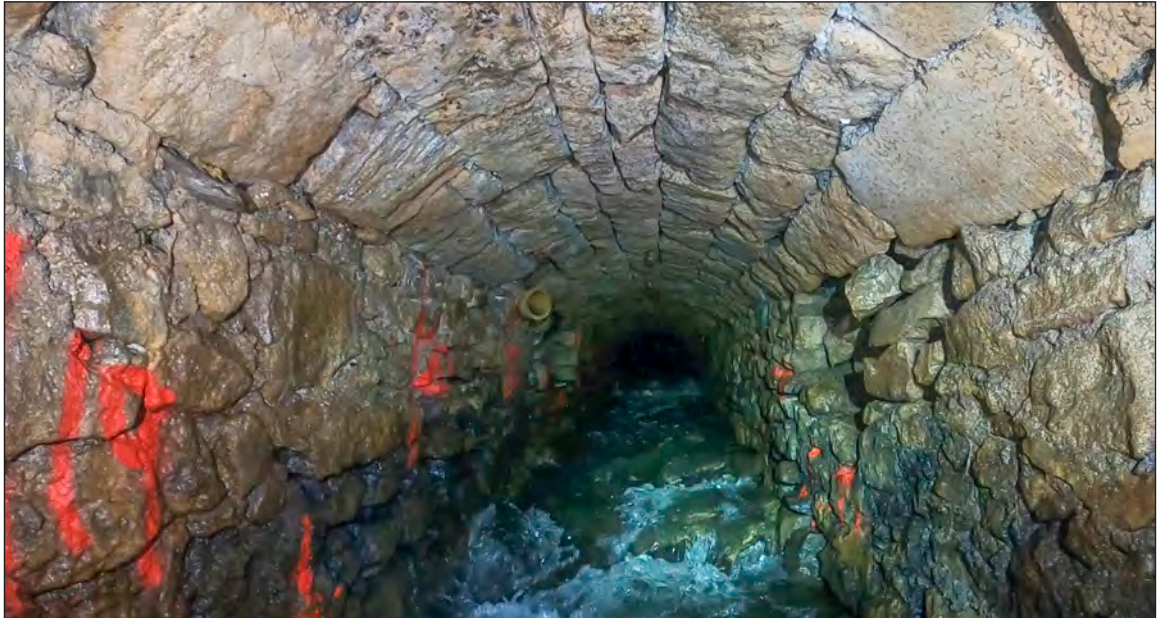
- 6.1.5 The rest of the historic southern channel varies between 0.90 and 1.10 m wide and 0.80 - 1.34 m high. The majority comprises a stone arch but some of the stonework has been lost because of scouring along the base of the walls. Towards the west end of the southern channel (close to the junction) there is another 3.9 m long area of modification, where the culvert walls are lined in concrete and the roof has been replaced by a corrugated steel soffit (damaged). To the west of this concrete and steel section, the culvert increases in height to 1.55 m with a flat soffit of concrete. The southern channel terminates in a stone arch where it meets the junction (**Photographs 2-7**).

Photograph 2: Intact stone arched part of the southern channel from the inlet

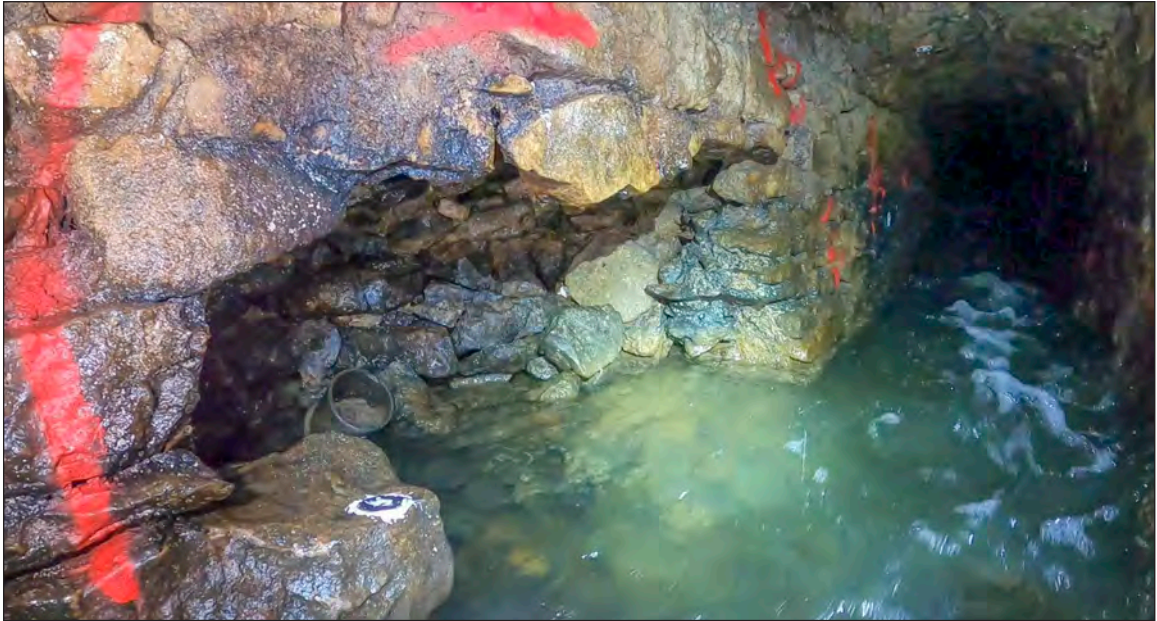
Photograph 3: Example of the scouring which has undercut the southern channel at the east end of the recorded culvert

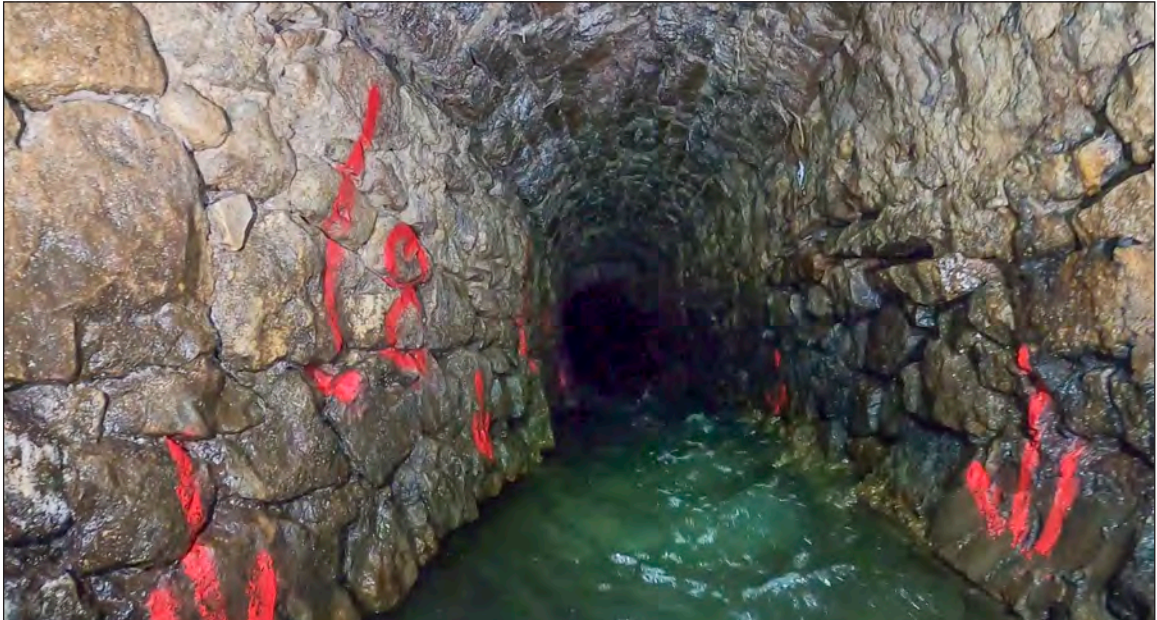
Photograph 4: Rough-coursed stone arch along the southern channel from the inlet

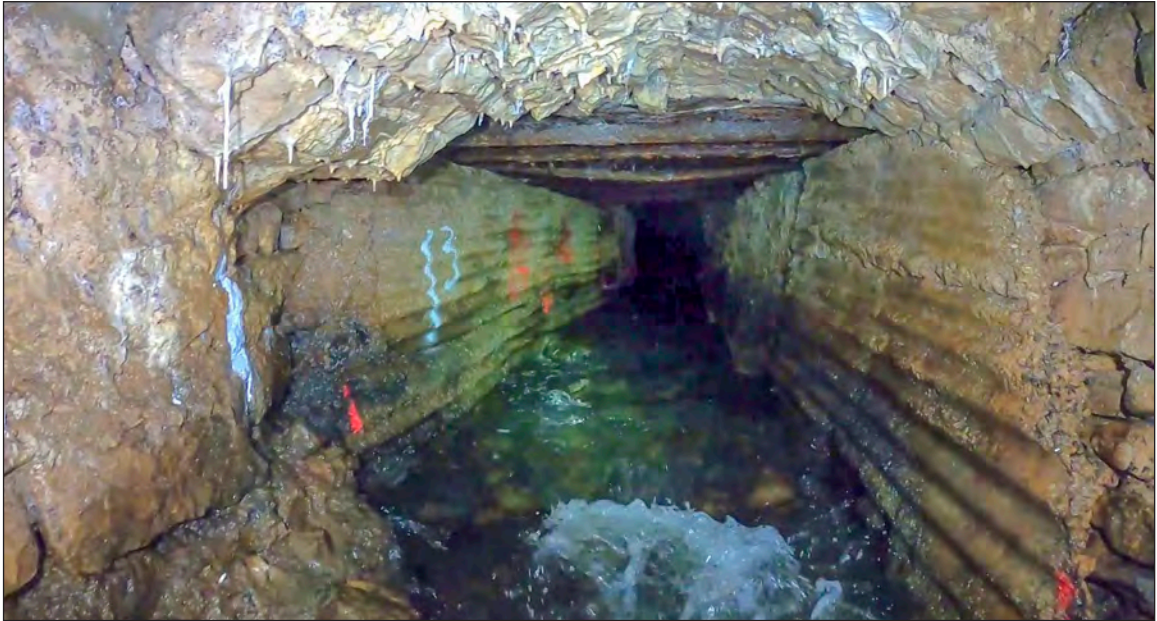
masonry walls are probably older. The concrete-lined walls and steel soffit repairs in the southern channel at the eastern end of the recorded culvert may have been carried out in the mid-20th century based on their appearance and where the culvert passes under the street a small area has been lined or rebuilt in concrete, probably in the late 20th century. Furthermore, the eastern end of the culvert was recently modified in 2010 as part of flood alleviation works when a second channel from the inlet was built to bypass the historic one, and part of the historic culvert was enlarged to form a junction chamber (works monitored by AC Archaeology). The modern concrete and corrugated steel materials contrast with the historic stone structure. As recorded in 2023, the historic southern channel appears to be in poor condition with the walls extensively undercut by scouring, damaged masonry and the metal soffit repairs are heavily corroded, hence the urgent need for the proposed lining.

Photograph 5: Another concrete-lined and metal-roofed section towards the western end of the southern channel from the inlet

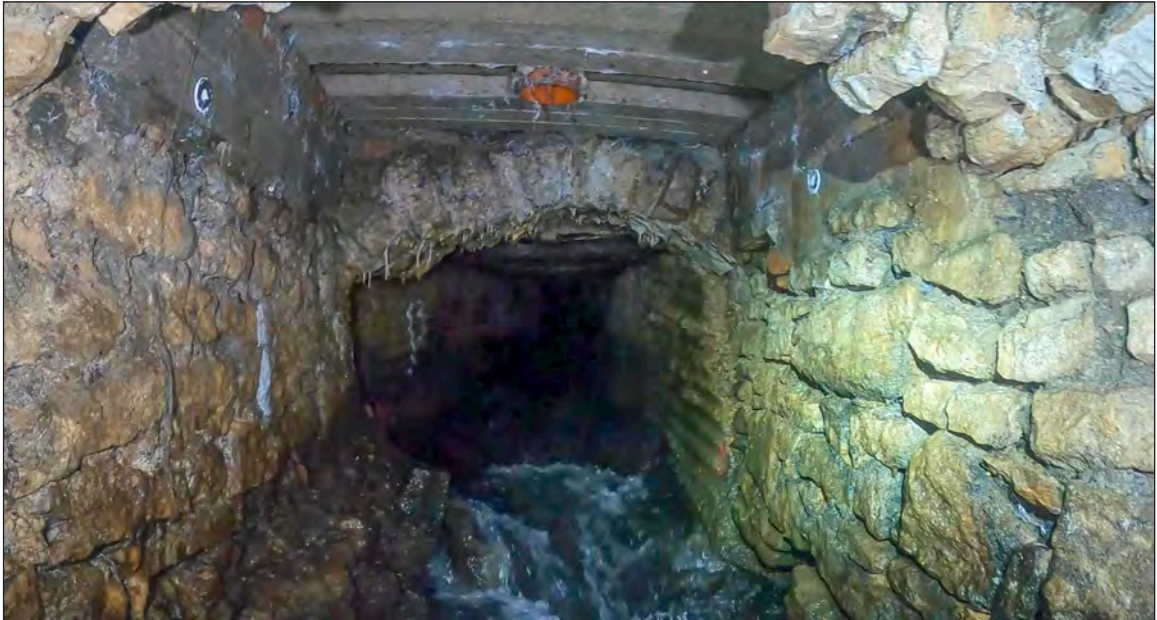
Photograph 6: The concrete soffit at the eastern end of the southern channel

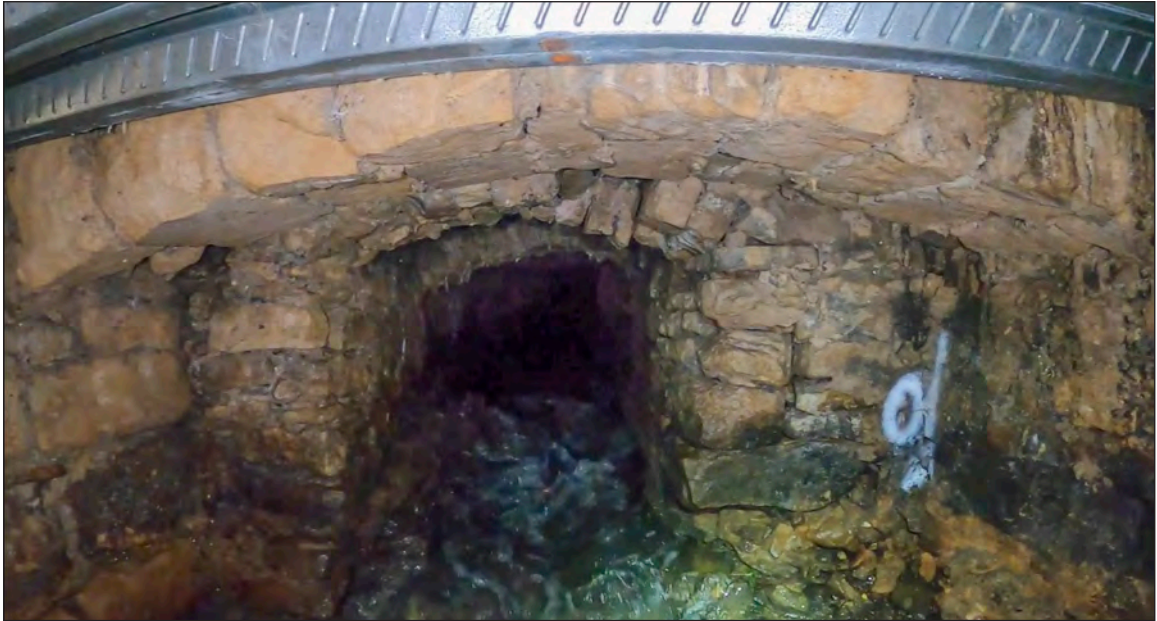
Photograph 7: The opening of the southern channel into the junction chamber

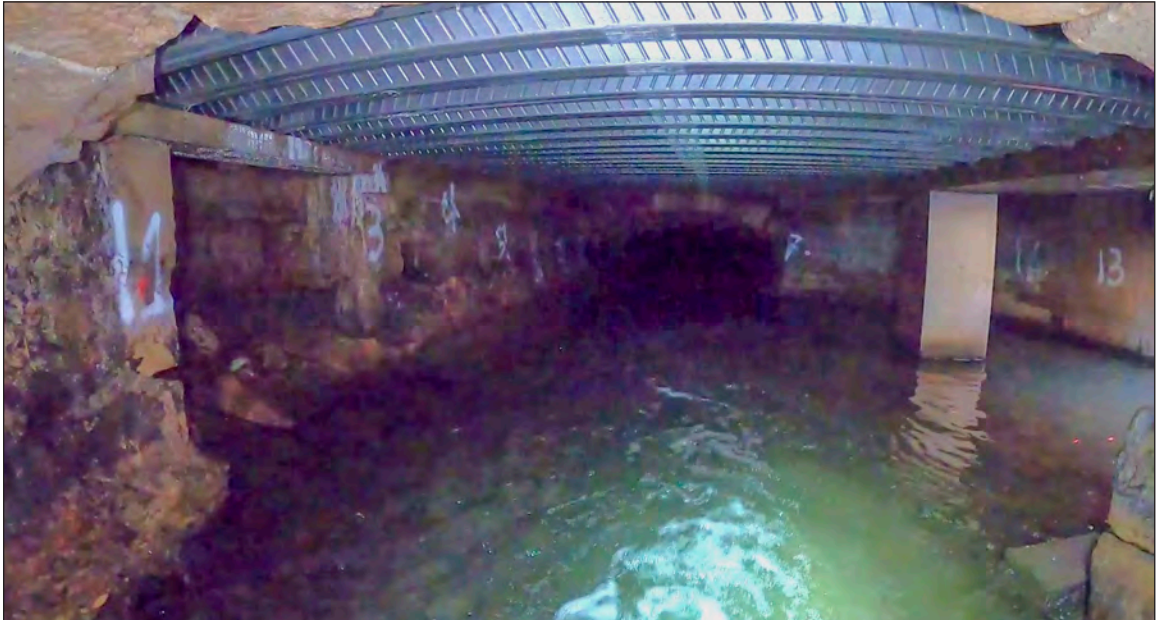
- 6.1.6 The junction chamber (also known as the distribution chamber) is an irregular plan space 8.14 m long, between 2.9 and 5.7 m wide and 1.31 m high. This chamber was formed when the historic culvert was enlarged to the north in 2010 to connect with the new northern channel from the Garston Street inlet. The walls forming the southern part of the chamber are mortared limestone block construction as this was part of the historic culvert, while walls that form the north side are a mix of concrete block and concrete construction. The former stone arched roof over the historic culvert was removed as part of the 2010 works, and the entire chamber has been reroofed with a corrugated steel soffit. The extrados of the previous stone arched roof was roughly finished, but inspection of the interior revealed a more neatly faced intrados (AC Archaeology 2011, 18). The bed of the culvert within the junction chamber has been replaced in concrete and this material continues westwards 7.6 m along the culvert (**Photographs 8-9**).

Photograph 8: The junction chamber viewed from the east

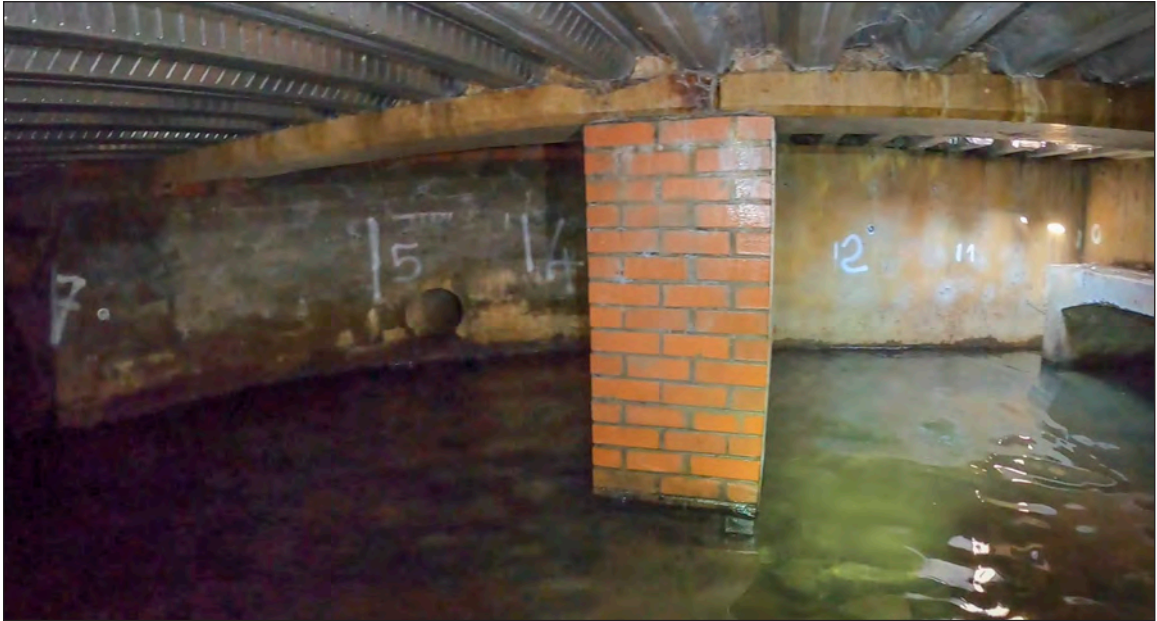
Photograph 9: The north side of the junction chamber, built in 2010.

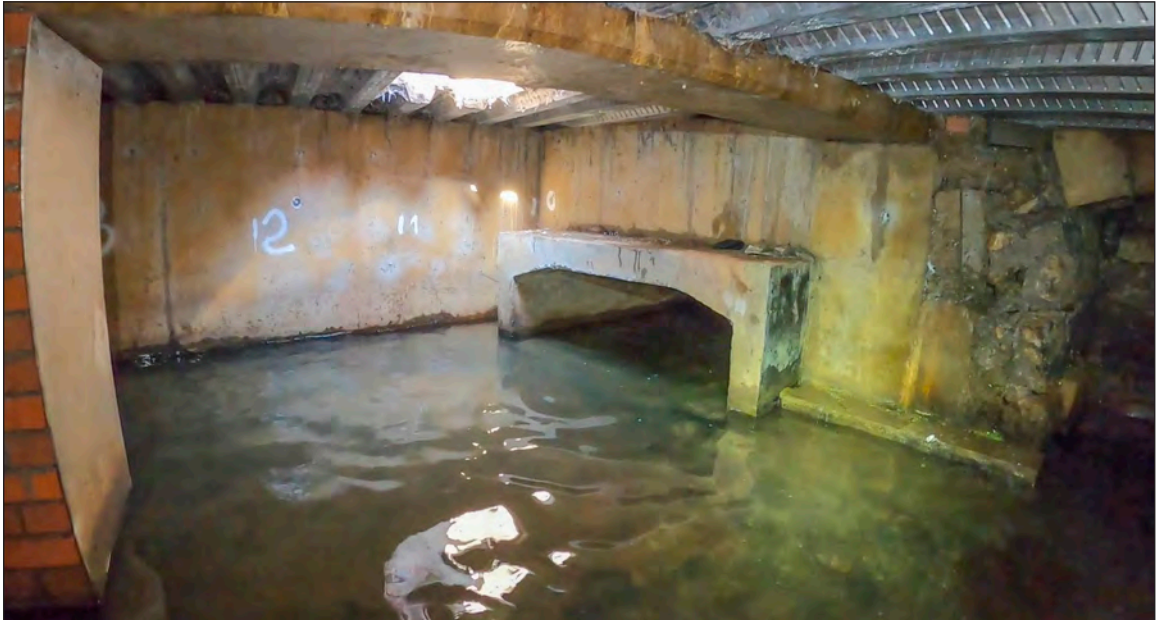
- 6.1.7 The modern northern channel from the inlet was built in 2010 to bypass the historic one. It was not covered by the laser scan or CCTV survey and its route presented on the plan is assumed rather than accurately surveyed. The channel runs north-east from the inlet for approximately 13 m before turning west. It measures approximately 63 m in total and is 1.5 m wide throughout. The west end of the channel (at the junction chamber) consists of a rectangular profile concrete frame (**Photograph 10**).

Photograph 10: The east end of the modern channel from the inlet, built in 2010.

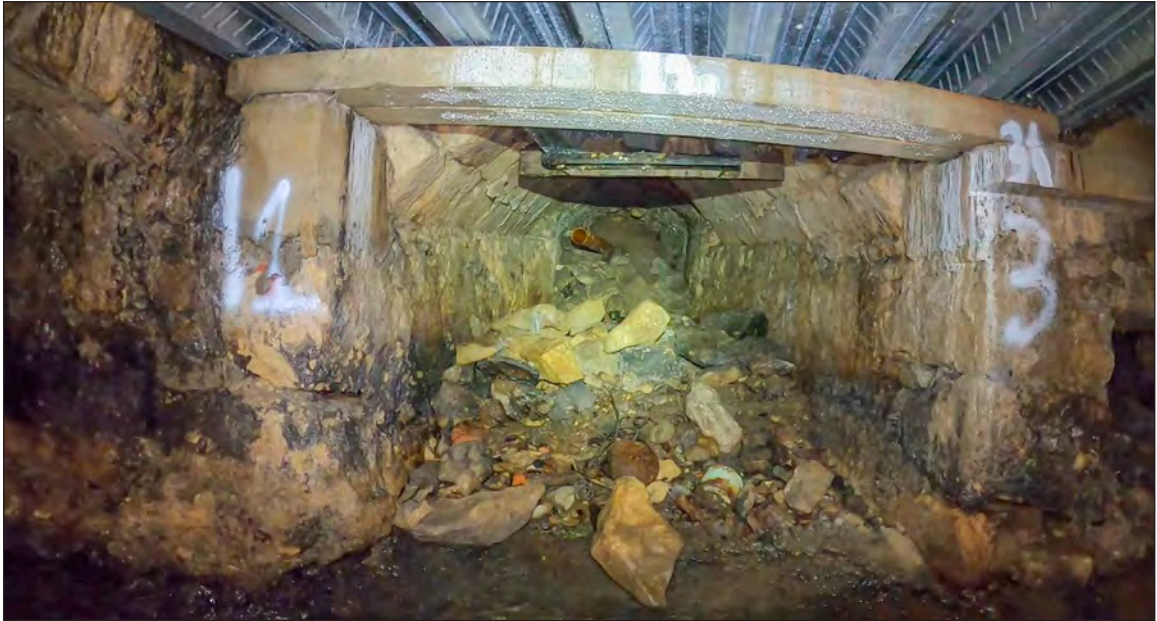
- 6.1.8 On the south side of the junction chamber is a smaller channel, or leat. This is the drain from the former high level leat that powered a wheel associated with the Old Flour Mill, Leg Square (also known as Old Mill House/formerly The Bake House) immediately to the south (AC Archaeology 2011, 18). The Old Flour Mill is identified in the Somerset HER as the town mill - built in 1760 or earlier, burnt down in 1850s and rebuilt. It was a cloth mill until 1810, a silk mill in the 1830s and 1840s, and a flour mill and bakery from the 1850s to 1890s (HER no. 11078). The drain from the mill leat has been largely backfilled with only 5.10 m length remaining open. It is a mortared limestone block arched channel but the opening into the junction chamber has been modified by the insertion of a concrete frame as part of the 2010 works. The stone arch survives further south (**Photograph 11**). A photograph of this part of the culvert with its roof removed and the drain from the mill leat in view is presented in the AC Archaeology report (2011, 18; not reproduced).

Photograph 11: The drain from the mill leat on the south side of the junction chamber

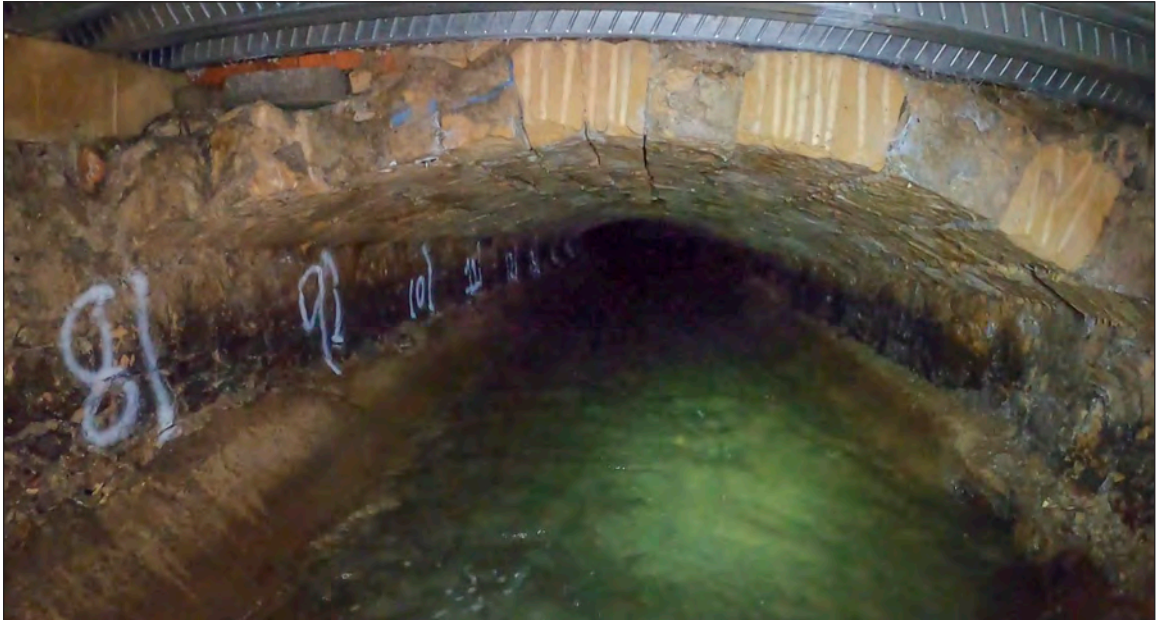
- 6.1.9 To the west of the junction chamber, the culvert continues as a stone arched channel built of mortared limestone blocks (**Photograph 12**). The concrete floor within the junction chamber continues for 7.6 m before changing to a natural bed. The culvert kinks as it crosses under the street. At 24.3 m chainage, where the culvert starts to cross under the street, there is a change in the soffit material from squared limestone blocks to rubble stone, with a slight drop in the arch and a brick repair on the north side (**Photograph 13**). At 29 m chainage, a small area of the culvert has been lined or rebuilt in smooth concrete with a shuttered concrete soffit. Here another stone arched culvert joins the main one from the south, although the opening between the two is also formed of concrete (**Photographs 14-15**). This other culvert runs south-east towards the Old Flour Mill (town mill HER no. 11078) and may be a former leat associated with this property similar to the one connected to the junction chamber. After the short concrete section, the main culvert changes back to a low limestone block arch construction (3.14 m wide by .086 m high) and a metal pipe cuts through the channel. After passing under the street, the culvert returns to its former alignment and runs behind buildings 4-6 Leg Square. The soffit changes to shallow arched brick at this point (**Photograph 16**).

Photograph 12: View looking west along the culvert from the junction chamber (8m chainage)

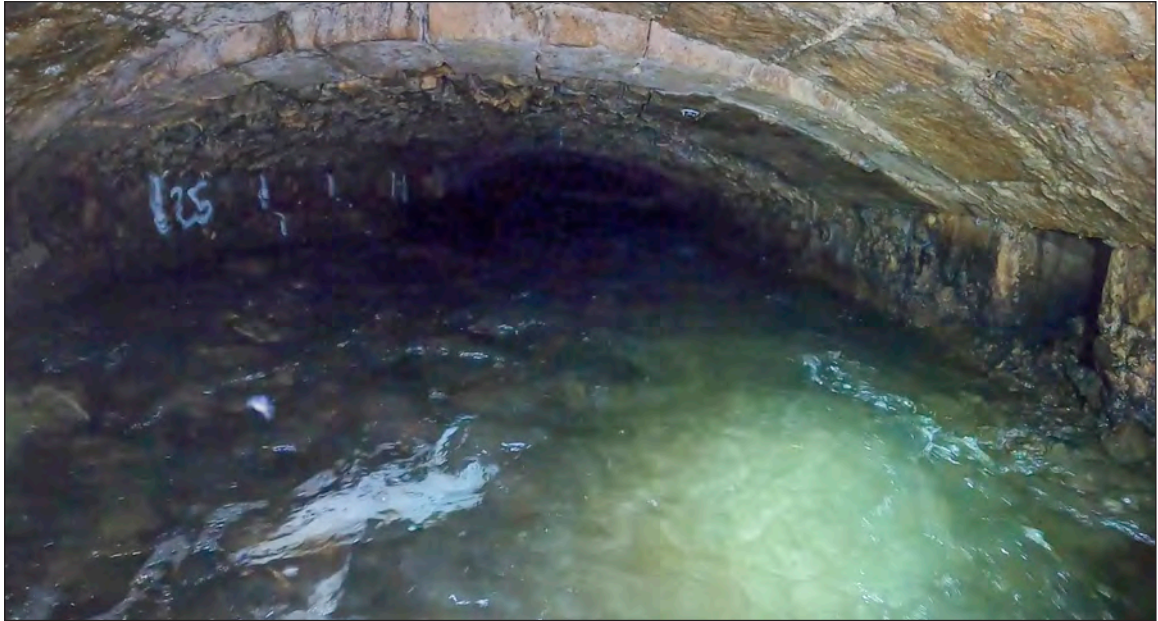
Photograph 13: A change in soffit material from limestone ashlar blocks to stone rubble and drop in the arch as the culvert crosses under the street (24.5m chainage)

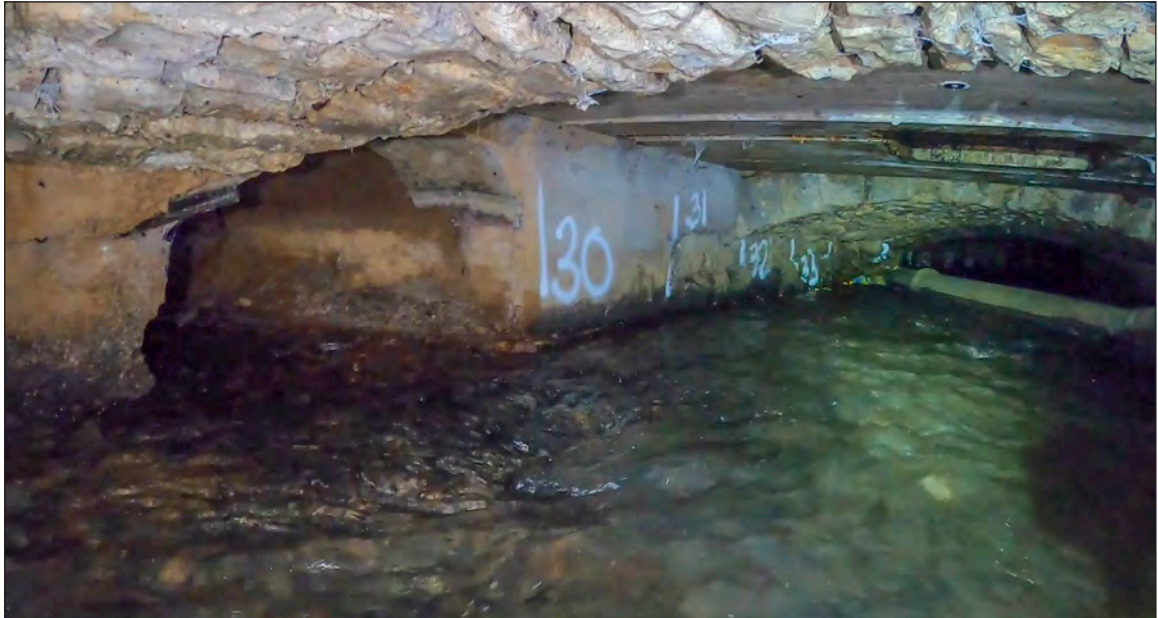
Photograph 14: A concrete section of the culvert under the street carriageway, with a smaller stone culvert joining from the south (left) (29.5m chainage)

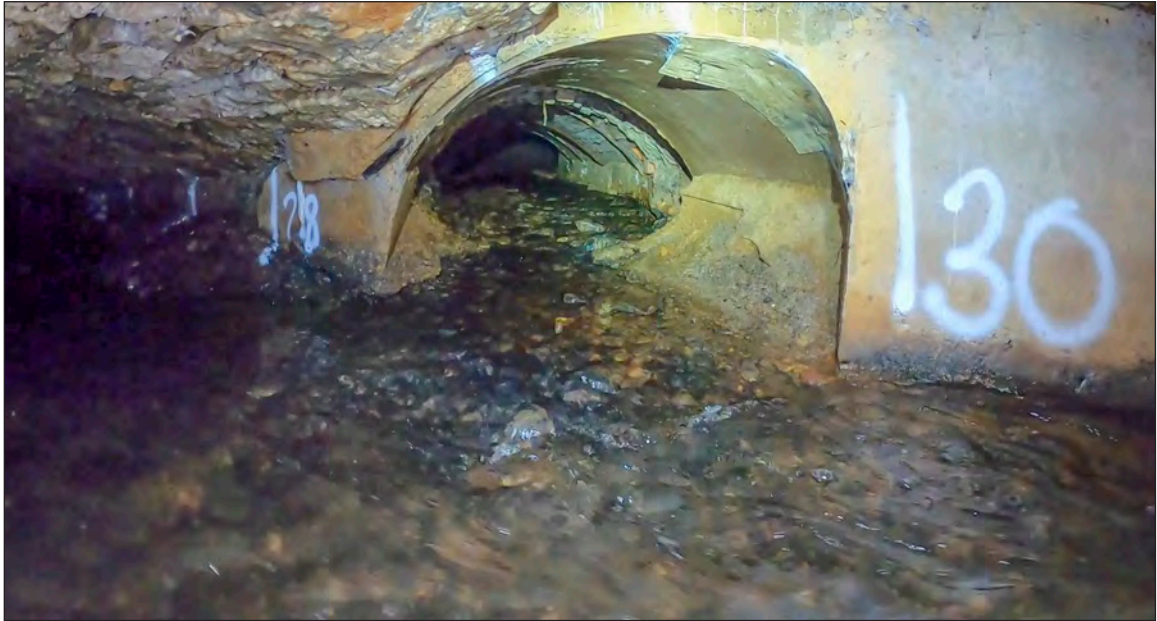
Photograph 15: The stone arch culvert which may be a leat associated with the Old Flour Mill, Leg Square (town mill, HER no. 11078; 29m chainage)

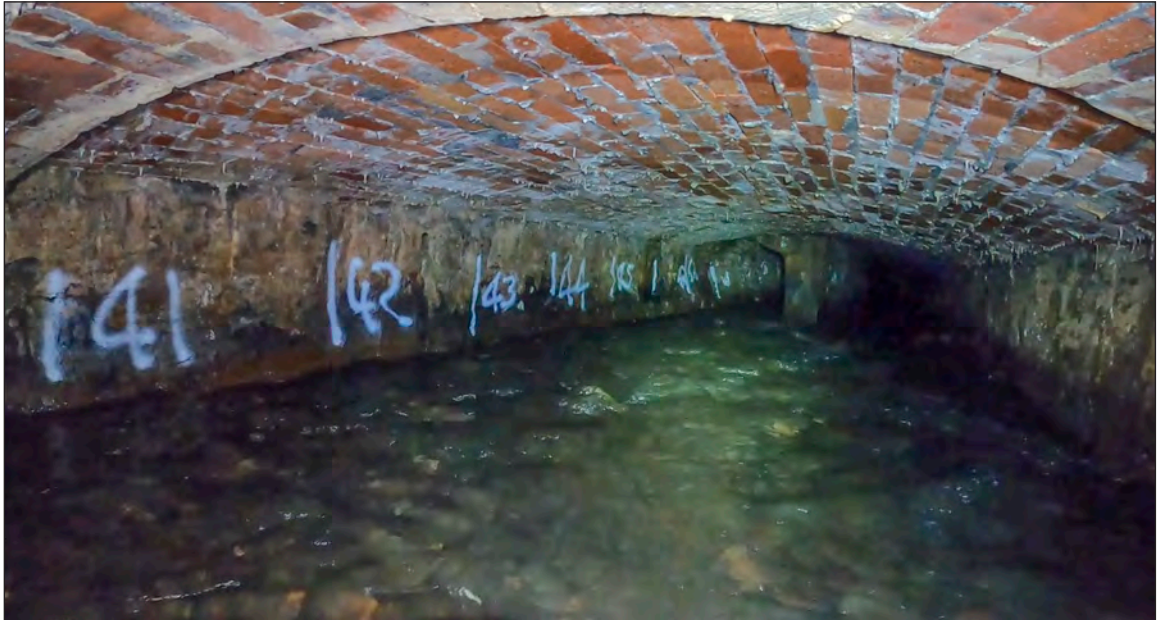
Photograph 16: A view looking west towards the bifurcation showing that the soffit has changed to brick (40.5m chainage)

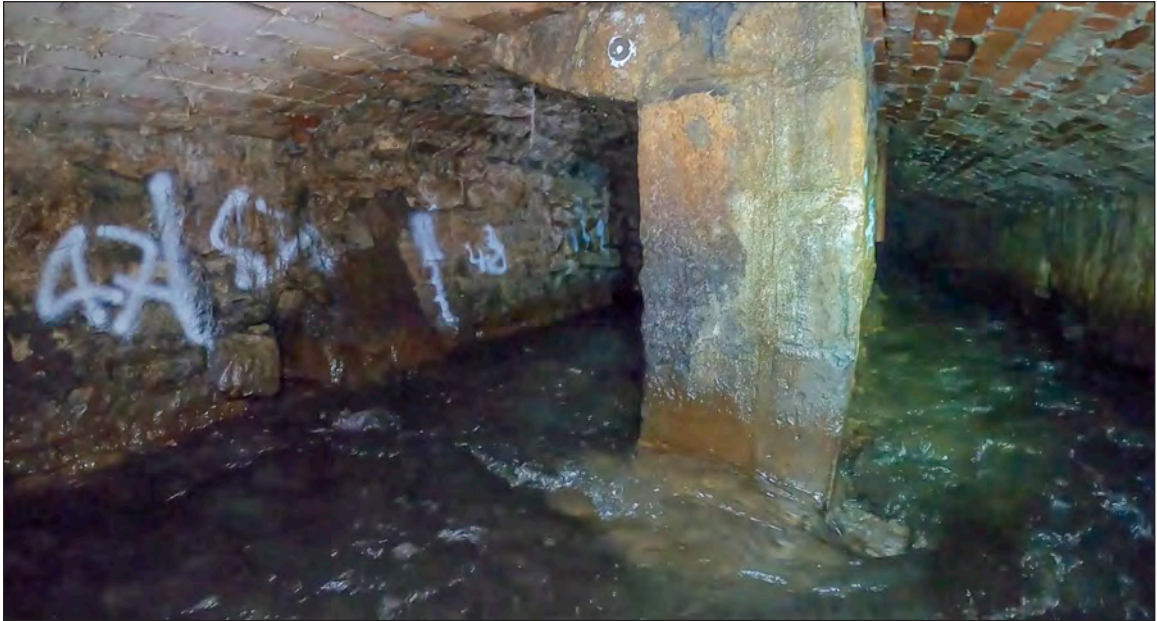
- 6.1.10 Behind buildings 5 and 6 Leg Square the culvert splits in two for a distance of 5.66 m. The bifurcation right (northern channel) is the larger of the two and the brick soffit continues through it. It measures 1.4 m in width compared to the stone-built bifurcation left, which is

Photograph 17: The stone wall which divides the culvert into bifurcation left and bifurcation right (c. 47m chainage)

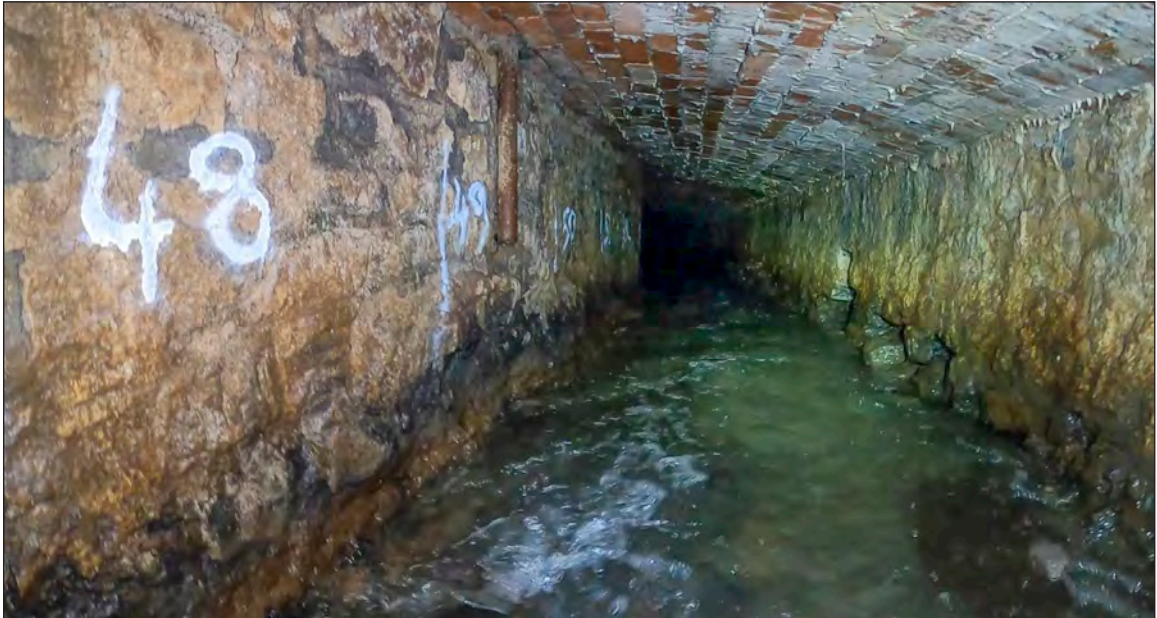
Photograph 18: Bifurcation right (48m chainage)

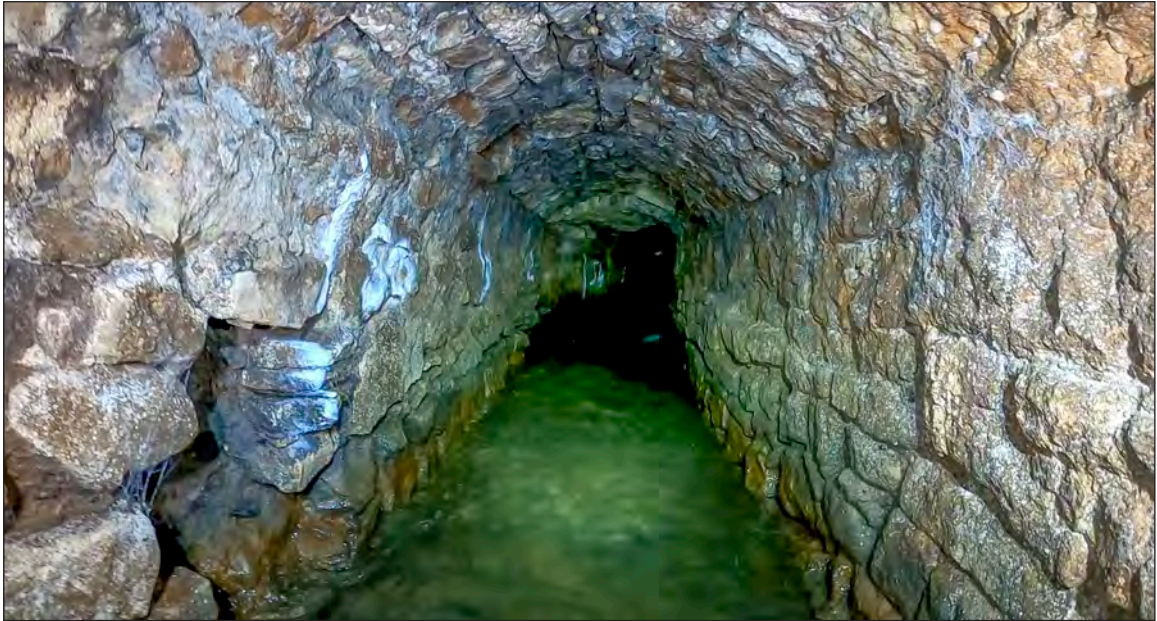
only 0.8 m wide and features worn stone walls and soffit. Towards the western end of the bifurcation left it is joined by a small incomer stone channel from the south (**Photographs 17-20**).

Photograph 19: Bifurcation left (49m chainage)

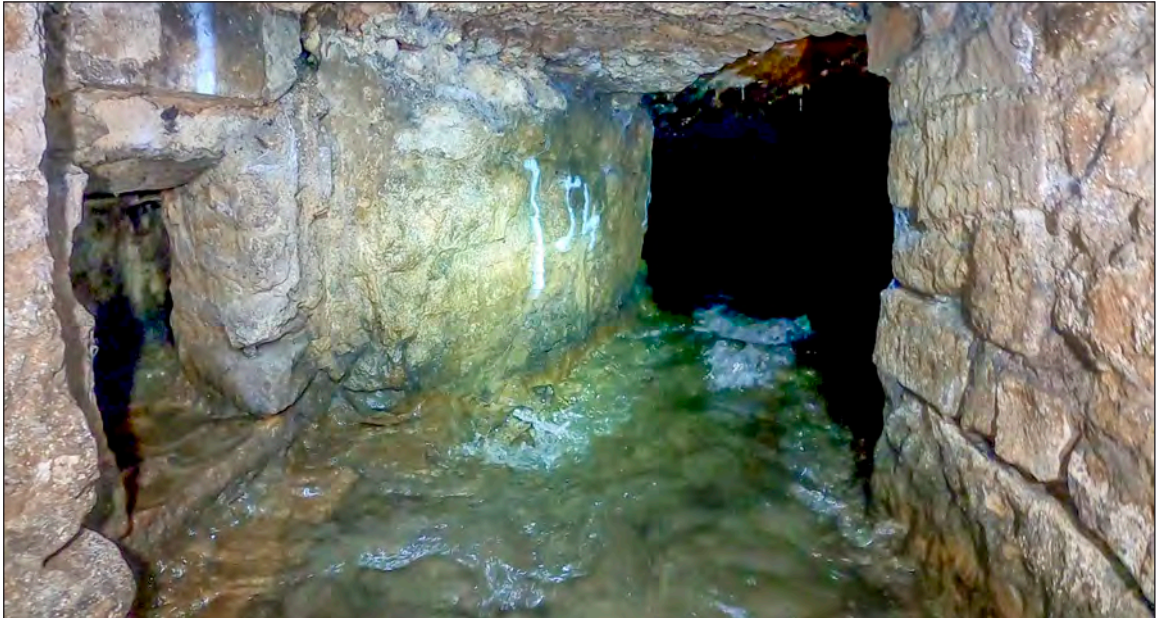
Photograph 20: The west end of bifurcation left with a lateral connecting channel or leat on the left (52m chainage)

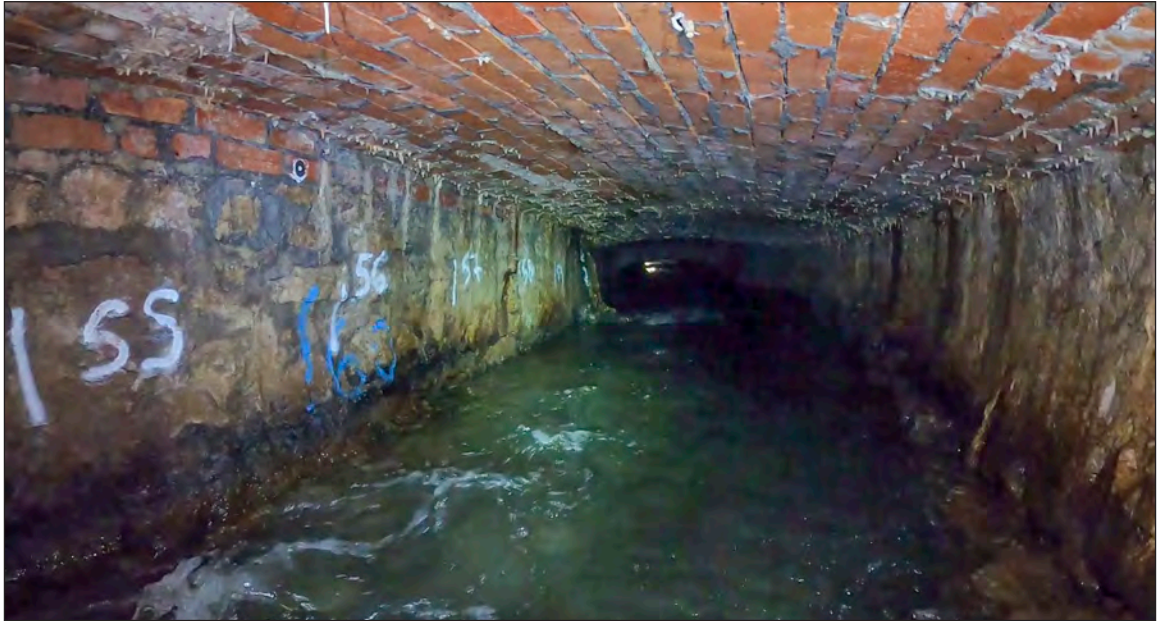
- 6.1.11 After the bifurcation, the culvert continues with limestone walls and a shallow arched brick soffit. Between the bifurcation and the outlet, the culvert varies slightly in dimensions ranging from 2.48 to 3.13 m wide and 1.04 to 1.69 m high. There are two drops in the floor level around the 60-63.5 m chainage mark, 6-9 m west of the bifurcation. Further west, at 68 m chainage, the main culvert is joined on the south side by a lateral stone channel at least 5 m long and assumed to extend much further (**Photographs 21-24**).

Photograph 21: The culvert to the west of the bifurcation (55m chainage)

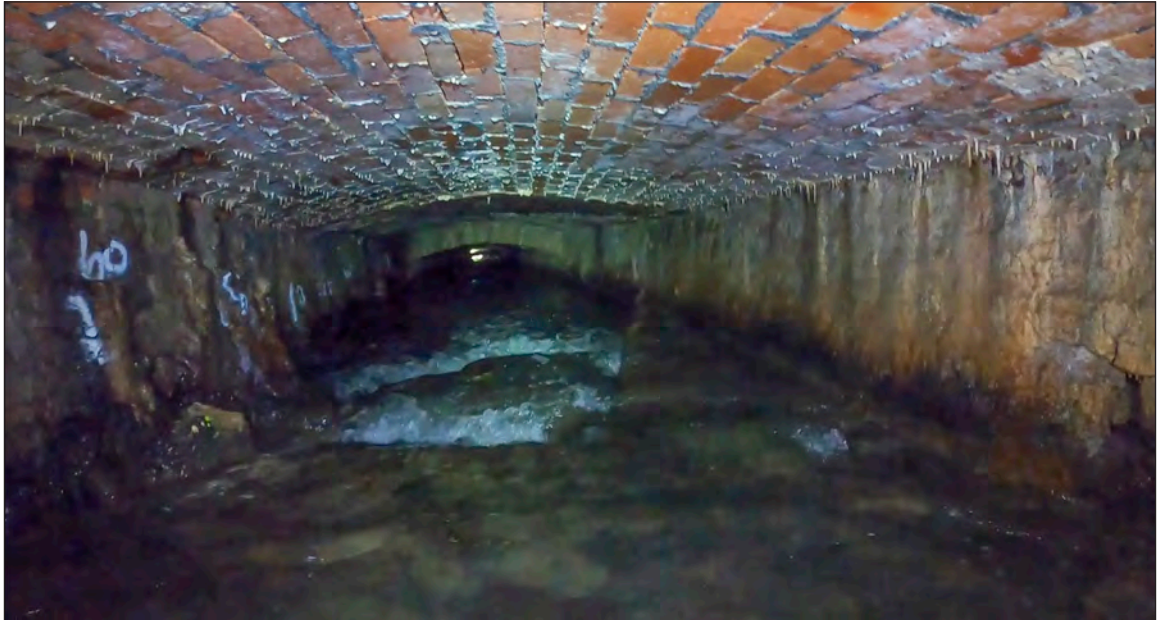
Photograph 22: A pair of drop structures lower the floor level (c.59m chainage)

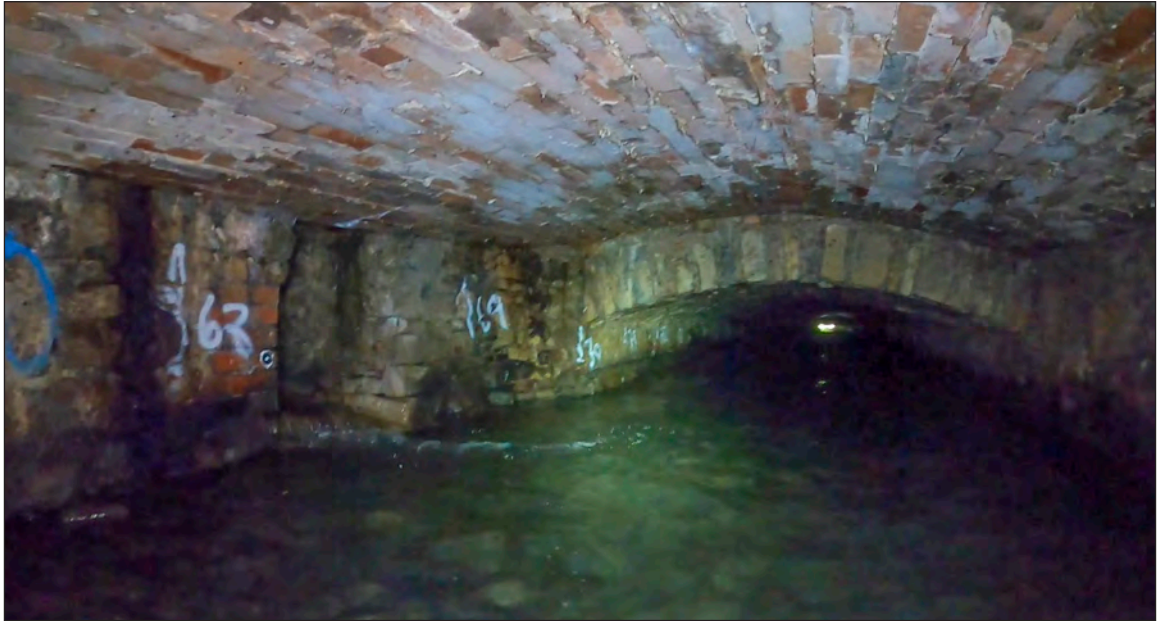
Photograph 23: Photograph showing the change from a brick soffit to a lower stone arch, plus a lateral channel or leat on the left (c.67m chainage)

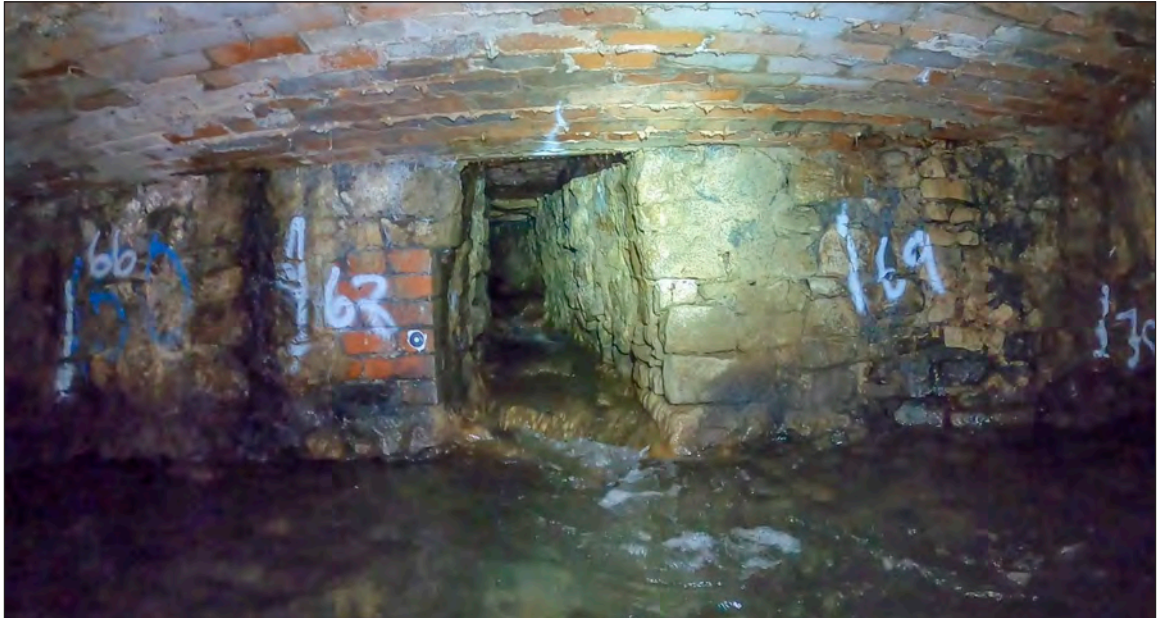
Photograph 24: The lateral channel that runs south under 4 Leg Square and presumably further under the Square (67m chainage)

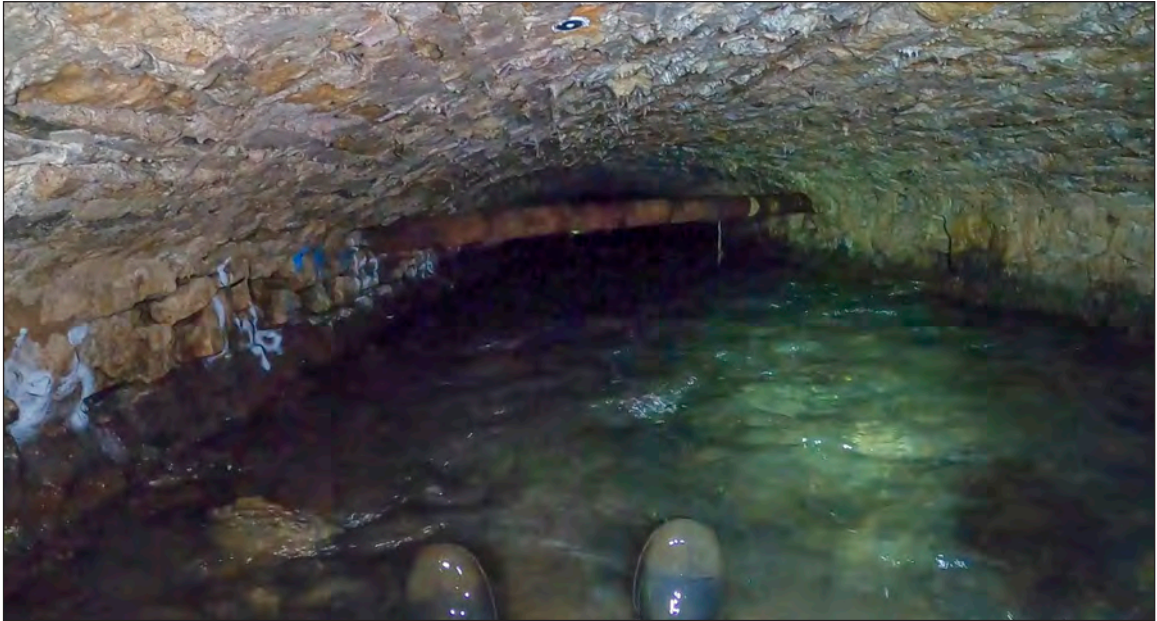
- 6.1.12 In line with the boundary wall for 4 Leg Square (70 m chainage), the culvert soffit changes from a brick to a lower stone arch (**Photograph 25**). Straight joints accompanied by at least five changes in culvert size, arch profile and character over a distance of 45 m clearly demonstrate that the western end of the recorded culvert was constructed in multiple phases as it has been extended several times, probably over the course of the 20th century.

Photograph 25: A pipe crossing through the culvert (c. 78m chainage)

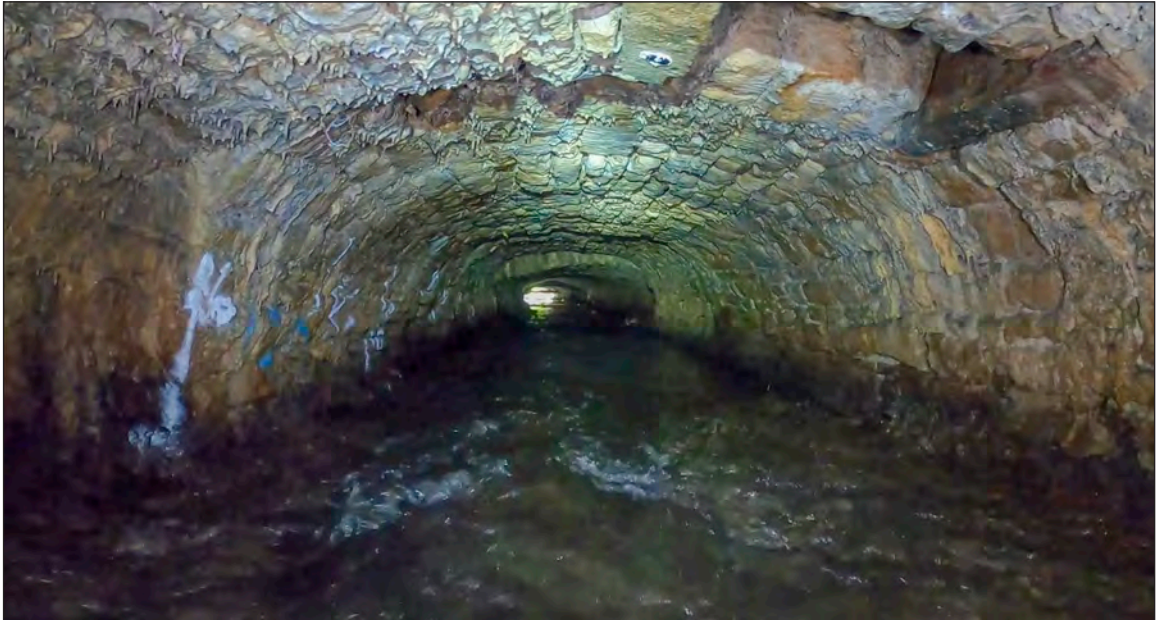
- 6.1.13 Proceeding west from 4 Leg Square, the low stone arch continues for 15.5 m at which point the culvert narrows to 2.48 m wide; there is a possible manhole cover overhead at this point (**Photograph 26**). This narrower section continues for 7.10 m (to 93.5 chainage) where the channel widens again to 2.82 m, there is another straight joint, and the line of the stone arch changes again (**Photograph 27**). This wider section continues for 11.7 m and contains another drop structure to deepen the culvert. A concrete plinth extends along the south side of this part of the culvert and the masonry forms a narrow shelf or ledge along the north side. At 106 m chainage the concrete plinth terminates as the culvert widens again but the stone ledge continues (**Photographs 28-29**). At 113 m chainage, there is another straight joint and change in size and direction as the culvert turns to flow into the outlet to the south of Bridge Cottage 16 Lower Lane. This end of the culvert is cut through by multiple metal pipes and cables and terminates in a two-course limestone arch (**Photographs 30-32**). The river Sheppey continues westwards along Lower Lane in an open channel (**Photograph 33**) heading towards the former site of the Lower Lane mill building and factory investigated by AC Archaeology (in 2011).

Photograph 26: The narrow part of culvert towards its western end (86-93m chainage). Note the multiple variations in the size and shape of the arch. A possible manhole cover is visible top right.

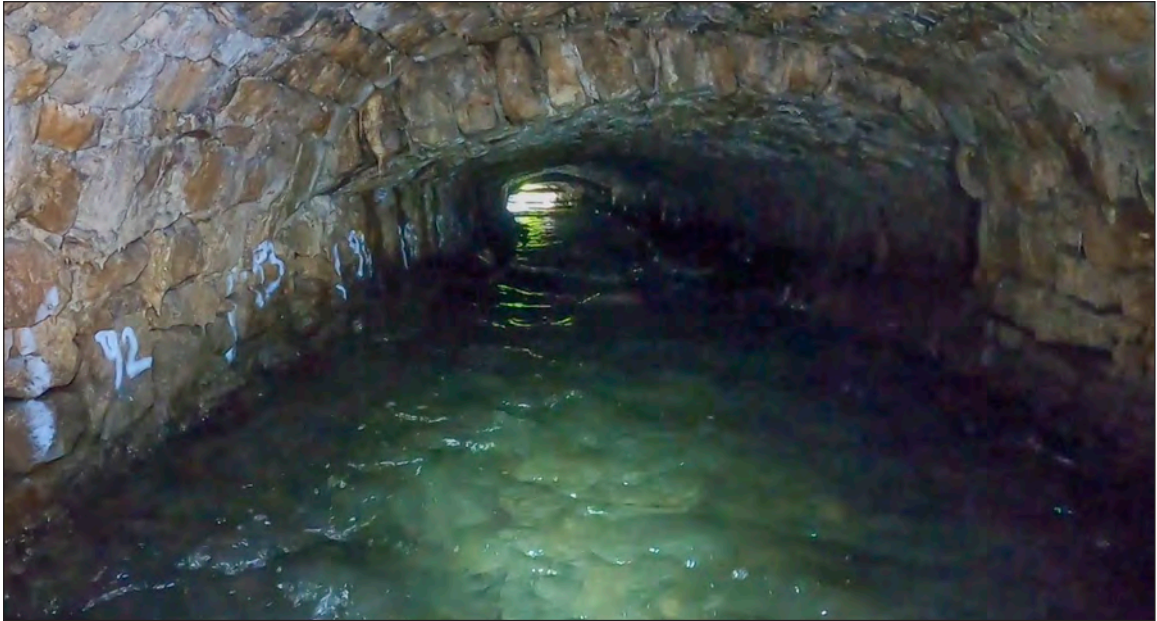
Photograph 27: Another change to the size and shape of the culvert (from 93m chainage)
