Garston Street Culvert Shepton Mallet, Somerset

Historic Structure Record

Document Ref.: 287010.01
November 2023

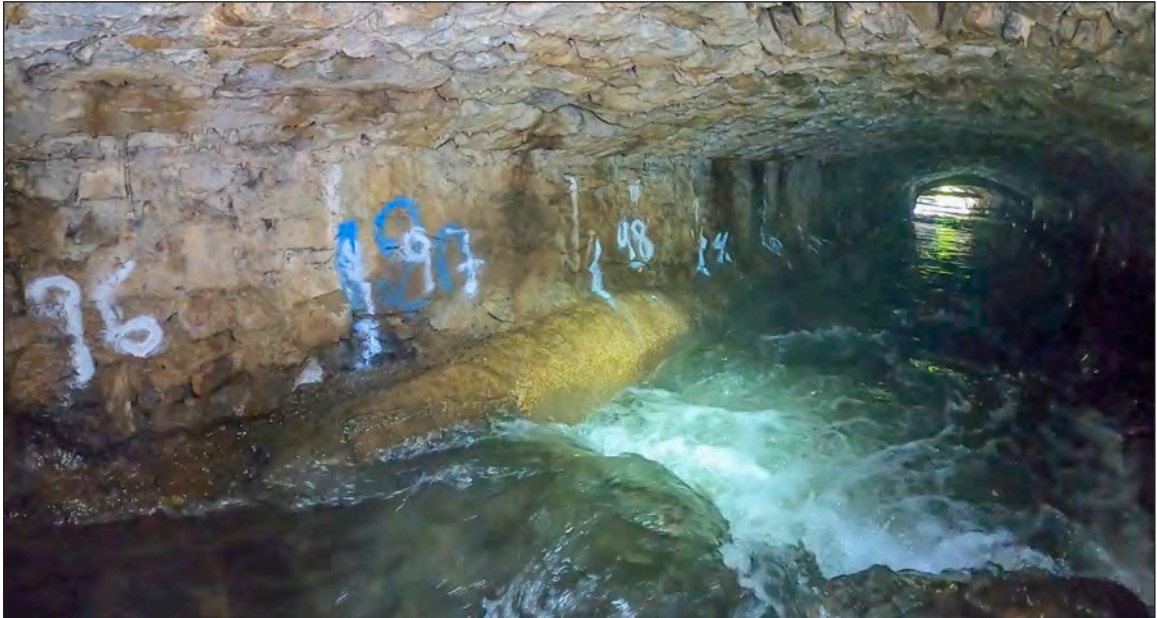
Photograph 28: Another drop structure (97m chainage) and the concrete plinth built along the south wall of this part of the culvert

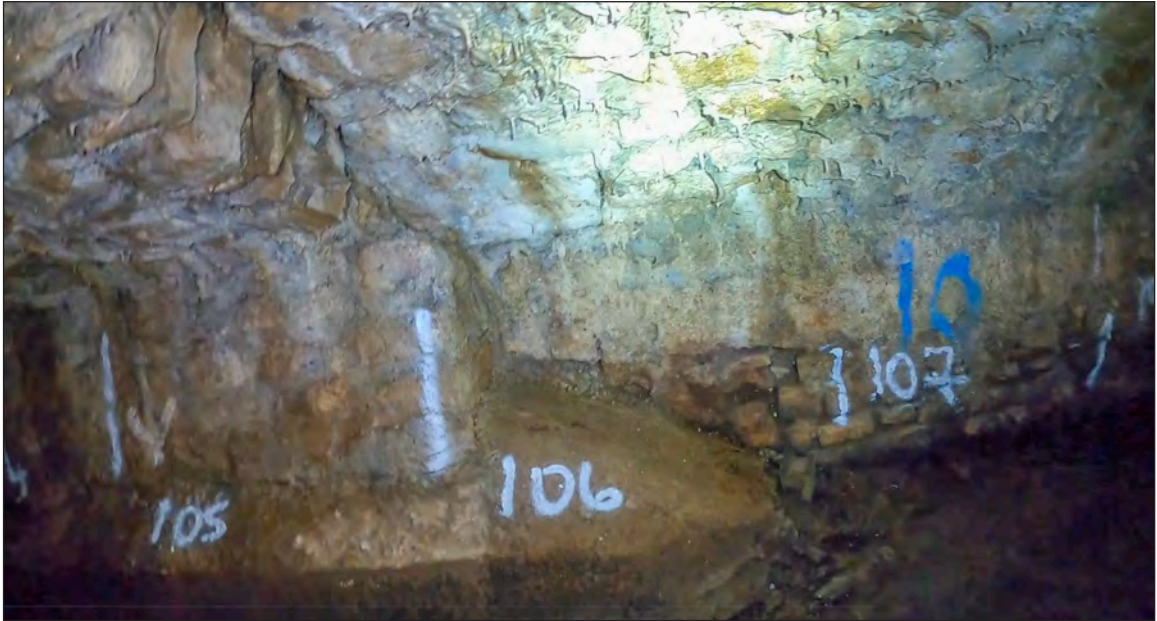
Photograph 29: The western end of the concrete plinth as the culvert widens again (106m chainage)

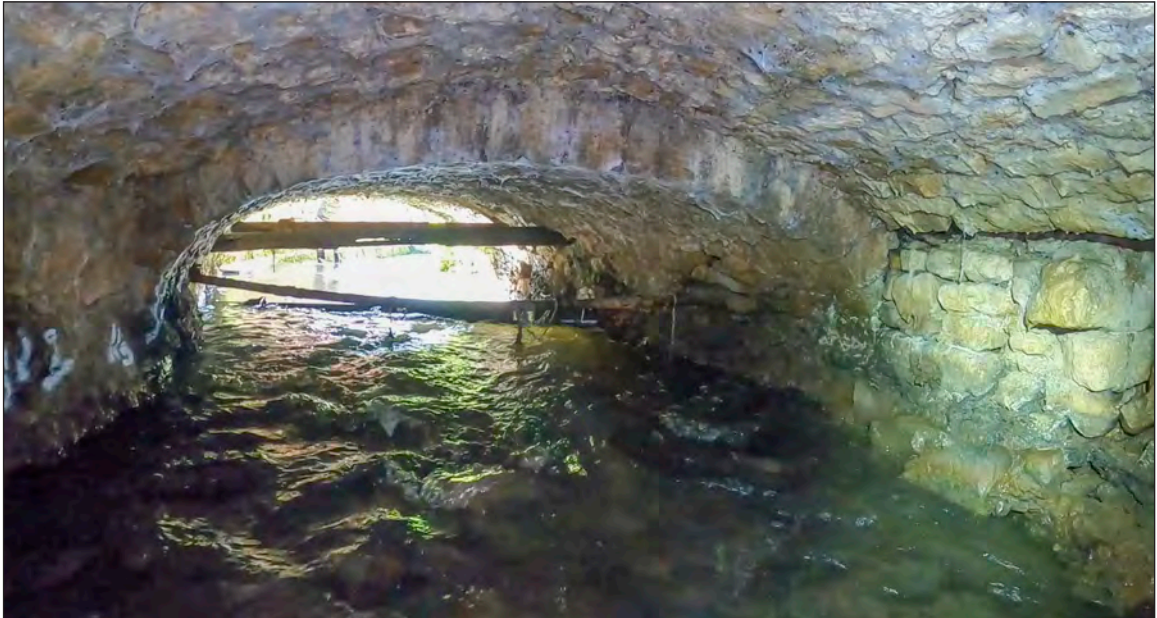
Photograph 30: The western end of the culvert partially blocked by pipes and cables (113m chainage)

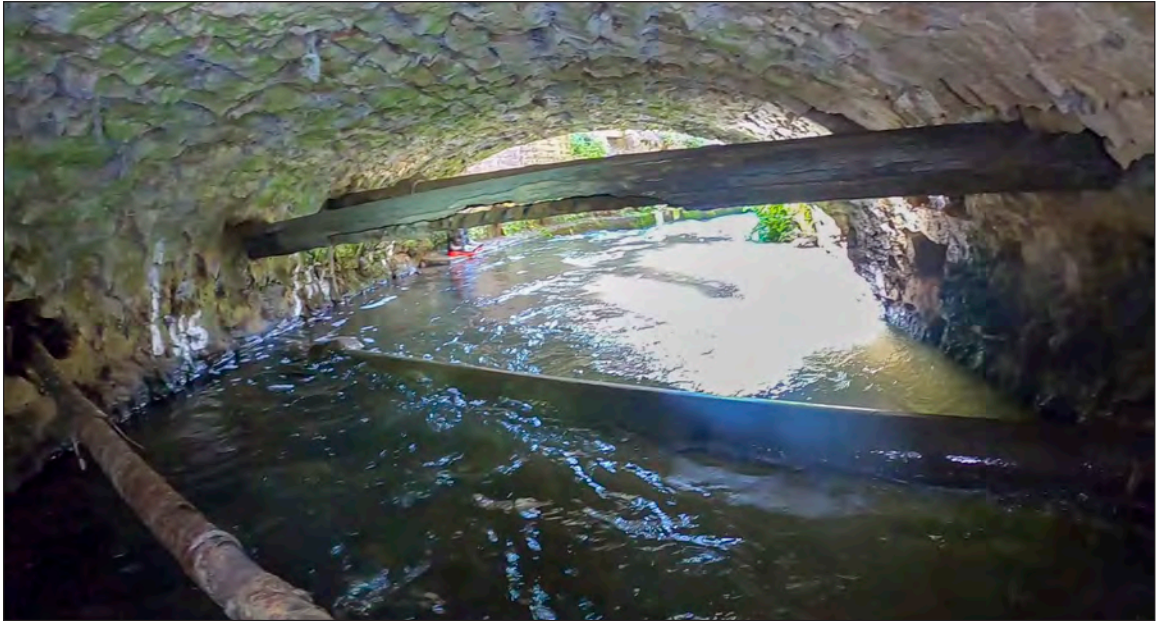
Photograph 31: The western end of the culvert partially blocked by pipes and cables (113-118m chainage)

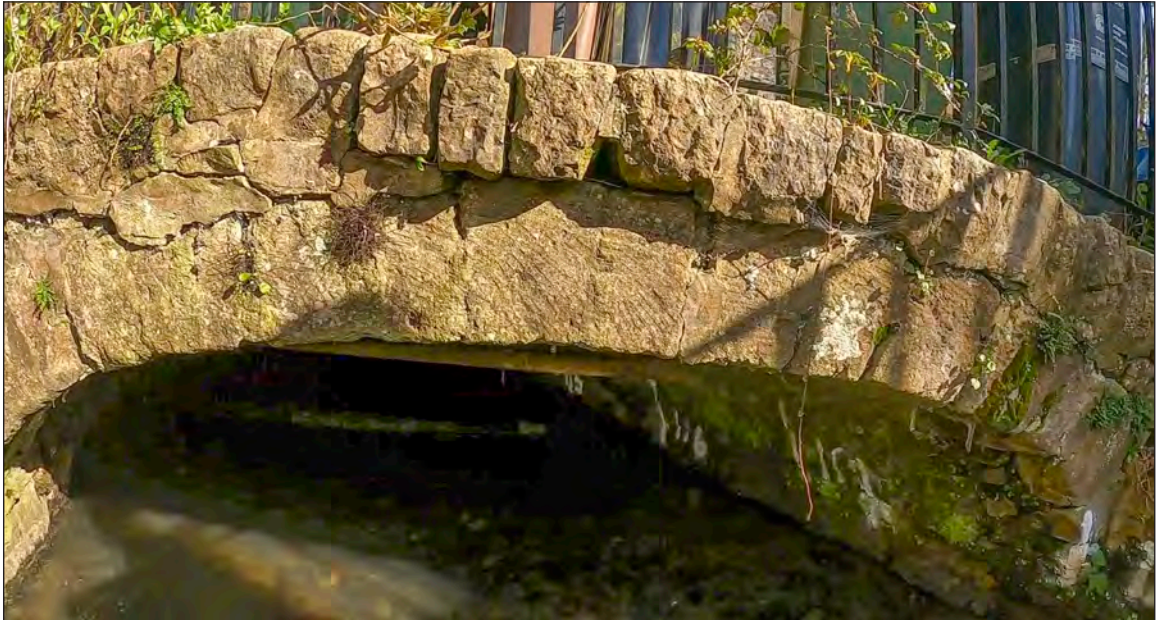
Photograph 32: The arch at the western end of the culvert (118m chainage)

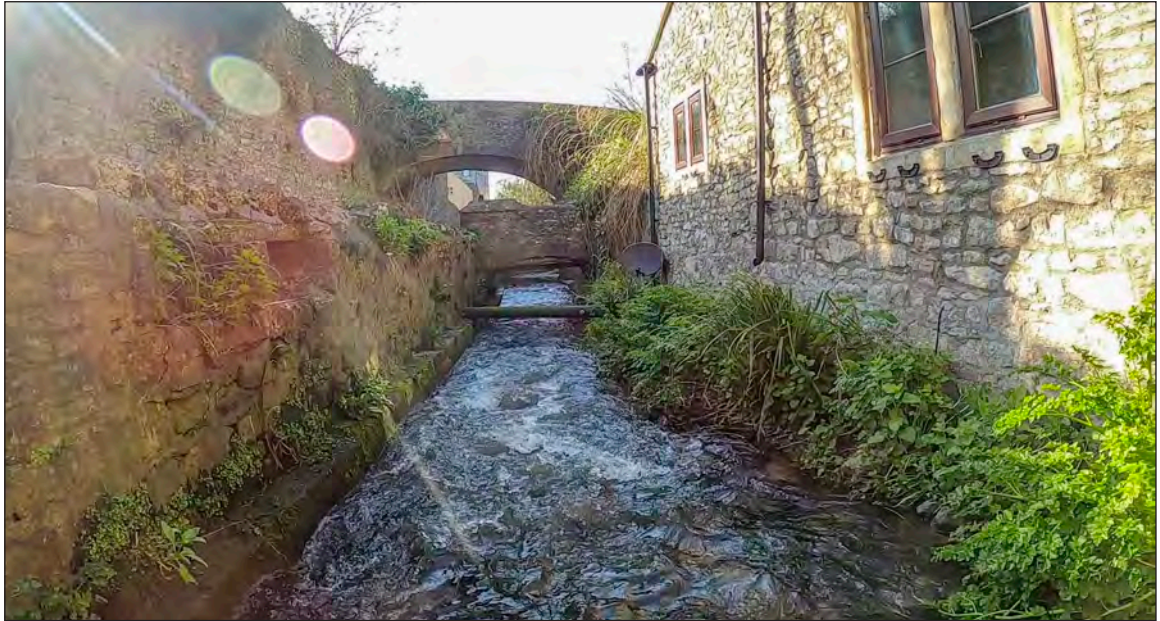
Photograph 33: At the outlet looking west along the river Sheppey. Bridge Cottage 16 Lower Lane is on the right.
