# St John's Churchyard John Street, Bristol

Archaeological Watching Brief

Planning Ref: 20/05571/FB  
Faculty Ref: 2020-054424  
Accession Code: BRSMG: 2022/15  
OASIS Ref: 412186  
Ref: 242730.3  
May 2022

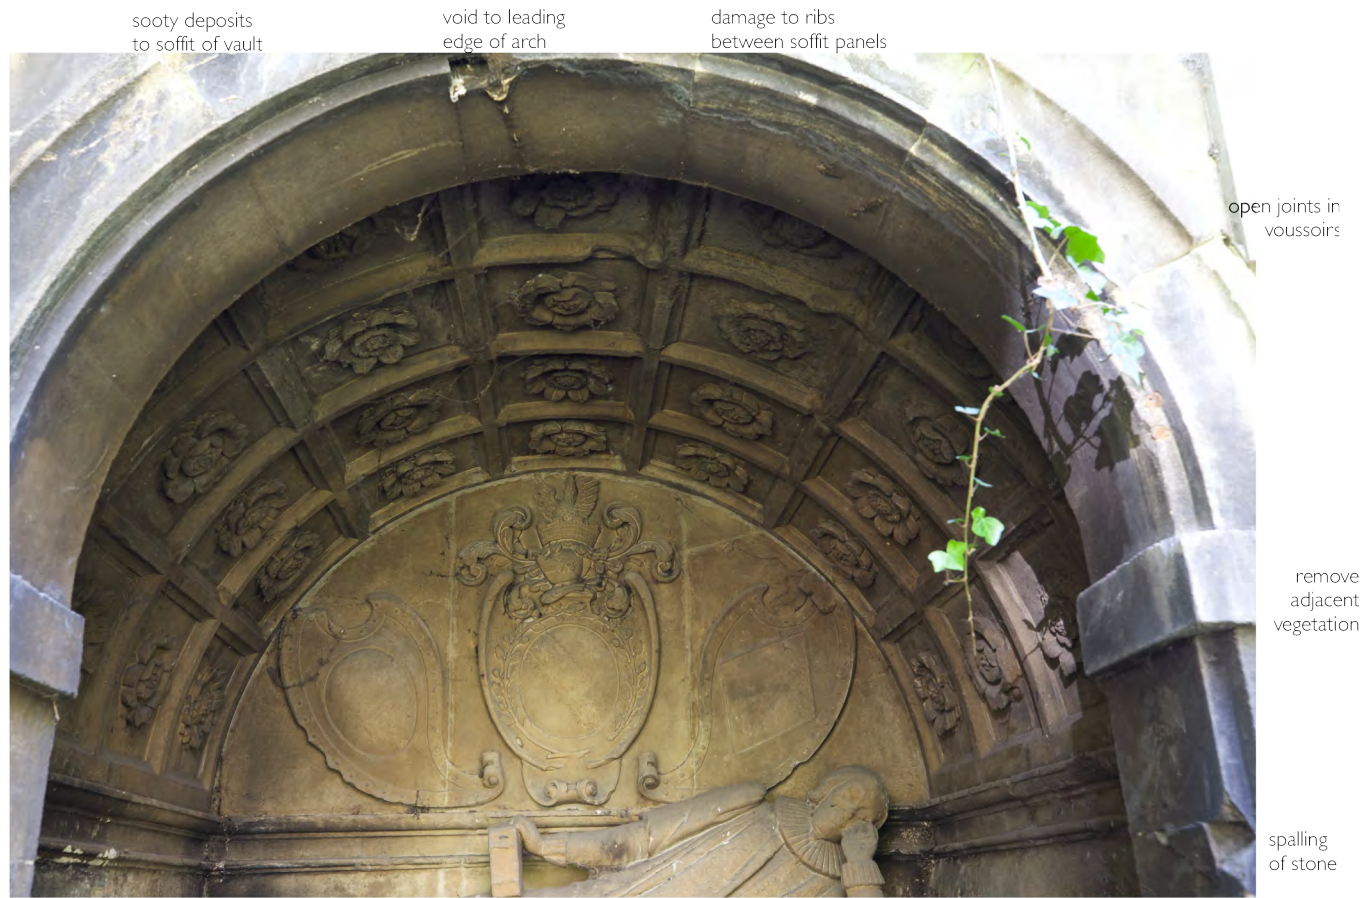
sooty deposits to soffit of vault

void to leading edge of arch

damage to ribs between soffit panels

spalling of stone

sulphation and blistering of limestone

open perpend joints in ashlar

remove organic growth and surface dirt from external surfaces of monument using Thermatech super heated water cleaning system, avoiding risk of damage to any delaminating surfaces of separation of asphalt weathering surfaces

cleaning shall be undertaken to ensure thorough inspection of defective masonry (and not to achieve a full clinical cleaning of patinated stone surfaces)

carefully clean and lift dirt and deposits from internal surfaces of monument using warm water containing Synperonic A detergent (biodegradable alcohol ethoxylate conservation grade wetting agent used to soften ground-in dirt and stains on a range of masonry finishes) using a range of soft natural bristle and nylon brushes

rake out loose and defective mortars from degraded ashlar using a range of sharp hand tools, ensuring no damage to arrises and/or reveals

mortar repairs to be undertaken with fat lime mortars following provision of site trial panels - to be assessed and agreed by Architect and masonry conservator

allow for localised conservation mortar repairs to decayed or damaged mortar (ie: damage to indents on outer face of rere-arch where spalled and/or missing or missing elements of ribs between rosettes)

note that no plastic mortar repair works are to be implemented to rosettes

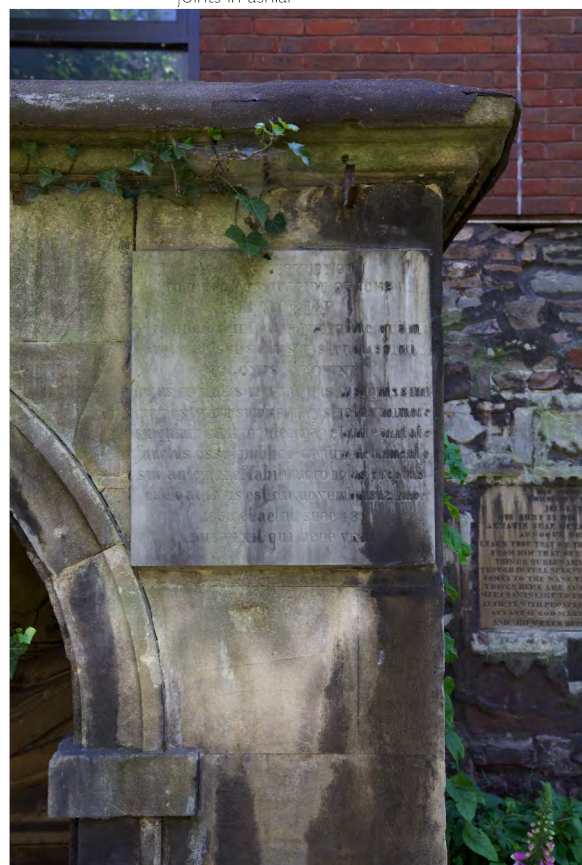
detail of se corner

ivy growth from ashlar joint beneath cornice

ferrous inclusions from former rainwater goods

severe sulphation to limestone

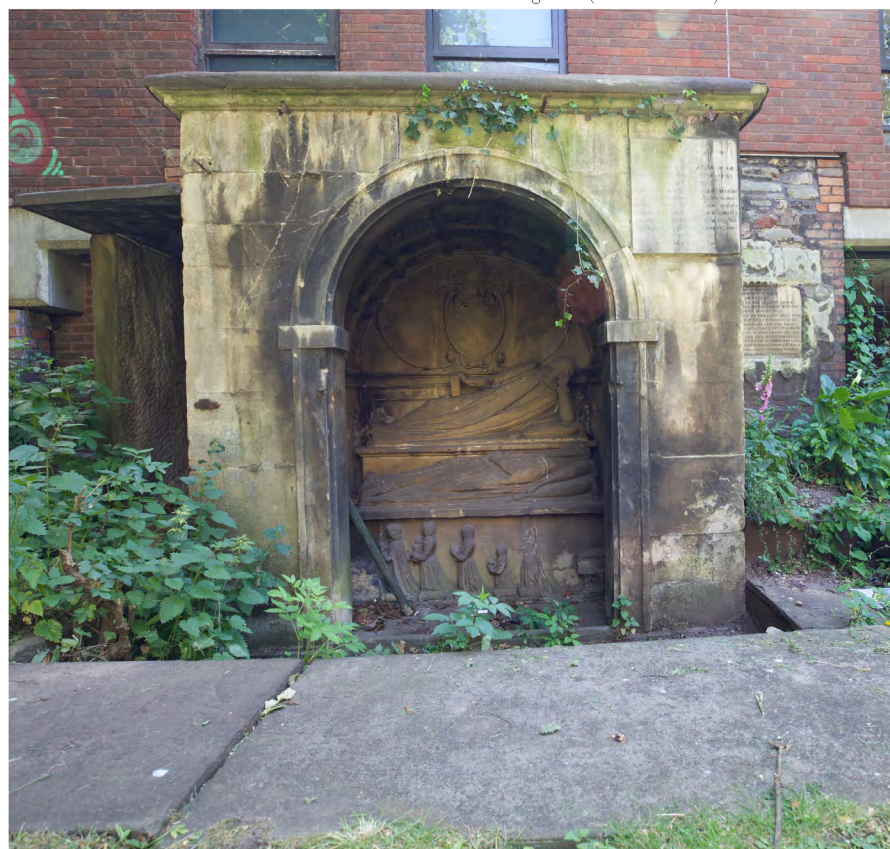
general view of monument to nw

ferrous inclusions from former rainwater goods (below cornice)

uneven ledgers to be reset as described elsewhere

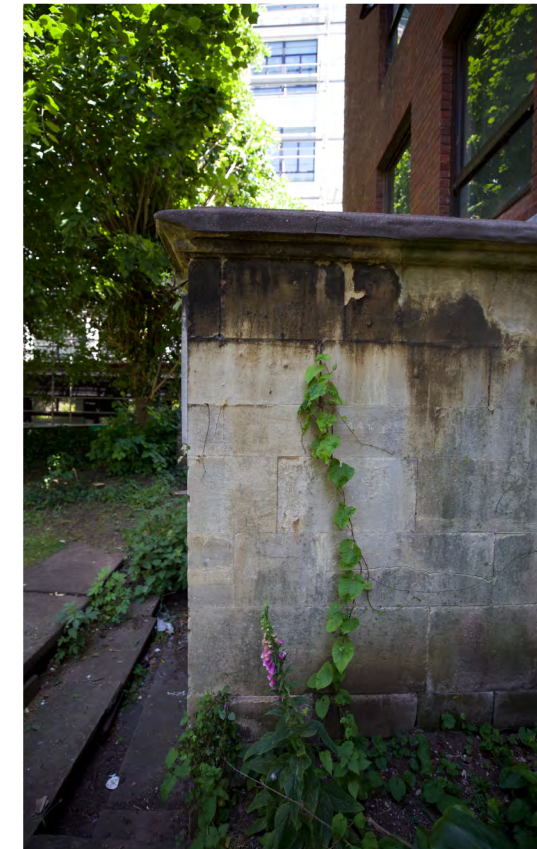
sulphation below projecting cornice

open mortar joints in ashlar

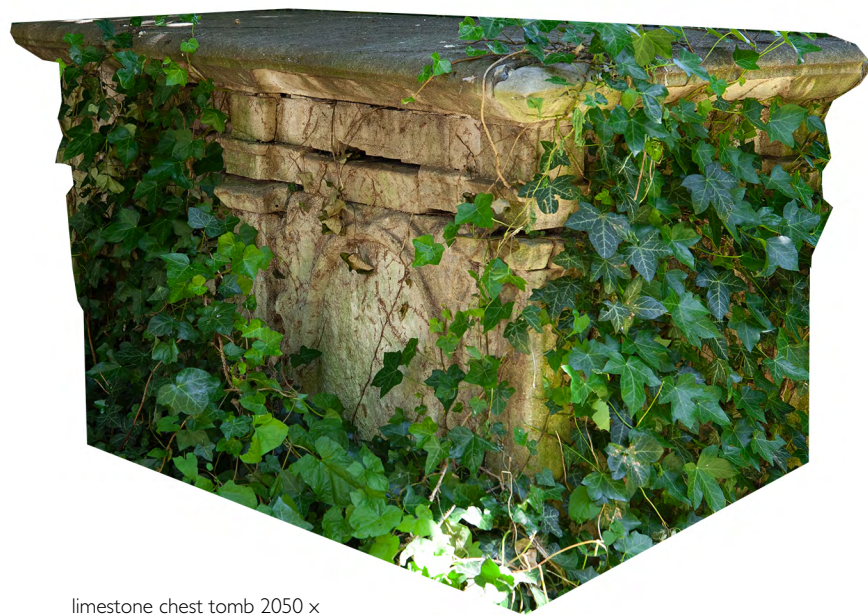
axonometric view

limestone chest tomb 2050 x 925 with oval inscription panels

rake out all loose and failed mortar from joints and deep pack point with nominal 1:2.5 lime conservation mortar

remove vegetation prior to light cleaning by conservator using Thermatech

carefully clean out loose mortar and replace with new sieved lime conservation mortar

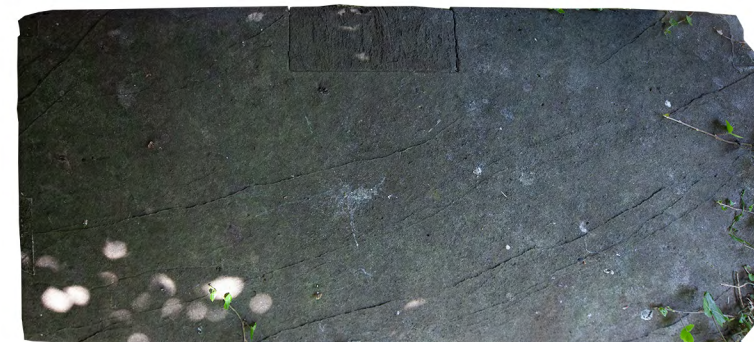
plan view

cut out decayed stone and allow for indentation of new corner of tomb lid, in new oolitic limestone, nominally 140 x 135 x 40

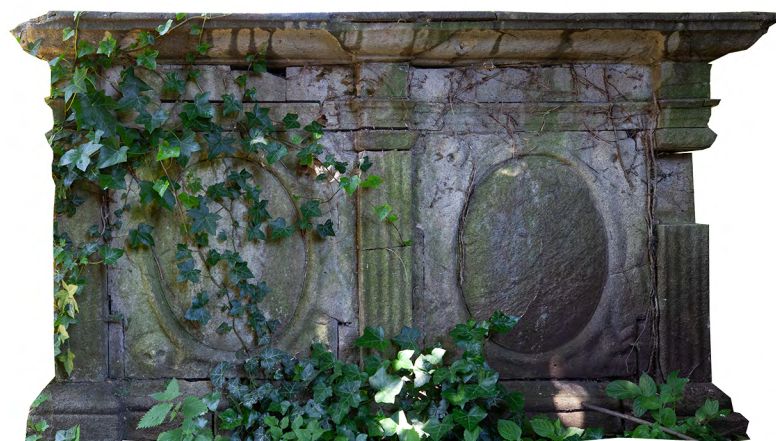
se elevation

refix existing detached element of pilaster; using 4ø stainless steel pins set in grout and repointed in 1:3 lime mortar

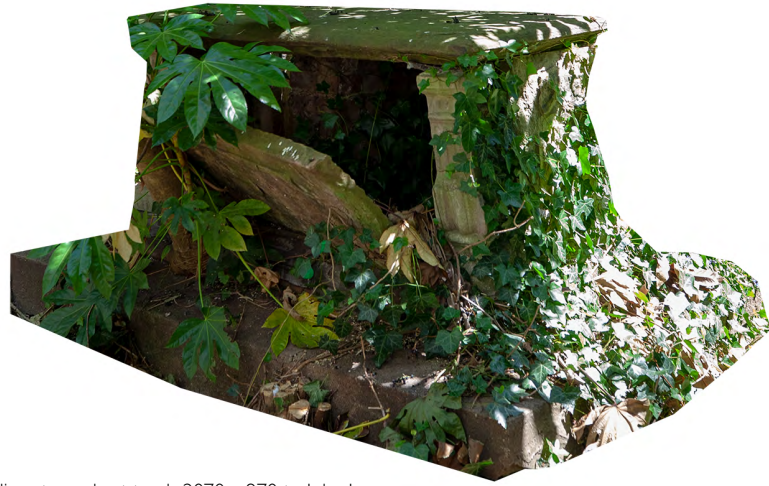
axonometric view

limestone chest tomb 2070 x 970 to John Jones dated 1785, with cement covered plinth

allow temporary support of monument to allow light cleaning using Thermatech masonry cleaning system, whilst avoiding risk of damage to delaminating components

using specialist lifting rig allow for careful dismantling of components of tomb to avoid damage to components. Remove existing corroding iron cramps and allow for drilling out any ferrous inclusions remaining

remove cement capping from plinth using a range of sharp hand tools to avoid damage to masonry beneath, Remove any elements of root growth and treat with approved herbicide to prevent regrowth. Flaunch with new 1:3 NHL 3.5 hydraulic lime mortar capping

reset components of monument in 1:2.5 lime putty mortar over newly repaired base, utilising new grade 316 austenitic stainless steel cramps

consolidate laminating stone surfaces by fine grouting with lime and fine sieved sand grout and localised utilisation of mortar flaunching to avoid water traps

mortar mixes to be agreed by Architect following preparation of local sample panels. At this stage assume a mortar mix comprising 1 part mature fat lime putty: 1 1/2 parts kiln dried sieved Bath stone dust: 1 part kiln dried silver sand: 1/16 part Horton brown stone dust

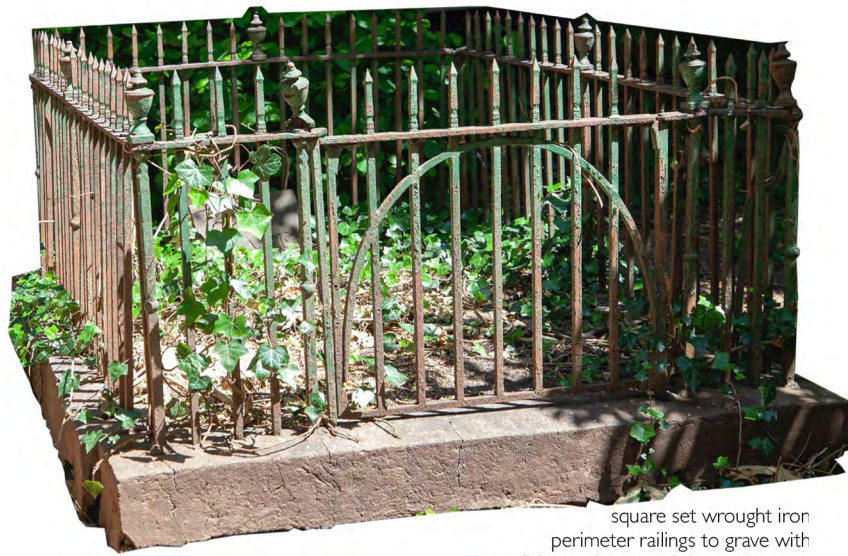
**axonometric**  
nts

square set wrought iron perimeter railings to grave with top rail, integral gate and decorative urns

repair corroded half-lap joint at corner of railings

reset damaged and dislocated urn to gate post

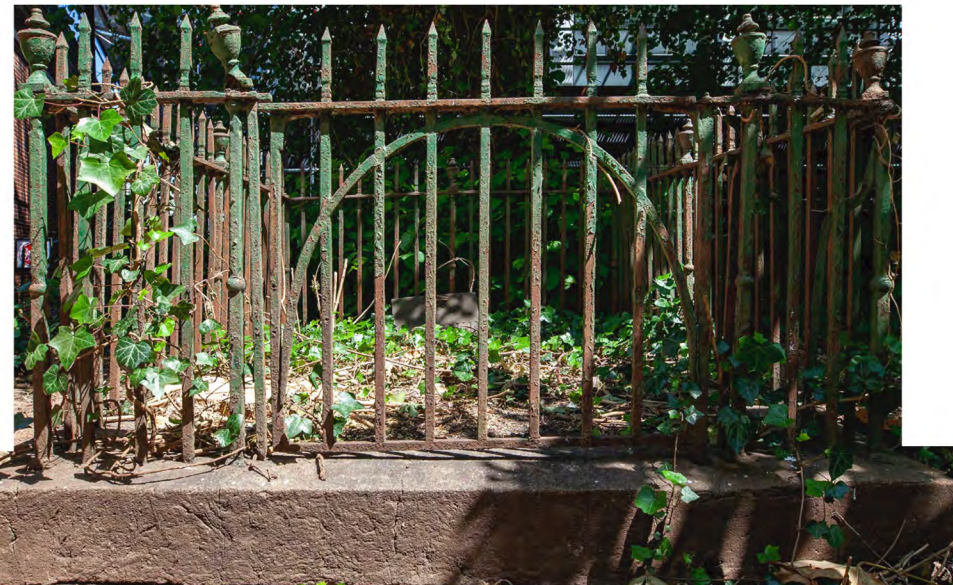
**south west**  
1:20

remove cement capping from stone plinths

masonry: site works  
kerb plinths to be reset to proper levels and bedded on new 150 deep x 200 width concrete strip foundation - to ensure head of 4no plinths are square and level to accept installation of repaired gate & railings from metalworker

if found to be necessary provide flanchued render finish to plinth as 1:3 hydraulic lime mortar consisting of 1 part NHL3.5 hydrate: 2 parts Holm sand: 1 part Chardstock sand

metalwork: site works  
reinstate repaired and primed sections of railing (and gate) into reset stone plinths, with balusters inserted into open sockets in stone and flooded with molten lead to secure in place

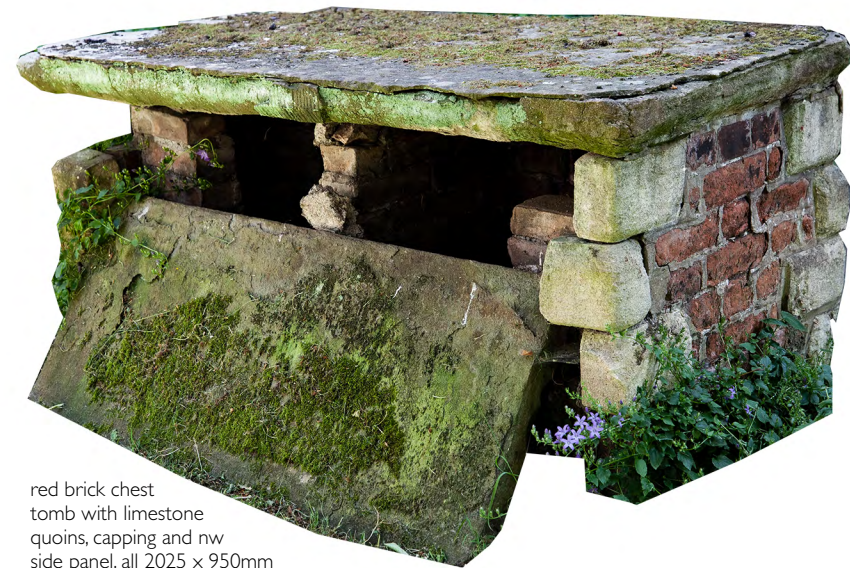
axonometric view

red brick chest tomb with limestone quoins, capping and nw side panel, all 2025 x 950mm

rake out cementitious pointing and reinstate with lime - see below

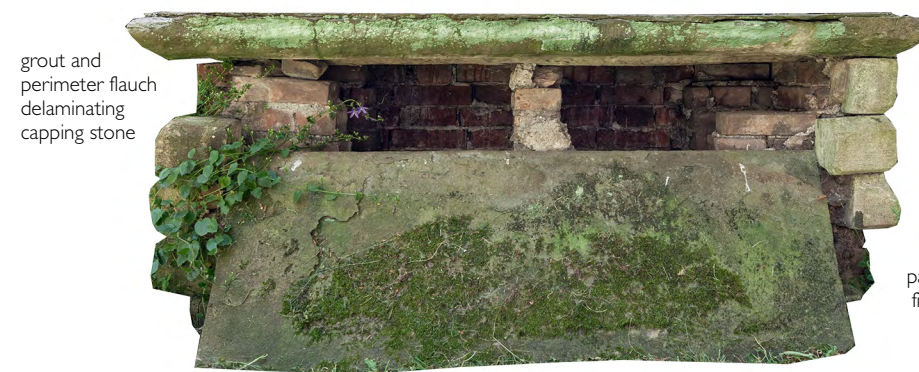
nw elevation

grout and perimeter flaunch delaminating capping stone

reset loose side panel with stainless fixings and reset in lime mortar

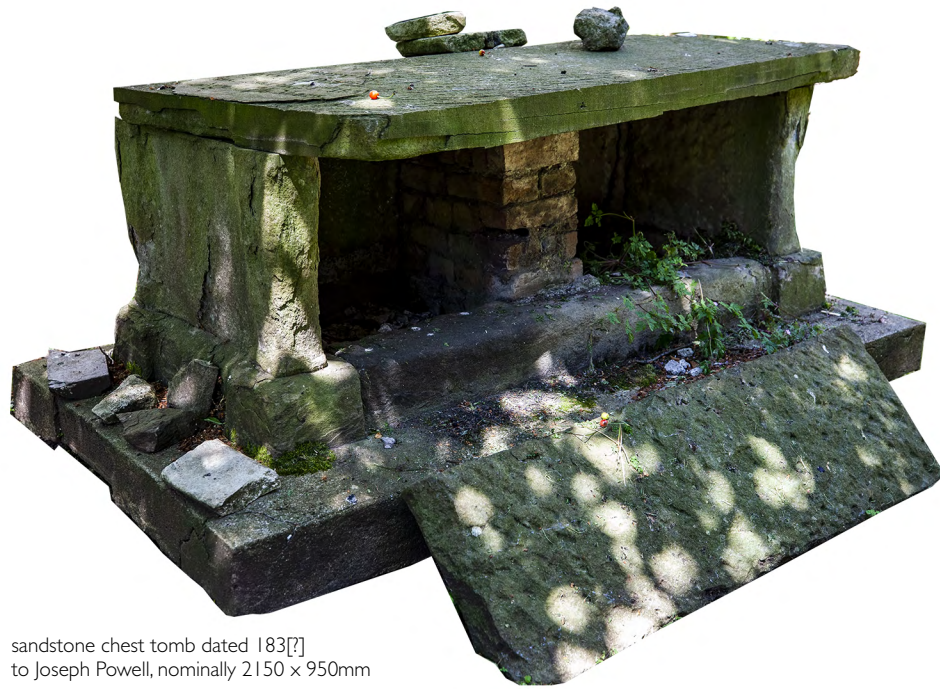
axonometric view

sandstone chest tomb dated 183[?]  
to Joseph Powell, nominally 2150 x 950mm

remove cementitious finish to plinth in order to expose original stonework  
install new hydraulic lime flaunching to base of monument - if found to be necessary

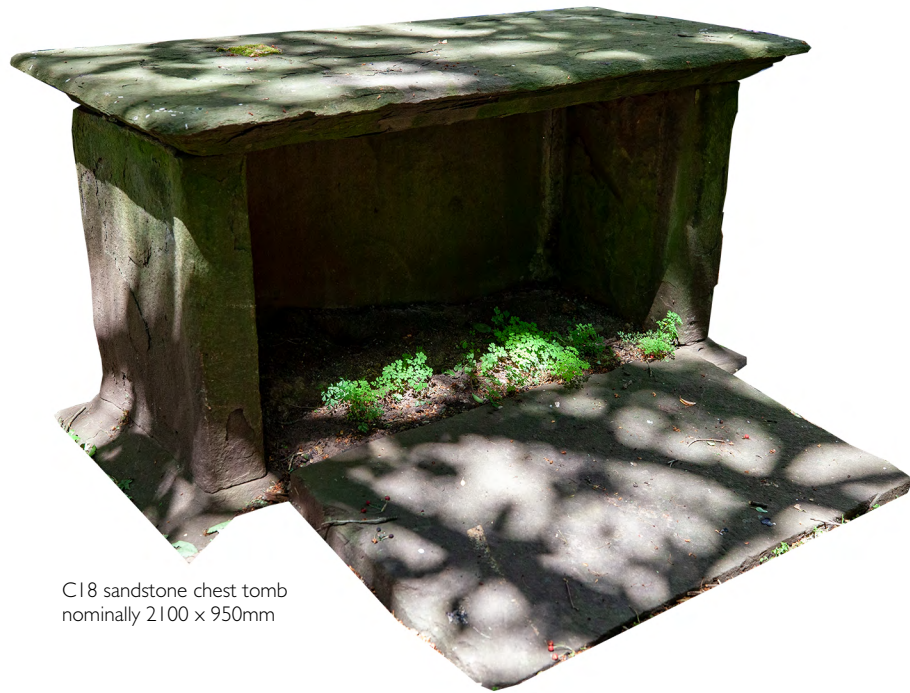
axonometric view

C18 sandstone chest tomb  
nominally 2100 x 950mm

all new mortars are to be agreed with Architect following preparation of samples

consolidate beneath laminating sandstone surfaces with sieved lime grout injected into cracks, with leading edges neatly and carefully finished with sieved lime mortar flaunching

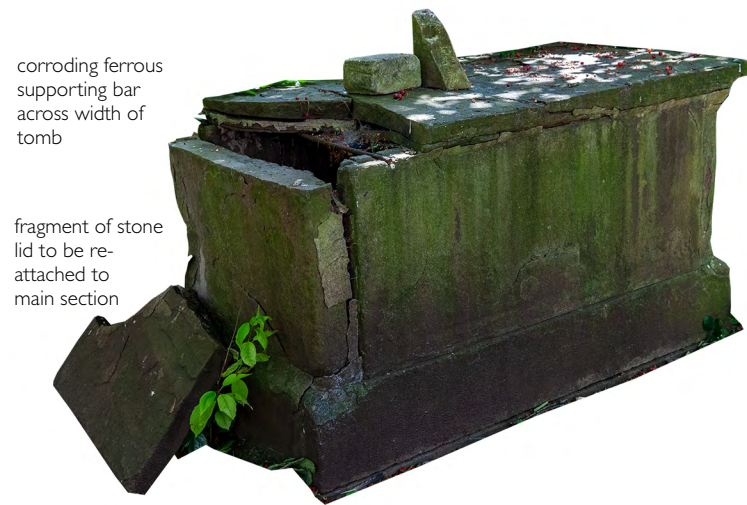
axonometric view

corroding ferrous supporting bar across width of tomb

fragment of stone lid to be re-attached to main section

C18 sandstone chest tomb 1975 x 950mm

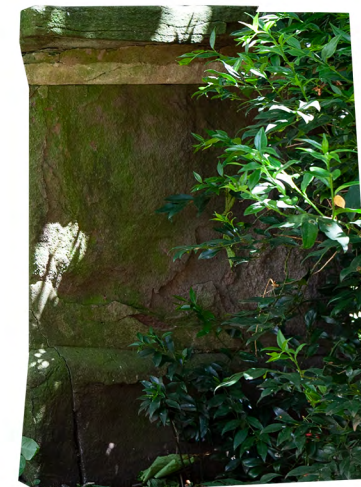
sw elevation

delamination of head of tomb

adjacent vegetation growth to be cut back

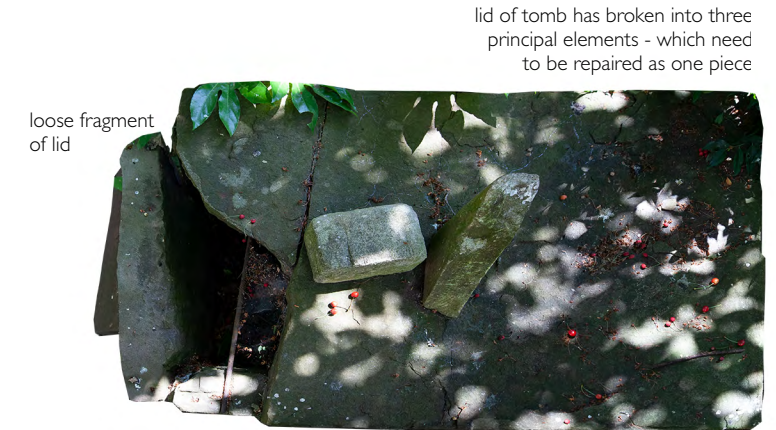
lid of tomb has broken into three principal elements - which need to be repaired as one piece

loose fragment of lid

remaining surface finished to be consolidated by insertion of lime grout and micro-pointing and flaunching of delaminating surfaces using sieved lime mortar

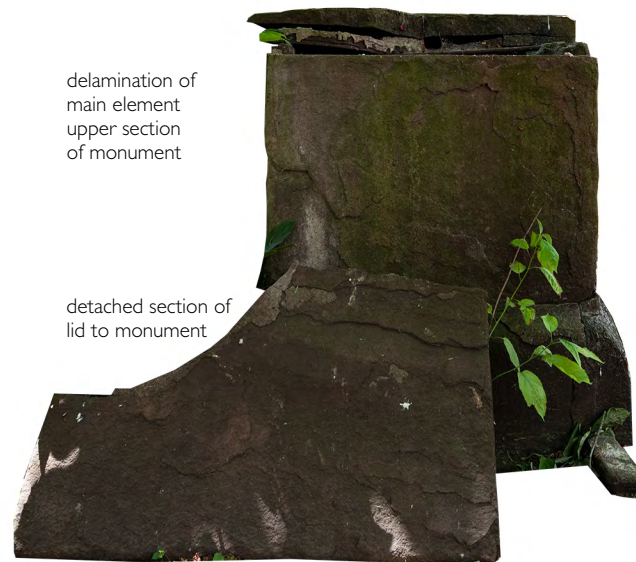
ne elevation

delamination of main element upper section of monument

detached section of lid to monument

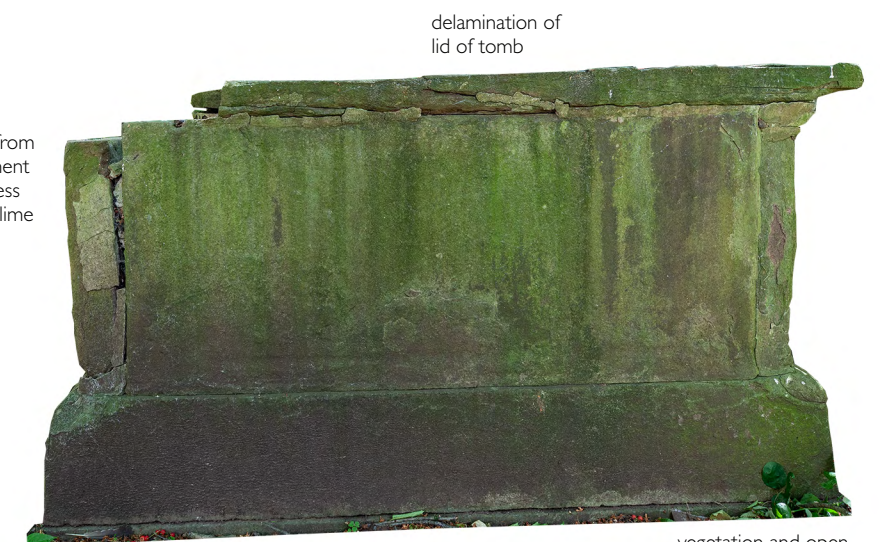
se elevation

delamination of lid of tomb

vegetation and open joints at base of plinth

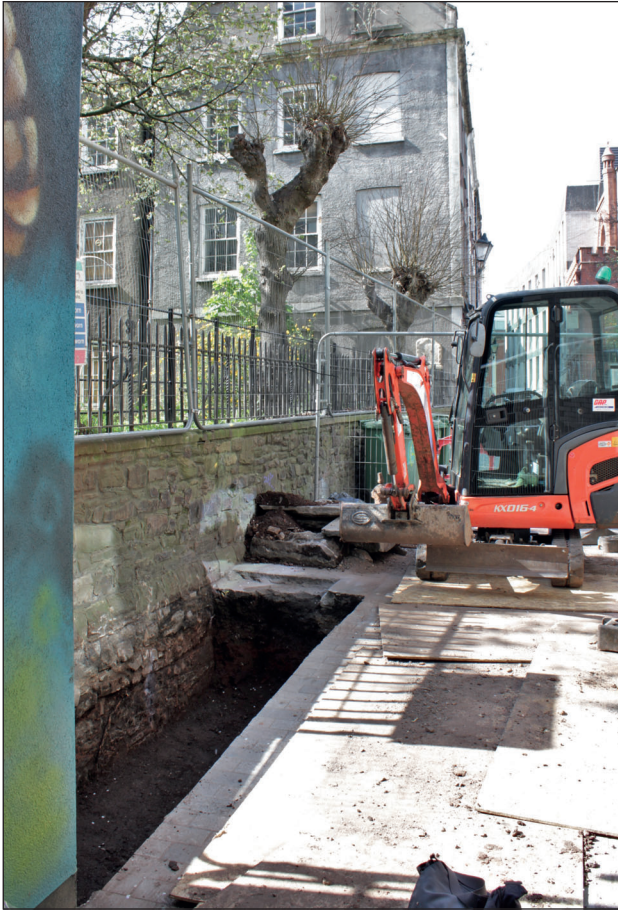
Figure 5: Trench for new steps in John Street, looking south (photograph by C. Hambleton)

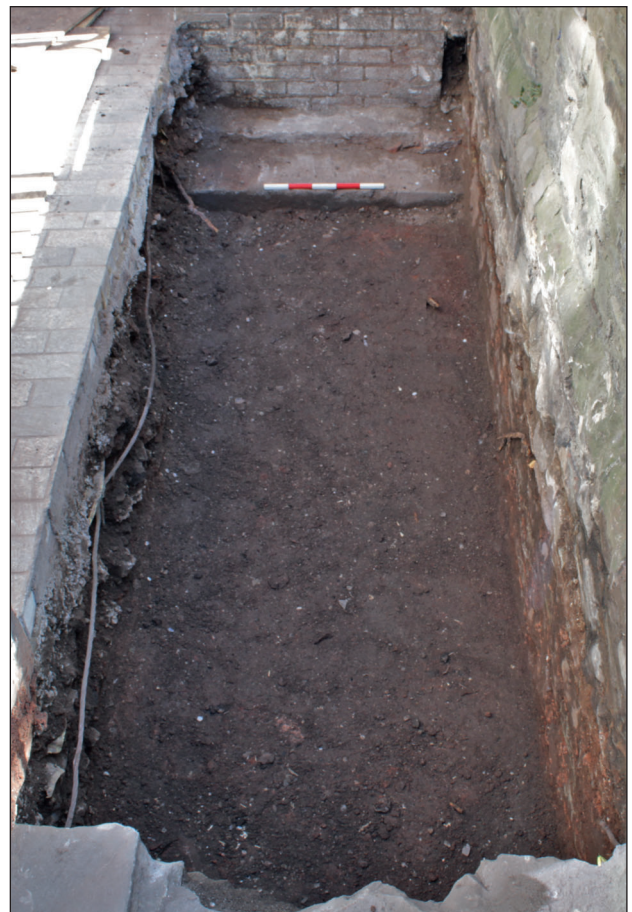
Figure 6: Trench for new steps in John Street, looking north-east, scale: 0.5 m (photograph by C. Hambleton)

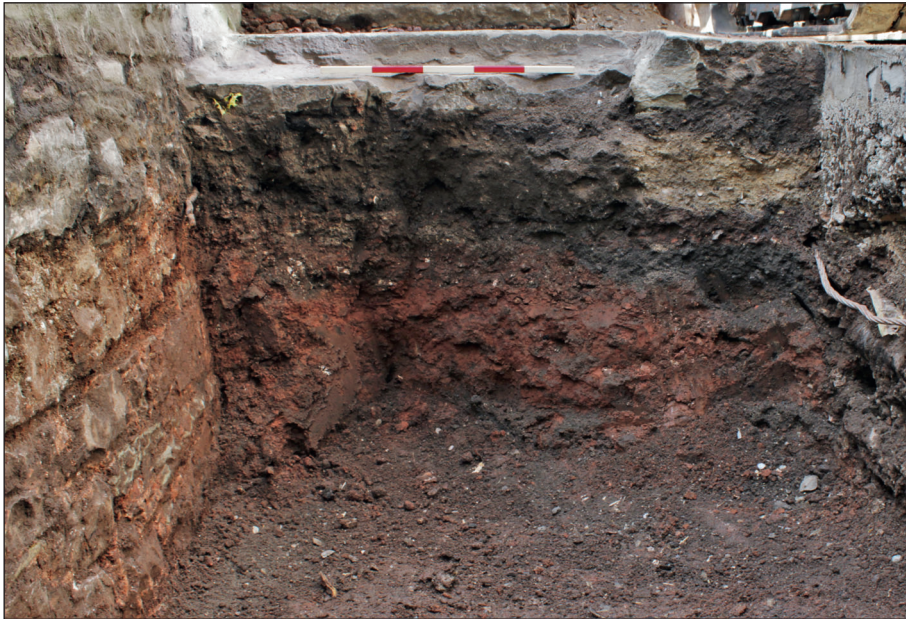
Figure 7: Representative section of deposit sequence below John Street, looking south-west, scale: 0.5 m (photograph by C. Hambleton)

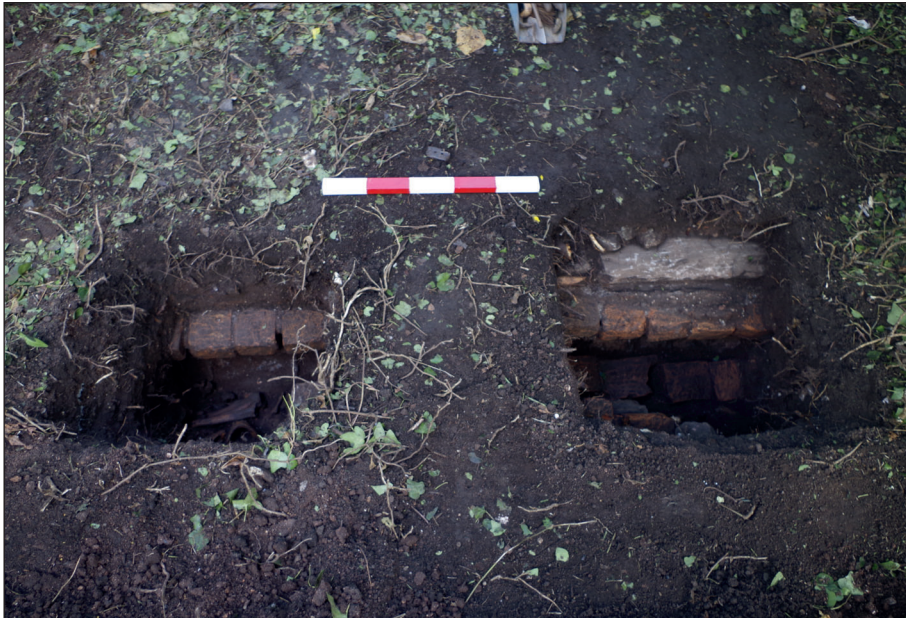
Figure 8: Brick-lined grave 1003, looking south-east, scale: 0.5 m (photograph by C. Hambleton)

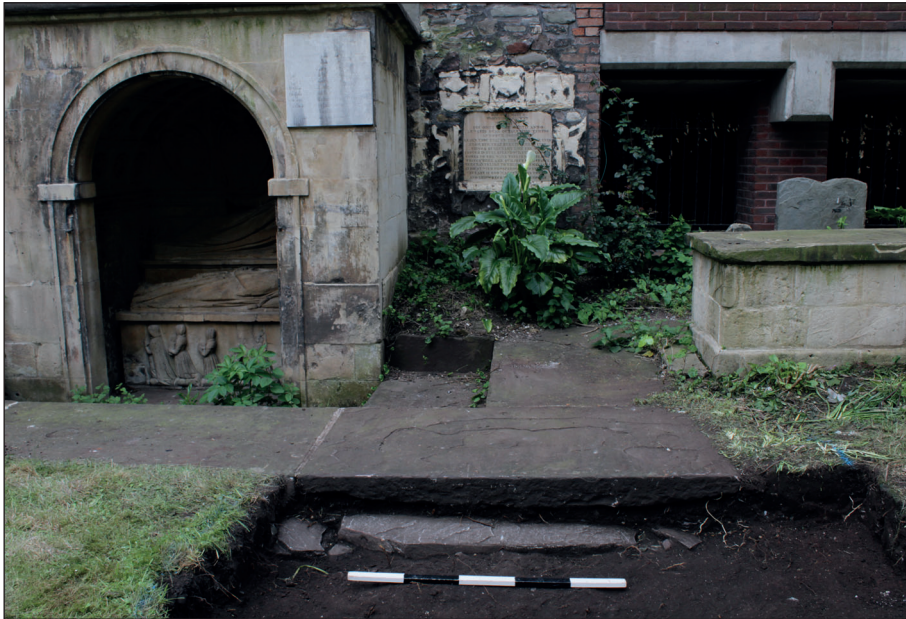
5.3.5 Capstones 1901, 1902 and 1903 (Figs 9 and 10), which comprised single or multiple roughhewn Pennant Sandstone slabs, are all likely to overlie unexcavated brick-lined graves.

Figure 9: Capstone 1901, looking south-east, with Hugh Browne's tomb in the background, scale: 1 m (photograph by C. Hambleton)

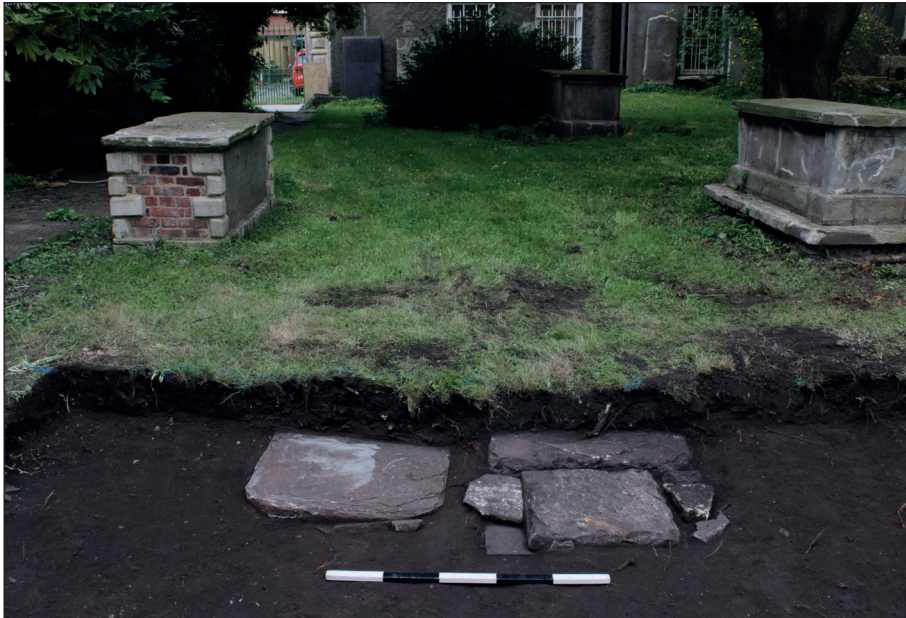
Figure 10: Capstones 1902 and 1903, looking south-west, scale: 1 m (photograph by C. Hambleton)

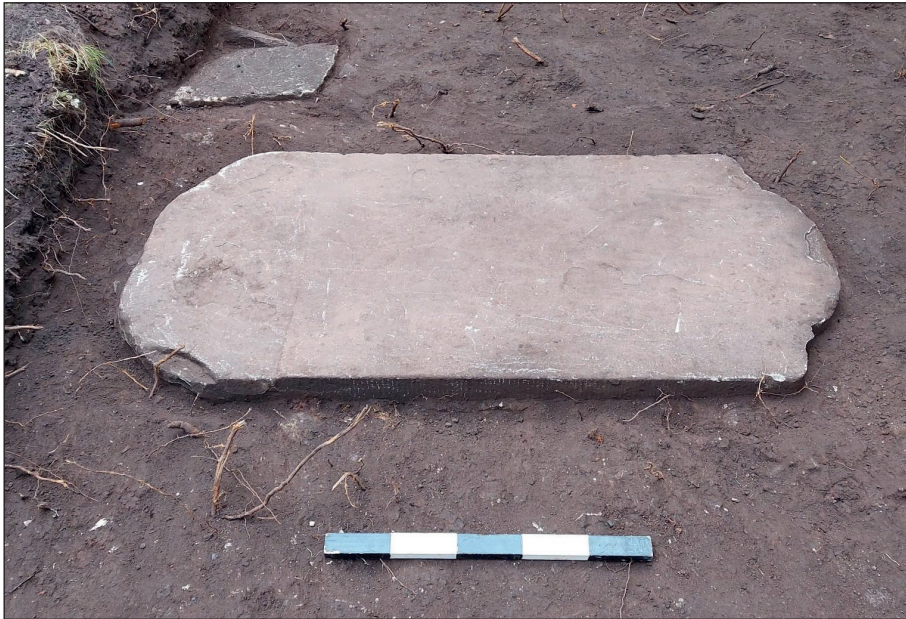
5.3.6 Pennant Sandstone slab 1905 (Cover and Fig. 11), which measured 1.39 x 0.7 m wide and 0.06 m thick, is identified as a gravestone by the presence of carved scrollwork on the south-west end. The opposite end, which would have originally been embedded in the ground, was roughhewn. There was no inscription evident on the stone, which suggests that it is laid face down. The stone was probably laid flat during an episode of reordering or maintenance of the churchyard.

Figure 11: Gravestone 1905, looking south-east, scale: 0.5 m (photograph by C. Hambleton)

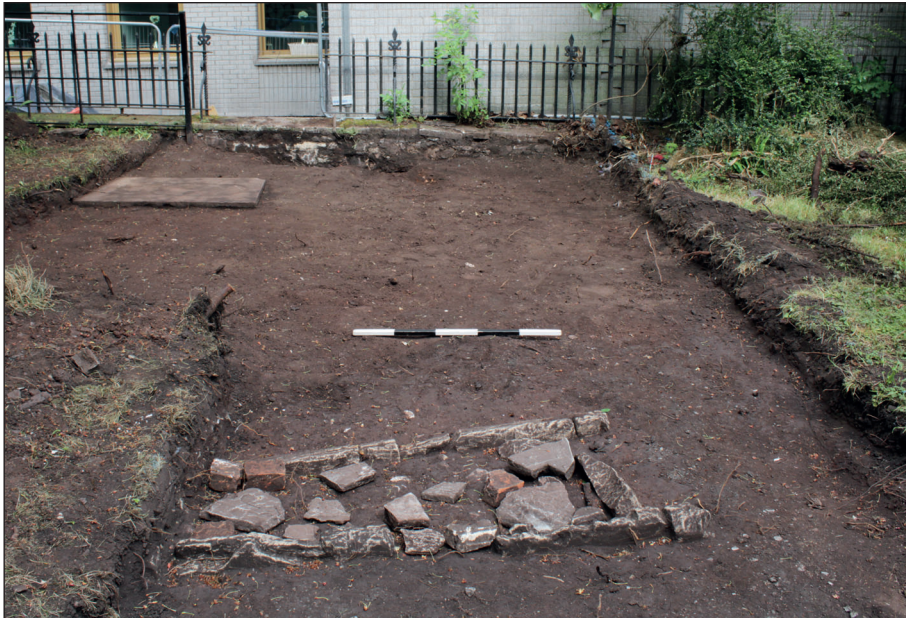
5.3.8 Two *in situ* Pennant Sandstone ledgers (1004/1907 and 1904; Figs 12, 14 and 15) were also partially uncovered. Too little of 1904 was exposed to determine if it has an inscription. Ledger 1004/1907 was more fully exposed, but there were no inscriptions evident, probably due to spalling and/or wear from foot traffic.

Figure 12: Grave structure 1906 and ledger 1004/1907, looking north-west, scale: 1 m (photograph by C. Hambleton)

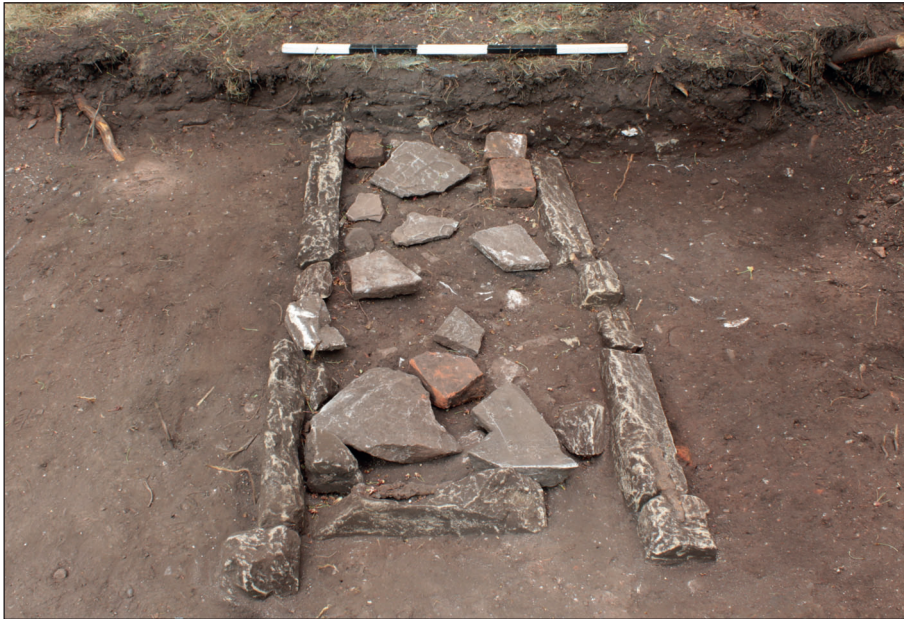
5.3.7 Grave structure 1906 (Figs 12 and 13) comprised lengths of roughly squared stone defining a 1.8 x 0.8 m wide rectangular area, with further smaller irregular stones and bricks within it. This structure was probably the foundation for a ledger, or possibly a demolished chest tomb.

Figure 13: Grave structure 1906, looking south-west, scale: 1 m (photograph by C. Hambleton)

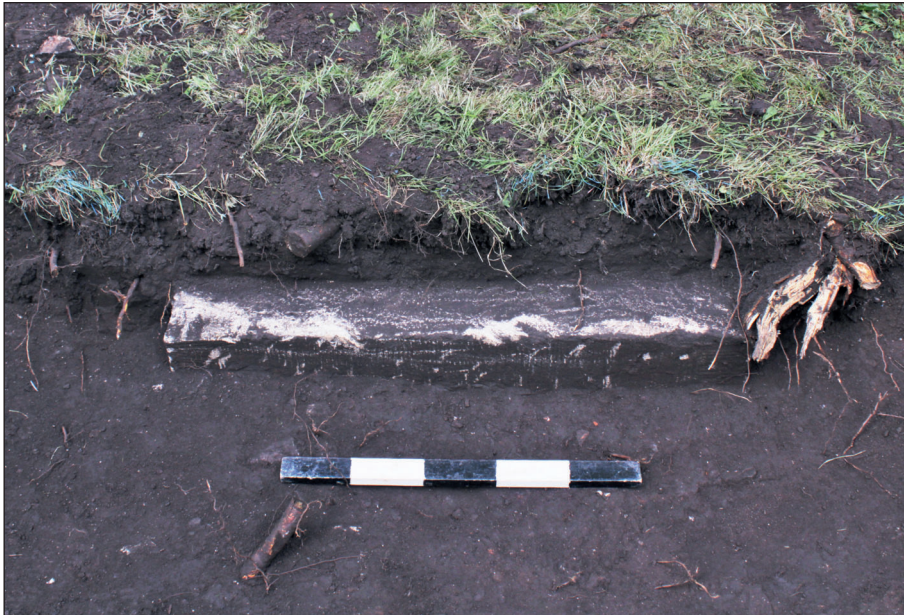
Figure 14: Ledger 1904, looking south-west, scale: 1 m (photograph by C. Hambleton)

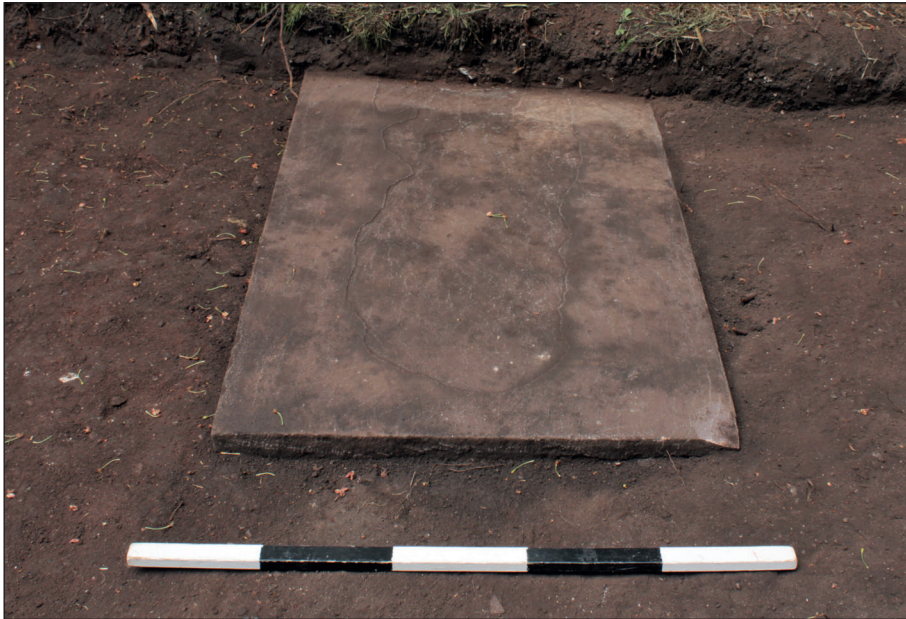
Figure 15: Ledger 1004/1907, looking south-west, scale: 1 m  
(photograph by C. Hambleton)
