# Jerrings Hall Farm, Solihull

Archaeological Watching Brief

Planning Ref: PL/2021/01351/HS2S50  
Ref: 263081.01  
January 2024

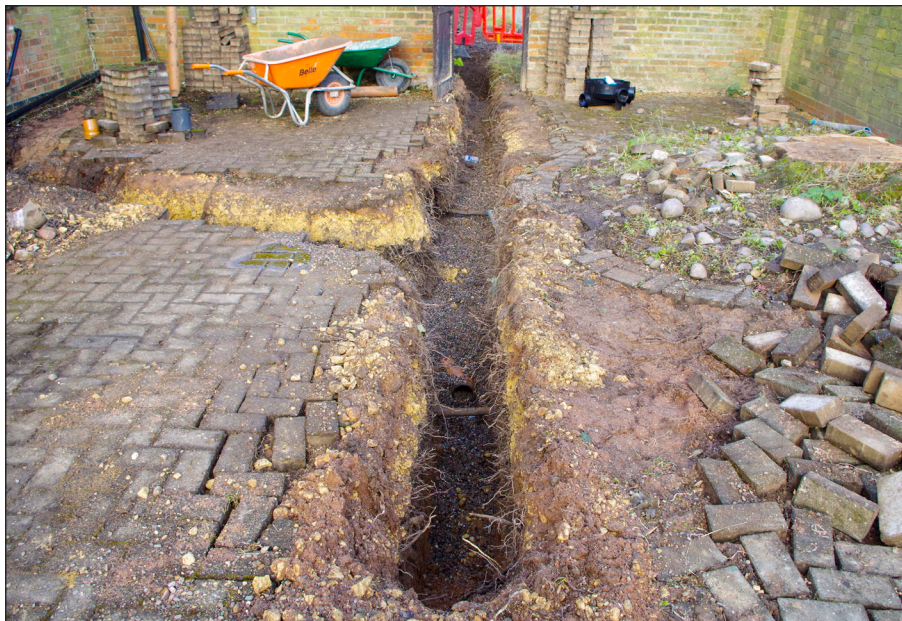
Figure 4: Brick paving 103 and made ground 104, viewed from the north-east

- 5.1.3 The ground surface in unoccupied parts of the site comprised dark brown sandy silt topsoil (101), while in the courtyard around the existing buildings the surface comprised brick paving (103; Fig. 4). The drive to the existing buildings consisted of loose gravels (124), which overlaid tarmac (123). Within the main hall, the floor surface was constructed from concrete (105). A complete late 19th/20th-century ink bottle was recovered from the topsoil as well as a 19th-century horseshoe.

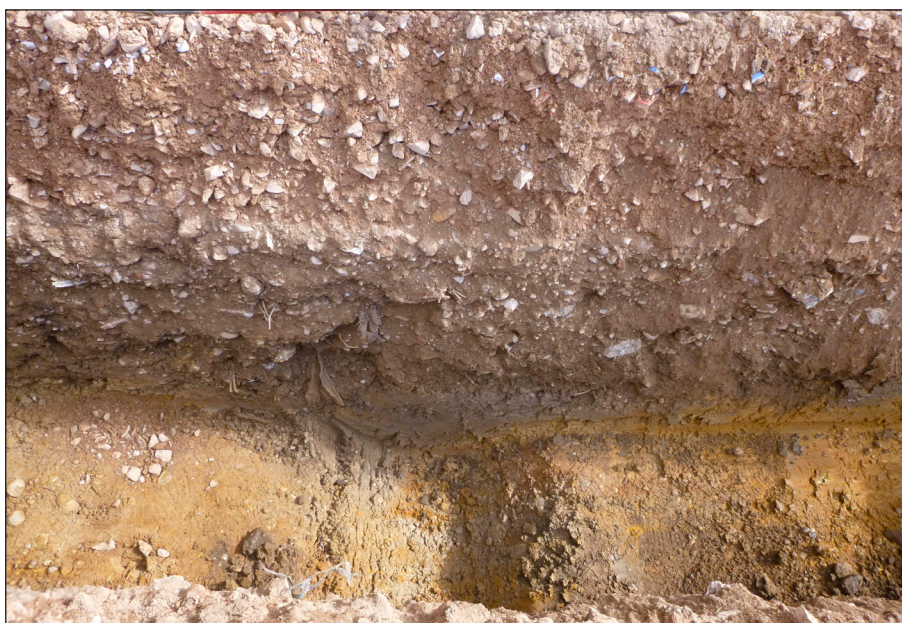
Figure 5: Brick paving 103 and made ground 104, viewed from the north-east

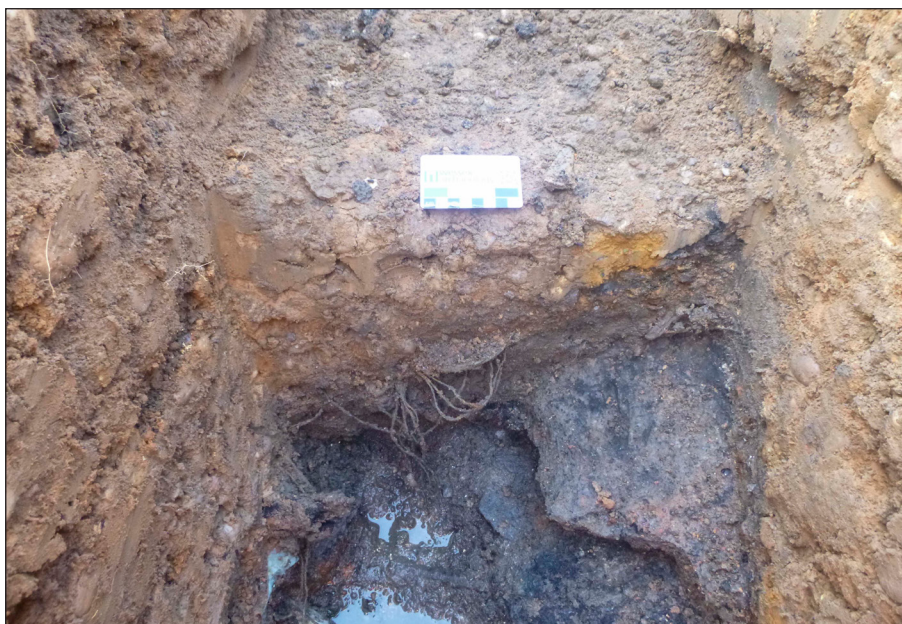
Figure 6: Pit 152 and made ground 155, viewed from the north-east

- 5.1.2 Made ground layers, ranging in thickness between 0.22 m and 1.5 m, were recorded within interventions around the main hall, in the new car park area and south of the existing barn building. The layers were probably for ground raising or levelling and consisted of hard core (104; Fig. 4), gravelly, silty sand (127; Fig. 5), sandy, stoney silt (130 and 133) and stoney, silty clay (155; Fig. 6) with demolition rubble inclusions (156).

- 6.7.3 The end of a plank (124 mm wide) was recovered from pit 152. This piece has a finely worked surface on one side and shows signs of burning on the others, which are all damaged. A small hole (12 mm in diameter) has been drilled through the plank, probably so that it could be screwed or nailed in place.

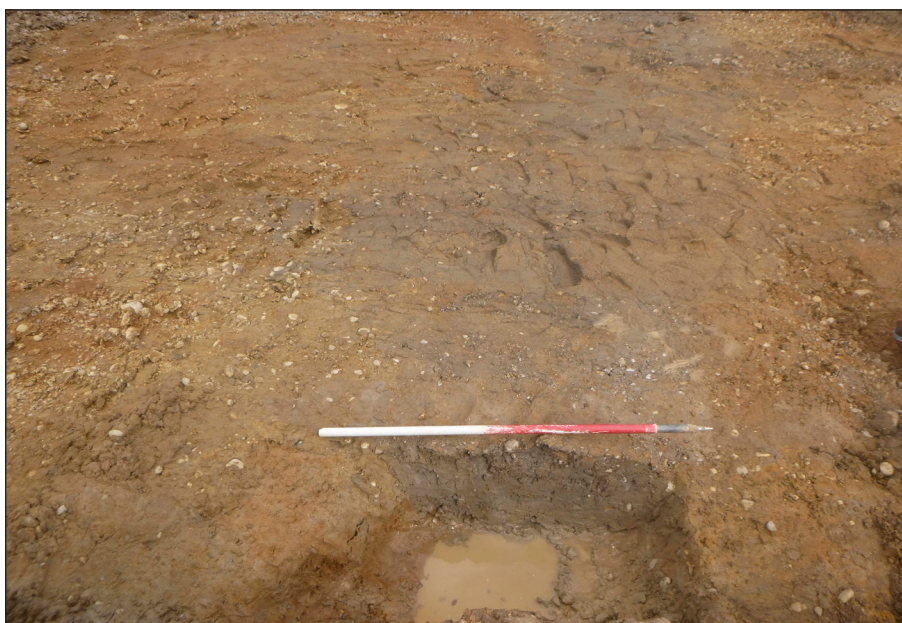
Figure 7: Ditch 119, viewed from the south-east, 1 m scale

- 5.2.1 In the east of the site, a north–south aligned ditch (119; 0.95 x 0.49 m deep) was uncovered. A large sherd of late 13th/early 14th-century pottery was recovered from the clayey, gravelly sand ditch fill (Fig. 7). It is probable that the ditch was a former field boundary.

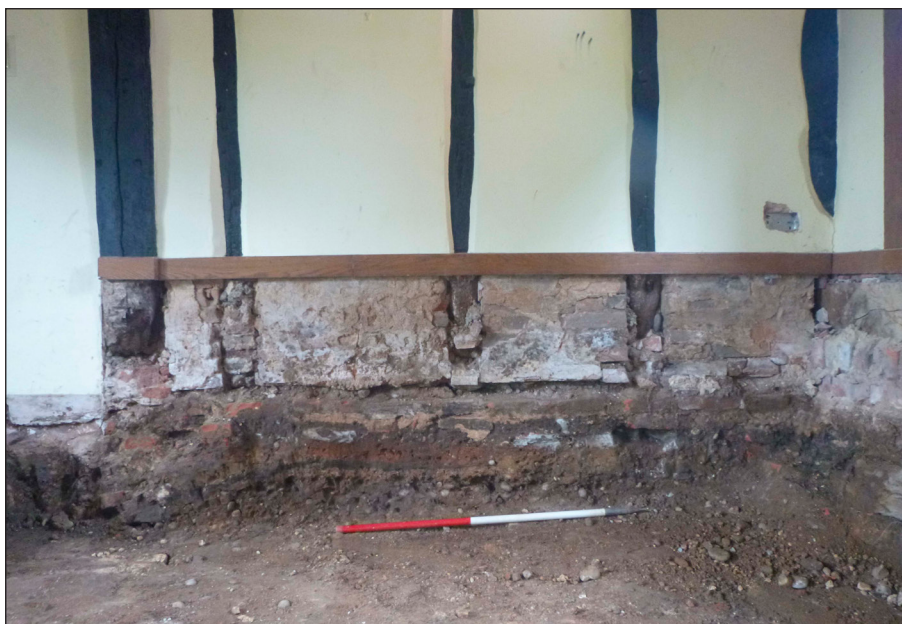
Figure 8: South-east facing internal wall 107/159 of main building, 1 m scale.

- 5.3.1 Inside Jerrings Hall, the removal of floor 105 exposed made ground 106 and the base of a brick (107) and timber frame (159) wall (Figs 3 and 8), which separated the kitchen from the living room. The gravelly, silty sand layer (106) butted up against the wall and was probably

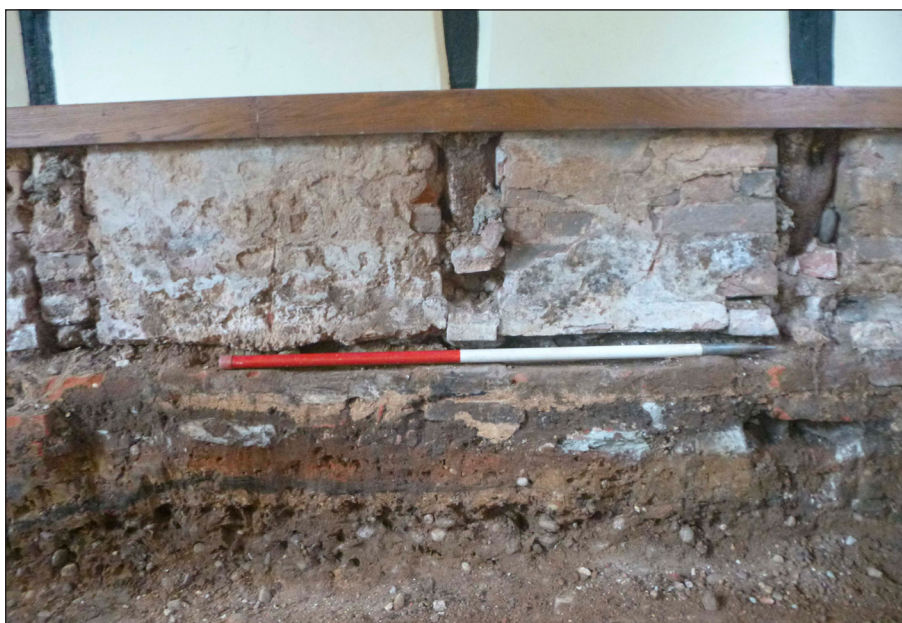
Figure 9: Close-up of layers 108–112 and possible brick floor 161 beneath internal wall 107/159, viewed from the south-east, 1 m scale.

- 5.3.2 Beneath the wall was a single layer of brick (161), potentially part of an earlier brick floor. Beneath the bricks were five ground levelling or raising layers (108–112) comprising stoney silty sand or sandy silt (Fig. 9). Deposits of ash, charcoal and burnt sand were also present, possibly representing an ash cap to level or seal off layers below.
- 5.3.3 To the south of the main hall, the foundations of a small brick structure (113; Fig. 10) measuring around 2.2 m square was uncovered. The internal space had been backfilled with a dark grey sandy silt, from which 19th/20th-century glass bottles and pottery, and a metal saucepan were recovered, but not retained.

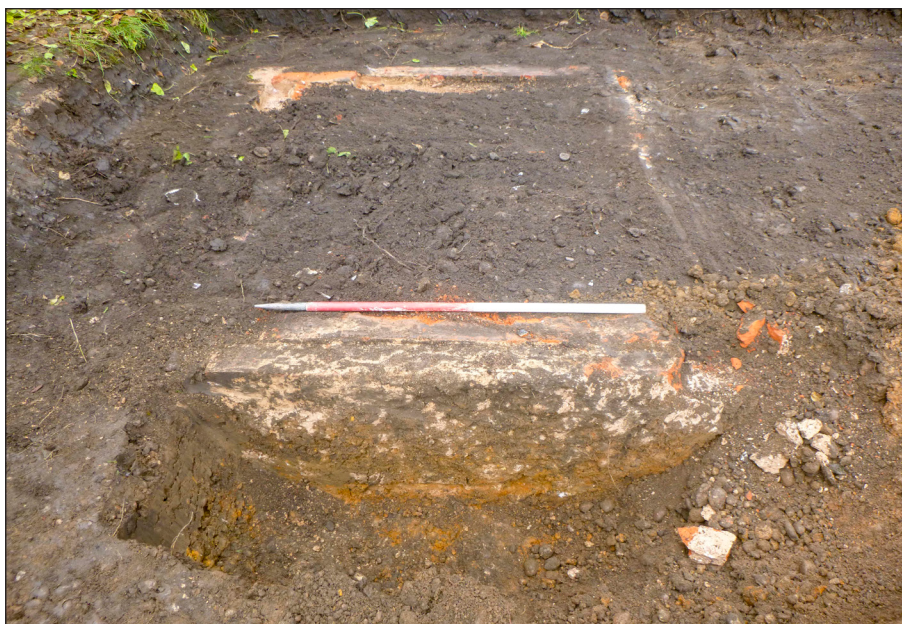
Figure 10: Outbuilding 113, viewed from the south-east, 1 m scale

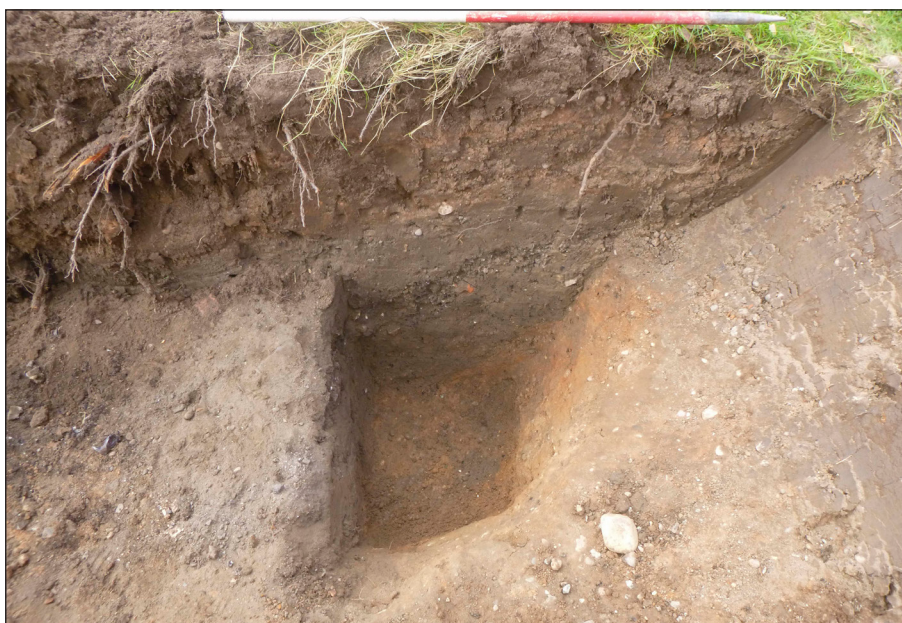
Figure 11: Pit 116, viewed from the east, 1 m scale

- 5.4.1 In a utility trench to the east of the cottage building, a pit (116; 1.78+ x 0.77 x 0.51 m) was uncovered containing two fills of charcoal rich silty sand and sandy, gravelly clay (Fig. 11). Finds of modern pottery, including two sherds of heavily burnt and vitrified industrial ware, animal bone, modern window glass, the handle of an iron bath or wash tub and clay pipe were recovered from the pit. It is probable that the pit was used for refuse.
- 5.4.2 A curving drainage ditch (148; 2.3 x 2 m deep) extended south-east from the pond and had a ceramic drain at its base.
- 5.4.3 Pit 152 (1.12 x 0.87 m deep; Fig. 6) contained two fills of charcoal rich silty sand and stoney sand, from which finds of worked wood, plastic, iron nails, a door latch, and a fragment of modern peg tile were recovered.

- 6.2.5 Four relatively modern sherds (c. post 1850) were excavated from two fills within pit 116. The sherds include two fragments, possibly from a bowl, of industrial whiteware that had come in contact with a heat source, causing the outer surfaces to partially melt and vitrify. The others are a body from a brown stone ware mineral bottle and a rim from a large transfer-printed serving plate exhibiting iron staining. A single complete white stoneware ink bottle of similar date was recovered from the topsoil 101.

- 6.4.1 The lower portion of a bowl and stem junction (spur broken) from a single tobacco pipe was recovered from pit 116. Unfortunately, the fragment has no diagnostic features to refine its date, but an association with other artefacts from this feature means a post 1850 date for this pipe bowl fragment is likely.

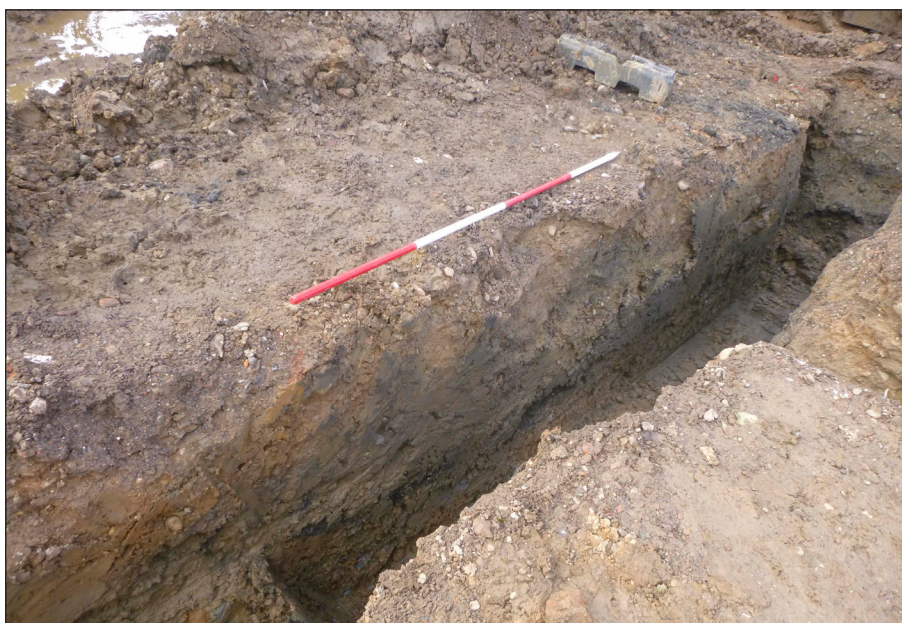
Figure 13: Feature 134, viewed from the south-east, 2 m scale

- 6.7.1 Worked wood was recovered from two contexts: the fill (137) of moat or pond 134 and pit 152. Ten large structural timbers, which may have formed part of a bridge or jetty associated with the moat/pond were recorded on site, but not retained. These timbers measured between 0.94 and 1.54 m in length and were all broken at one or both ends.

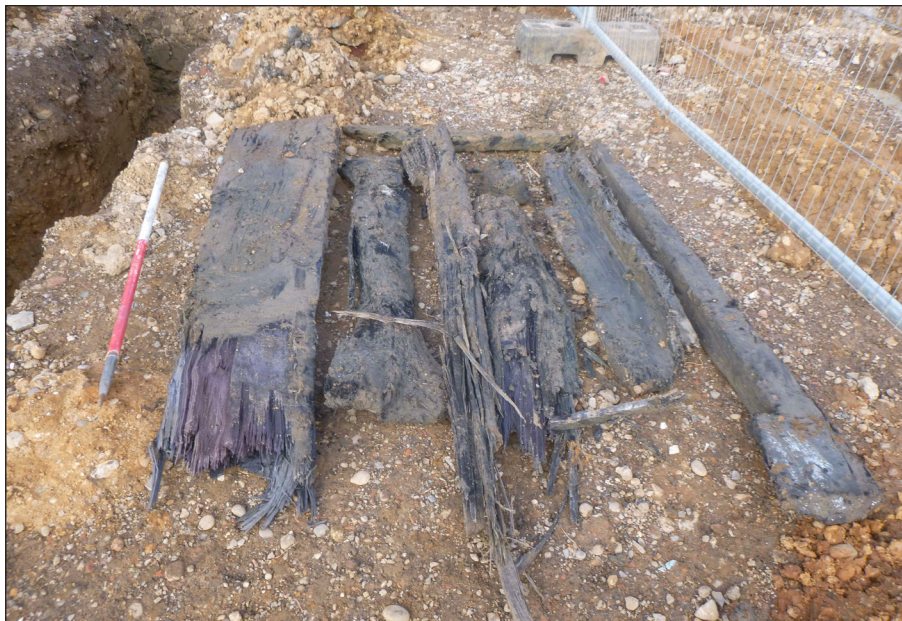
Figure 14: Sample of wood recovered from feature 134, 1 m scale

- 6.7.2 Three smaller timbers were retained for further inspection, of which two came from the moat/pond. One is part of a possible plank which is severely damaged, so no original dimensions could be ascertained. The second piece came from a larger timber, possibly a post with a sawn top and a 20 mm hole drilled obliquely from the top to one of the sides. Cut or axe marks could also be seen on this side.

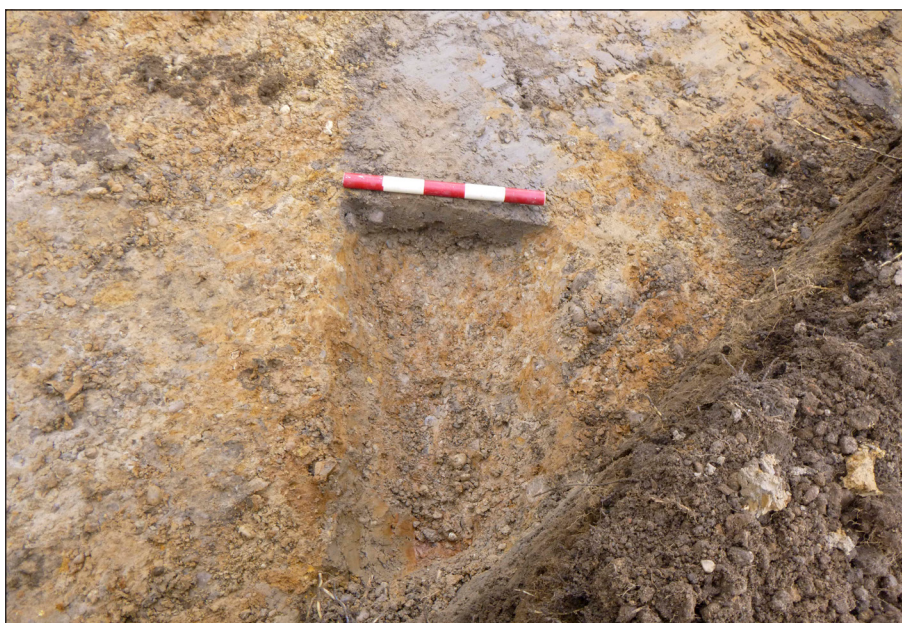
Figure 15: Gully 157, viewed from the west, 0.5 m scale
