# Mayfield Court, 52–56 West Street, Sheffield, South Yorkshire

## Archaeological Investigations Report

Ref: 117232.01  
September 2018

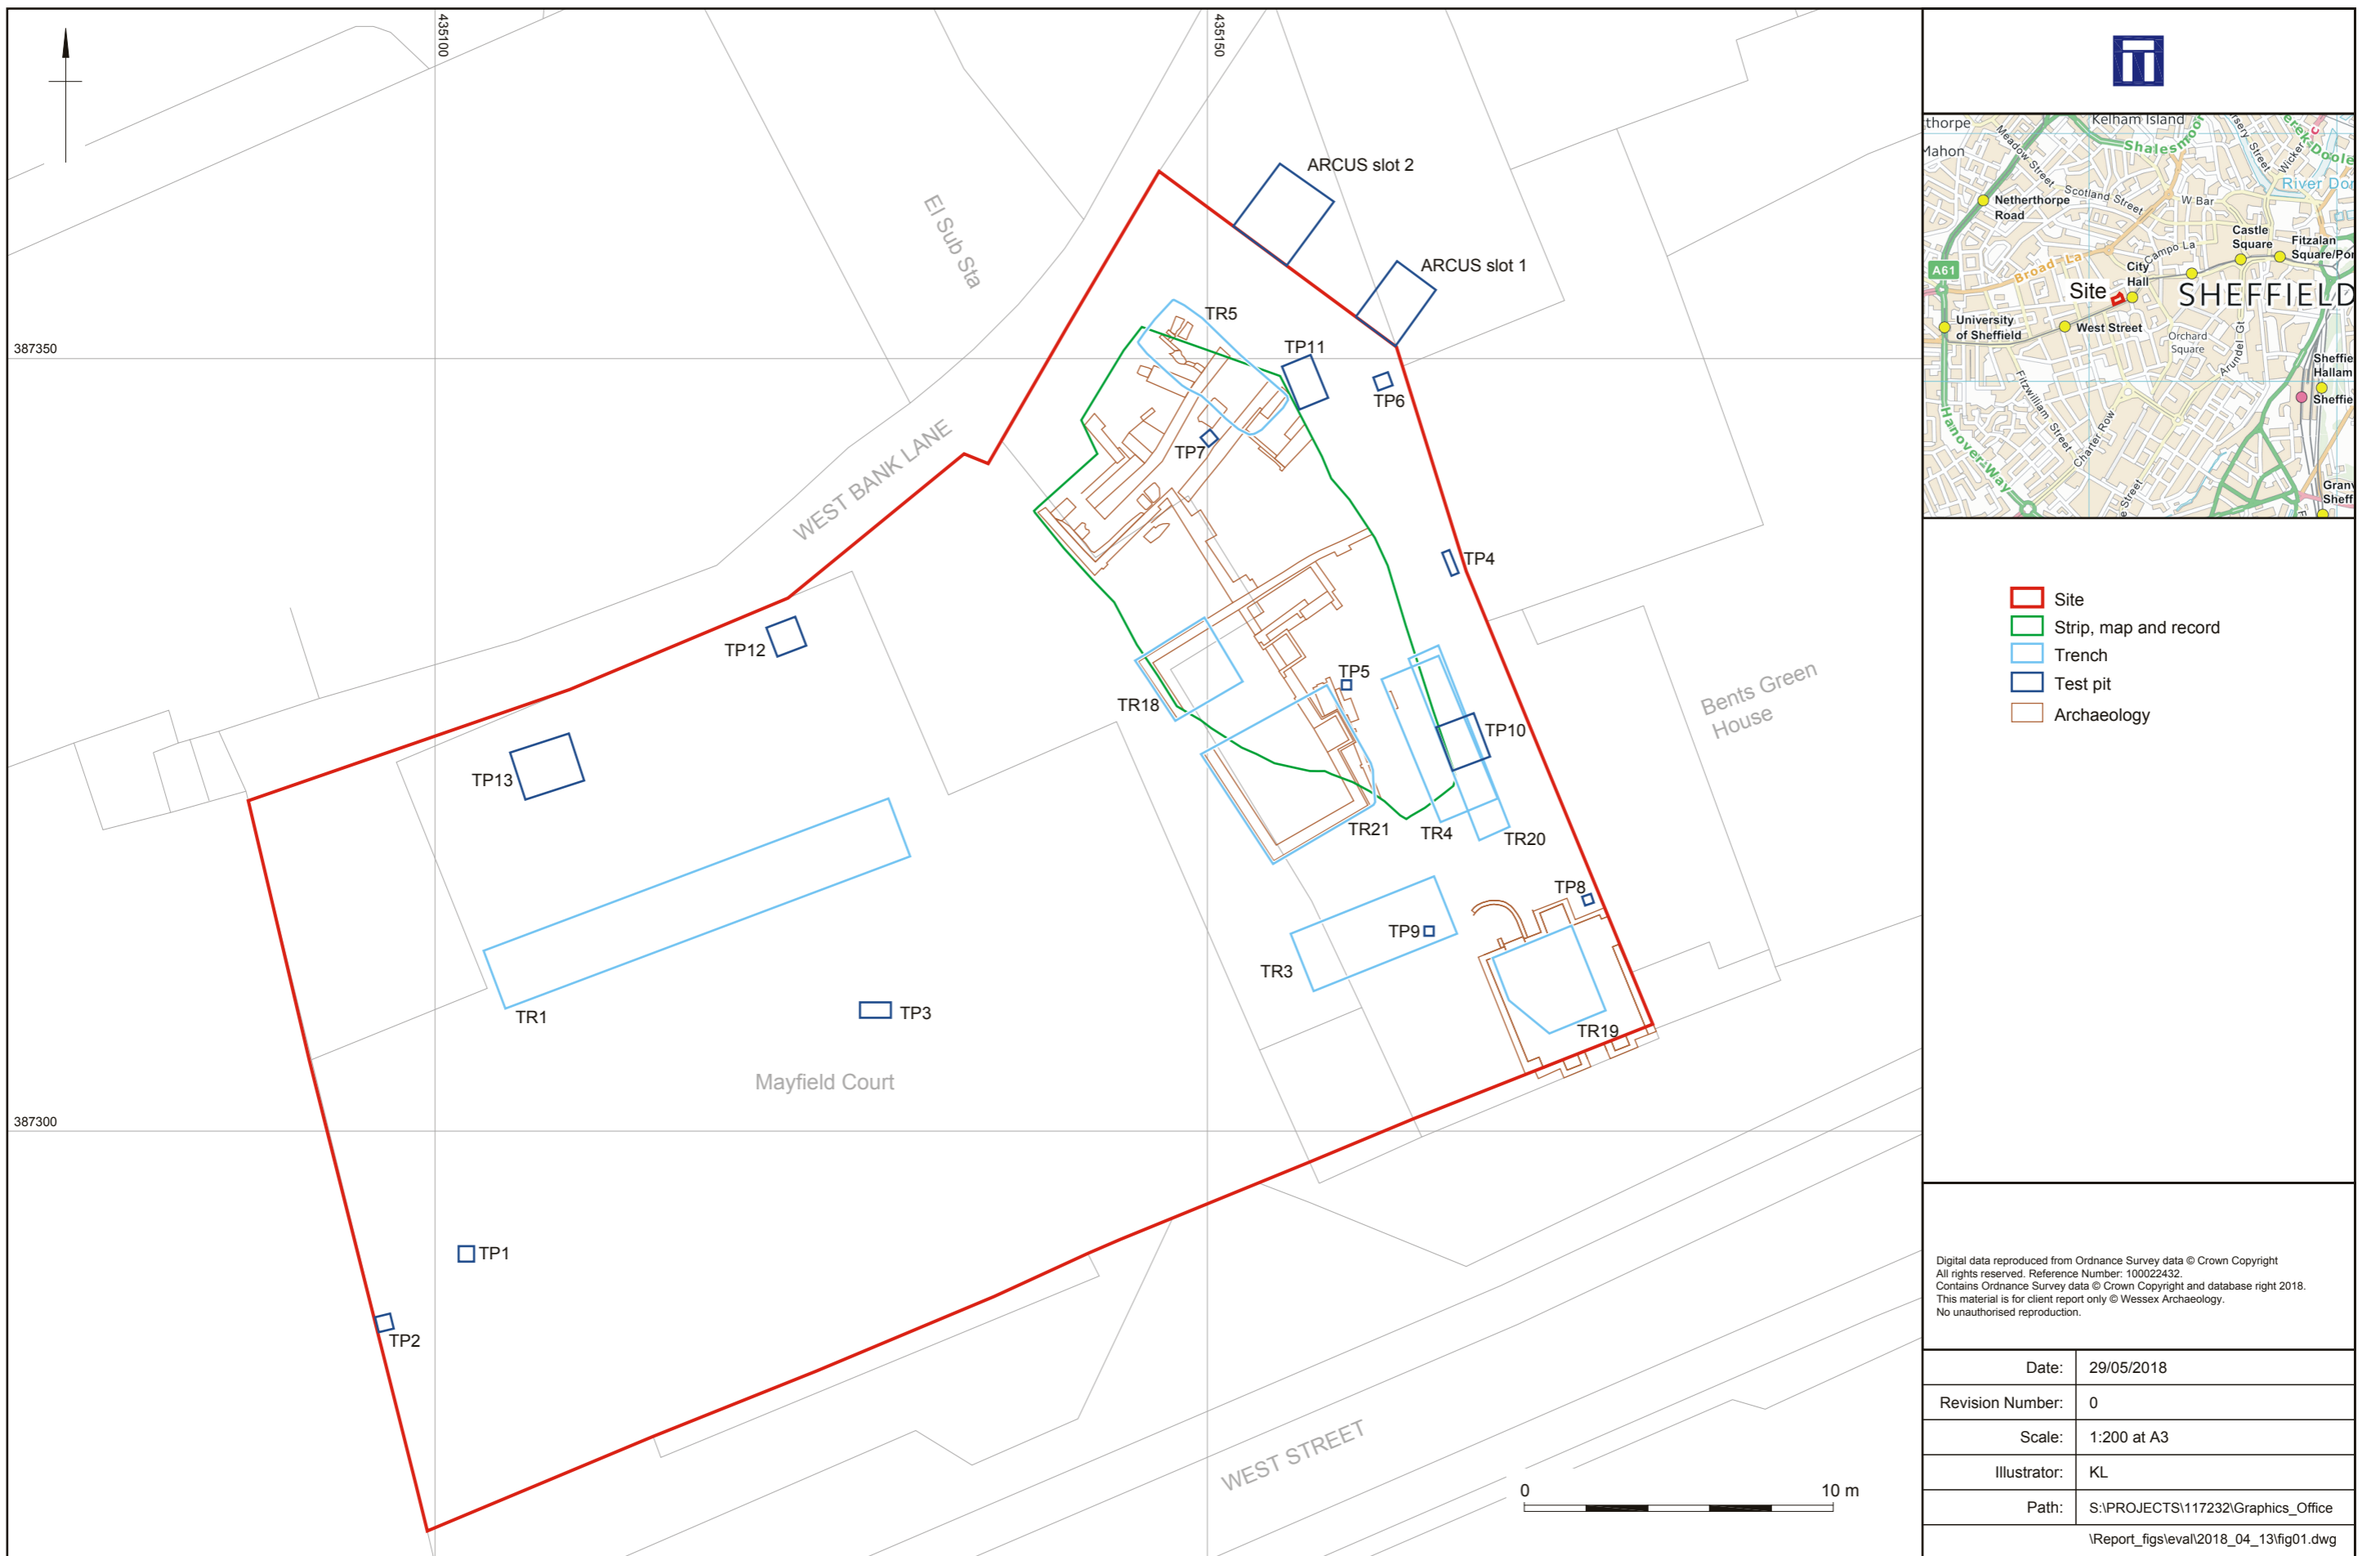
Figure 1

Site location and plan of trenches

8.1.1 During the 18th century, quarry pits (1057 and 1060) were excavated for the extraction of sandstone bedrock. Further examples of quarry pits were previously recorded on an adjacent plot (ARCUS 2006) as shown on Figure 1. Indeed, the discovery of a quarry pit (ARCUS context no. 1062) found backfilled with clinker waste and redeposited natural mirrors the results of this investigation. It is also possible that strata of redeposited natural identified both during the ARCUS project and this project represent further backfilled quarry pits. The quarry pits were excavated on the fringes of the expanding settlement of Sheffield prior to the development of the Site. The quarry pits were then backfilled with waste and the spoil arisings from quarrying activity. The dating of the quarry pits is reasonably secure and is supported by 43 sherds of pottery and 36 pieces of clay tobacco pipe. One further sherd of pottery suggests a 19th/20th century date and is likely intrusive. On the basis of the latest clay pipe bowl, the quarry pits may date to later than 1780. Other clay pipe bowls recovered from the quarry pits date to the 17th century and early 18th century. Bone handle waste likely relating to cutlery manufacture was recovered from pit 1057. *Ad hoc* quarrying activity on the fringes of Sheffield likely began prior to the 18th century, however at least the bulk of the quarrying activity on this Site appears to date to the 18th century. In the 18th century the Site was at the fringes of Sheffield; *ad hoc* quarrying likely preceded the historically attested expansion of the settlement.

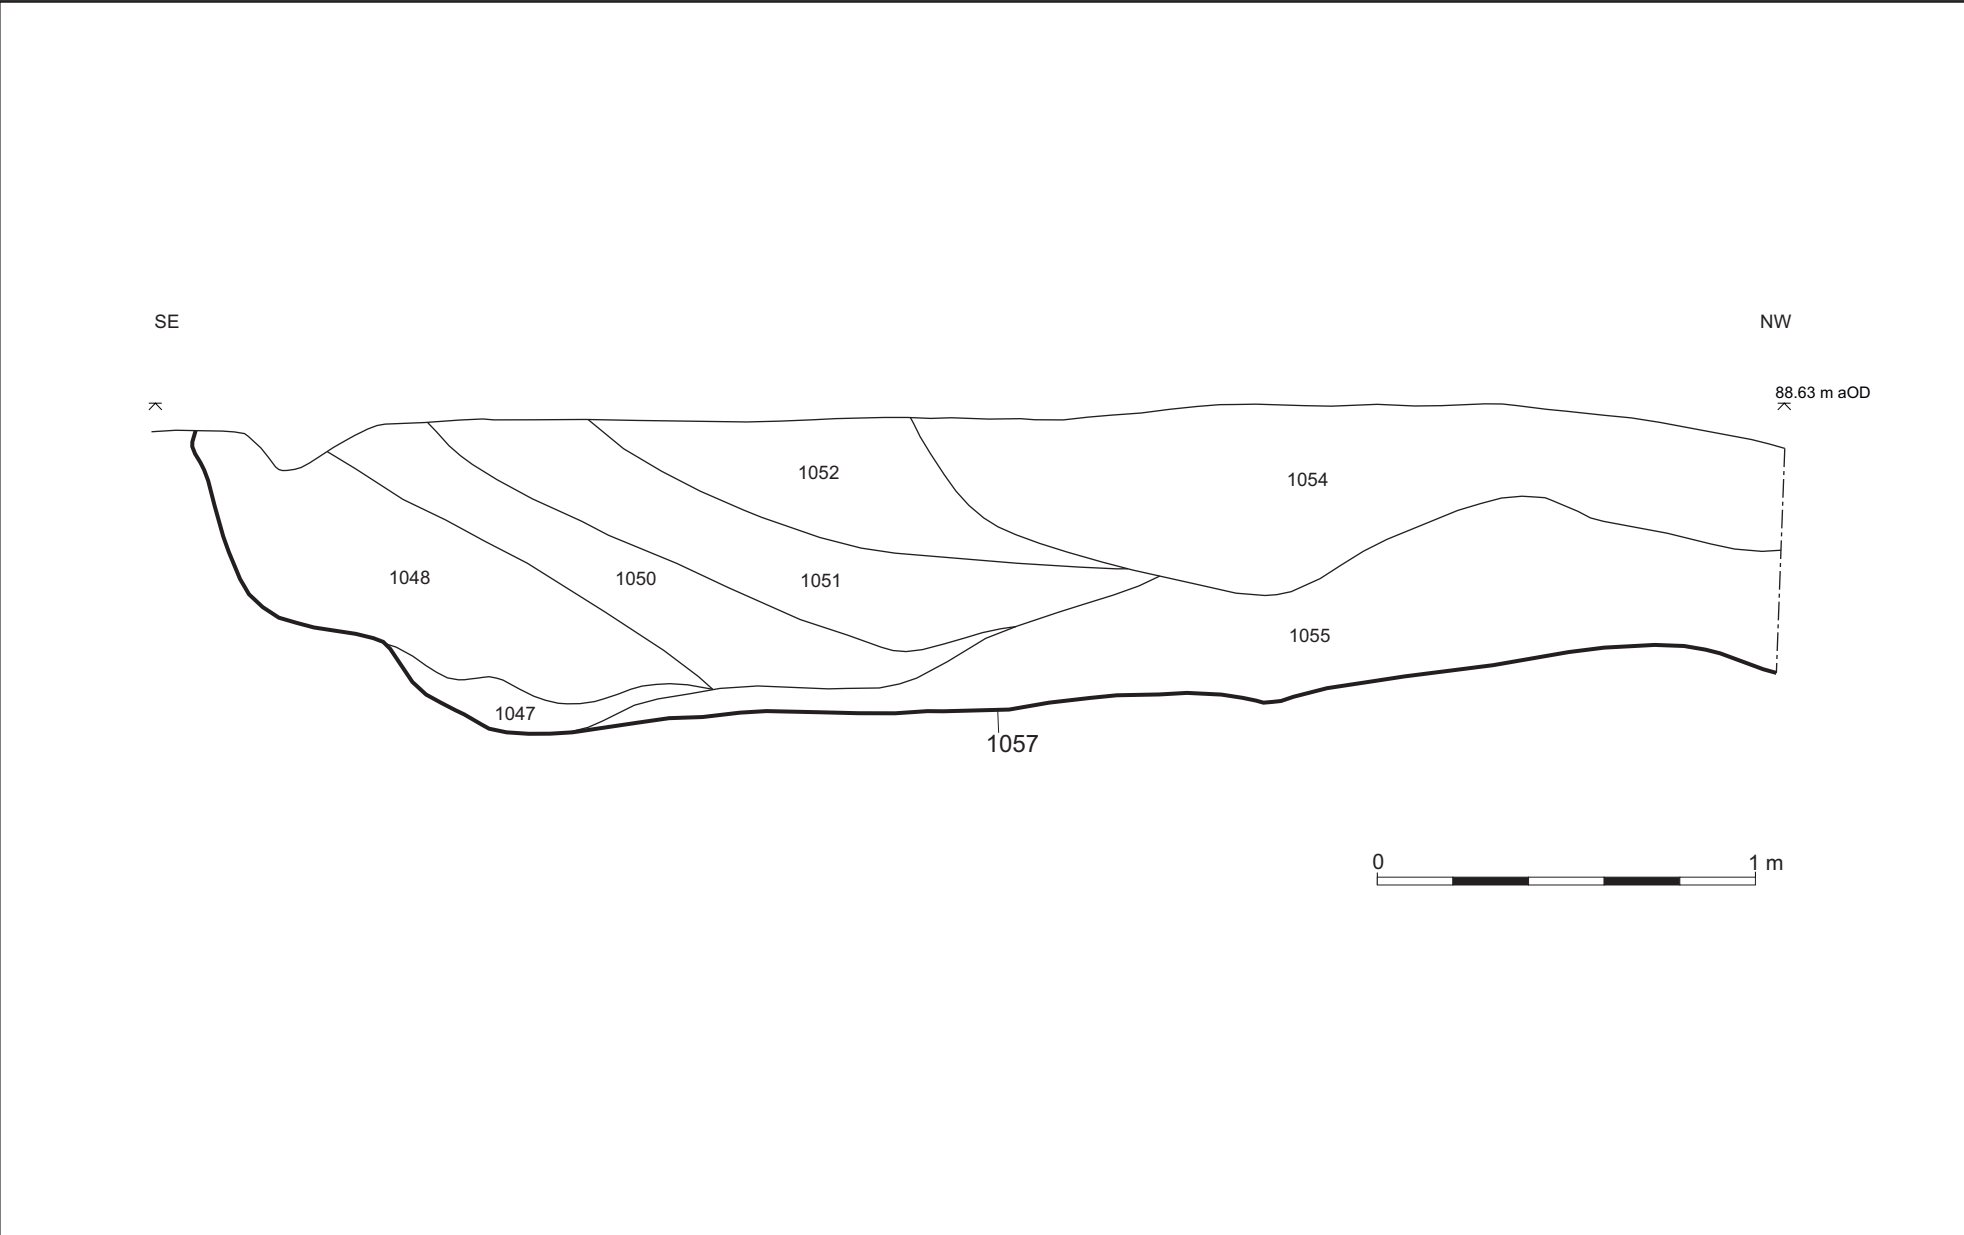
Figure 7

Section of quarry pit 1057 from north-east

some degree of re-cutting of the quarry pit occurred, however the motive for re-excavating the fills of a quarry pit or rubbish pit is not obvious. The second fill (1047) comprised dark blue black silt sand with sub-rounded stones and probably represents burnt waste material opportunistically disposed of in an existing pit. The remaining five fills (1048, 1050, 1051, 1052 and 1054) represent arisings derived from the natural (presumably from nearby quarrying activity), mixed with varying proportions and colours of waste material. The waste material component of the fills of pit 1057 included ash and similar materials as well as domestic artefacts. Fill 1052 produced a relatively large (for the Site) quantity of dateable artefacts including 39 sherds of pottery suggesting a 17th- or 18th-century date. Clay tobacco pipe from deposit 1052 was broadly in agreement with the pottery, with three bowls dating from 1660–1690, the late 17th century to early 18th century and 1780–1820 (see Artefactual Evidence below for detail).

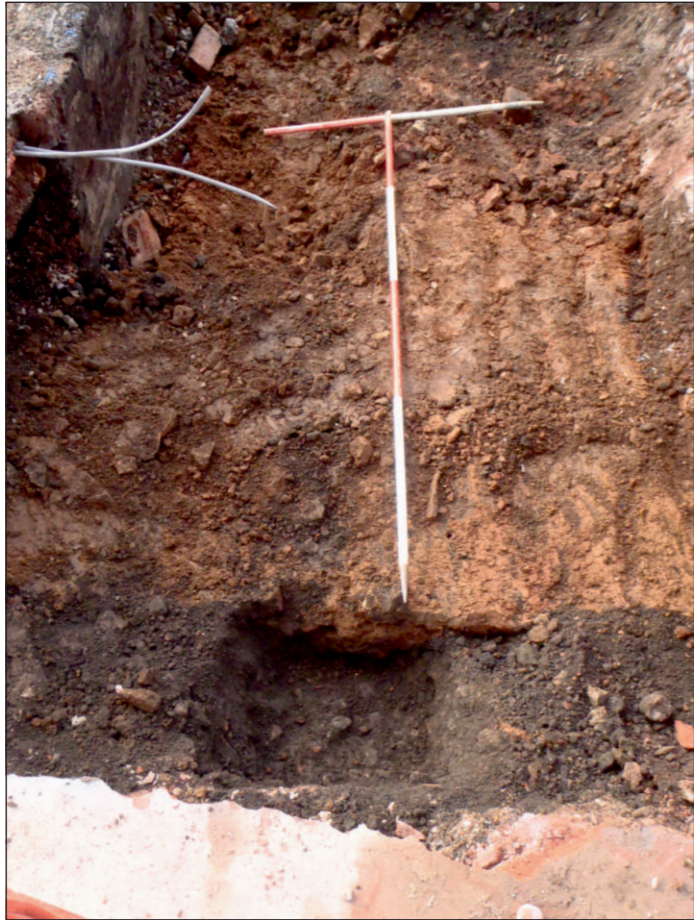
Plate 1: Construction cut 303 (at bottom of shot) from south

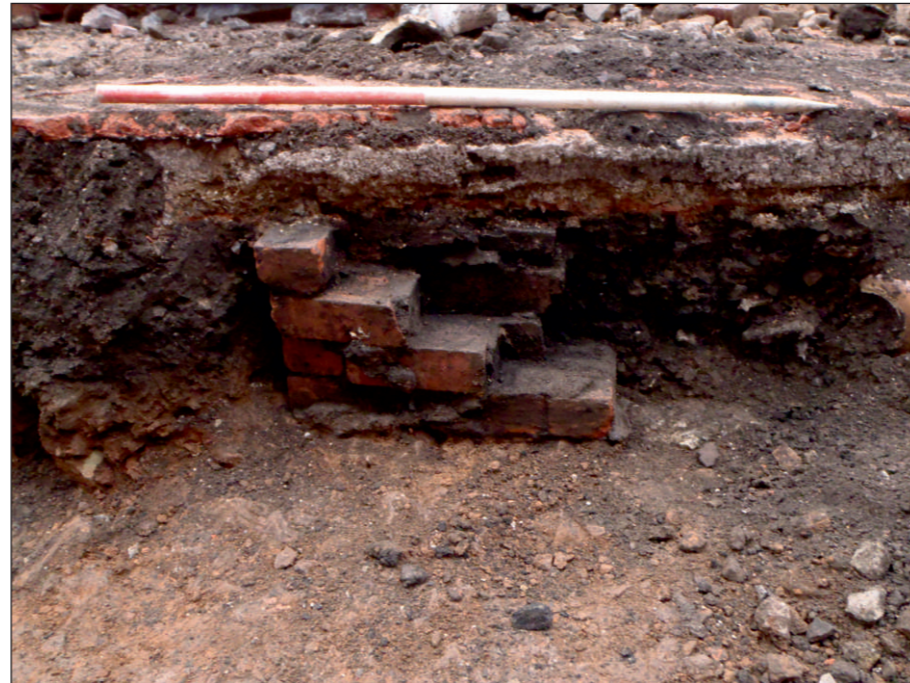
Plate 2: Wall 406 from east

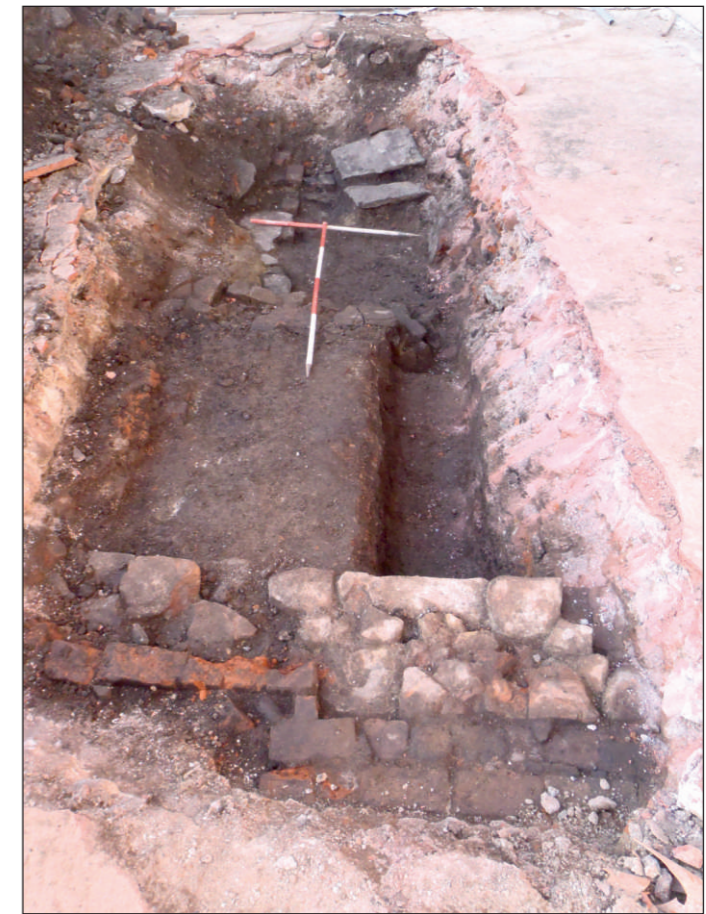
Plate 3: Overview of trench 5 from the south

5.4.8 In the north of the strip, map and record area were a series of sandstone foundations bonded with lime mortar (1004, 1005 and 1020; Plate 6). Parts of these structures had previously been exposed in evaluation Trench 5 (Plate 3).

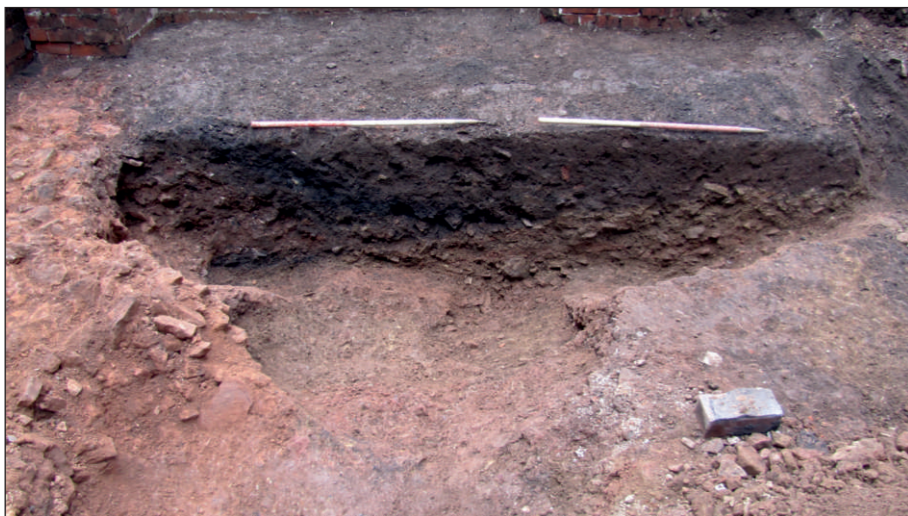
Plate 4: Quarry pit 1057 from east

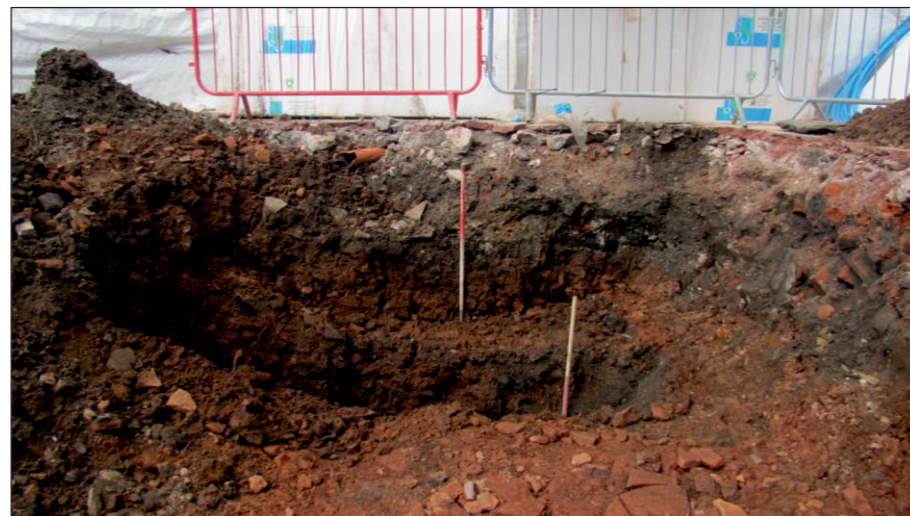
Plate 5: Quarry pit 1060 from south

5.4.6 A second quarry pit was present in the far north corner of the strip, map and record area (1060; Plate 5). Pit 1060 was located under flagstone surface 1007 and was recorded under watching brief conditions at the conclusion of the strip, map and record excavation. Pit 1060 was over 4.5 m by over 2 m in plan and was 0.8 m deep with a generally concave profile. The quarry pit had been backfilled with demolition rubble (1031) which may represent material imported specifically to backfill the pit. Artefacts from deposit 1031 included a clay pipe bowl from 1680–1710 and a small group of pottery that could not be closely dated but which originates in the 18th century or later.

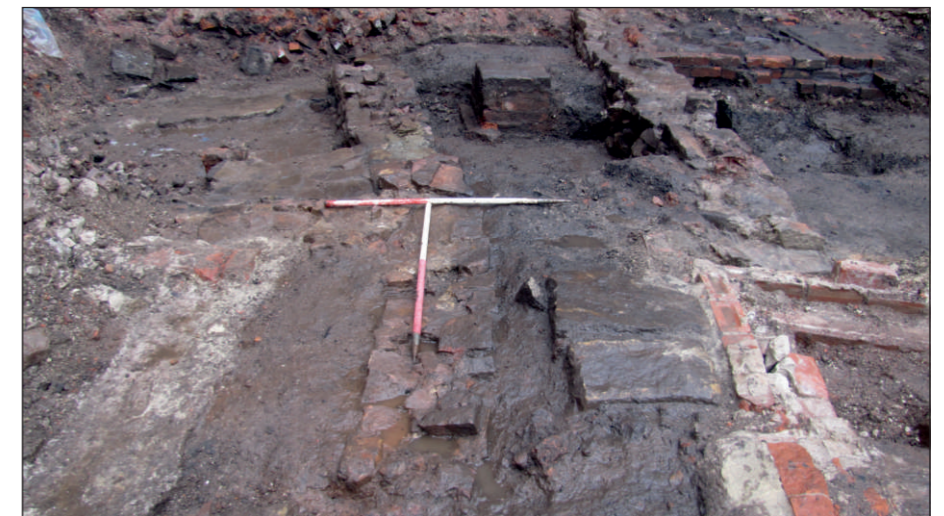
Plate 6: Northern part of strip, map and record area from west, showing sandstone foundations of back-to-back housing and later alterations

- 5.5.1 Also between walls 1004 and 1005 was a frogged brick and black ash mortar pier base set on a sandstone flag foundation (1006; Plate 6). Pier 1006 was 0.8 m by 0.5 m in plan and appeared to have been constructed as a foundation. Comparison with historic maps (Figure 5) suggests that by 1890, structure 1006 was the base of a stanchion or similar supporting the wall of a Carpenter's Workshop, with a masonry building to the north-west and a wooden building extending to the south-east (as evidenced by the Goad Fire Insurance Plan of 1896; Figure 6). This date is consistent with the materials used in the construction of pier 1006.

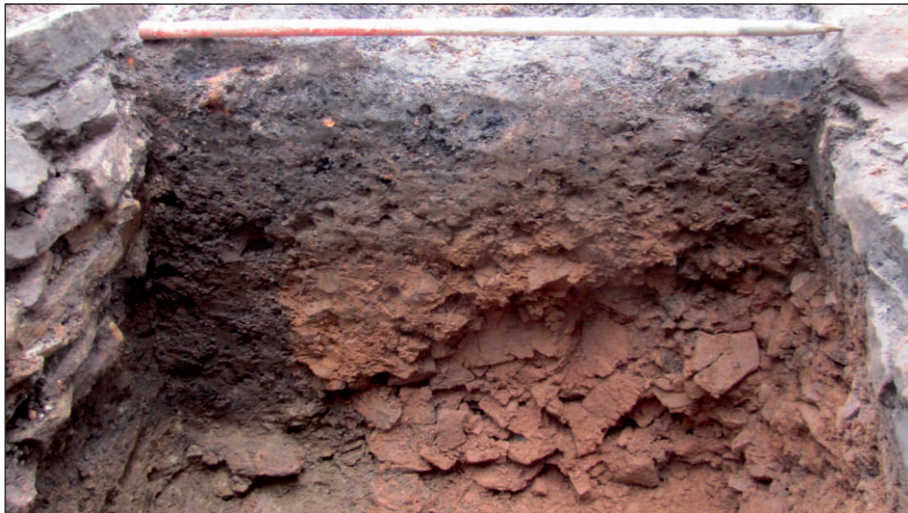
Plate 7: Detail of construction cut 1039 from south-west

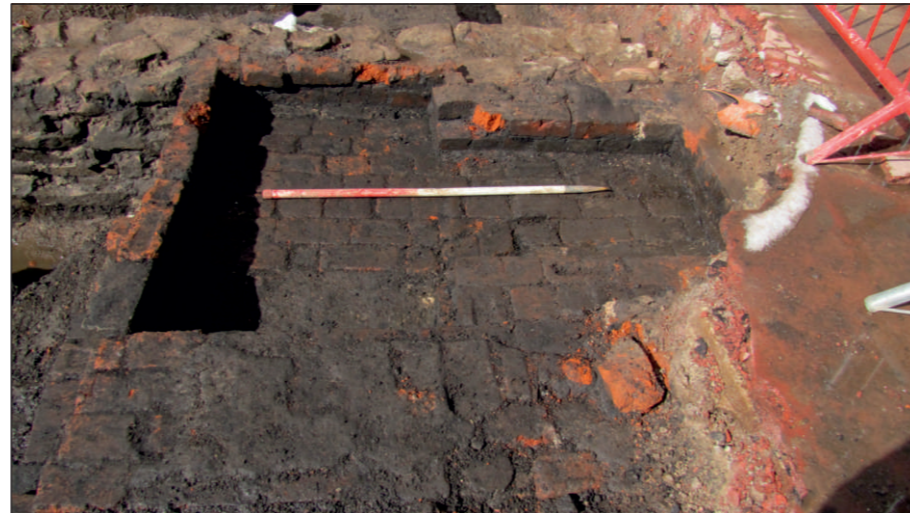
Plate 8: Complex structure 1010 and 1033-1035 from south-east

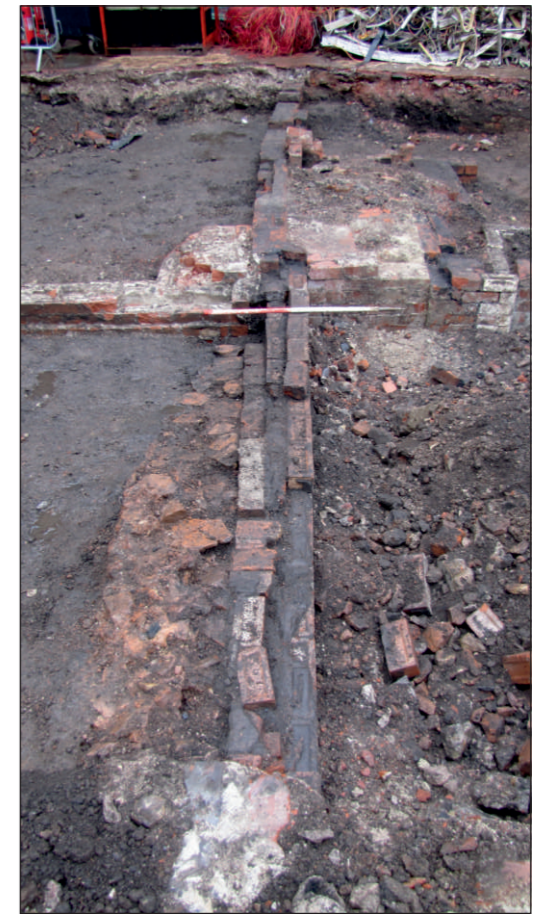
Plate 9: Wall 1012 from south-west

- 8.4.1 An east to west or north-east to south-west aligned wall (1012) crossed the Site on the alignment of a boundary depicted on maps as far back as 1853 (Figure 4). Wall 1012 was built of frogged machine bricks and black ash mortar, and therefore may relate to redevelopment of the buildings in the early 20th century or late 19th century. Wall 1012 divided the carpenter's workshop from the adjoining brass foundry as shown on the Goad Fire Insurance Plan of 1896 (Figure 6) and also on the Ordnance Survey map of 1890 (Figure 5). A staircase recorded on the south side of wall 1012 appears to be depicted on the 1890 Ordnance Survey map as an external staircase open to the sky.

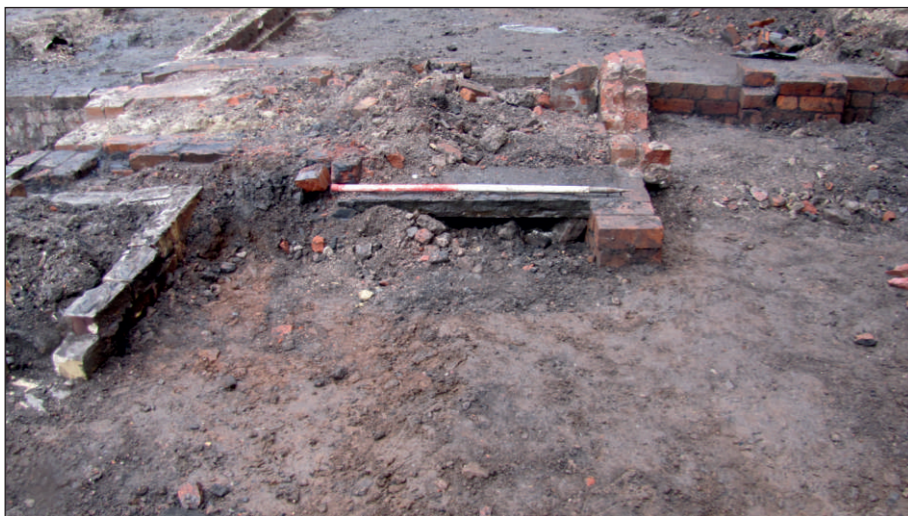
Plate 10: Stairway 1013 etc. from south-east

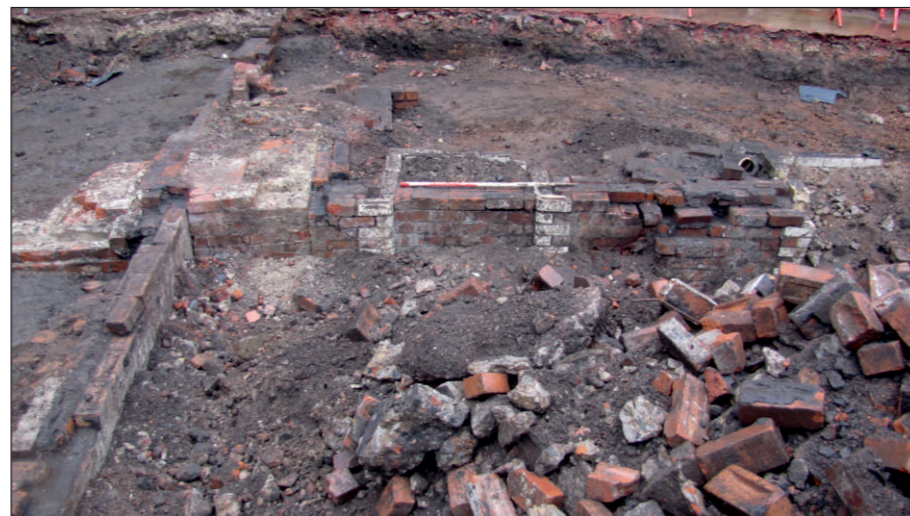
Plate 11: Complex wall 1026 with bays in white glazed brick from south-west

- 8.7.6 Evidence for the brass foundry is chiefly cartographic. The white glazed brick bays built into wall 1026 are probably (but not definitely) associated with the brass foundry and raise the possibility of an archaeological representation of some specific process associated with brass founding. Speculatively, it is possible that the hot work may have occurred in an almost detached wing at the rear of the foundry, separated from other buildings by a small yard. It is possible that the decommissioning of the bays may relate to a change in operations at the foundry, however it is perhaps more likely that the bricking up of the bays related to conversion of the building to an electrical engineer's premises and then a garage.

8.9.5 A further cellar and walls were probably associated with the late 19th-century brass foundry. One of these walls (1026) contained a series of small bays built of white glazed bricks. Further research might lead to the identification of these bays with some specific process associated with the brass foundry.

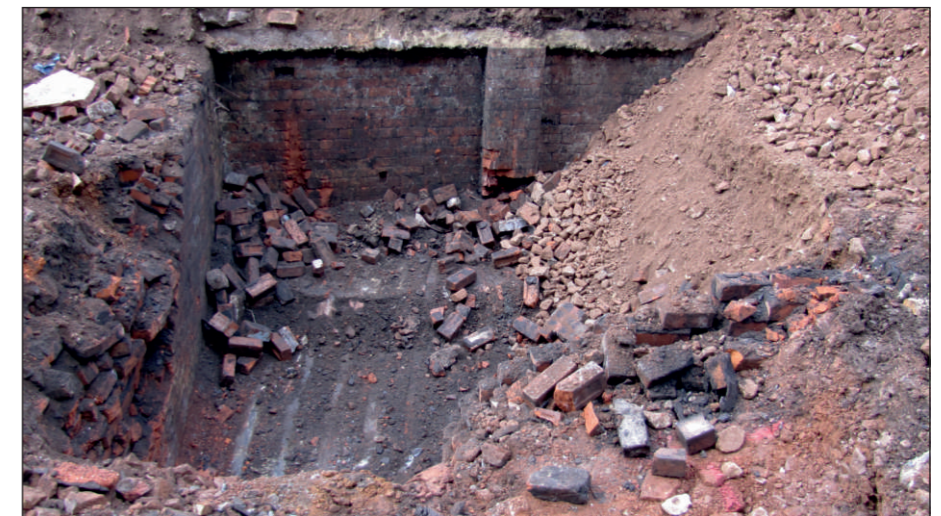
Plate 12: Cellar to the south-west of wall 1026 = 2102 from north-east as seen in watching brief trench 21

- 5.5.8 Within trench 18 a 2 m by 2 m area of the rubble cellar fill (1801) in the west corner of the cellar was excavated to a depth of 2.3 m below ground level, and trench 21 similarly removed the rubble cellar fill (2106) from the south-east 4 m and full width (around 3.4 m) of the cellar. The base of the cellar was located between 2.3 m (trench 18) and 2 m (trench 21) below ground level and comprised a flagstone floor in trench 18 (1802) which had been replaced in trench 21 by an unusual bluish concrete (or possibly an ash-mortar-derived concrete analogue, 2109) bedded on a layer of bluish ash mortar with some hydrocarbon contamination (2110). In both trenches, the undisturbed red sandstone bedrock (1803 and 2101) was seen directly below these flooring structures and deposits. The cellar was defined by walls 1012, 1026 = 2102, 2107 and 2108.

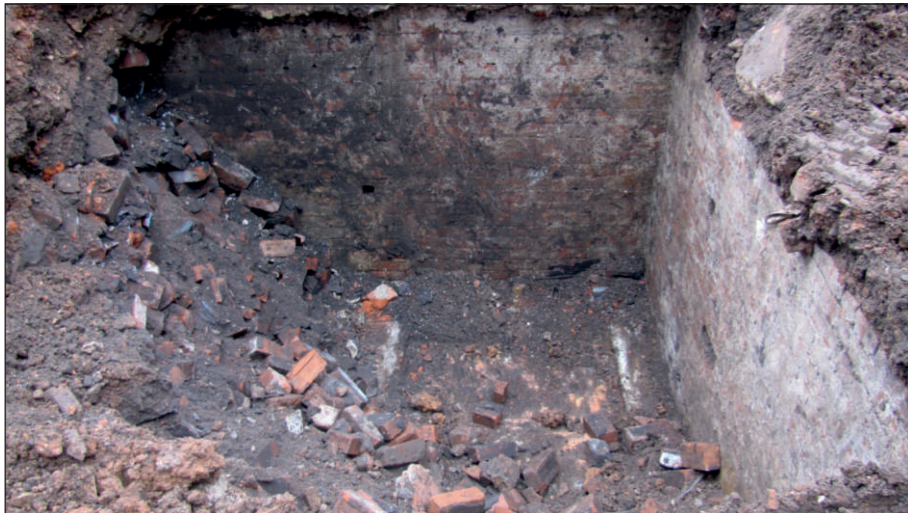
Plate 13: Watching brief trench 18 showing cellar at junction of walls 1012 and 2108 from north-east

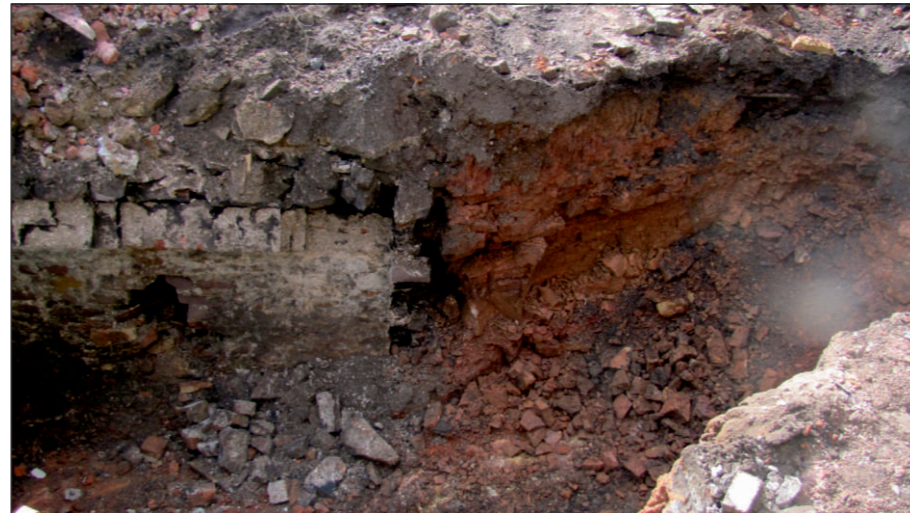
Plate 14: Watching brief trench 19 from east with wall 1903 removed to show construction cut 1914 containing wall 1901

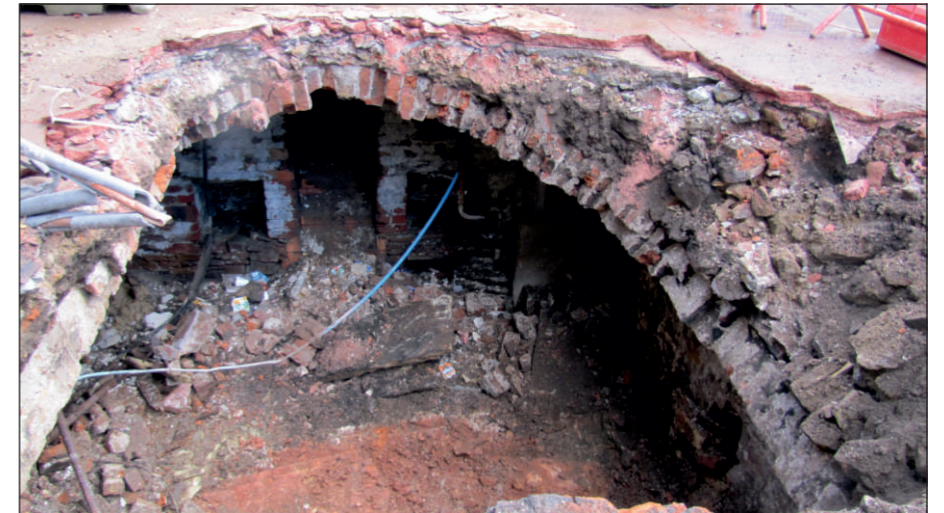
Plate 15: Watching brief trench 19 from north showing wall 1906 under vaulting 1900

- 6.5.3 During the watching brief, an *in situ* collection of glass bottles and jars was found in trench 19, in keeping holes in the cellar's south wall (1906). Eight of these were collected as a sample, comprising two wide-mouthed jars, one octagonal (both with a basal mark in the form of the monogram TMF); a taller octagonal jar, probably for sauce or condiments; a small cylindrical jar with contents and metal screw cap still *in situ*; a clear beverage bottle

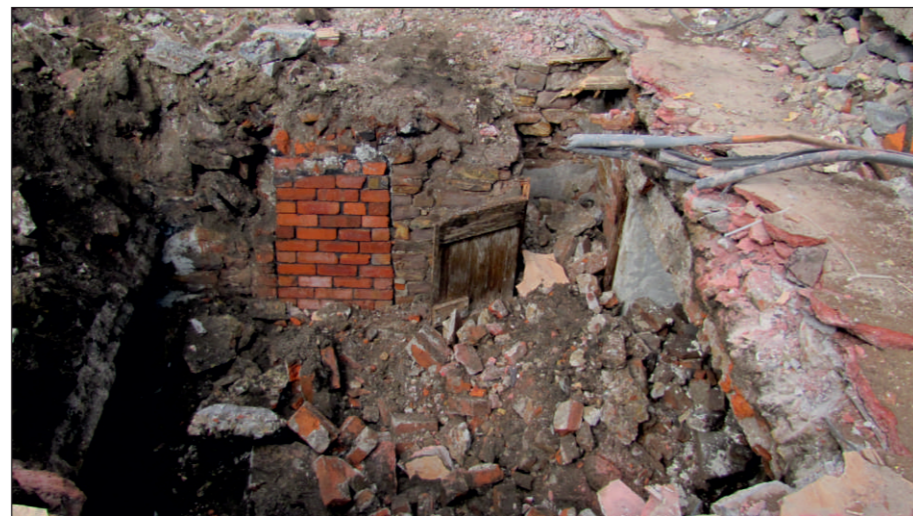
Plate 16: Watching brief trench 19 from south showing door 1905 and blocked opening 1904

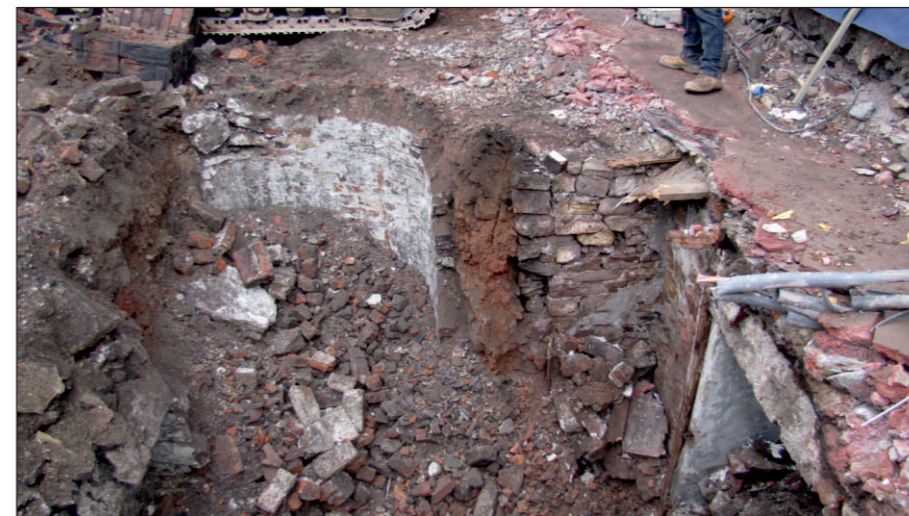
Plate 17: Detail of curving passage 1912 during demolition from south
