Archaeological Services in Relation to Marine Protection

Josephine Willis off Folkestone, Kent

Undesignated Site Assessment

Ref: 214390.12
June 2020

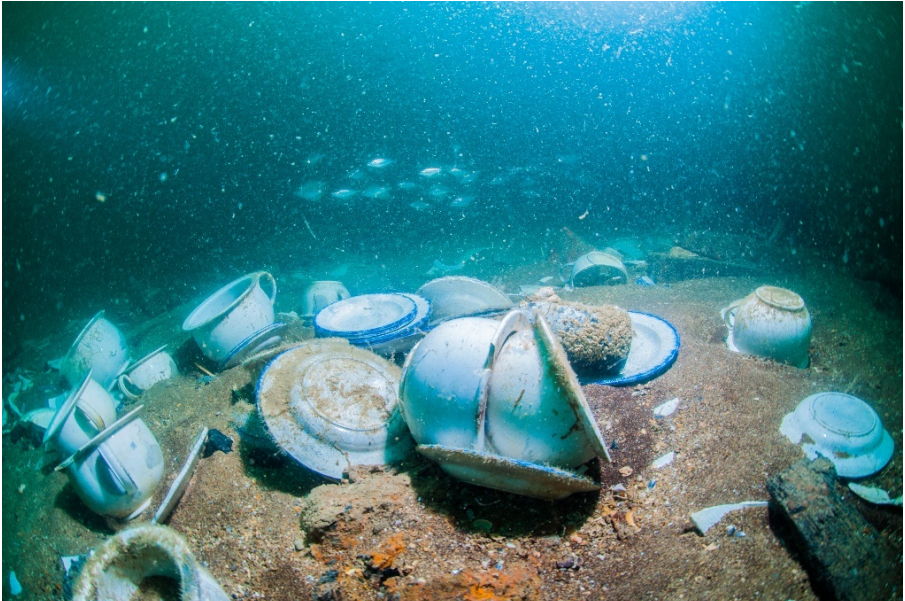
| Description | Image |
|--|---|
| <p>3. Various ceramics, including plates with simple blue and white transfer printed rims and plain chamber pots of various sizes.</p> | |

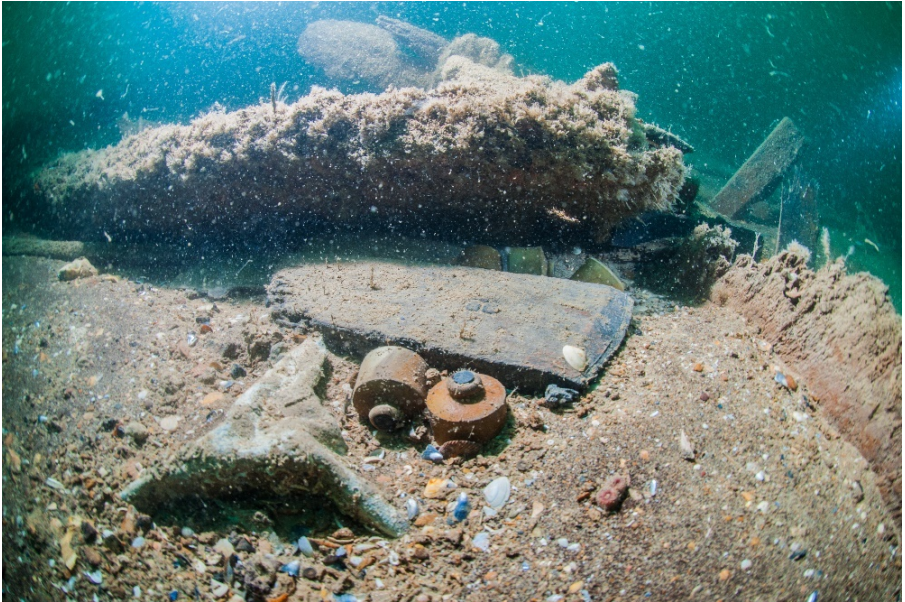
| Description | Image |
|--|---|
| <p>4. Inkpots and barrel stave centre, one clearly sealed. Both are reported to have been full. Unidentified object rear. Possible <i>in situ</i> barrel planking on right. Unidentified object foreground, possibly lead rainwater goods.</p> | |

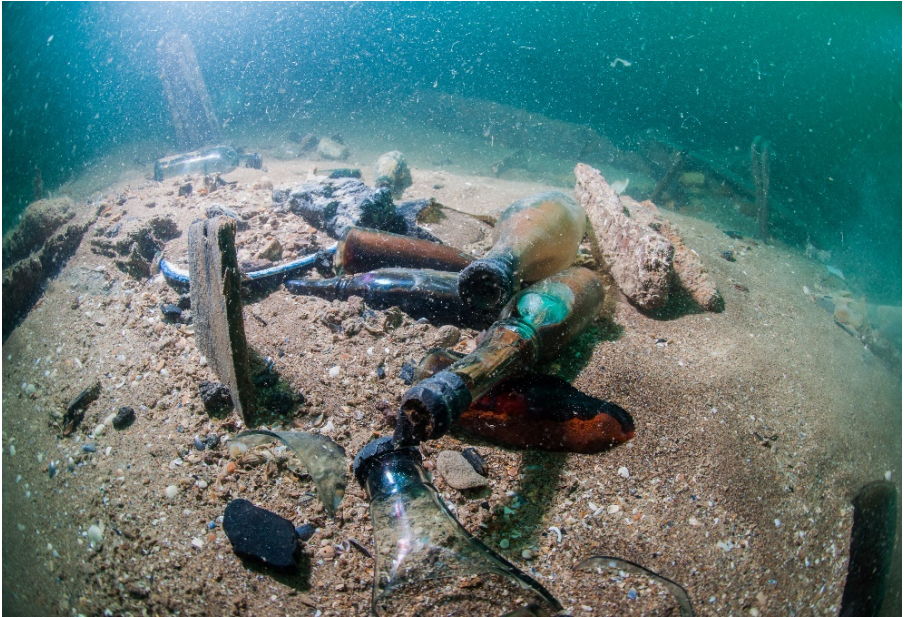
| Description | Image |
|---|--|
| <p>5. Various sealed glass bottles with debris from wooden boxes/crates.</p> | An underwater photograph showing a collection of debris on a sandy seabed. Several glass bottles, some with labels, are scattered among wooden planks and other fragments. The water is clear and blue. |

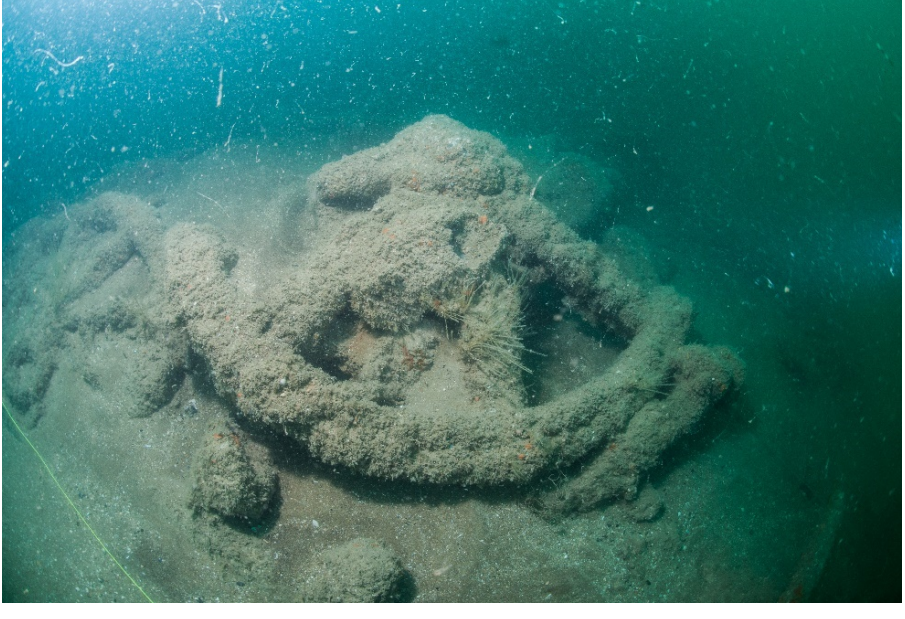
| Description | Image |
|---|--|
| <p>6. This image was described in an article in DIVER magazine dated July 2018 as "Remains of the rudder". However, it appears from this photograph to be the remains of two wheels (centre and left). If so, it could be related to a small fire engine being carried onboard.</p> | An underwater photograph showing large, rusted metal remains on the seabed. The remains appear to be two large, circular wheels or components of a machine, possibly a fire engine. The water is clear and blue. |

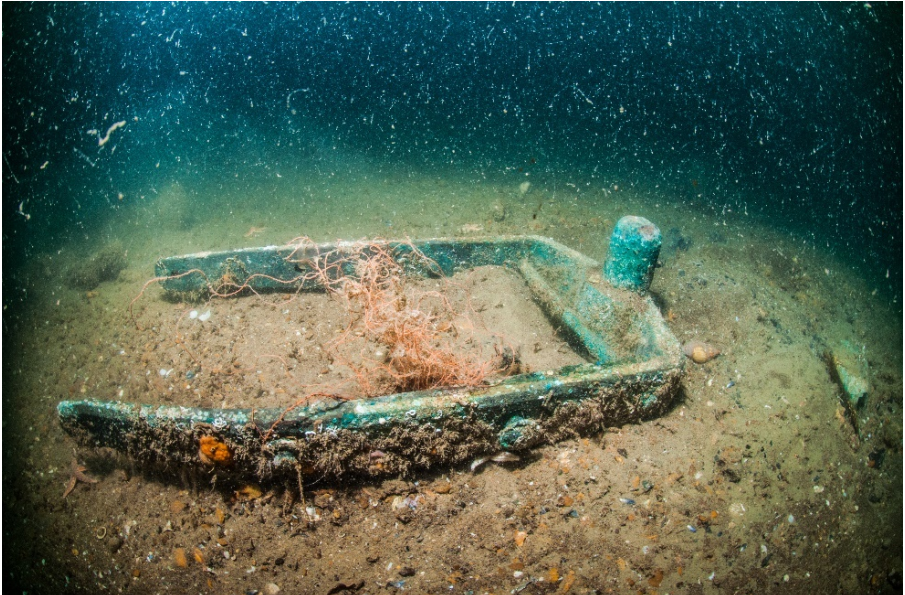
| Description | Image |
|---|---|
| <p>7. Cuprous rudder pintle. Found close to the objects in the previous image in the area identified to the ENE as the stern.</p> | |

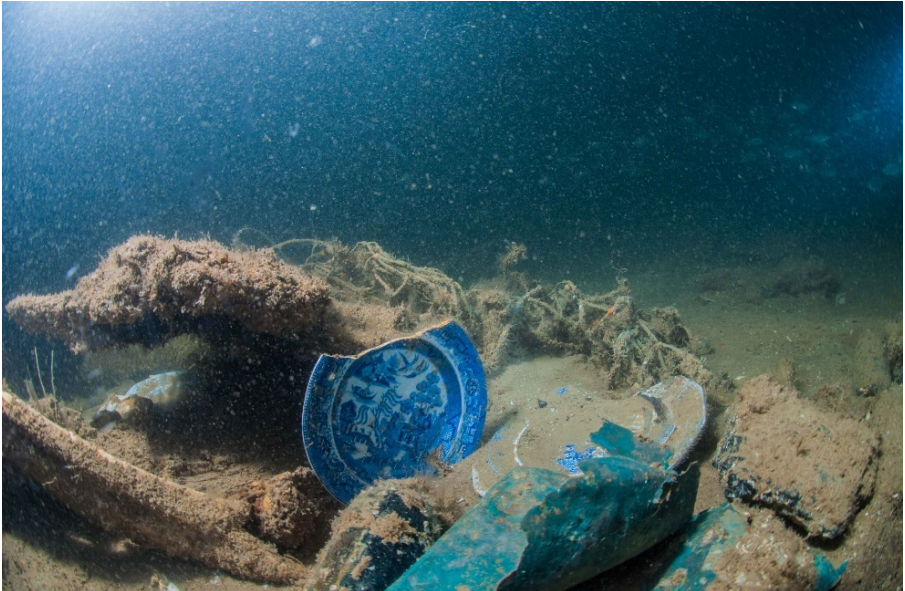
| Description | Image |
|---|---|
| <p>8. Various debris and ceramic, including cuprous sheet/s foreground right. It is not known whether it is the sheathing reported. Note the modern fishing net debris middle ground.</p> | |

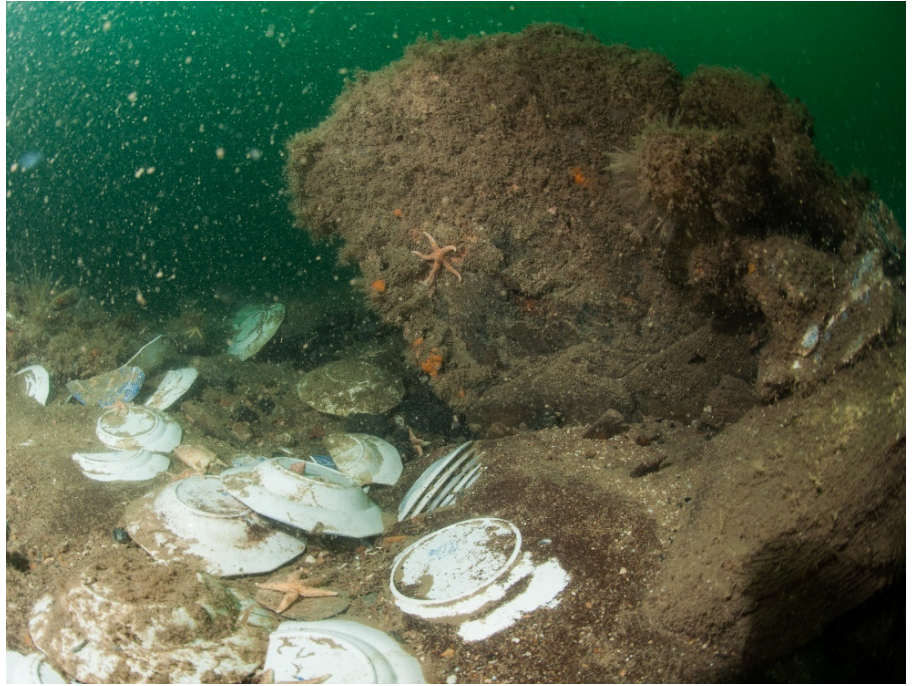
| Description | Image |
|--|---|
| 9. Blue and white transfer printed plates, below large unidentified object upper centre and right. | |

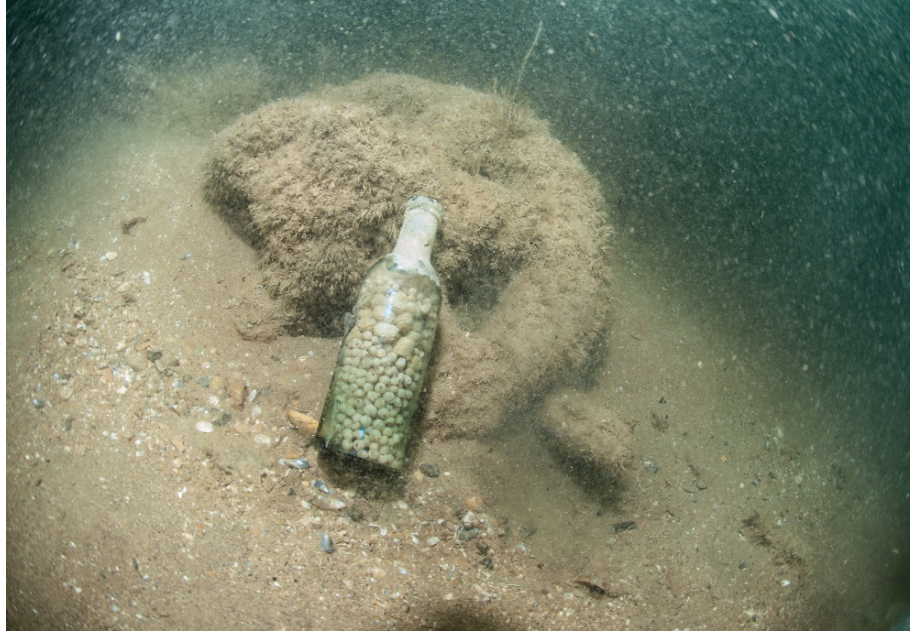
| Description | Image |
|--|---|
| 10. Bottle containing unidentified, possibly pickled foodstuff; lying across possible wheel. | |

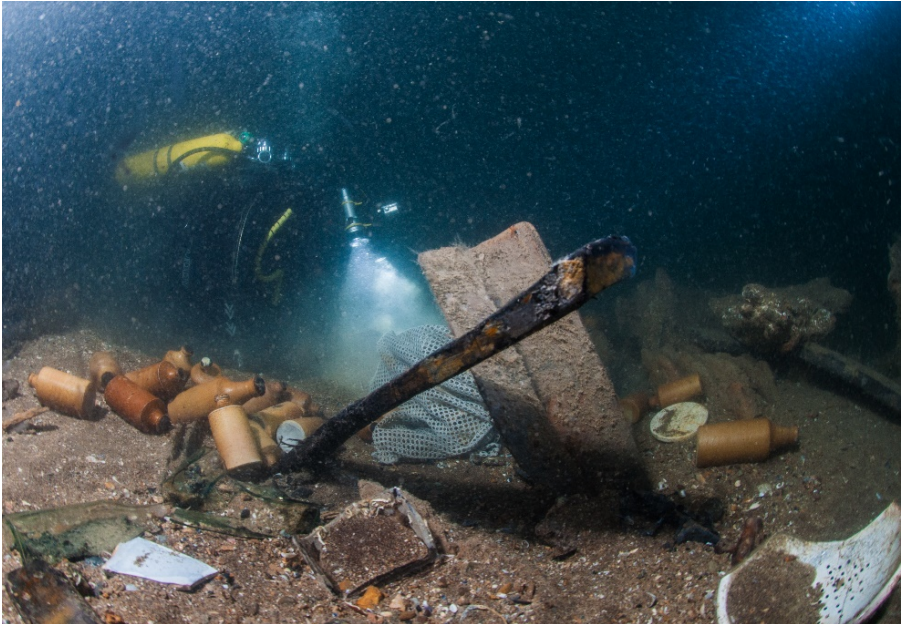
| Description | Image |
|--|---|
| <p>11. Diver excavating inkpots. The ferrous metal plate bar in foreground could be a fragment of one of the ship's iron plate riders. Alternatively, it could be part of a large crate or box or a cargo restraining bar.</p> | |

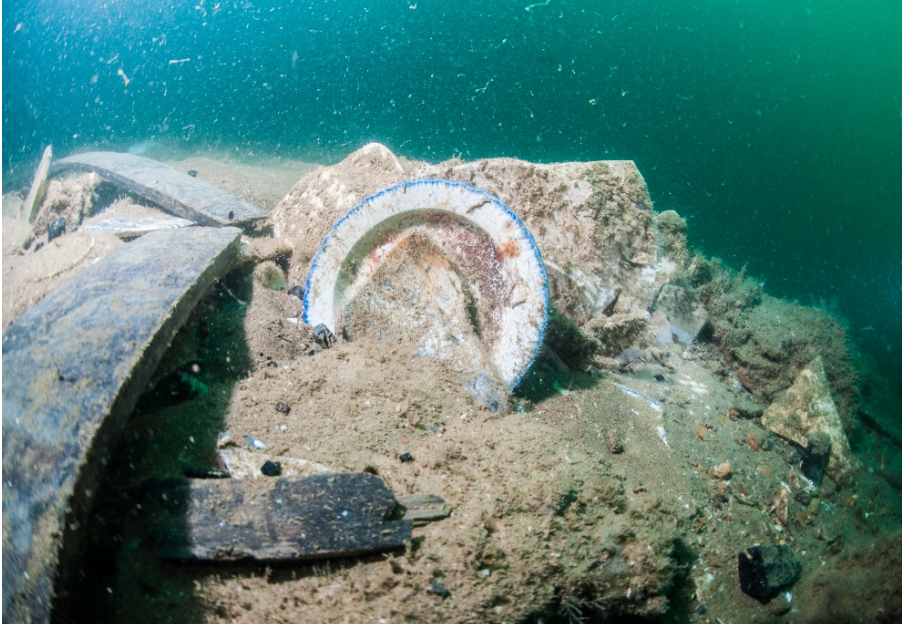
| Description | Image |
|--|---|
| <p>12. Barrel staves on left, with ceramics centre.</p> | |

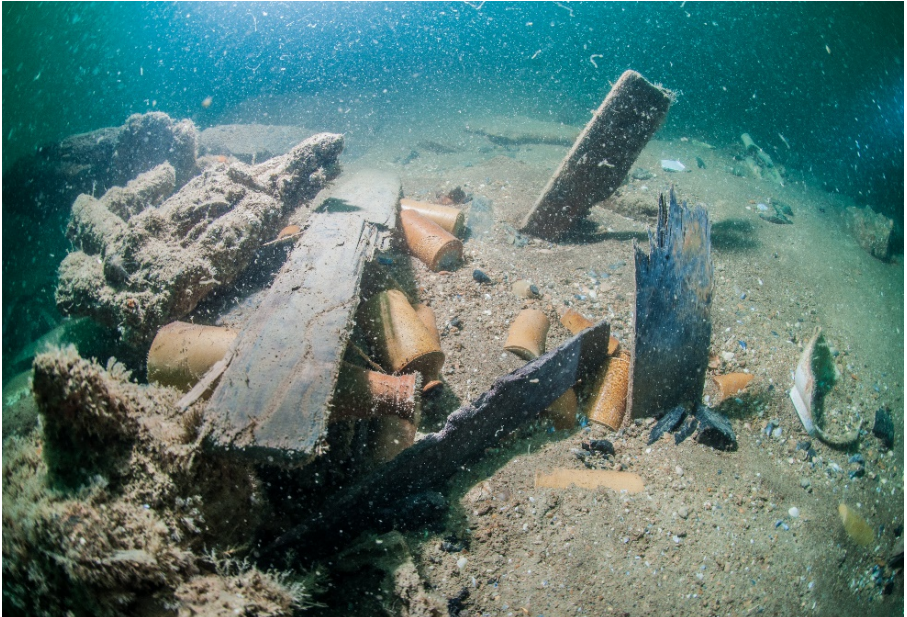
| Description | Image |
|---|---|
| 13. Ink pots and wooden crate fragments. Unidentified concretions left. | |

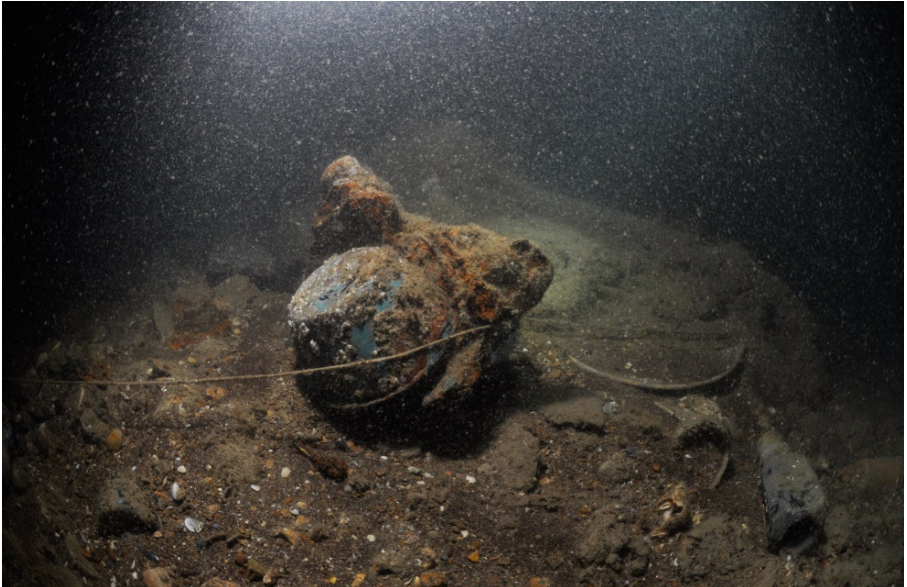
- 4.4.17 Several transfer printed toilet pans have been found on site and one has been recovered. It has a flushing mechanism, although this has not been examined and is separate to the pan. It is marked 'P.B. & Co. Armitage'.

| Description | Image |
|---|---|
| 14. Toilet pan with mechanism, prior to recovery. | |

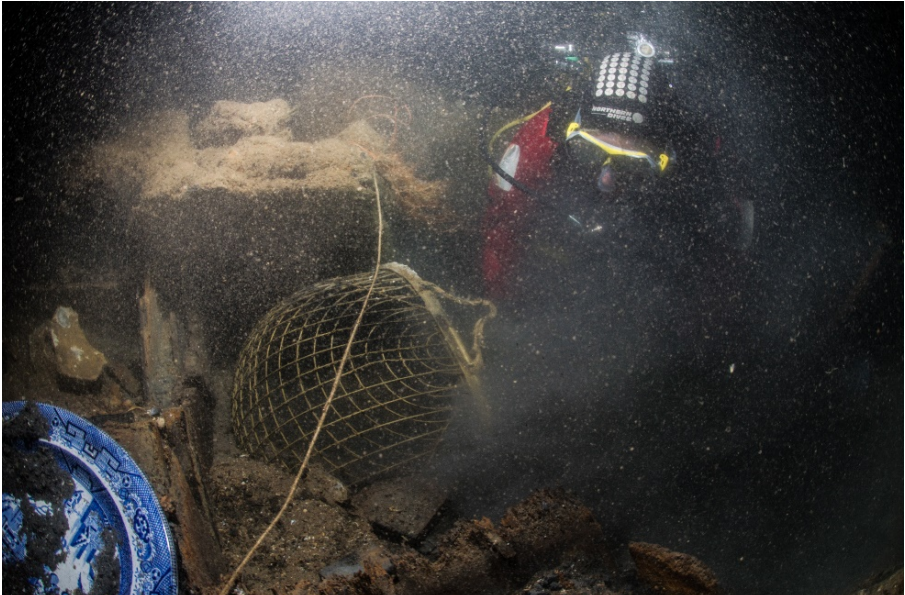
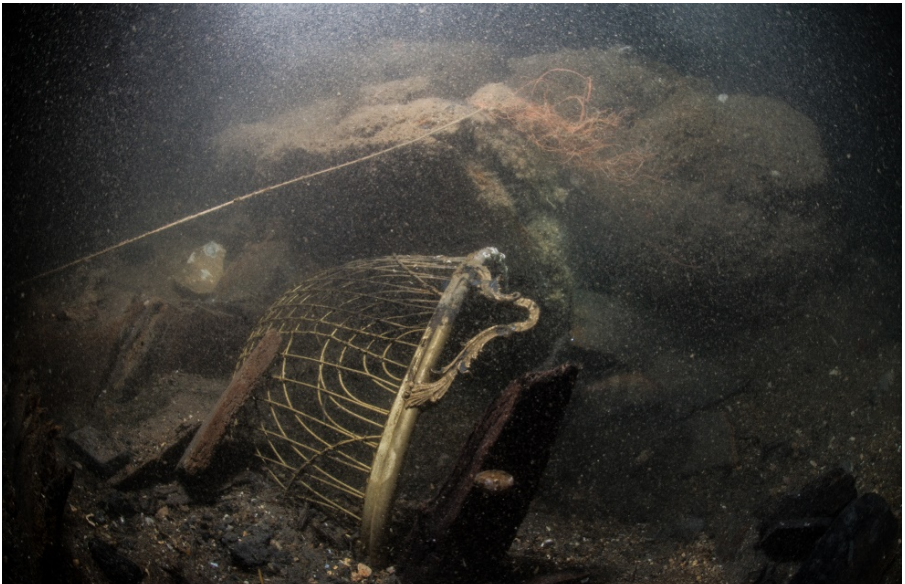
- 4.3.6 Domestic objects such as the swinging crib and the toys were found in the stern, as well as a sink. This was found attached to a lead pipe, which suggests that it was plumbed in and therefore part of the fittings of the ship.

| Description | Image |
|--|---|
| 15. Swinging basket from brass cradle. Diver Eddie Huzzey for scale. | |
| 16. Ditto. | |

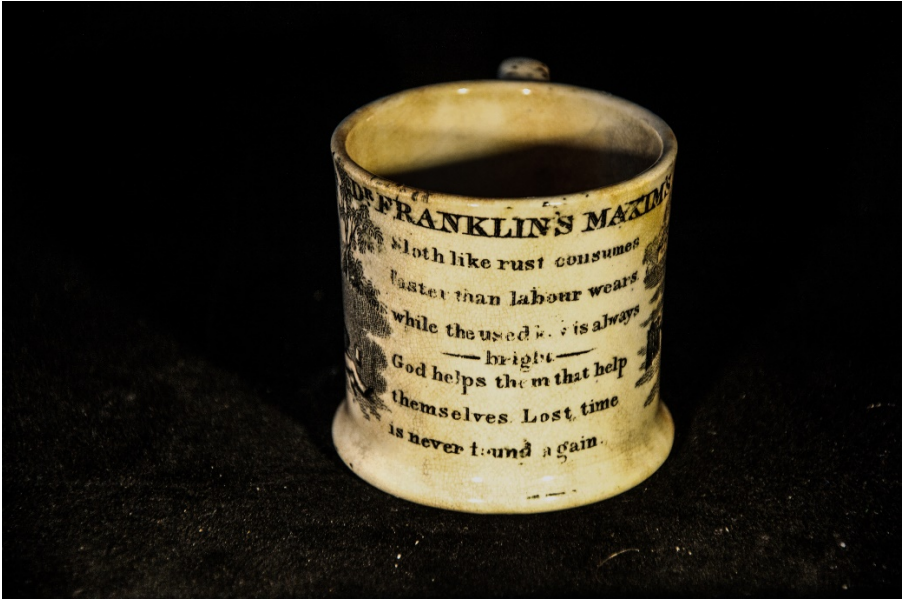
| Description | Image |
|---|---|
| <p>17. Although there is no scale, this appears to be one of at least two Dr Franklin's Maxims Children's Mugs recovered from the site. It is transfer printed with sayings from the work of Benjamin Franklin. These mugs were a 19th century Staffordshire innovation.</p> | |

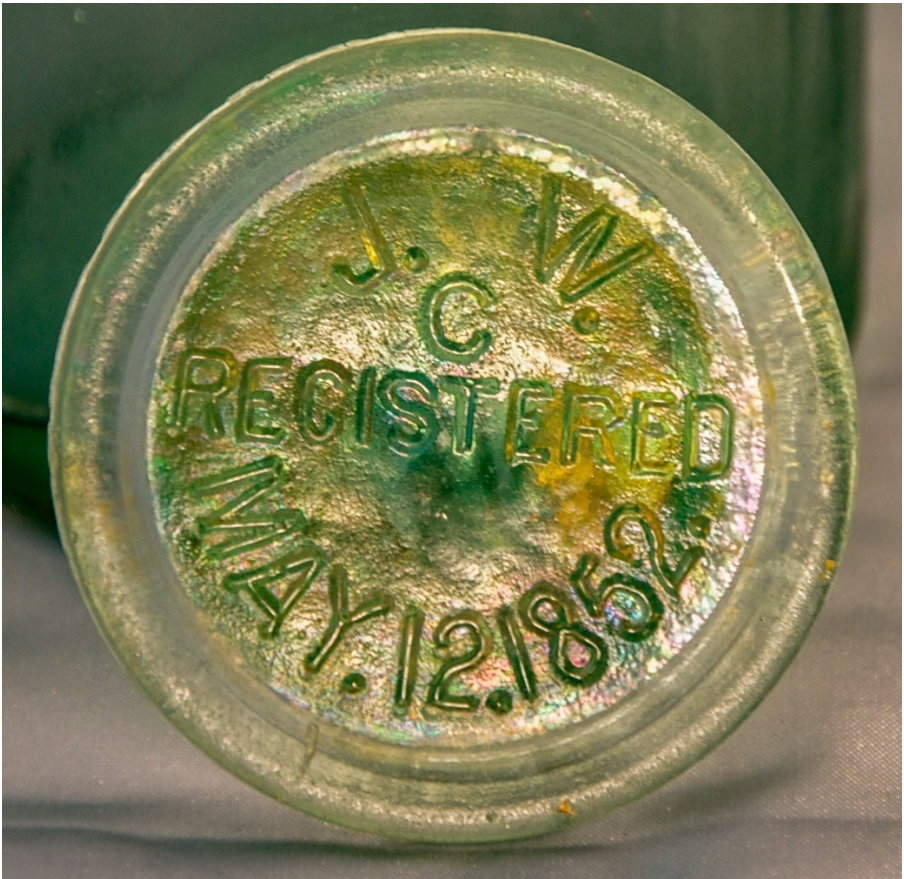
| Description | Image |
|---|---|
| <p>18. Glass jar lid, probably from a preserves or condiment jar. The registration date refers to a design registration for the glass stopper (see 4.5).</p> | |

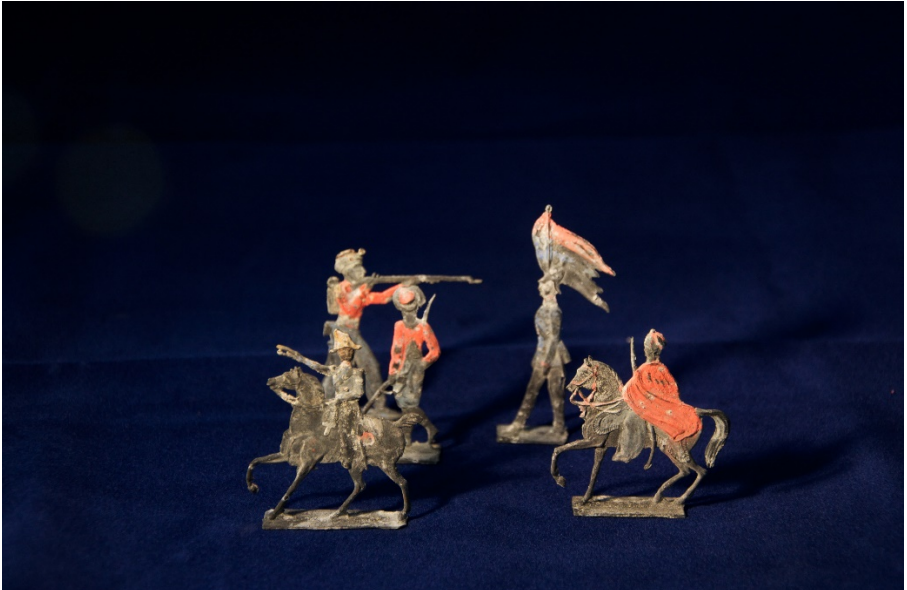
| Description | Image |
|--|--|
| <p>19. Pewter model soldiers. The scarlet paint indicates that they are British or colonial.</p> | |

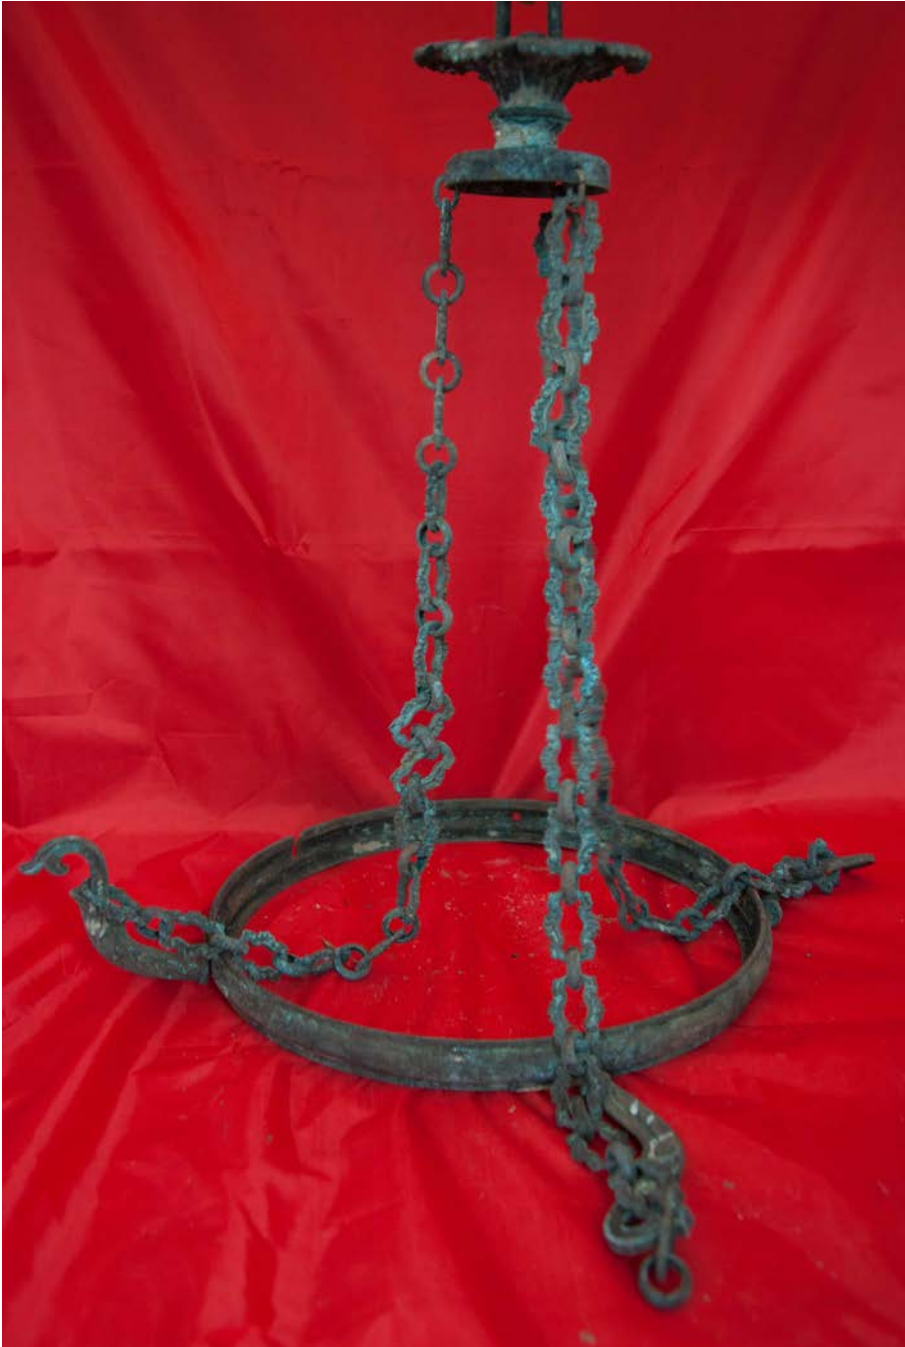
| Description | Image |
|---|---|
| <p>20. Metal hanging light fitting, cuprous. Probably from a hanging oil lamp. The canopy, chains, shade band and arm frames have survived.</p> | |

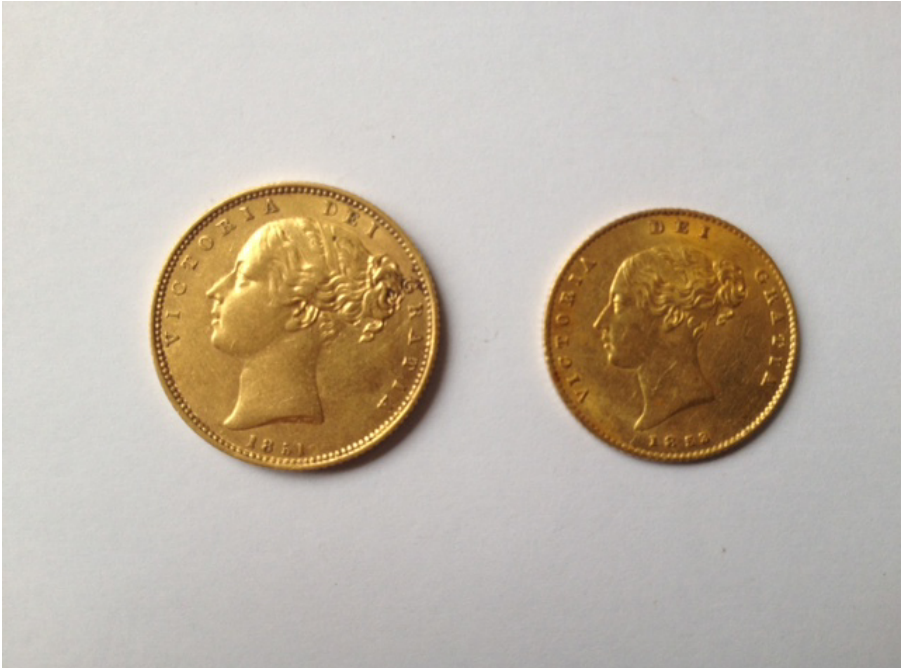
| Description | Image |
|---|---|
| <p>21. 1851 gold Sovereign, young head, (left); 1852 gold Half-Sovereign, young head (right).</p> | |

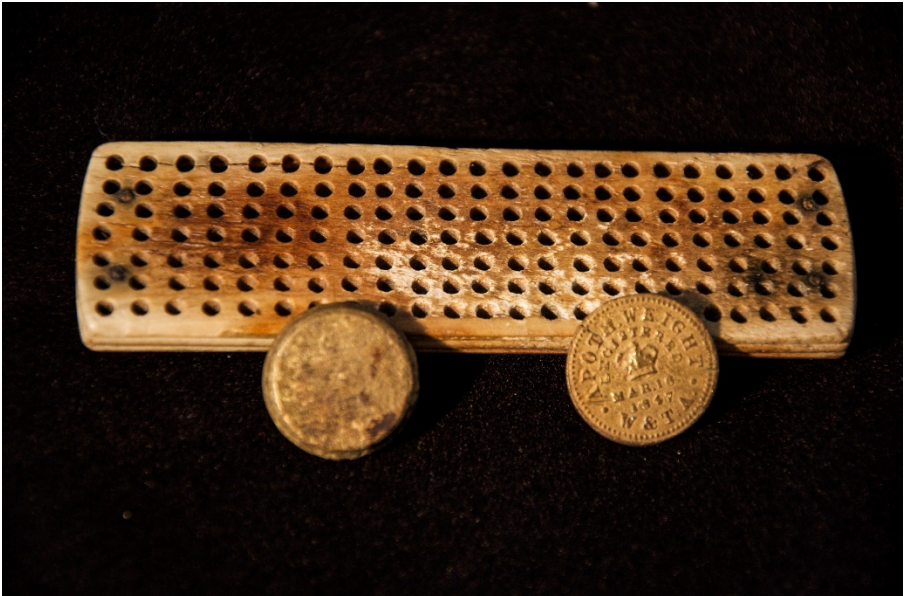
| Description | Image |
|---|---|
| <p>22. Probable scrubbing brush with missing bristles rear. Forward are two apothecary weights, the right of which is dated 16th March 1847 and marked 'W&T.A.' for W & T Avery Ltd, a manufacturer of weighing machines based in the West Midlands.</p> | |

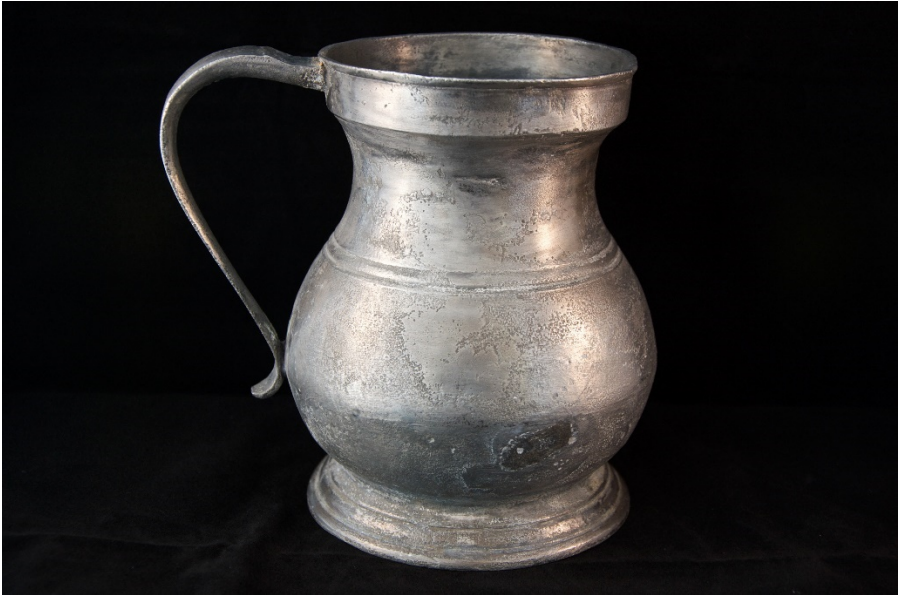
| Description | Image |
|---|---|
| <p>23. Pewter jug, round bellied with a collared rim. The jug apparently has a maker's mark, but this has not been seen.</p> | |

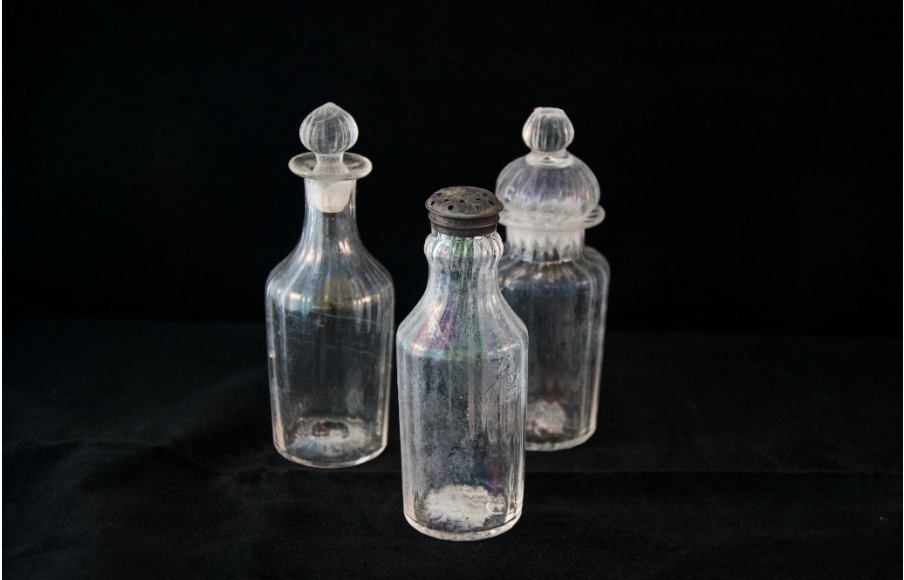
| Description | Image |
|---|---|
| <p>24. Three glass bottles with vertical ribbing. Two have glass stoppers (also with vertical ribbing) and the third a perforated 'shaker' top. Probably for pharmaceutical (health /beauty) products</p> | |

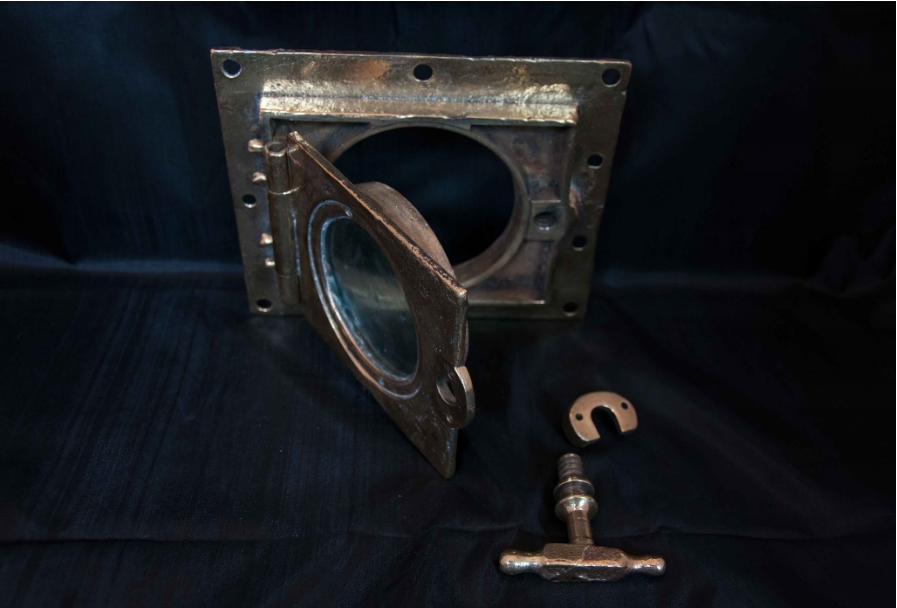
- 5.2.10 Several square and rectangular portholes/lights have been recovered from the wreck, as described in section 4.5 and **Appendix 3: Image 25**. They are described as having been found in the stern area, lying on the seabed rather than attached to ship structure.³⁹ Paul Wilkin describes the recovered portholes as follows:⁴⁰

- “the port holes came in various sizes, the smallest 6 inches by 4 inches up to 12 inches by 14 inches, around 10 have been recovered in good to bad condition, they were fixed to the ship by large slotted screws.”

| Description | Image |
|---|--|
| <p>25. Brass square porthole. The backing plate nine fastening holes and coaming for the square swing plate, which has an opposed hinge and single dog. This may be the square porthole observed of Facebook, after cleaning.</p> | |

- 5.2.11 Ports are not shown on the Lower Decks of the comparator ships discussed above, but they are shown in the sides of the vessel in the Poop Deck accommodation. It is therefore likely that the ports found on site are from Poop Deck cabins. The dimensions suggest that they are 12-14” (305mm-356mm) wide, which approximates that of the recovered portholes. The plan of the full poop frigate-built ship John MacVicar shows these ports as being rectangular. It is therefore likely that the portholes recovered from the wreck are from Poop Deck cabins.

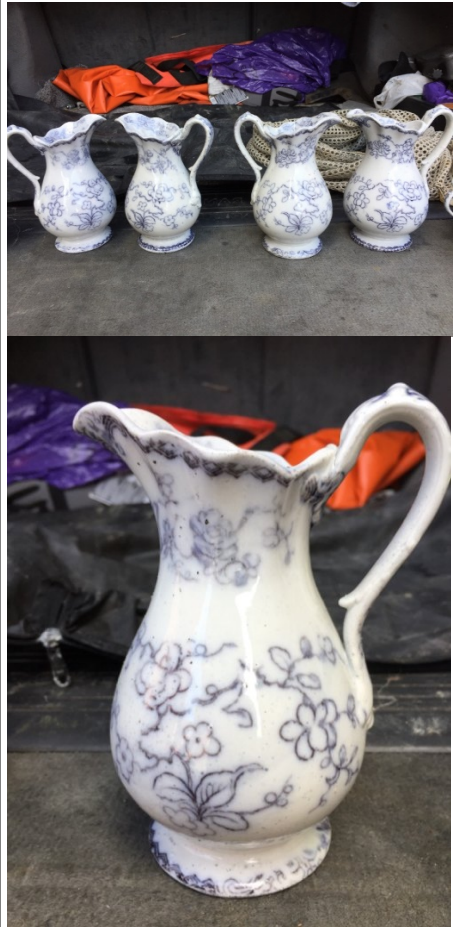
| MAS UID | Description | Droit No. | Image |
|---|--|---|---|
| MAS-D100054 | Four milk jugs with a Chinese style design and a light grey coloured pattern and appear to be made of porcelain (although this has not been confirmed). Similar in decorative style to the bowls recorded as MAS-D100047, it is assumed that the these milk jugs were made by either Charles Meigh of Hanley, Staffordshire (1835-49), the preceding company, J. Meigh and Son (c.1805-34), or the succeeding company, Charles Meigh and Son (1851-61) (Godden 1964, 428-429). Found with MAS-D100048. | 121/17 | |

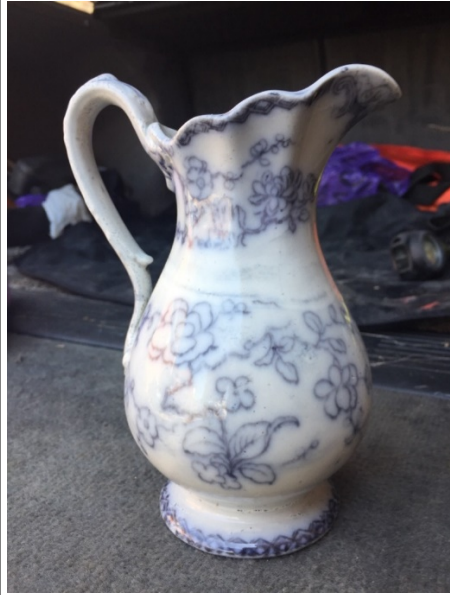
| MAS UID | Description | Droit No. | Image |
|---|---|---|--|
| MAS-D100058 | One milk jug with a Chinese style design and a light grey coloured pattern and appear to be made of porcelain (although this has not been confirmed). Similar in decorative style to the bowls recorded as MAS-D100047 , it is assumed that the these milk jugs were made by either Charles Meigh of Hanley, Staffordshire (1835-49), the preceding company, J. Meigh and Son (c.1805-34), or the succeeding company, Charles Meigh and Son (1851-61) (Godden 1964, 428-429). | 145/17 | |

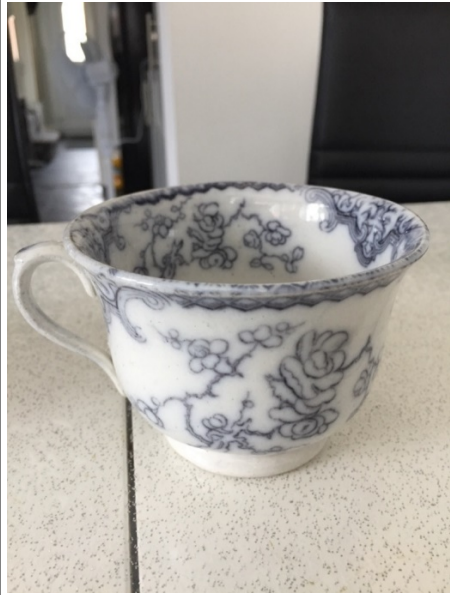
| MAS UID | Description | Droit No. | Image |
|---|---|---|--|
| MAS-D100059 | Four cups with a Chinese style design and a light grey coloured pattern and appear to be made of porcelain (although this has not been confirmed). Similar in decorative style to the bowls recorded as MAS-D100047, it is assumed that the these milk jugs were made by either Charles Meigh of Hanley, Staffordshire (1835-49), the preceding company, J. Meigh and Son (c.1805-34), or the succeeding company, Charles Meigh and Son (1851-61) (Godden 1964, 428-429). Found with MAS-D100058, MAS-D10060 and MAS-D100061. | 145/17 | |

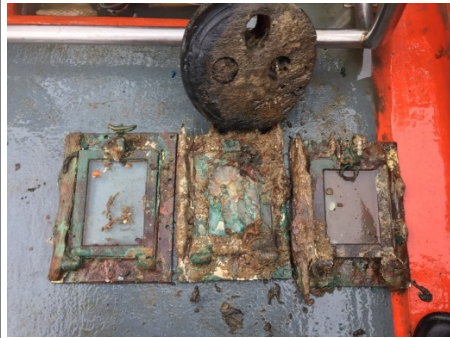
| MAS UID | Description | Droit No. | Image |
|---|---|---|--|
| MAS-D100060 | Three hinged rectangular portholes/lights. Dimensions unknown. Clear glass lights with brass frames. Single dog closure with single dogs that have a mechanism at one end to close them. Opens inwards. No evidence of a deadlight. Four fastener holes on each side. Fastener type unknown. Traces of wooden planking on each. Found with MAS-D100058, MAS-D100059 and MAS-D100061. | 145/17 | |

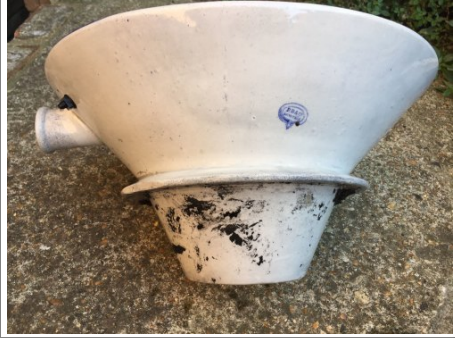
| MAS UID | Description | Droit No. | Image |
|---|---|---|---|
| MAS-D100208 | Ceramic glazed toilet bowl 15x17x10 inches with flushing mechanism. Stamped 'P.B.&Co. Armitage'. Believed to have been donated to the Gladstone Pottery Museum. | | |

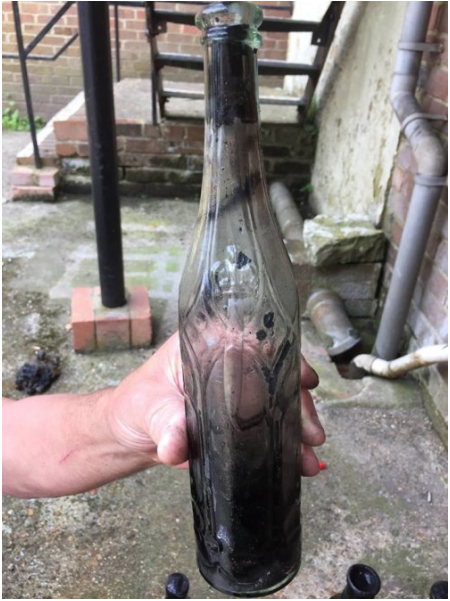
| MAS UID | Description | Droit No. | Image |
|---|---|---|--|
| MAS-O100185 | Nine cathedral bottles in the shape of cathedral pattern with an English crown on bottle and adate mark on bottom. The bottle exhibits very gentle and smooth sloping on shoulders, with a thin straight body and neck slowly tapering to a straight shape, before a wine finish. There is no evidence of stoppering or corking remaining. Found with MAS-O100186, MAS-D100187 and MAS-D100188. | | |

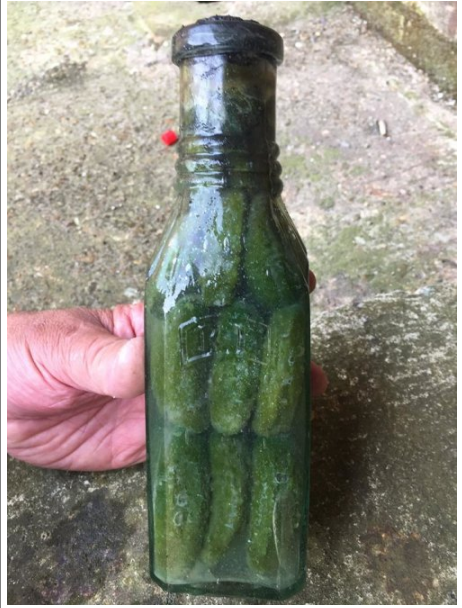
| MAS UID | Description | Droit No. | Image |
|---|---|---|--|
| MAS-O100188 | <p>One square section green glass jar of gherkins. There is embossing on jar of RF (perhaps RT), likely an 18/19th century condiment manufacturer's mark. The bottle has straight sides and neck, with a gradual sloping on the shoulders before a tooled finish. There are three rings on the neck. Found with MAS-O100185, MAS-O100186 and MAS-O100187.</p> | | |

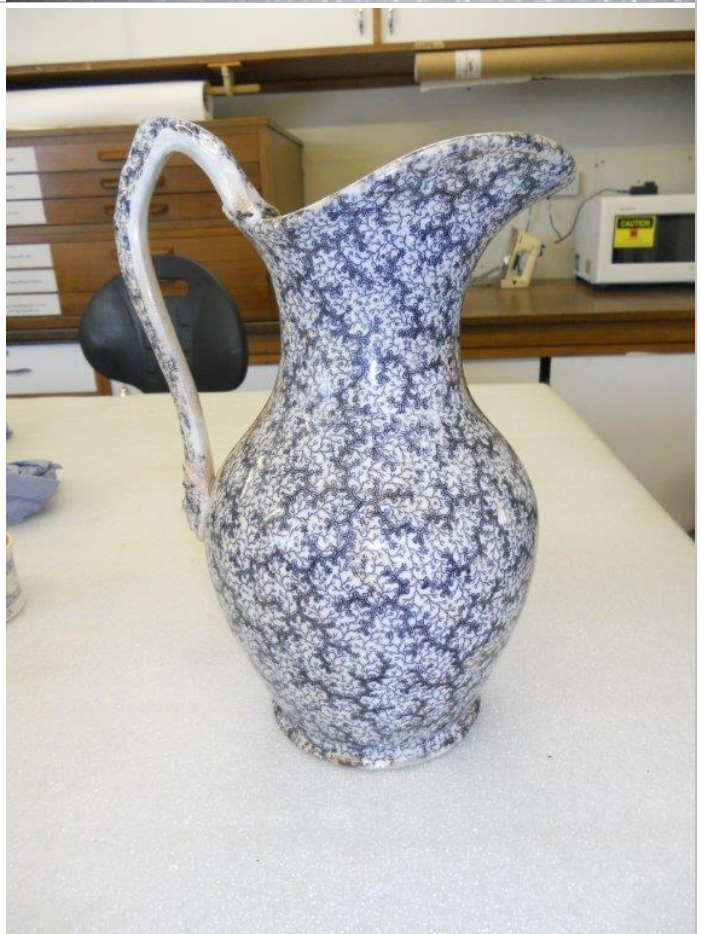
DONMG :
2018.6.23

Large jug from toilet set.
Black and white funicular pattern

- 4.4.10 A slightly iron stained earthenware pitcher that is printed with a black sheet pattern had a 'FUNICULAR' pattern mark. The maker's mark is 'J. REED'.

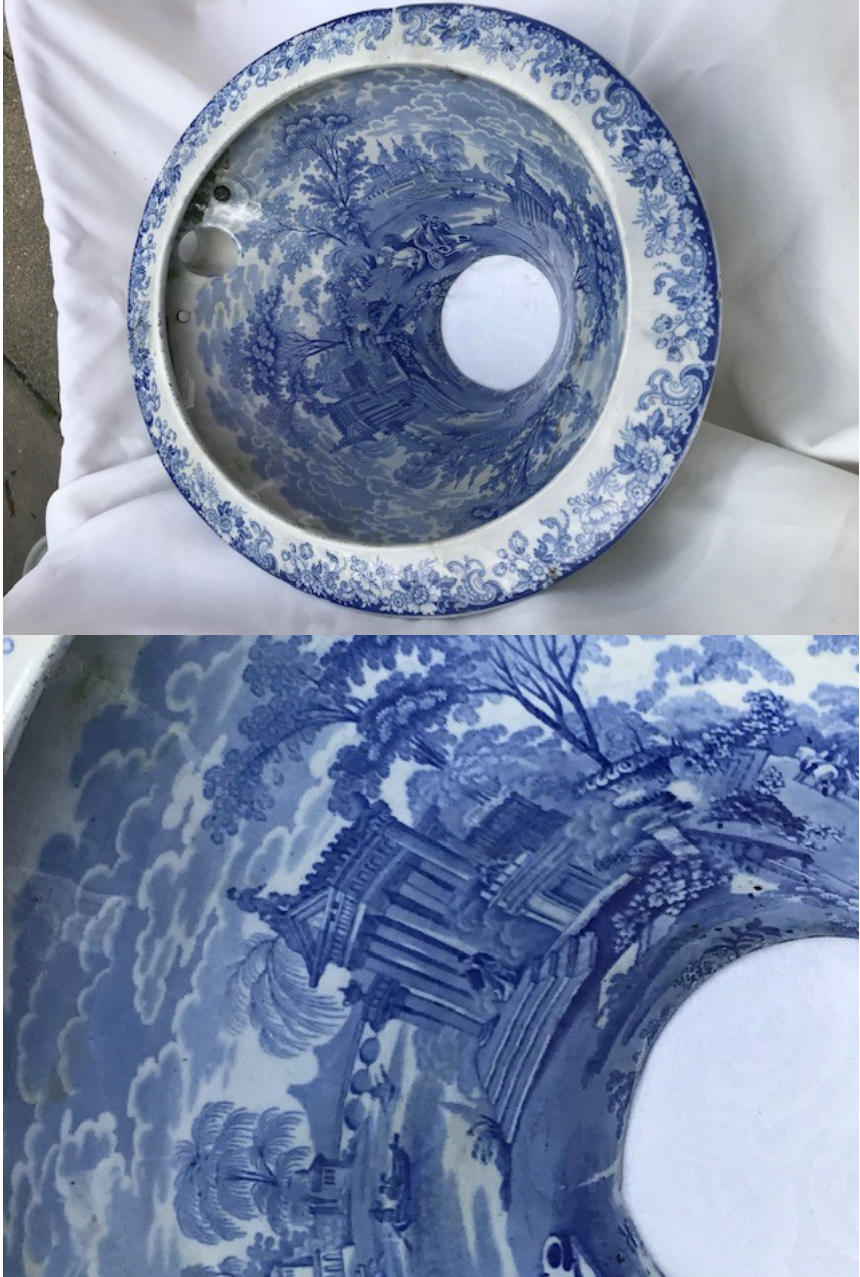
| Object | Images |
|--|---|
| <p>Underglaze blue and white transfer-printed toilet pan made by Armitage (Gladstone Pottery Museum)</p> | |

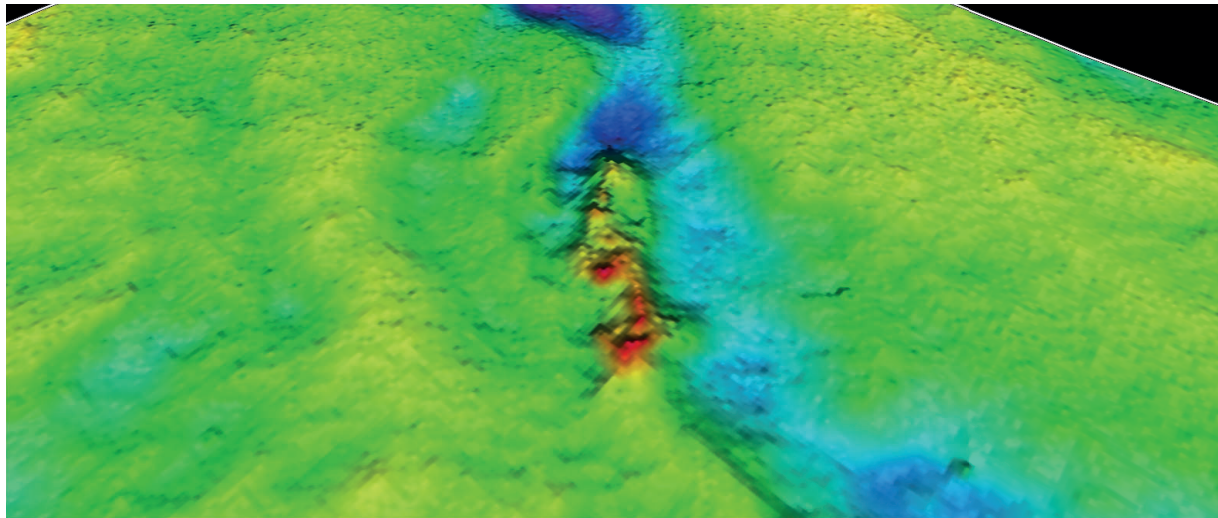
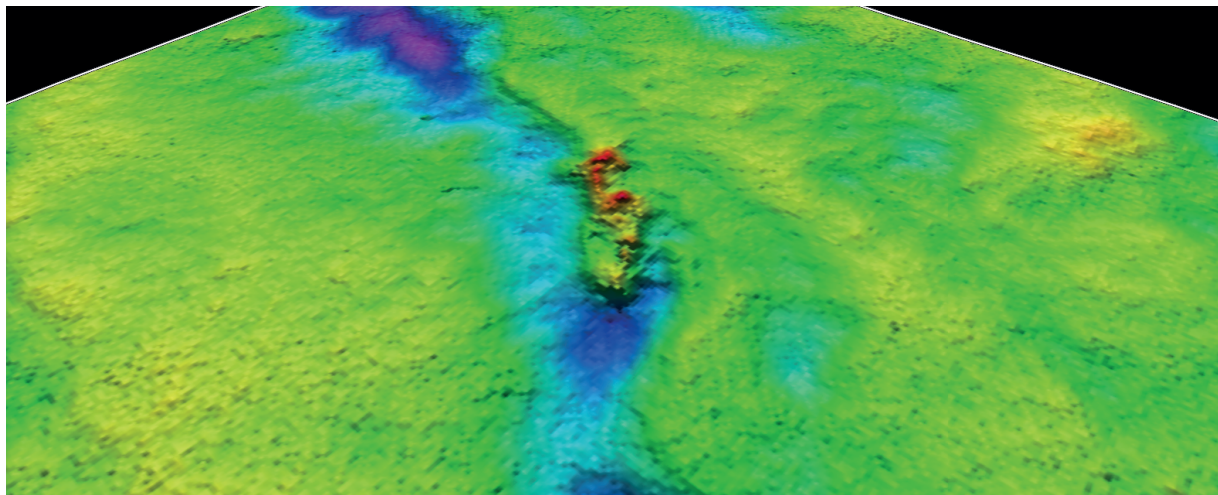
Figure 2

- 4.3.9 The mound is aligned NNW to SSE and appears settled at an angle on a slope. It is possibly partially buried along the north and east edge within the slope and within the general seabed. The slope is caused by a north-west to south-east trending linear seabed scour or depression, which measures approximately 550m in length. At the location of the mound, the slope varies in depth from -23.3m CD (measured at the SSE end of the mound) to -22.3m CD (as measured at the NNW end). This feature appears natural in origin and is unlikely to be scour resulting directly from the wreck.

MBES data, plan view with simplified inset

A: MBES oblique view, looking SE

B: MBES oblique view, looking NW

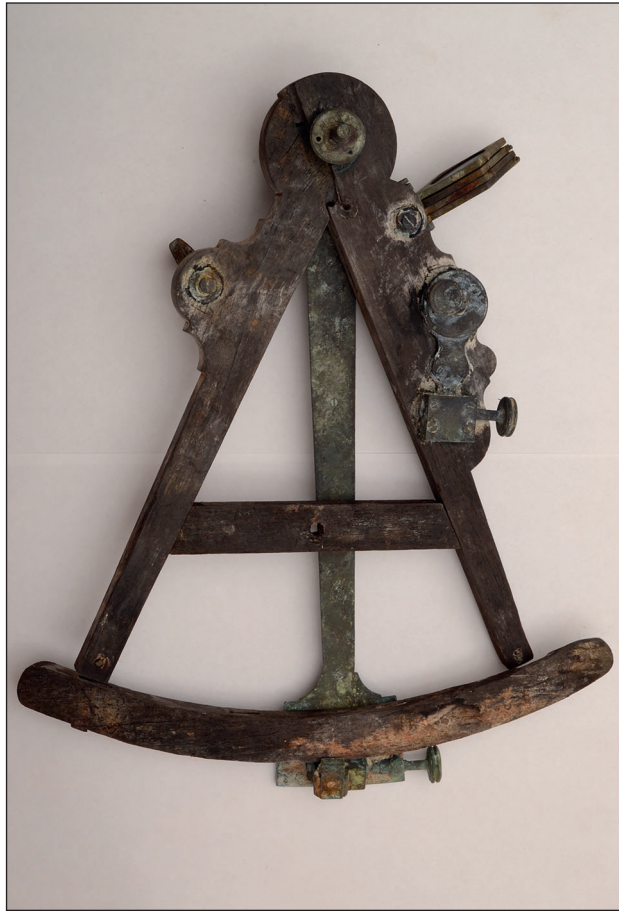
Plate 1: Octant, other side

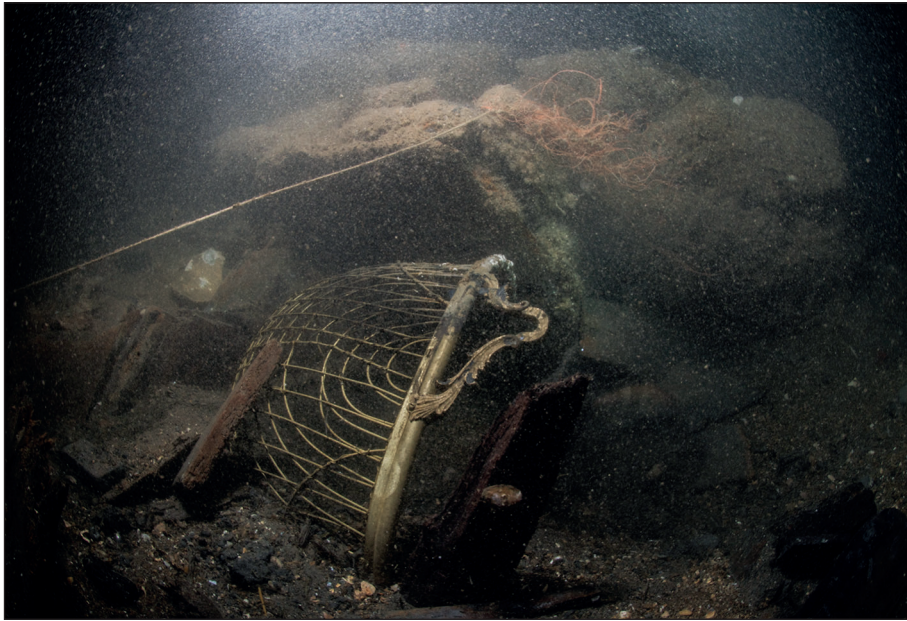
Plate 2: Crib in-situ

Suddenly Eddie signalled to me. He had found a brass crib for a baby – a unique discovery. We took some photographs and then, even more amazingly, Eddie discovered inside the crib pewter toy soldiers and cannon.
