Archaeological Services in Relation to Marine Protection

Josephine Willis off Folkestone, Kent

Undesignated Site Assessment

Ref: 214390.12
June 2020

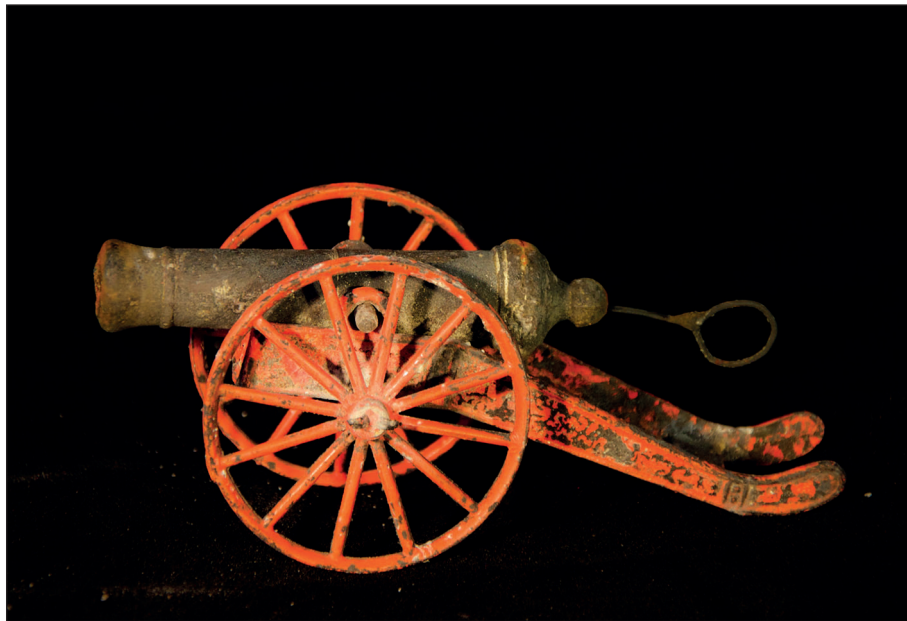
Plate 3: Toy cannon

- “Block of harmonicas, 13cm cube”;
- Grinding or sharpening stones;
- Clock parts;
- Wooden seat and lid;
- Brush;
- Chart weight;
- Seven pewter toy soldiers and two cannons (**Plate 3, Appendix 3: Image 19 and Appendix 6**);
