# Denge Quarry Shipwreck Timbers: Recording and Assessment Stage

Ref: 264781.02  
July 2025

Document subtitle Timber interpretation

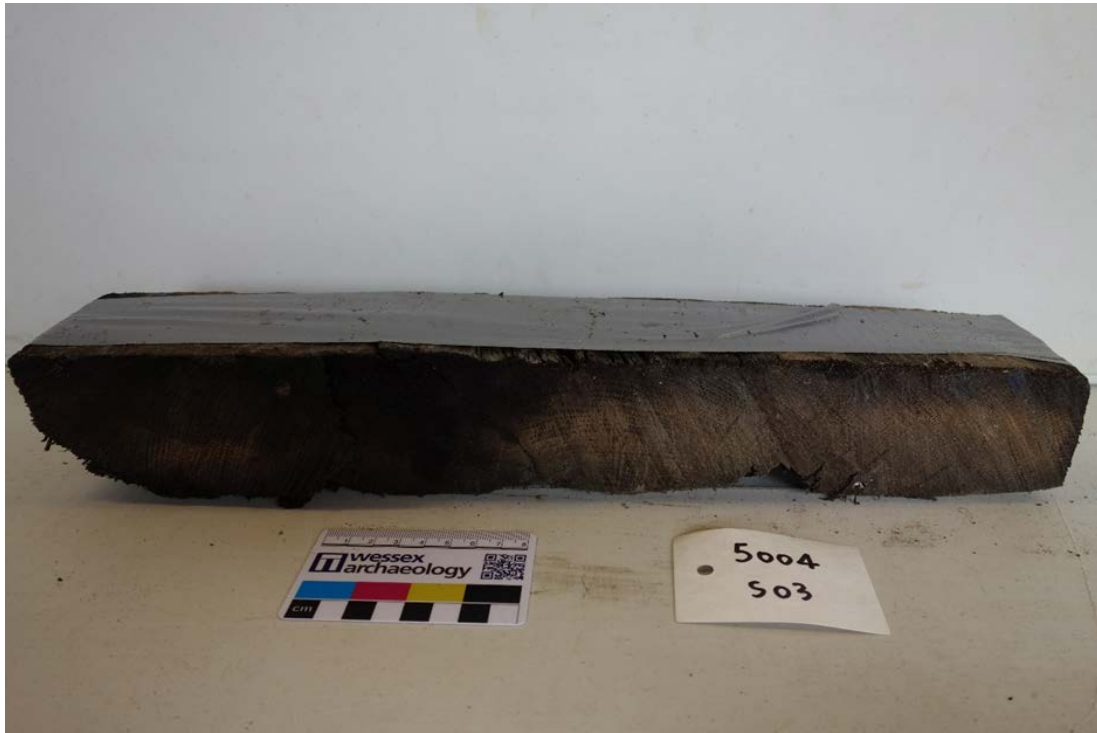
Figure 4a: Oak outer plank sample 079 (vessel section 5004, sample 3) as supplied to the Nottingham Tree-Ring Dating Laboratory. [photograph Wessex Archaeology]

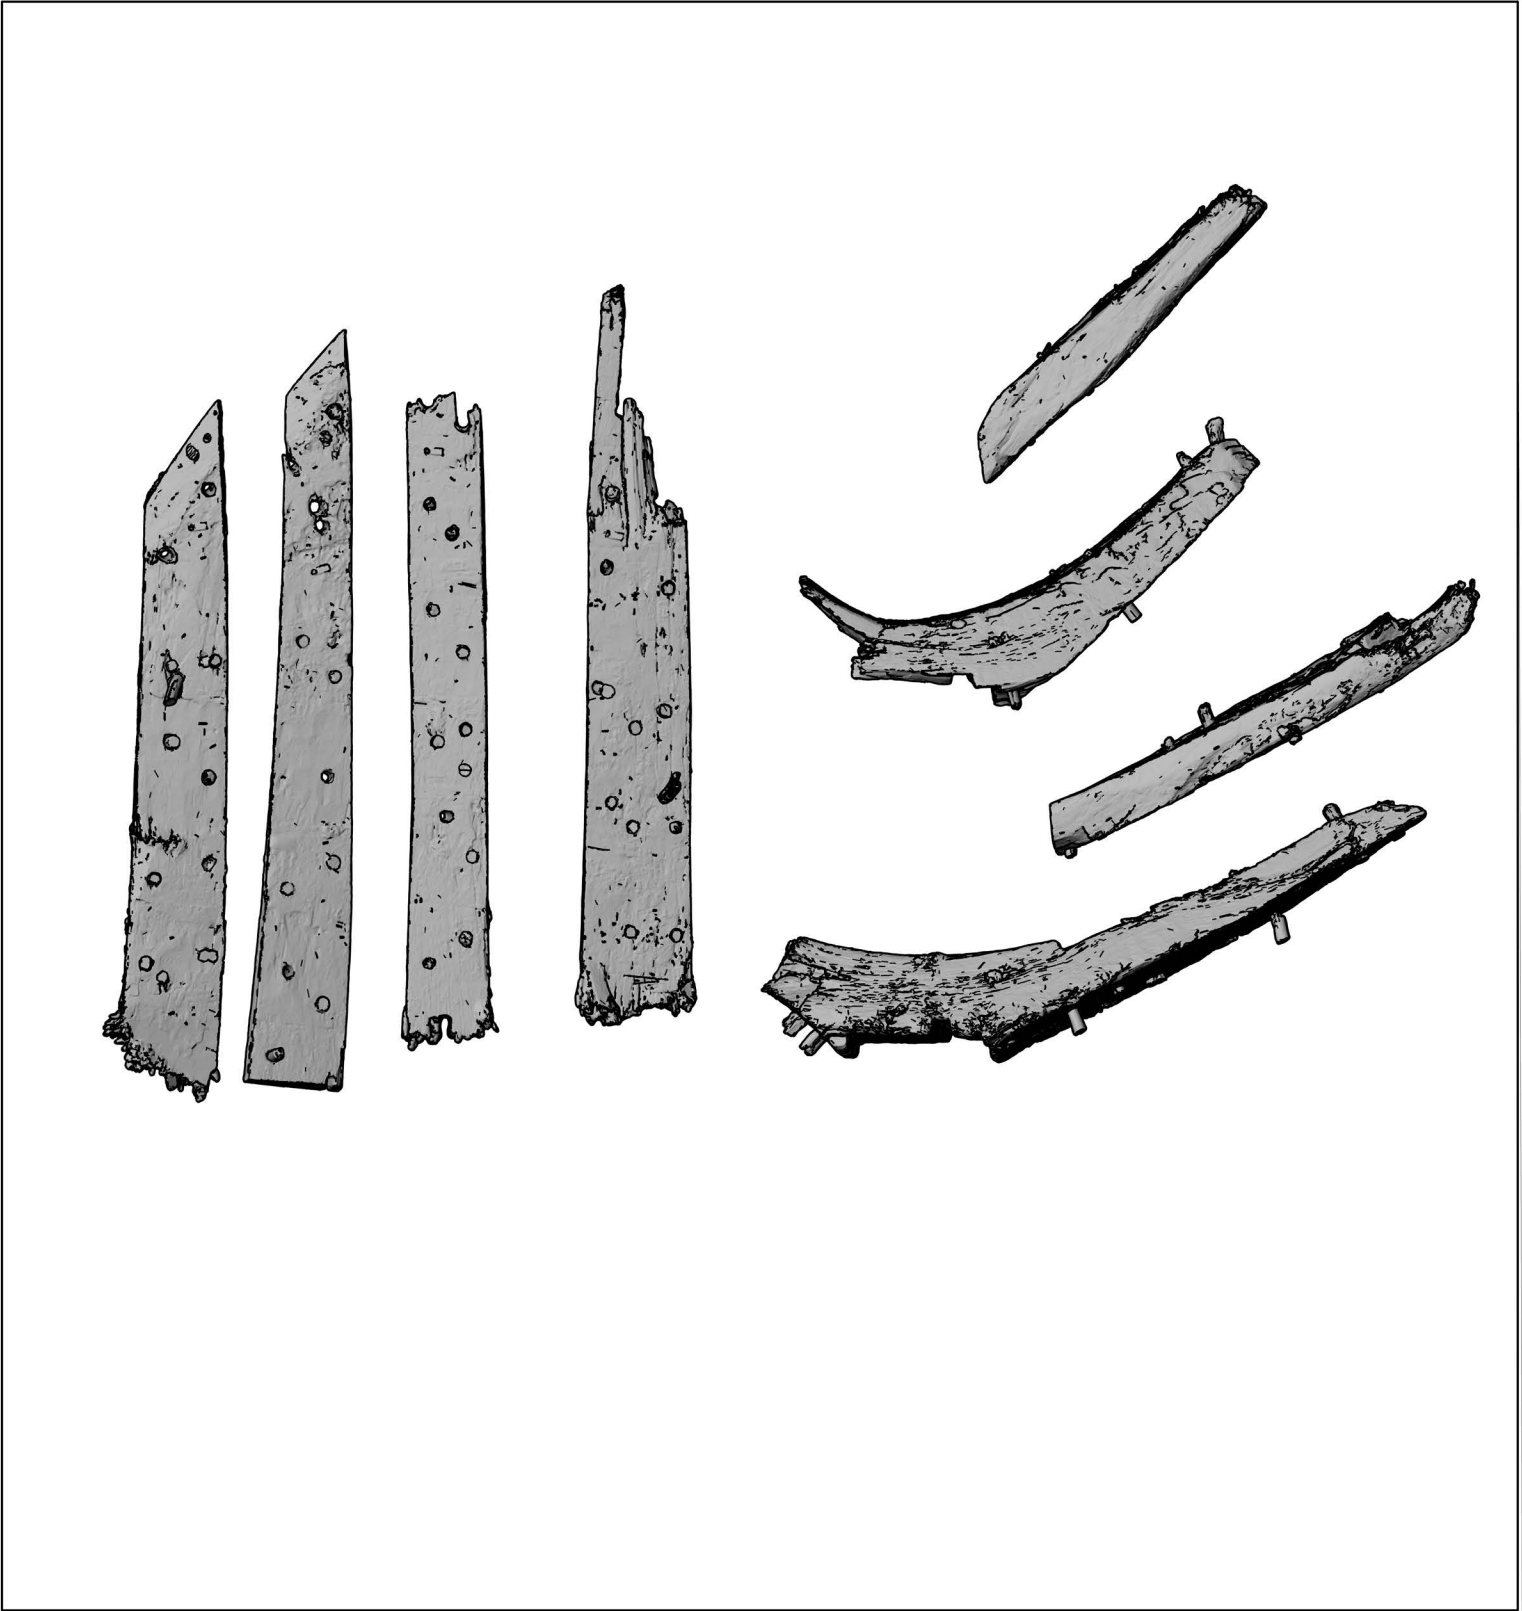
Plan view and section view of 5005

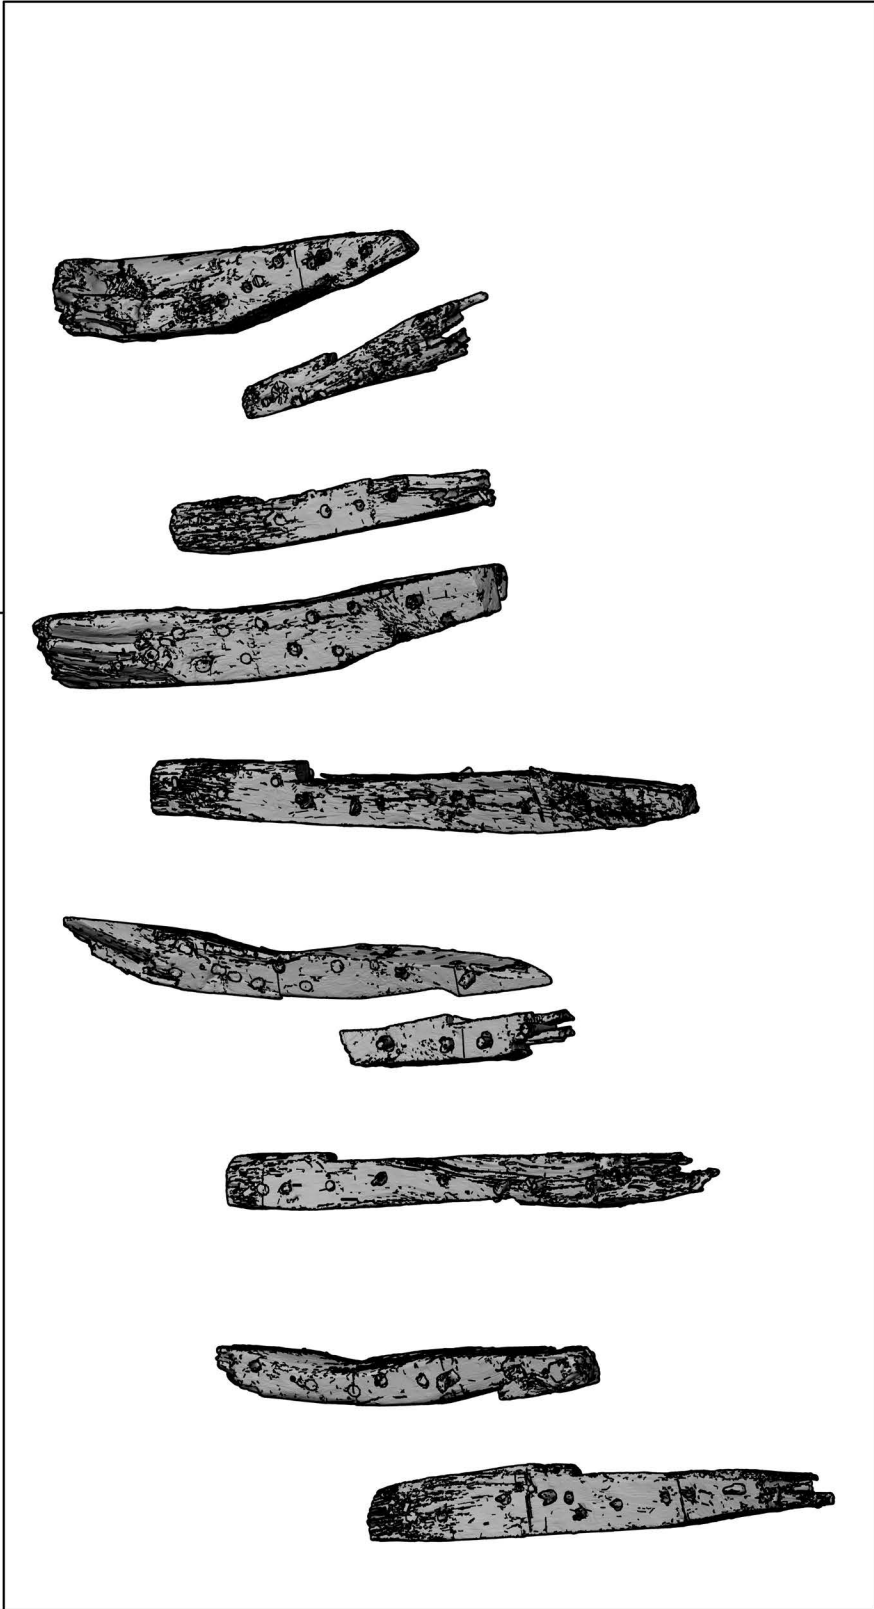
View of outer planking strakes from inboard and outboard

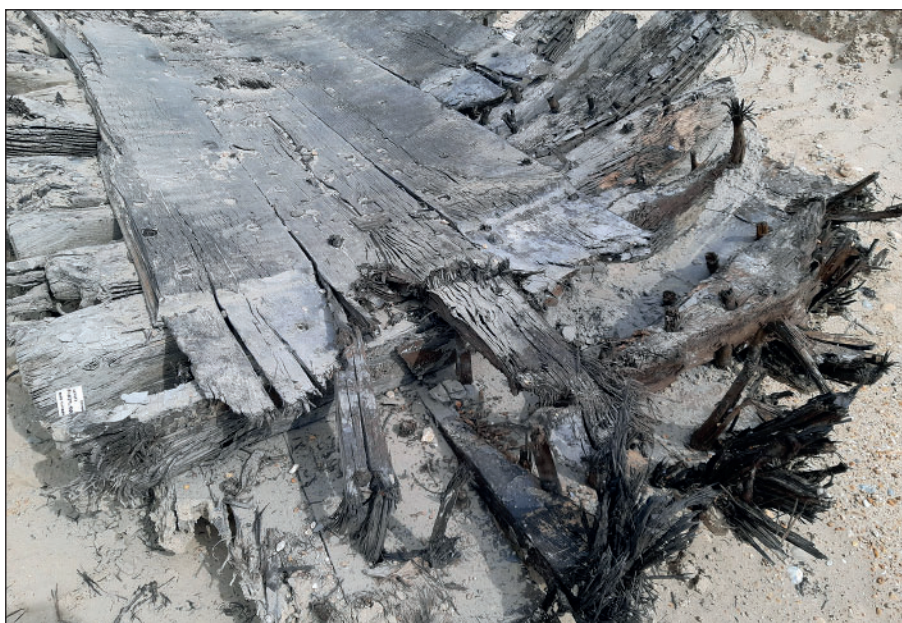
Figure 5: The timbers were damaged during the recovery from the quarry

- 4.2.7 Obviously, in the larger sections 'fresh' damage consistent with the way that the timbers were recovered was observed. Timbers were visibly disarticulated, bent out of their original position. For example, the top ends of the frames and those of the planking had been forcefully pulled upward (Figure 5). Several of the timbers were frayed and ceiling planks on the main section (5004) were clearly scored by the teeth of the bucket.

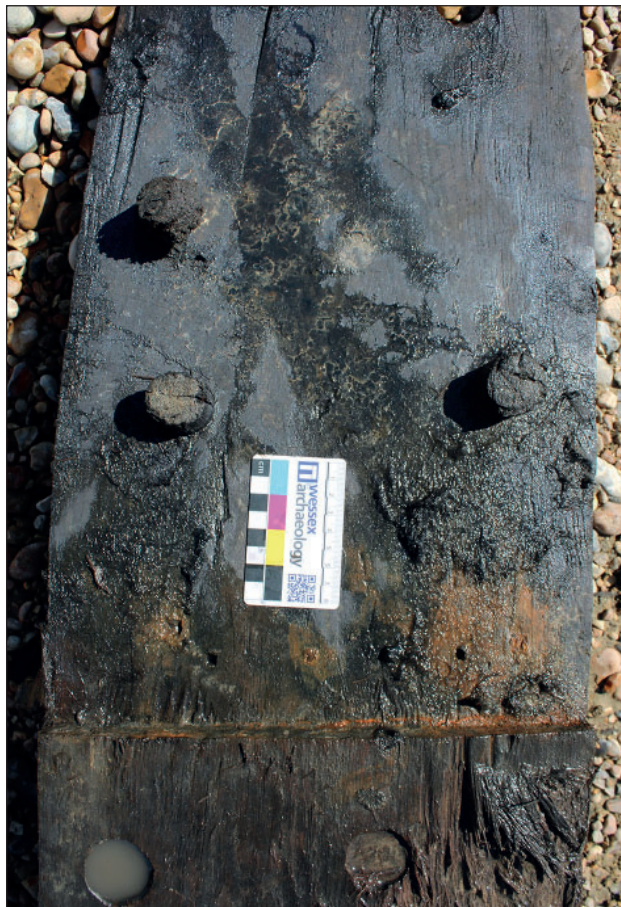
Figure 23: Line of nails at lip of scarf in the outer planking

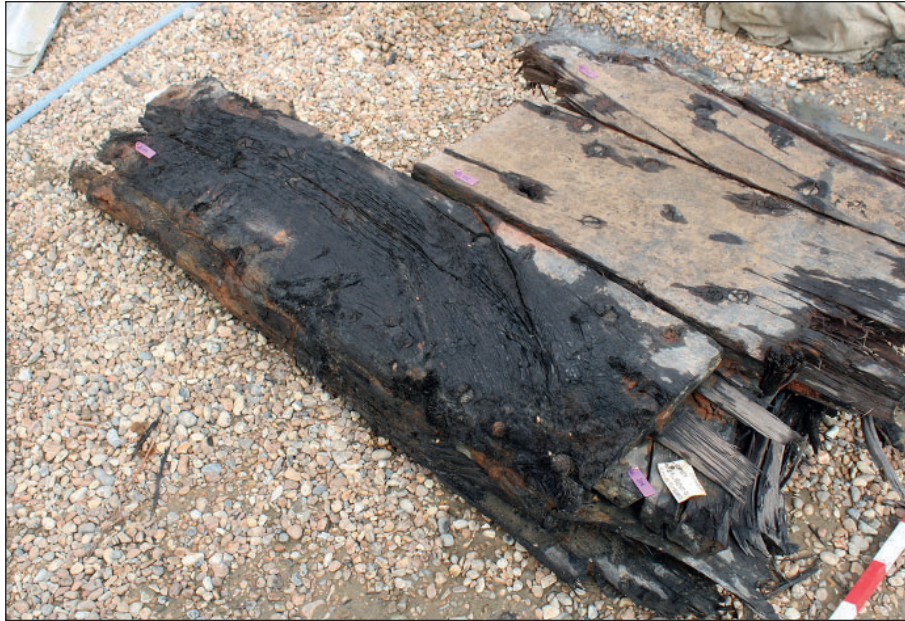
Figure 45: Large broads planks lined the lower stern. The garboard is in the foreground

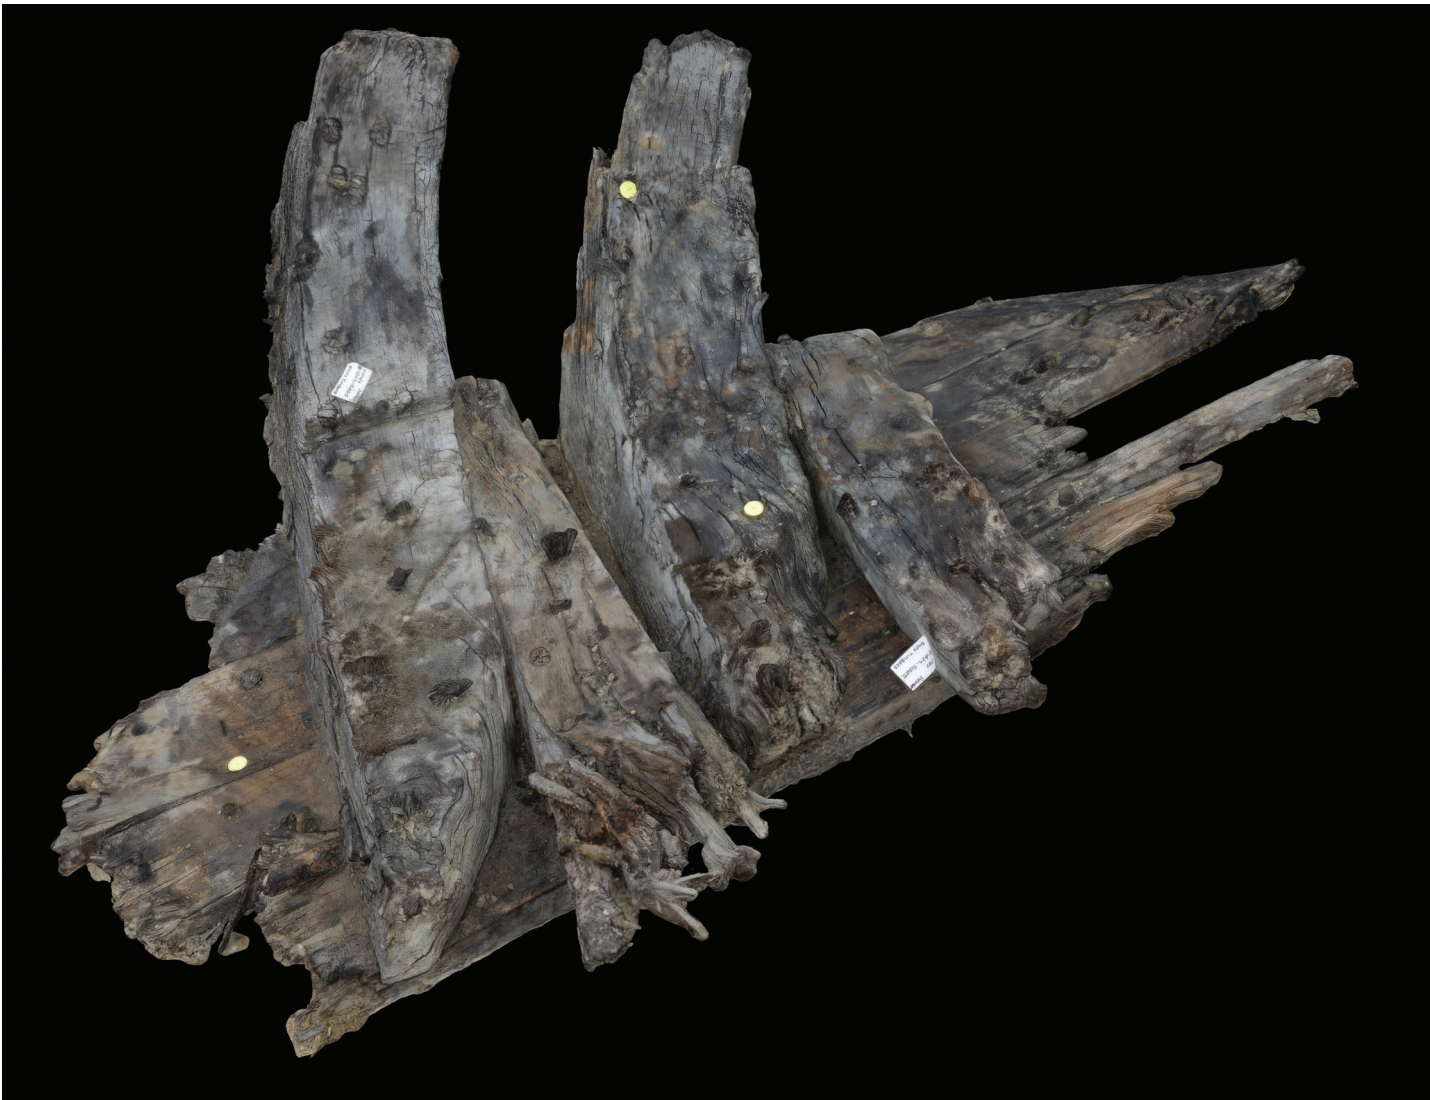
Plate 1: Section 5005, top view, bow on the right, from photogrammetry model

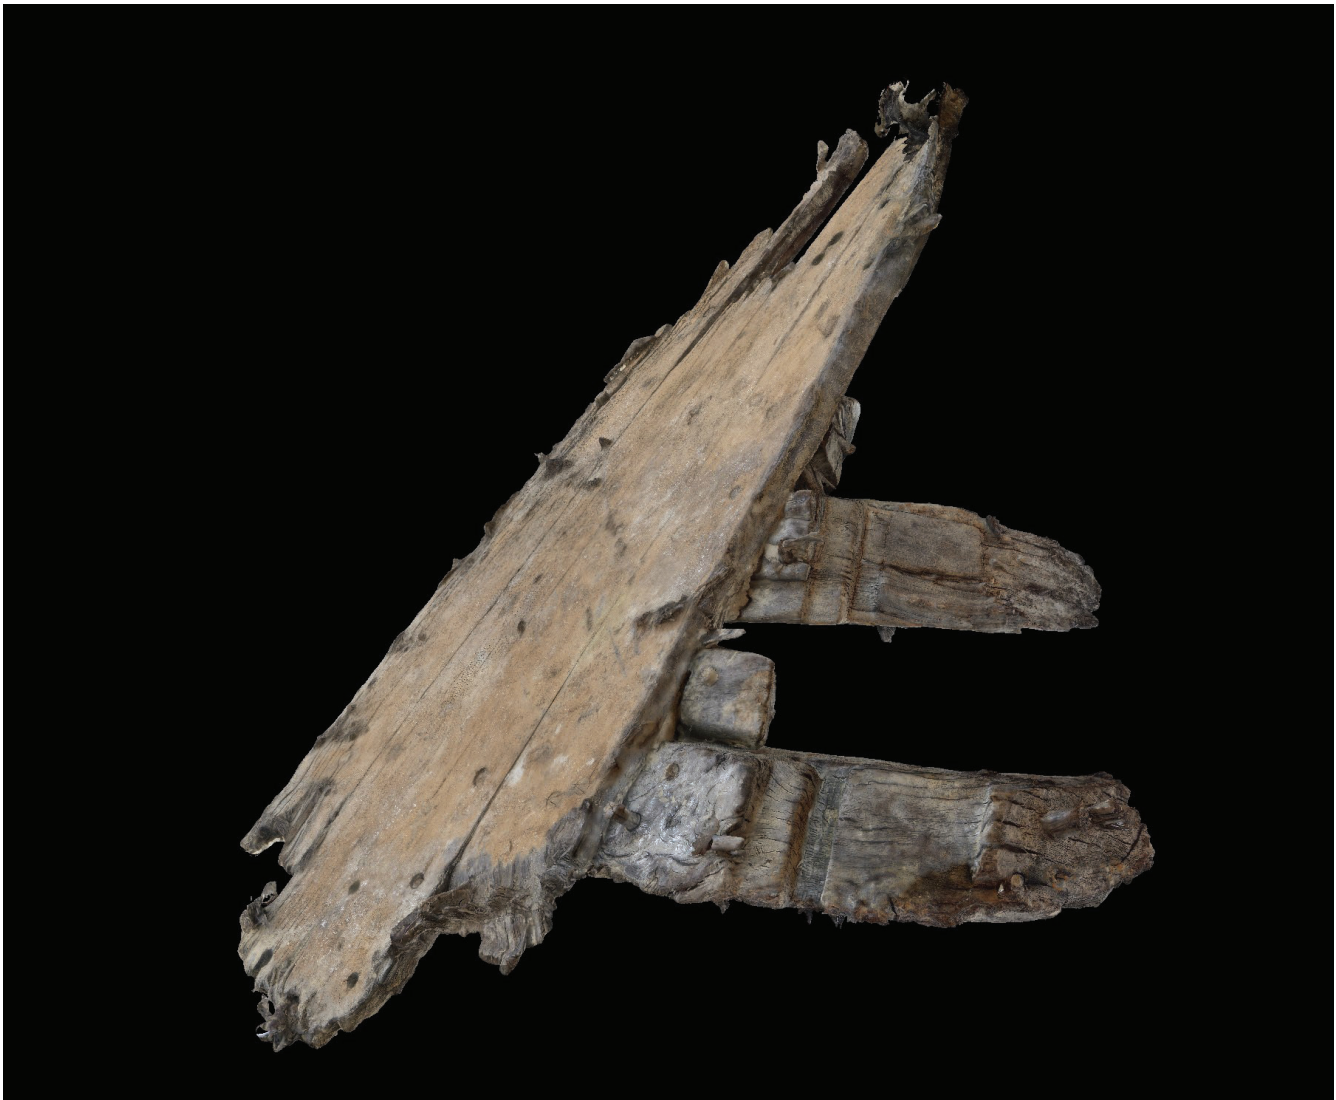
Plate 2: Section 5005, bottom view, bow on top, from photogrammetry model

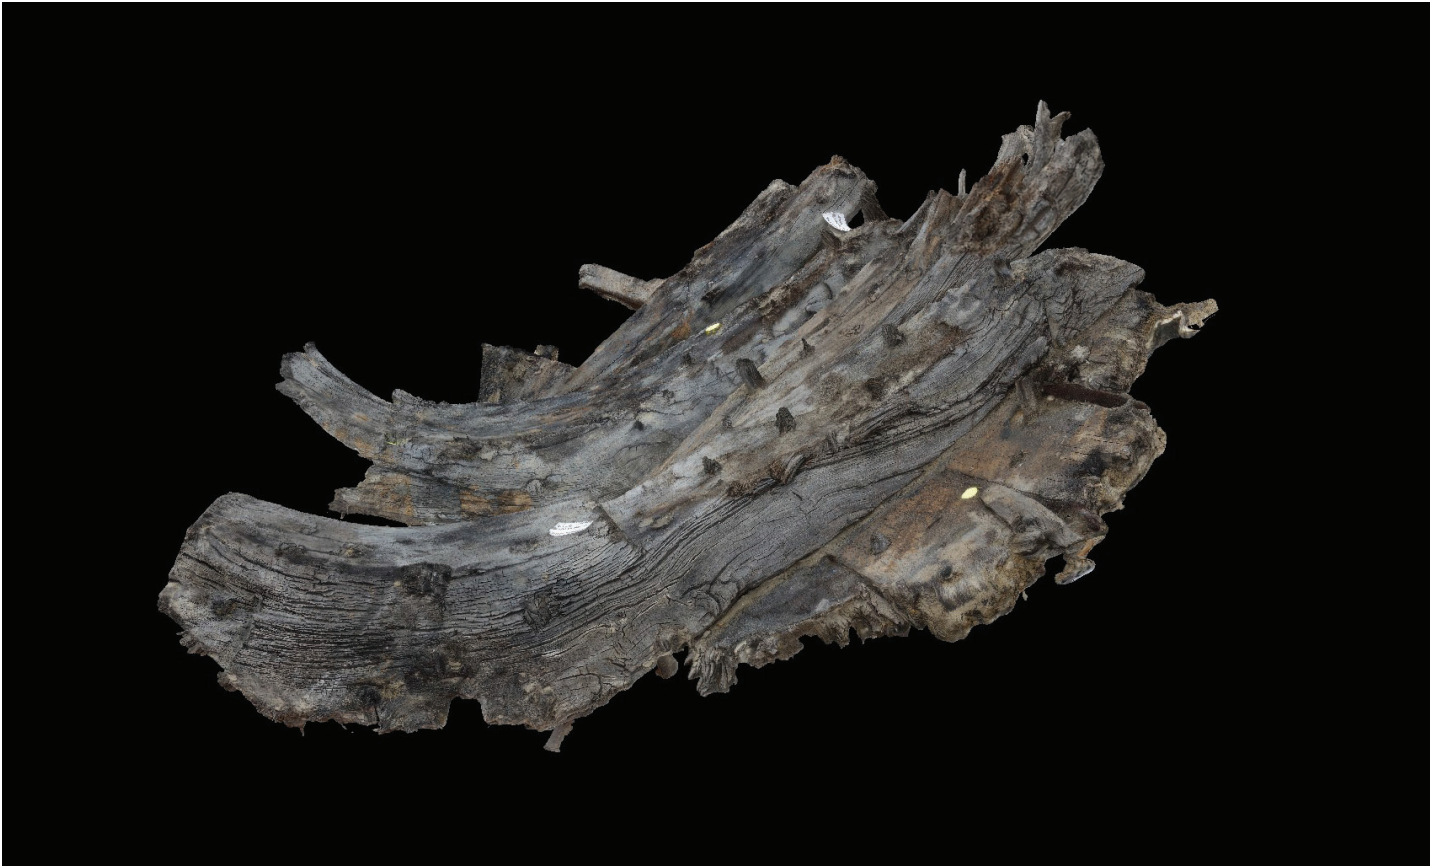
Plate 3: Section 5005, view from aft, from photogrammetry model

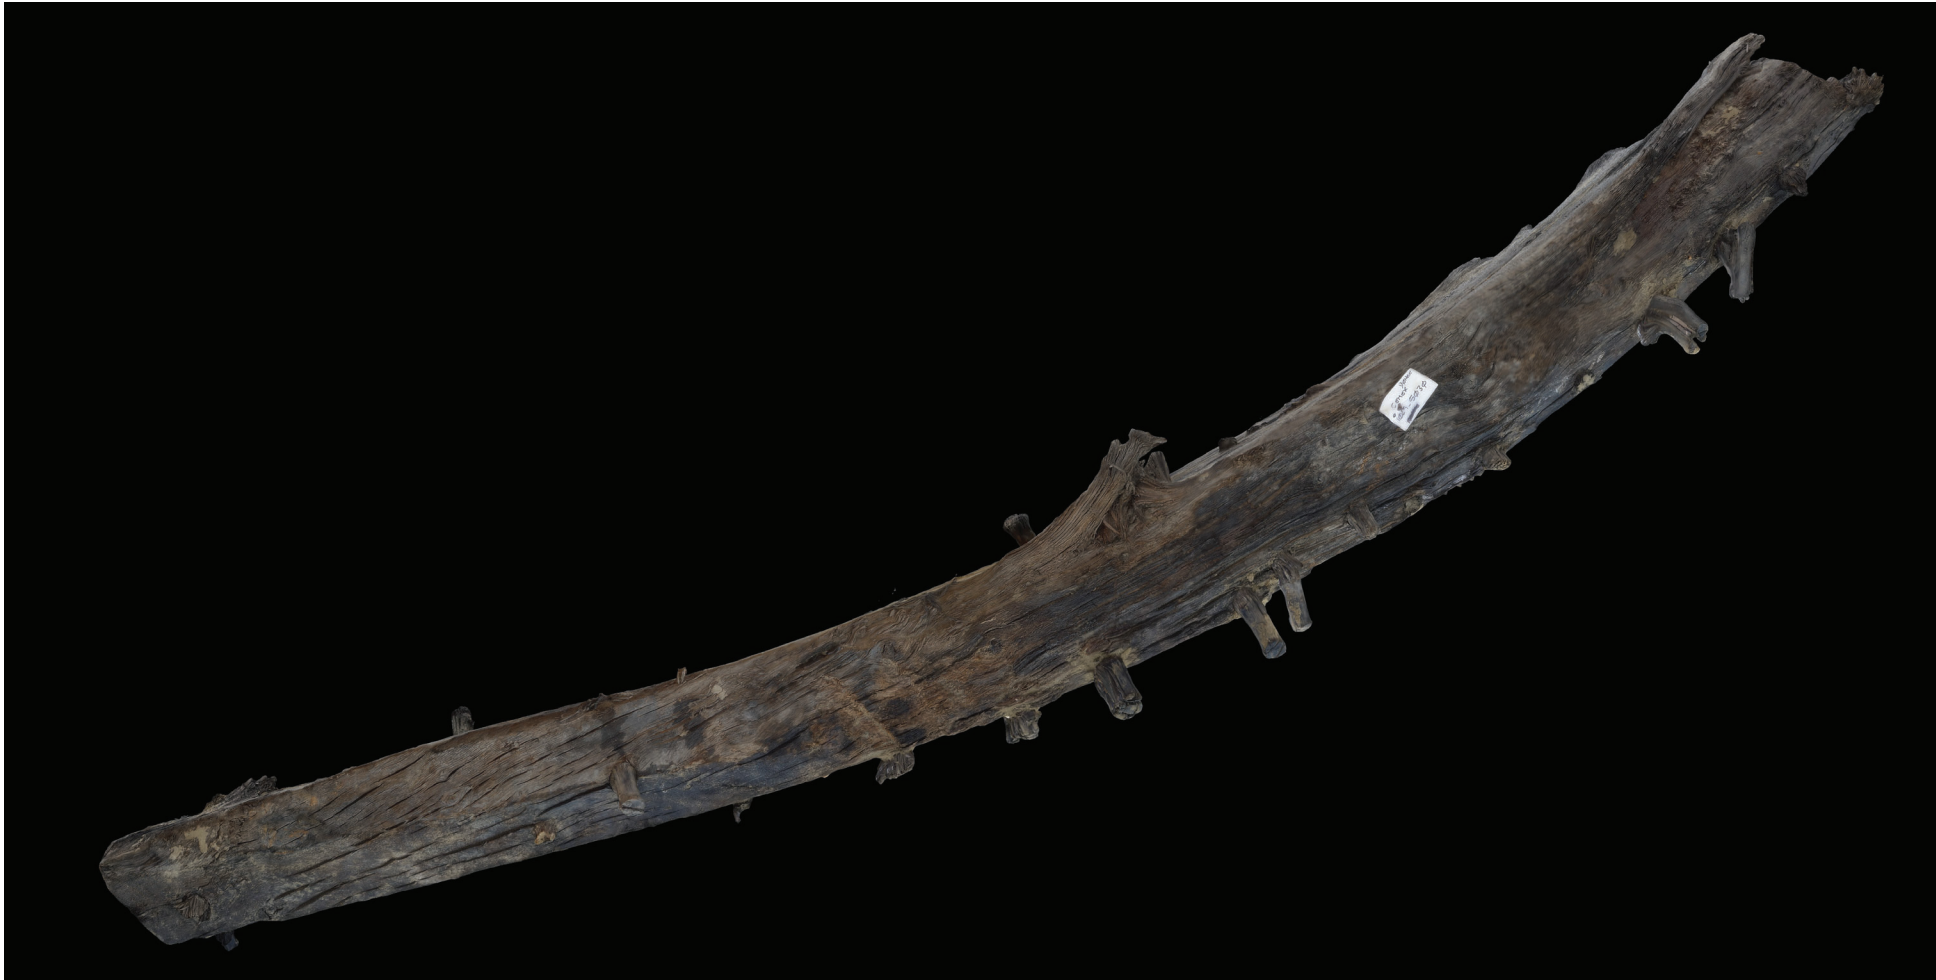
Plate 4: Timber [080], side view, bow on the right, from photogrammetry model

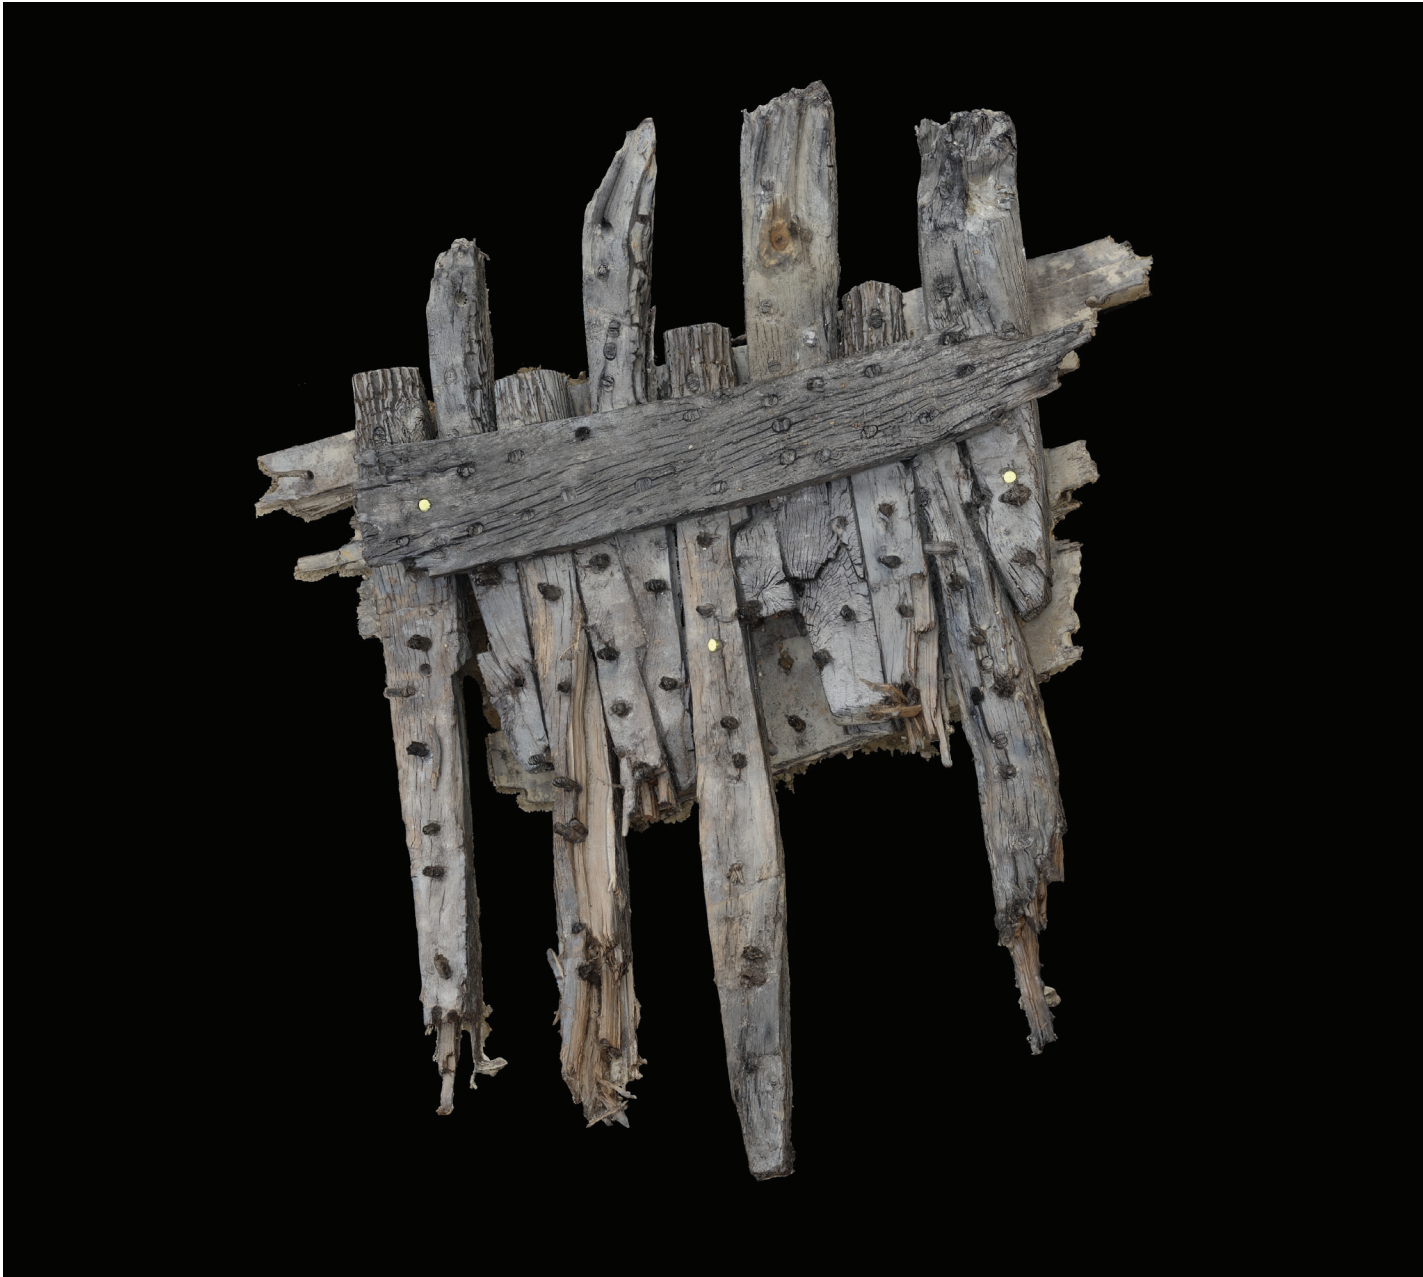
Plate 5: Section 5006, top view, bow on the right, from photogrammetry model
