# The Charter, Gravesend Car Parks Gravesend, Kent

Post-excavation Assessment and Updated Project Design

Planning Ref: 20120931  
Ref: 233911.3  
March 2022

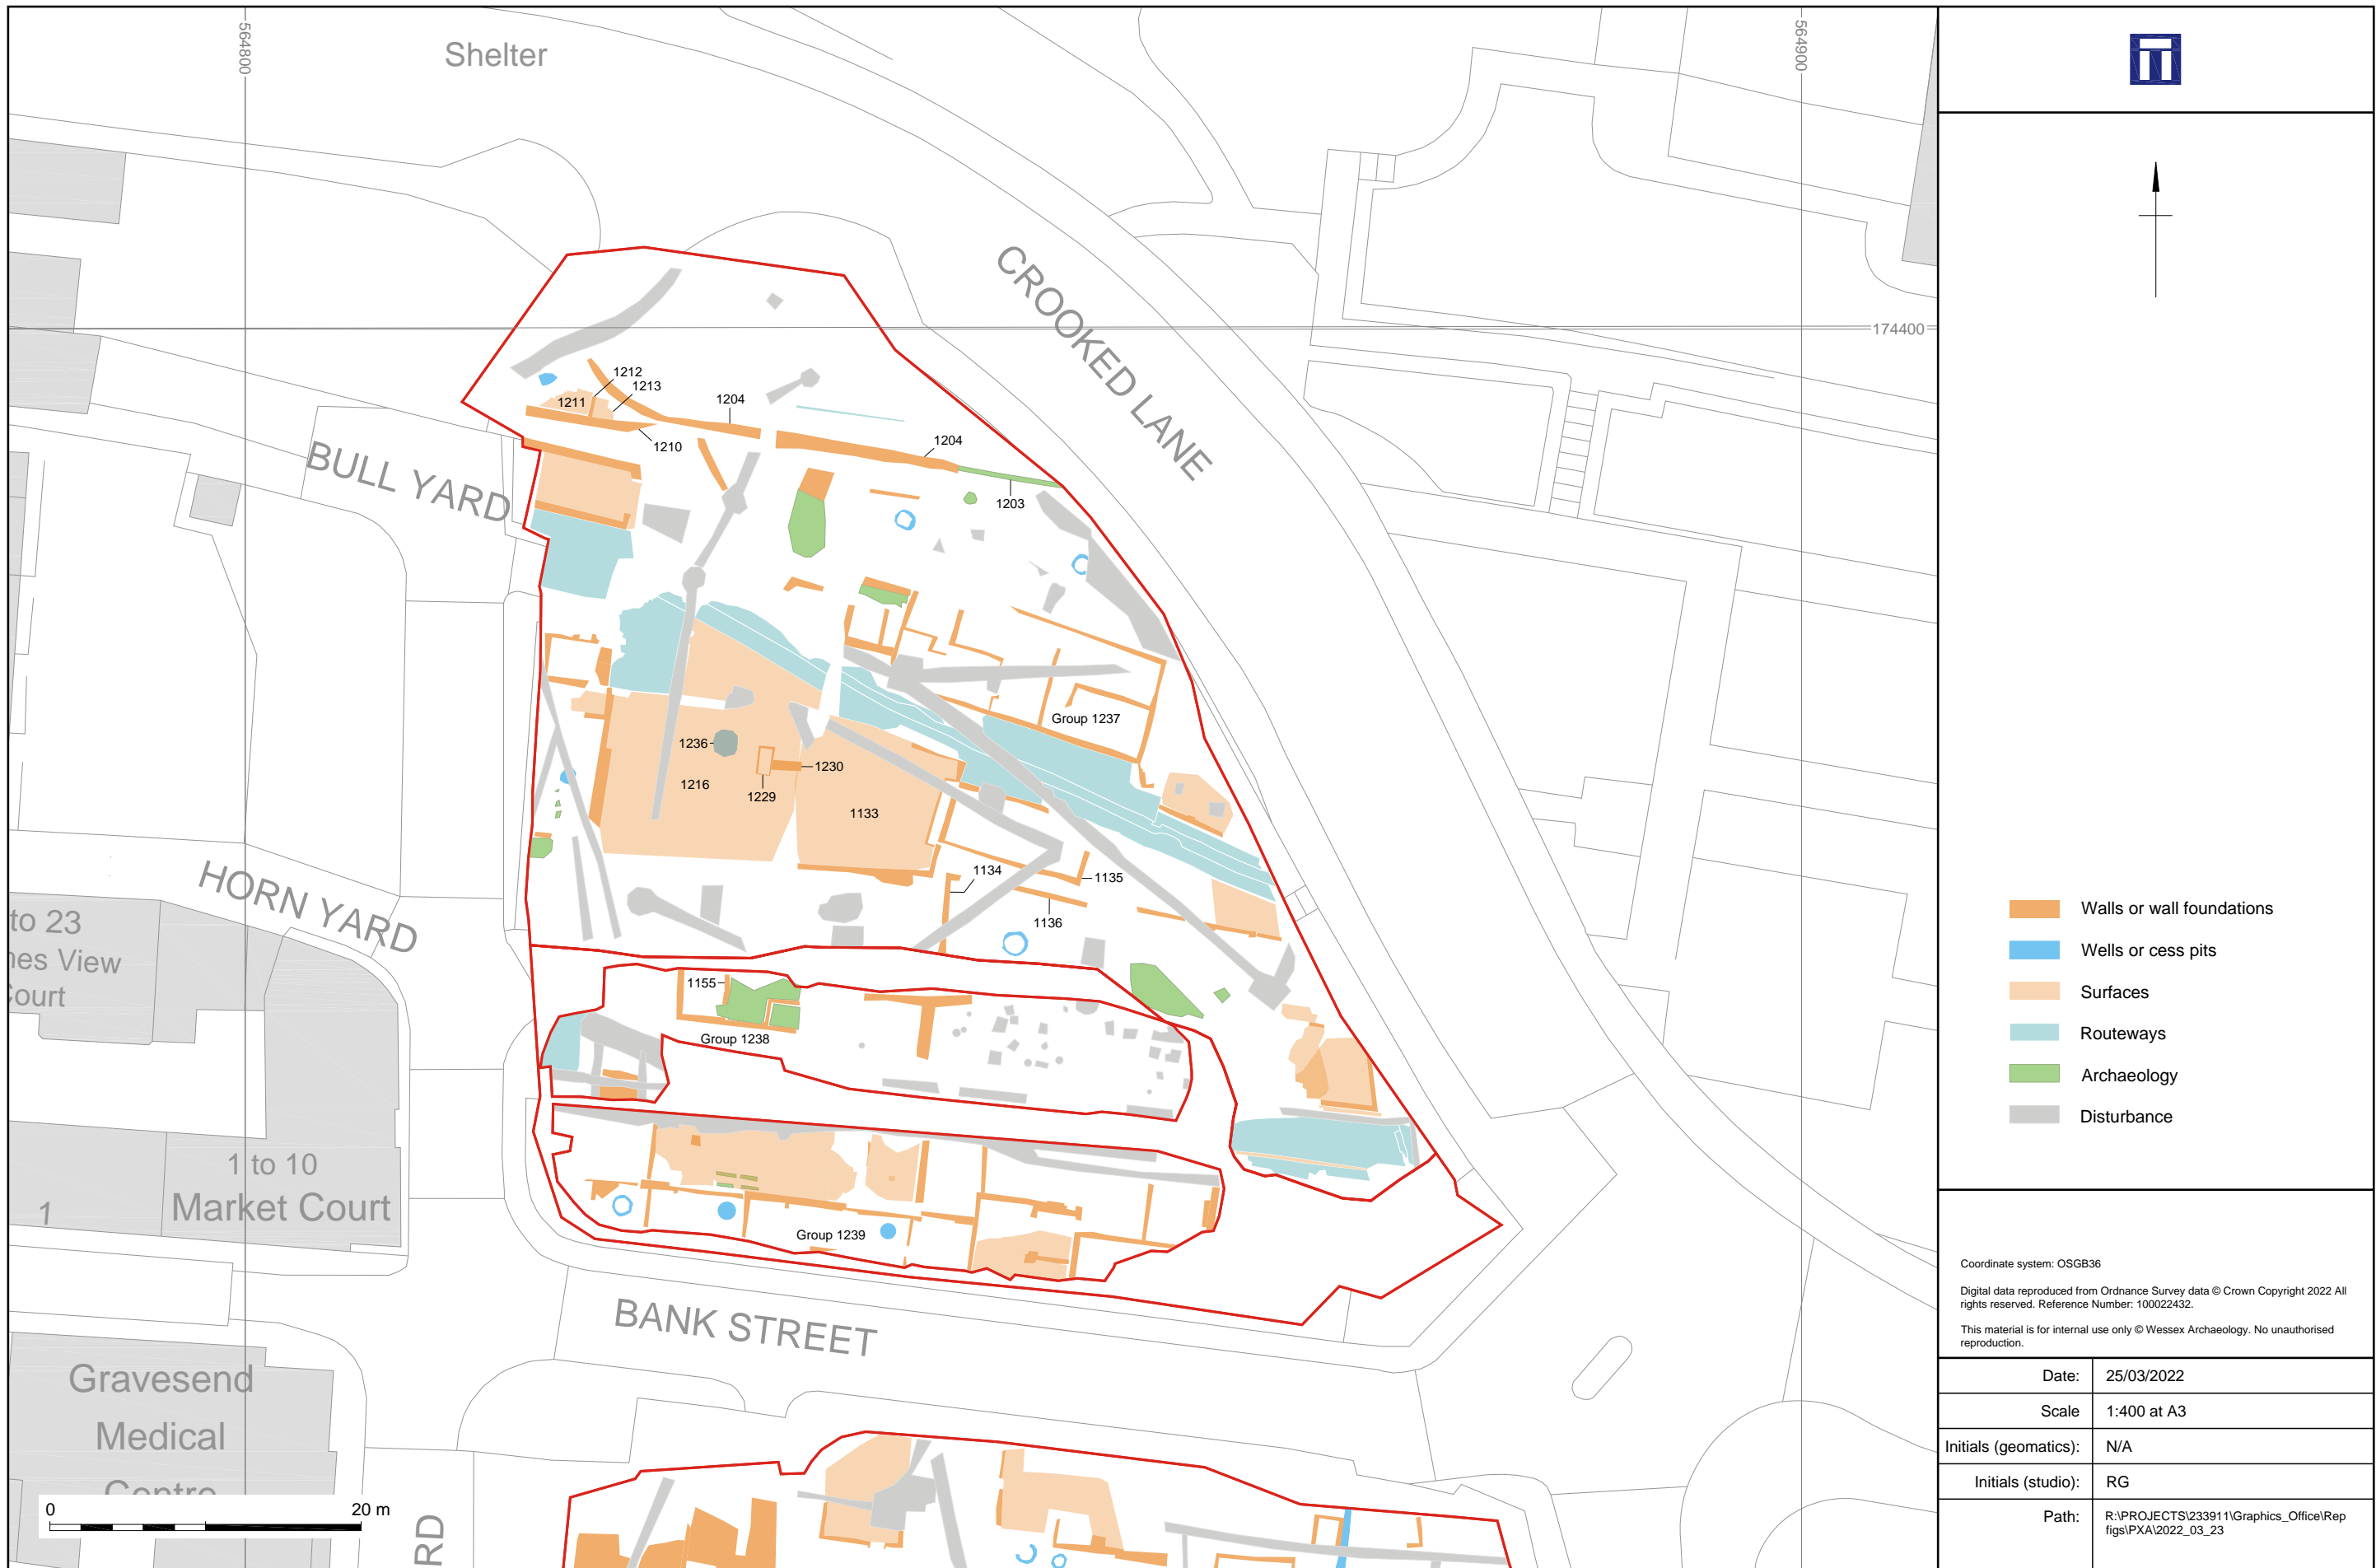
Figure 2

Archaeological Results: Car Park north of Bank Street

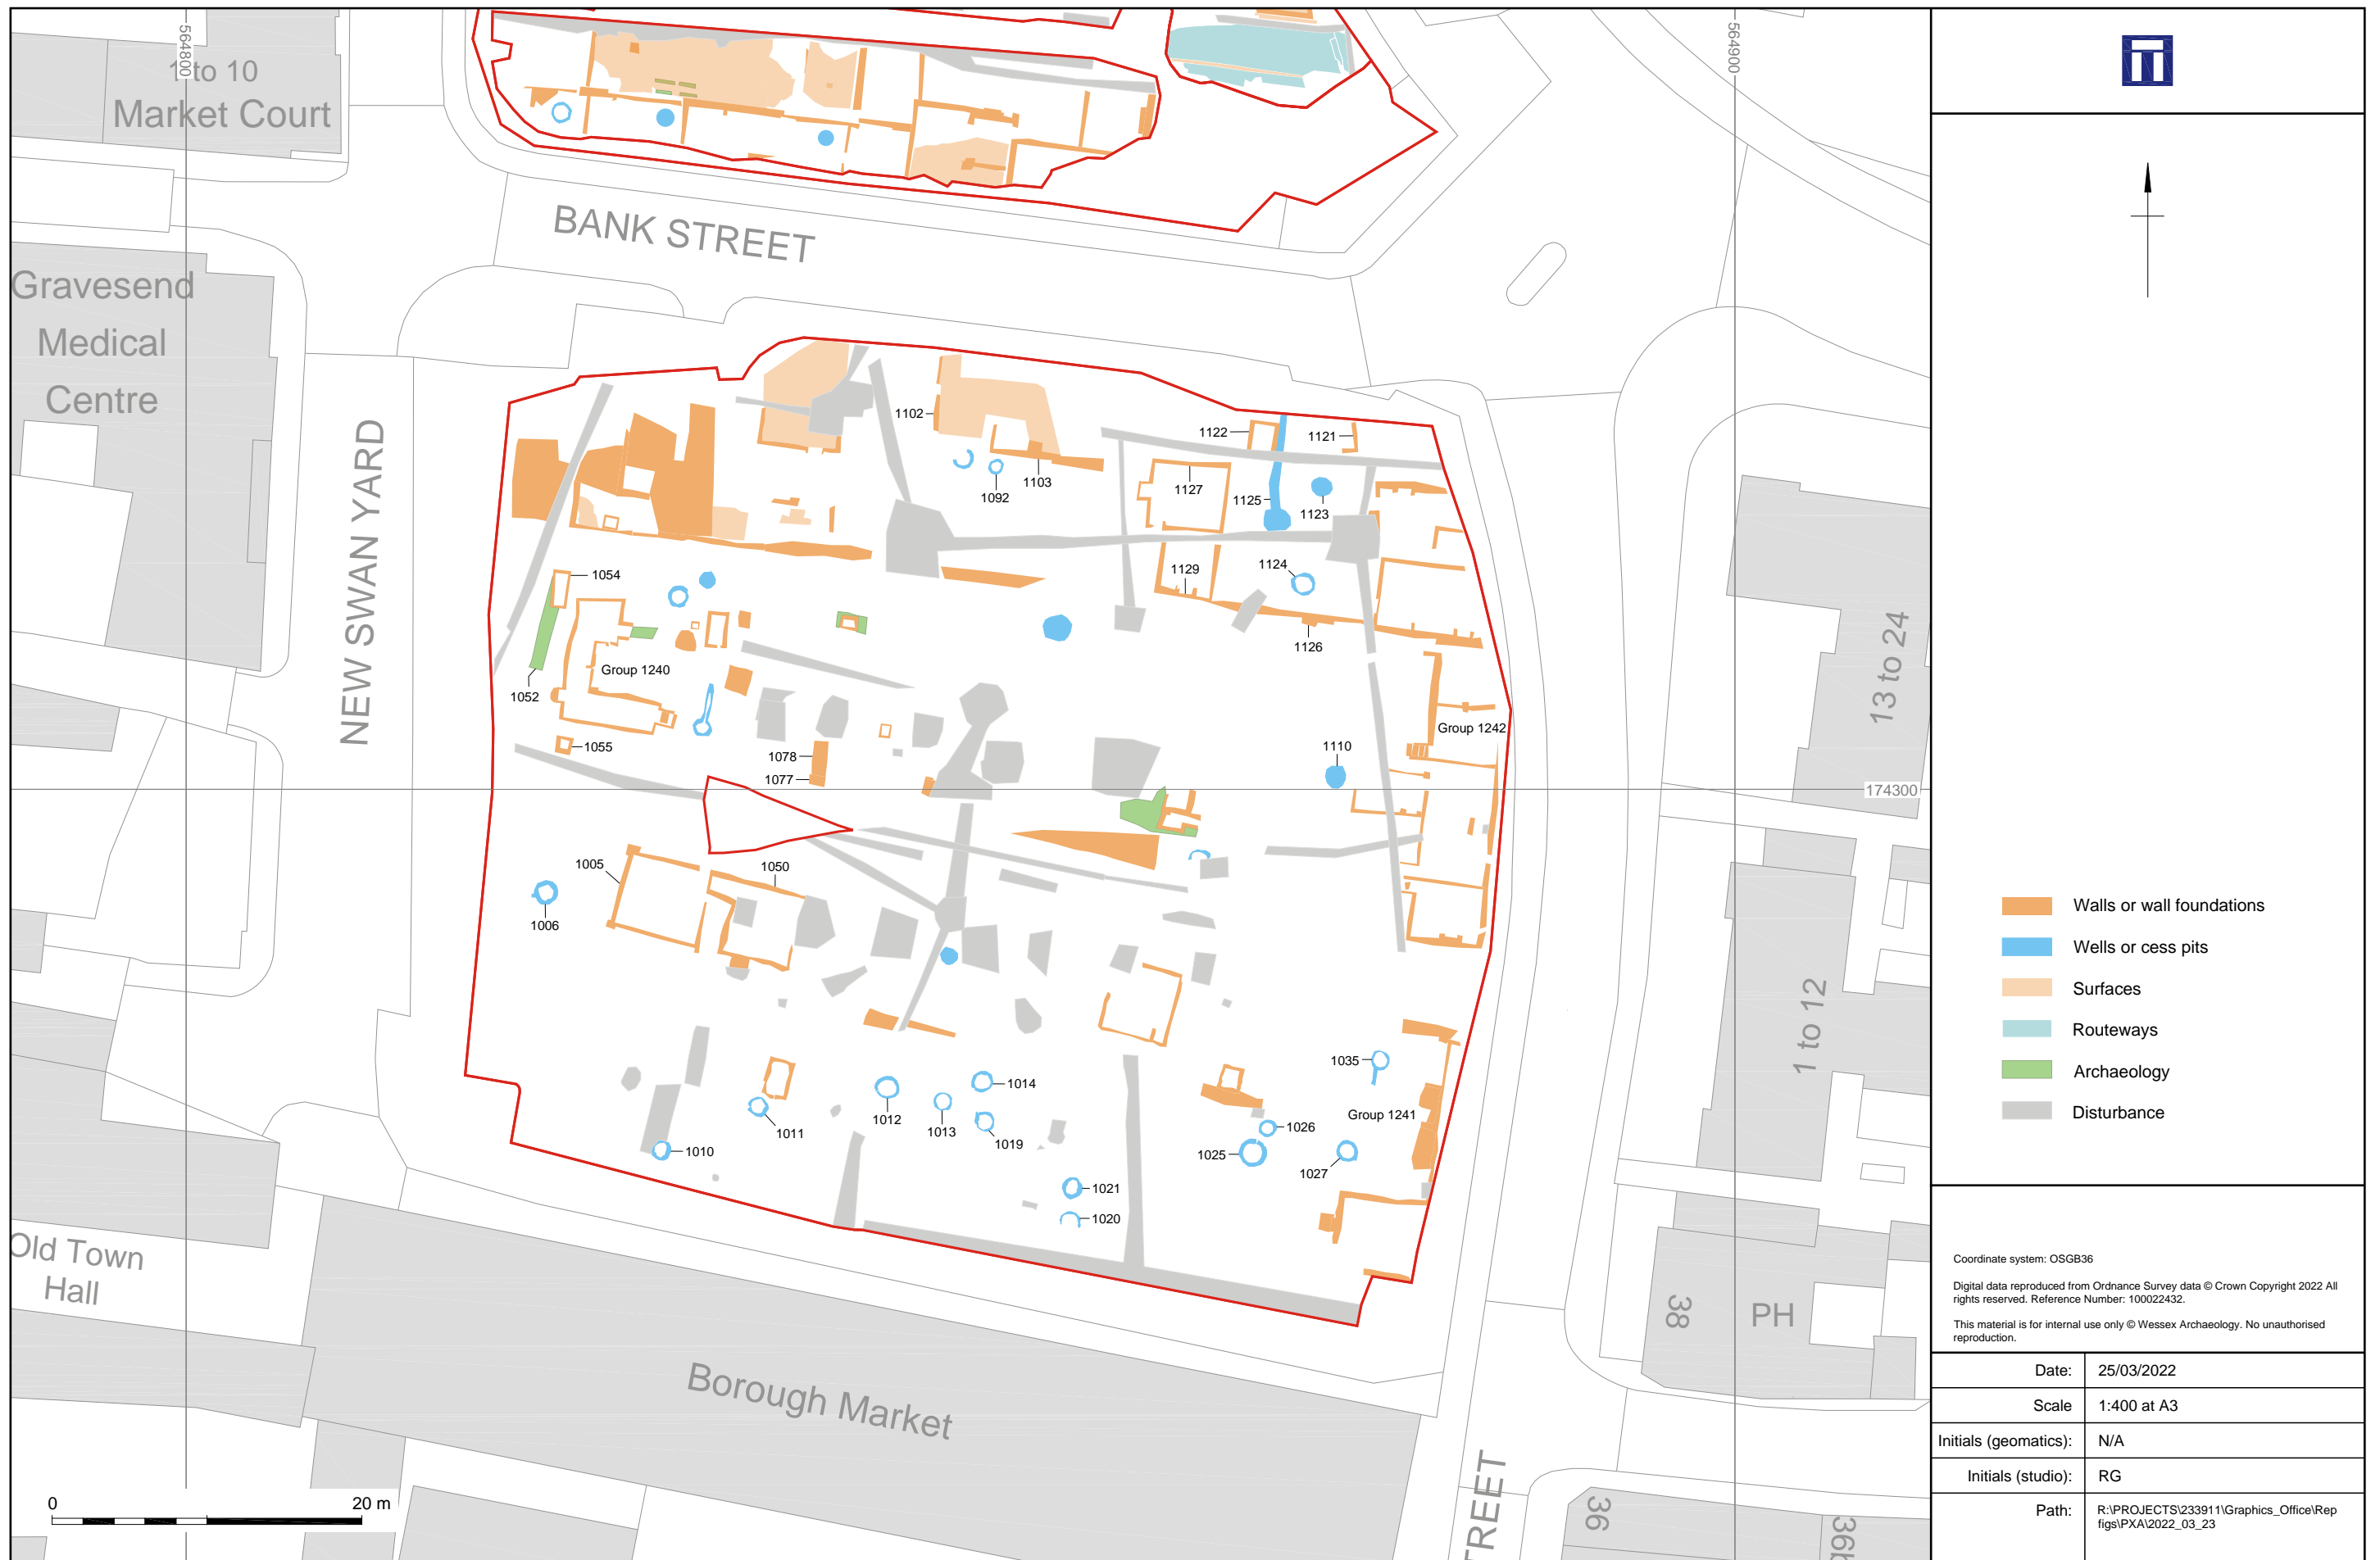
Figure 3

Archaeological Results: Car Park south of Bank Street

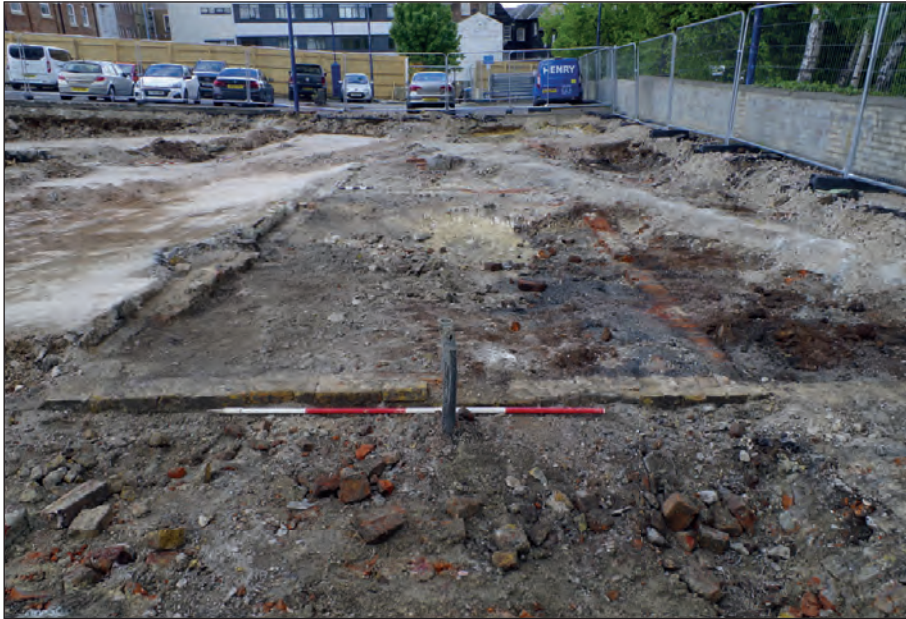
Plate 1: Building 1237, viewed from the east

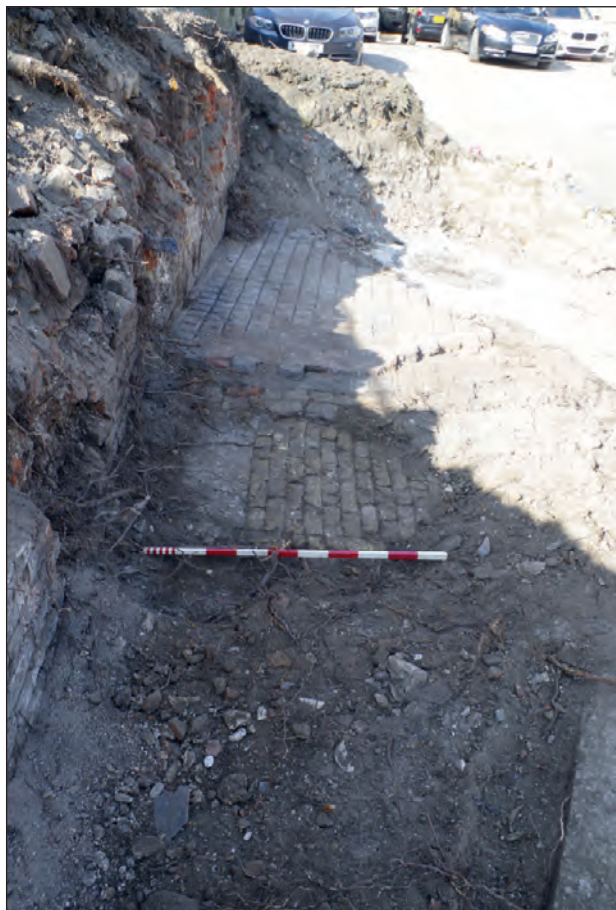
Plate 2: Walls 1210 and 1212, floor 1211 and yard surface 1213, viewed from the east

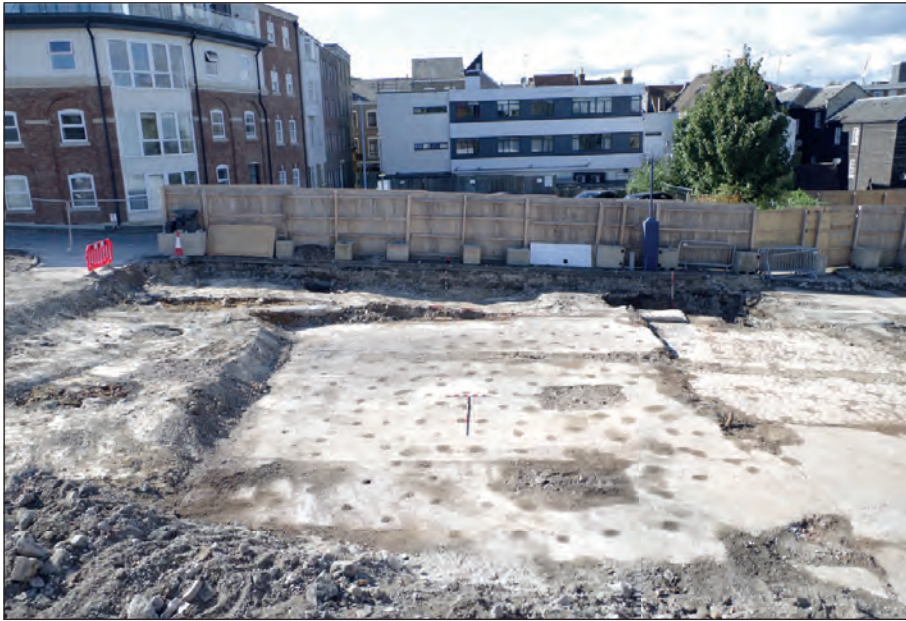
Plate 3: Concrete surface 1133, viewed from the east

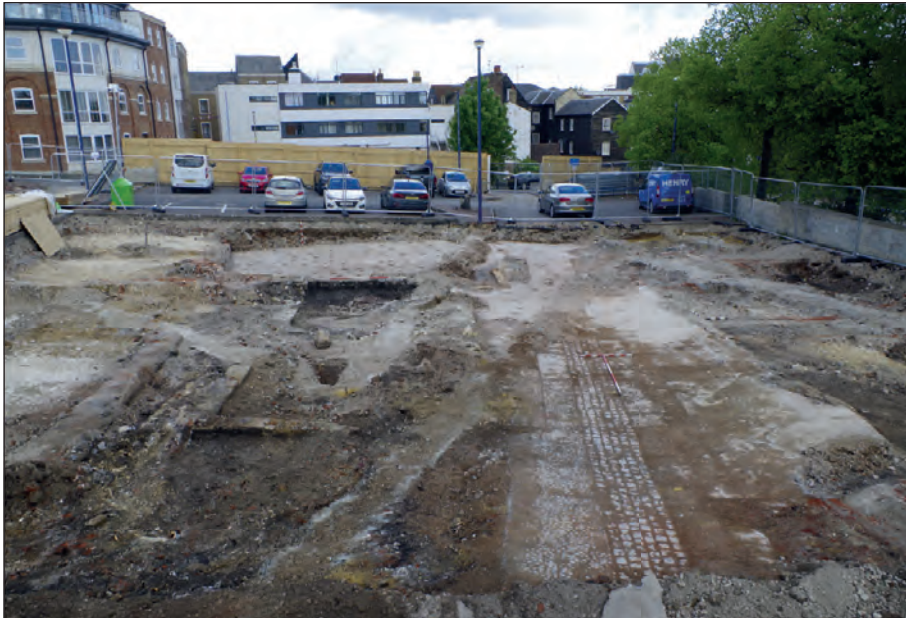
Plate 4: Walls 1135 and 1136 and surface of the former Bull Yard, viewed from the east

- 5.3.5 Directly east of the industrial buildings were the foundations of a smaller rectangular brick building 1135 directly adjacent to Bull Yard and a separate pair of north/south and east/west aligned walls (**Plate 4**). The north/south aligned wall 1134 is likely the eastern exterior wall of a mid-19th century building first seen on the 1866 OS map, while east/west aligned wall 1136 appeared represent a boundary wall separating a small alleyway off Bull Yard and a courtyard north of Horn Yard.

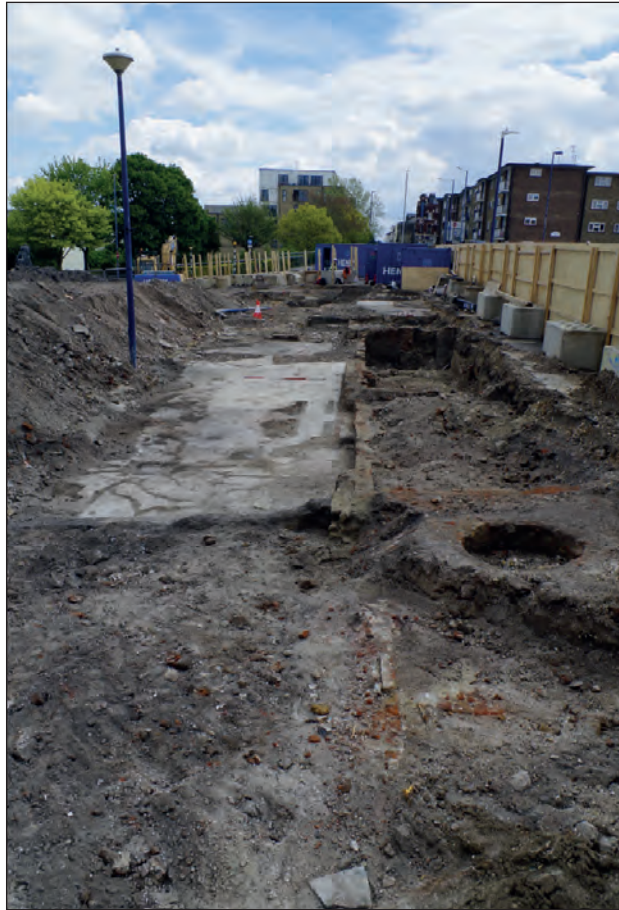
Plate 5: Terraced building 1239, viewed from the west

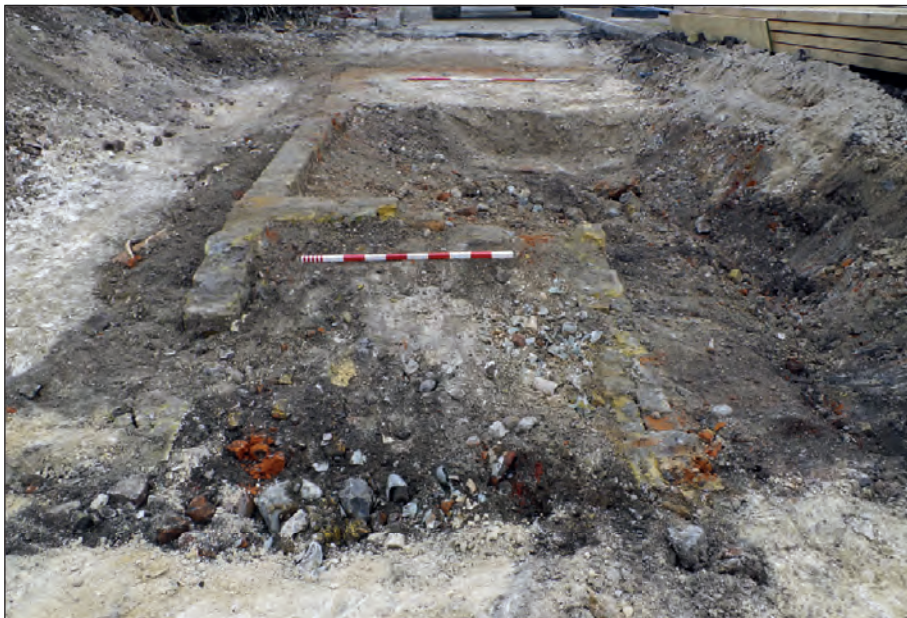
Plate 6: Building 1238, viewed from the north

- 5.3.9 The basements/foundations of at least three distinct rooms 1238 were identified on the northern side of the former 'Horn Yard' road (**Plate 6**). The remains comprised at least five wall segments and appear to be associated with an expansion of the buildings north of Horn Yard between 1866 and 1909. It is possible that wall 1155 is part of an earlier structure as it appeared to be constructed of a slightly different type of brick and was roughly aligned with an external boundary wall shown on the 1866 OS map. A robbed out wall foundation was recorded 4-11m east of the identified foundations and may represent additional sections of the same buildings seen on the 1909 OS.

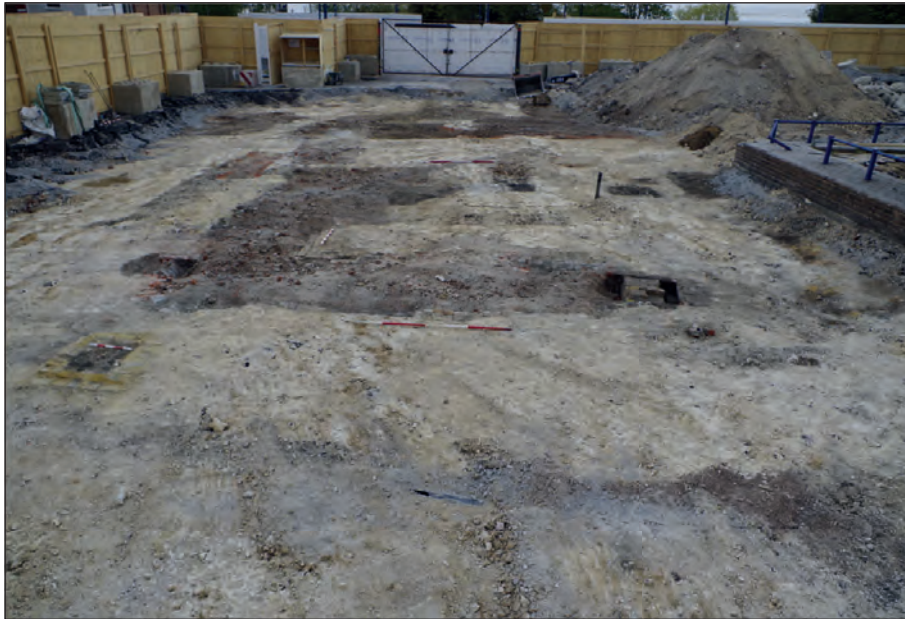
Plate 7: Irregular basement foundation 1240, viewed from the south

- 5.3.11 Large irregular basement foundation 1240 (**Plate 7**) was recorded near the western boundary of the area. The foundation comprised an east/west southern section up to 7.5m long, a north/south section up to 8m long and an east/west northern section up to 3.9m long. A chute was recorded at the southwest corner of the foundation, with a bricked up stairway recorded at the southeast corner. The bricked up stairway suggests that the basement went out of use prior to the demolition of the building itself although there is no clear reason why this may have occurred. The basement does not appear to directly match any buildings shown on historic mapping. However, this may be due to the basement not matching the footprint of the building above, with several large rectangular buildings shown on the 1866 and 1909 OS maps.

- 5.3.12 Square brick structure 1055 (**Plate 7**) was recorded directly south of irregular basement foundation 1240. Constructed from a combination of solid and frogged yellow bricks the feature likely represents a drainage feature, possibly an access hatch. The feature measured 1m long, 0.92m wide and survived to a height of at least 0.19m. The yellow brick marked a significant difference from the neighbouring structure.

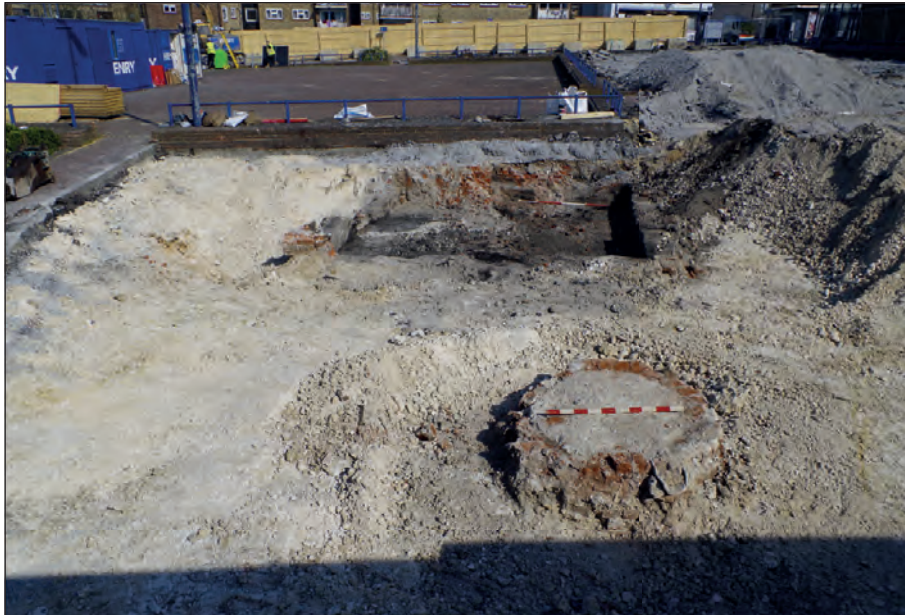
Plate 8: Basement 1005 and cess pit 1006, viewed from the west

- 5.3.13 Square and sub-square basements 1005 (**Plate 8**) and 1050 were recorded in the southwest corner of the area. While a direct relationship between the two basements was not recorded this is likely due to the required excavation methodology caused by the limited space available rather than a lack of a direct relationship. The two basements appear to be similar in size and construction, although only basement 1050 had evidence of a surviving entranceway. The two basements likely relate to a terrace identified on the 1866 OS map, but also line up with possible structural elements on the earlier Tithe map. Basement 1042 was recorded 20m east-southeast of basements 1005 and 1050 and was a similar size and alignment. It is likely to relate to a contemporary building also shown on the 1866 OS map but was not part of the same terrace. Cesspit 1006 (**Plate 8**) to the west of basement 1005 is unlikely to be related as it appears to fall within a separate property boundary and the waste pipe is directed west rather than east.

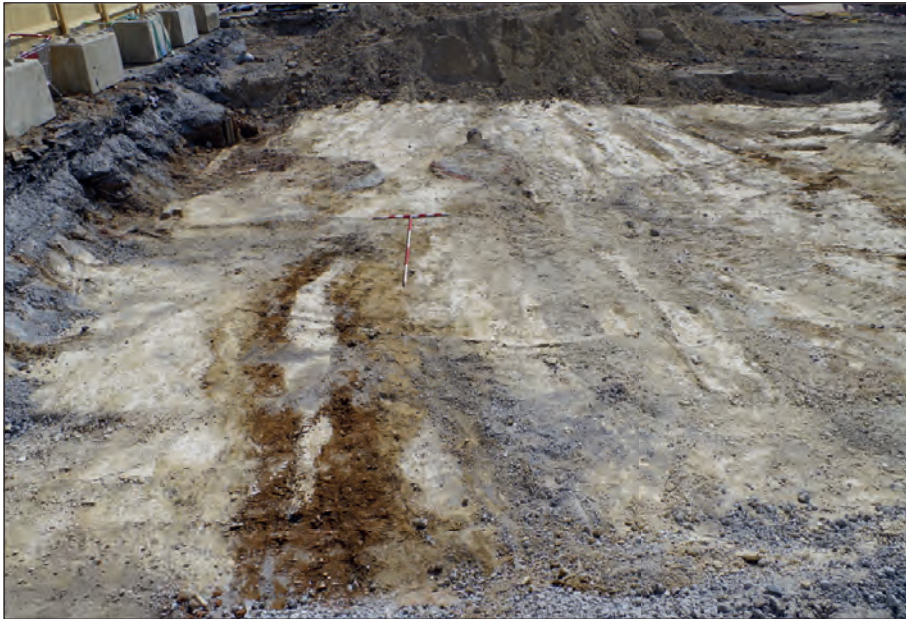
Plate 9: Structural remains 1241, viewed from the north

- 5.3.14 A collection of structural remains 1241 were recorded along the southeast boundary of the area, comprising a number of construction cuts, foundation and basement walls, running approximately north/south (**Plate 9**). The survival of the structural remains in this area was relatively limited, with walls extending to the west but the western end no longer present. There was also only evidence for one distinct basement in the group, which appeared to

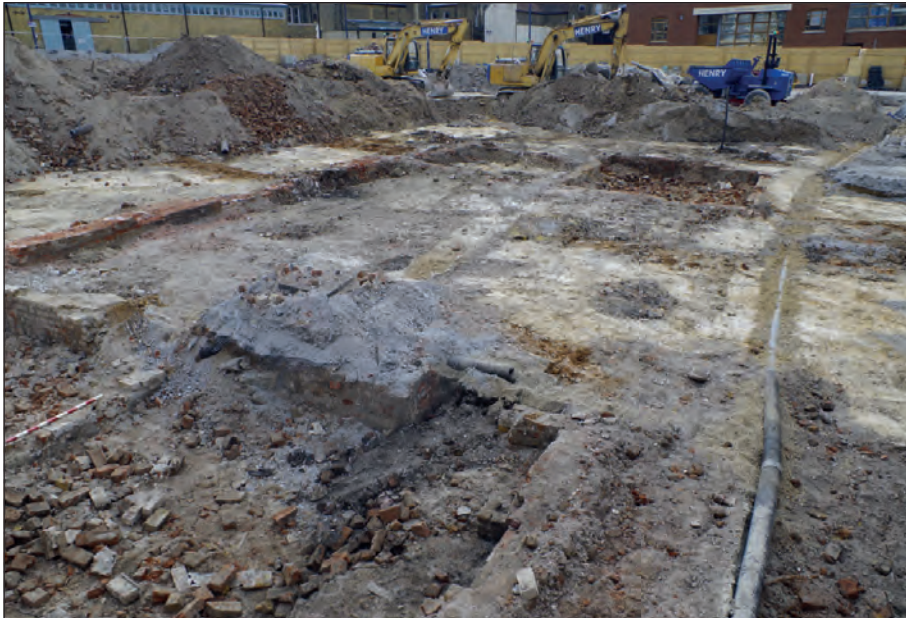
Plate 14: Boundary wall 1126, basements 1127 and 1129 and wells 1123 and 1124, viewed from the east

- 5.3.24 A further three wells (1110, 1123 & 1124) and cess pit (1125) were recorded to the rear of a line of terrace basements 1242 in the northeast quarter of the area. None of the features survived in a good condition, with evidence of material robbing. The cess pit was fed by a north/south aligned waste pipe which extended towards Bank Street, running adjacent to a former brick tank of unknown purpose (1122). As such the cess pit is likely not associated with the neighbouring terrace, and it is unknown which if any of the identified remains were associated with it.

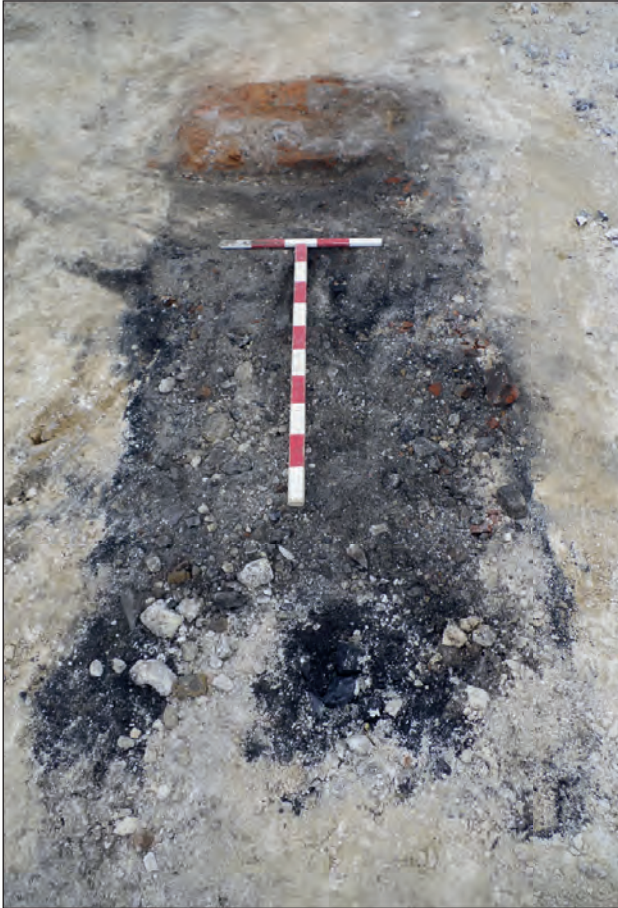
Plate 15: Probable chimney base 1077 and robbed foundation 1078, viewed from the north

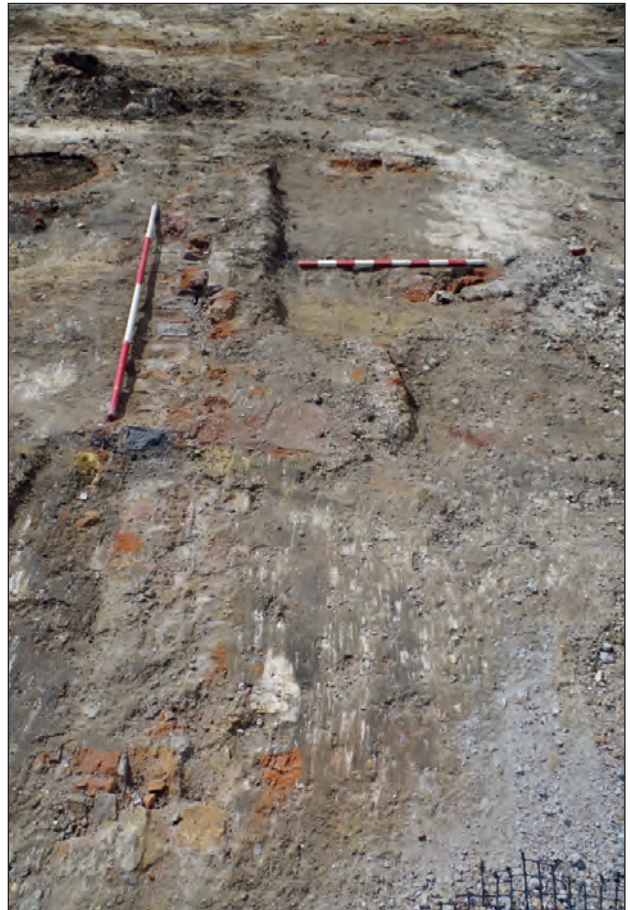
Plate 16: Walls 1102 and 1103 and well 1092, viewed from the east

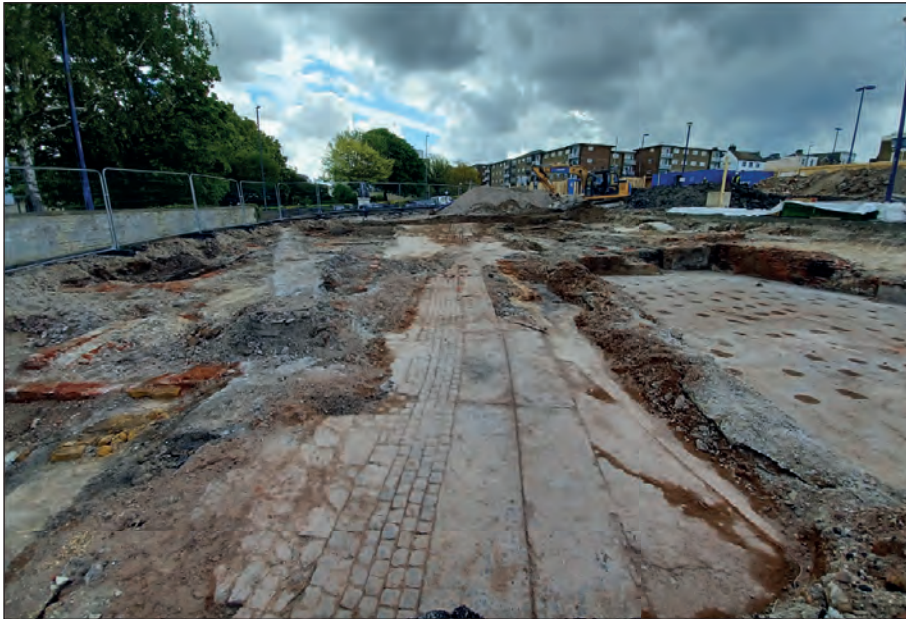
Plate 23: 'Bull Yard' routeway, viewed from the west

- 5.3.28 Bull Yard largely survived across the entire area, running on a northwest to southeast alignment (**Plate 23**). At the southeast end the yard survived as a paved and cobbled surface, while its northwest extent appeared to consist of tarmac. There is no clear reason for the change in cartographical sources, so it may simply represent repairs or later relaying of the surface. Like Swan and Horn Yards, the alignment of the adjacent buildings also gives clear evidence of Bull Yards location and extents, with the southern extent of 1237 clearly respecting the alignment of the Yard. Cobbled surface 1221 likely represented part of the roughly square 'courtyard' seen to the south of the main Bull Yard from the 1840s Tithe Map until the 1909 OS (**Plate 24**). By 1936 this courtyard had been built over with a single large building, which is likely the source of concrete floor 1216., which capped a disused brick well 1236 that may have been a communal well for the surrounding buildings. A brick tank 1229 and unknown wall 1230 were also recorded beneath the concrete layer and may have formed part of the courtyard.
