Steelworks, Crucible Furnaces and Workers' Housing

Archaeological Investigations at Hoyle Street, Sheffield

By Andrew B. Powell

Wessex Archaeology 2014

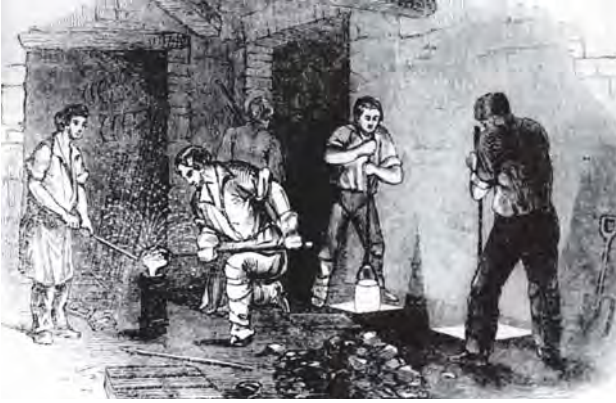
Figure 8 Casting ingots, drawing the crucibles (Sheffield Local Studies Library Picture Sheffield s10815)

When the melter was satisfied that the melting was completed, the 'puller-out' lifted out the crucibles using long tongs (Fig. 8). The 'teemer' skimmed off the slag from the surface of the metal and poured, or 'teemed', the molten steel into rectangular-section cast-iron moulds, made of two halves bound by iron rings, set upright in 'teeming pits' in the melting shop floor. Care had to be taken that the molten steel did not touch the sides of the mould until it reached the bottom, otherwise the metal would instantly set, creating serious flaws in the ingot. When the mould

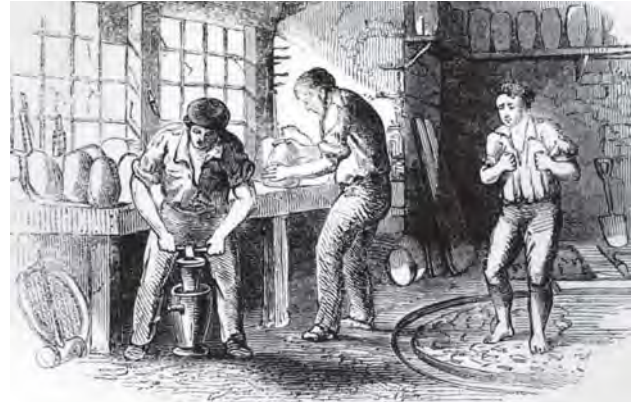
Figure 9 Making crucibles for melting, treading the clay (Sheffield Local Studies Library Picture Sheffield s10816)

In addition to the melting room, there were other important components of the crucible works, including the 'charge room' where the raw materials were prepared and weighed. Much of the works was also involved in the production of the crucibles, of which a ready and regular supply was needed. These were made in the 'pot shop'. Their main ingredient was Stannington clay from the north-west of Sheffield, with additions of Stourbridge, Derby or sometimes China clay, as well as coke dust and 'grog' fragments from smashed used crucibles. The ingredients were mixed dry in a puddling pit or tray on the pot shop floor, and water was added until the mixture was saturated. The mixture was kneaded with bare feet for several hours, to drive out any air bubbles which would weaken the crucible (Fig. 9).

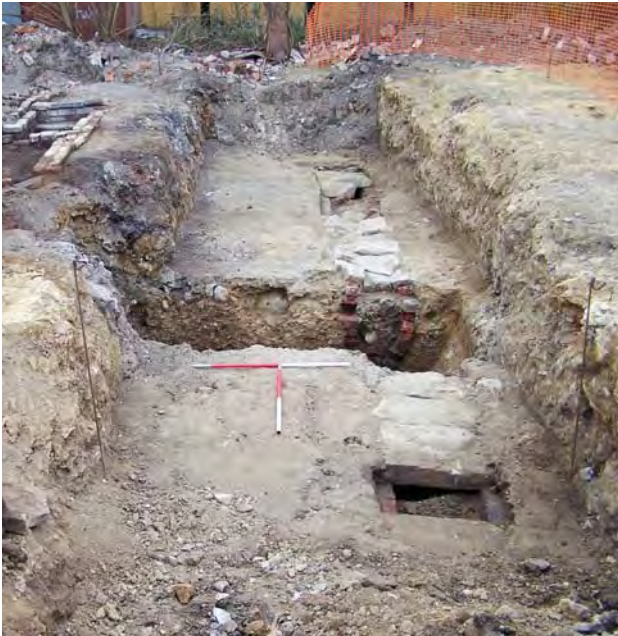
Figure 12 Roscoe Place Works, Trench 1 viewed from the south-west

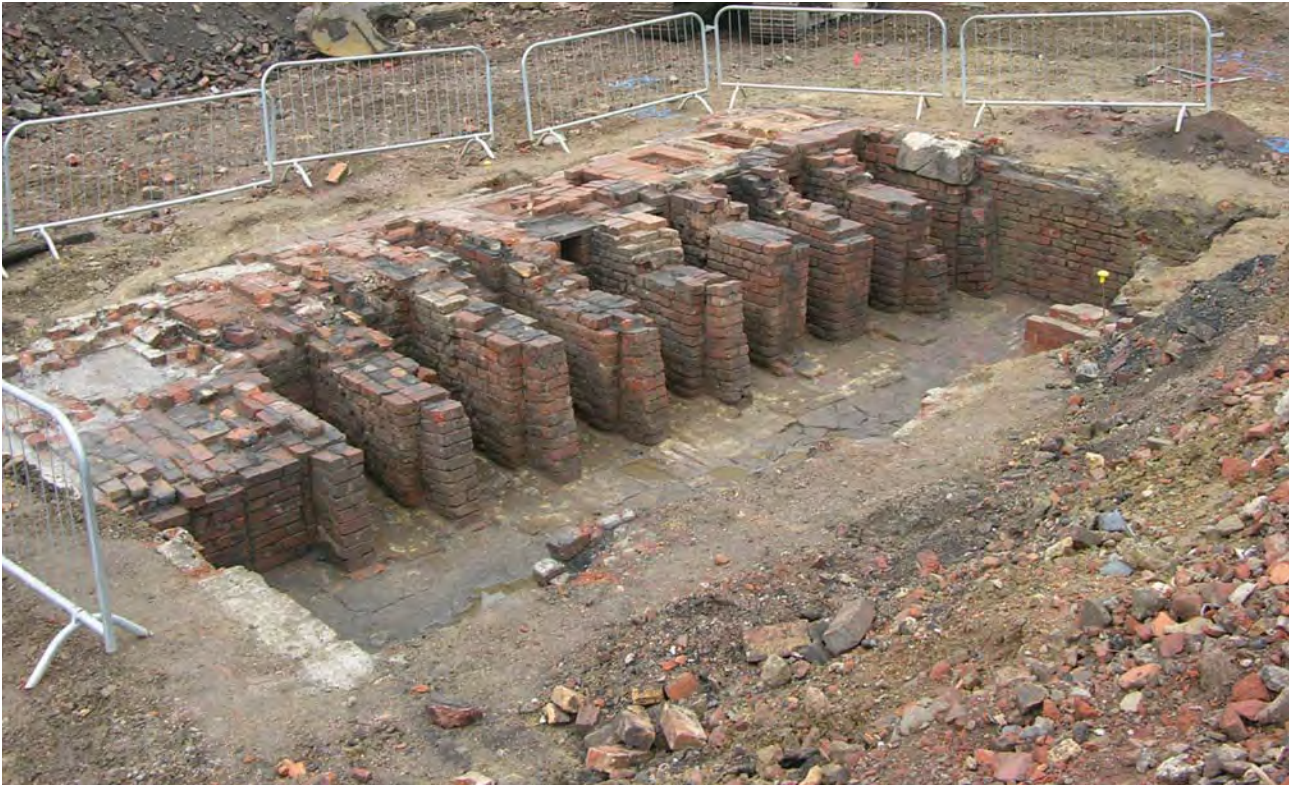
Figure 14 Malinda Works, William Hoole's crucible furnace cellar after the evaluation, viewed from the east

In its original form the cellar was constructed with eight ash pits, indicating the number of melting holes in the furnace above. However, the two at its south-east end had subsequently been completely blocked up with brickwork (Fig. 14). It is not possible to say how long after the original construction (by 1818) this happened, although in the earliest description of the works, in 1836–7, they were described as having just six melting holes (RB 1836–37 SL2.1). No evidence was recorded on the base of the two ash pits (following removal of the brickwork) to indicate that

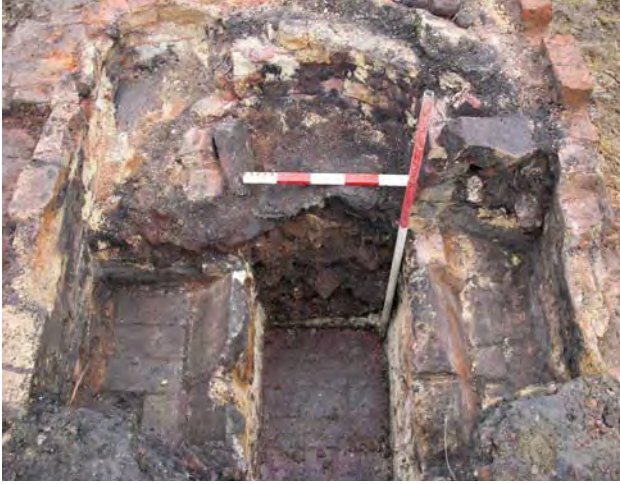
Figure 16 *Malinda Works, boiler base viewed from the south-east*

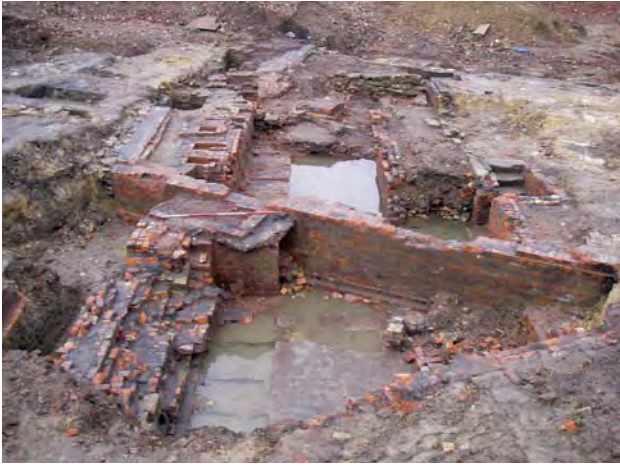
Figure 22 Hoyle Street Works crucible furnace cellar, viewed from the south

As at William Hoole's Works (above), the cellar had a chamber, here 1 m wide, behind the cellar, between the rear of the chimney stack's sandstone foundations (8006) and wall 8005 (Fig. 22). The chamber appears to have stopped just short of the northern end of the furnace, the sandstone chimney foundations turning outwards at that point, and narrowing the gap to the rear wall to 0.5 m. However, it is also possible that this marks the furnace's original northward extent. It is notable that the additional 1 m which the stack continues beyond that point (8007) was constructed with brick foundations, suggesting that it was a later extension. No trace of the original southern end wall of the furnace survived, due to later developments, including the construction of wall 2035.

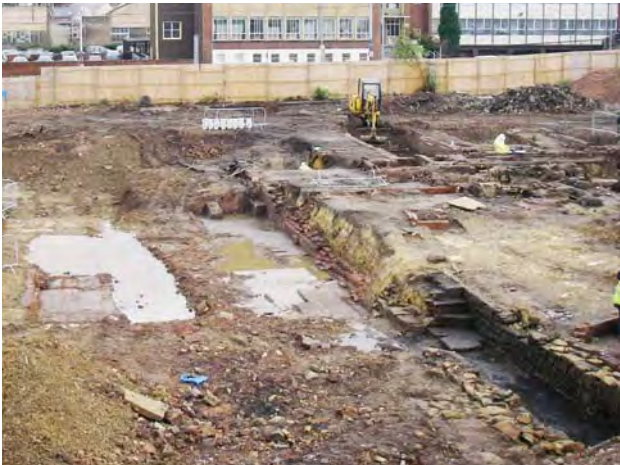
Figure 23 Hoyle Street Works north-east range, viewed from the north-west

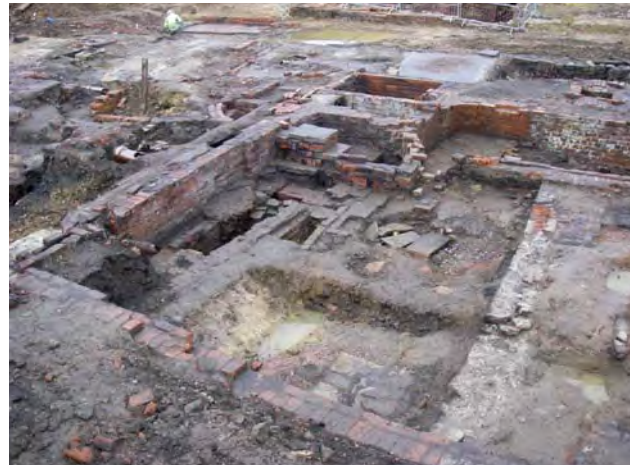
Figure 24 Hoyle Street Works south-west range, viewed from the south

The 1852 map shows the south-west range running as far as the bend in Burnt Tree Lane, with what may have been a small square chimney (no trace of which was recorded) on its front wall (Fig. 4). The position of the front wall corresponds with that of wall 2074, which had a deep foundation of rough sandstone blocks, although it did not survive to the north-west, in Trench 7. However, drain 7053/7054 (see below) in Trench 7 is likely to have marked the extent of the range.

By 1890, however, the range had been shortened, its north-western end now possibly represented by wall 7001, beyond which there was an open yard, measuring 8–9 m by 10 m, which the engraving published in 1893 (Fig. 20) shows was bounded by a wall or fence along its north-east and north-west sides. At the same time the range had been extended 1.6 m further into the works yard, which the engraving shows was due to the addition, to its front, of a single-storey extension (topped by an open balcony), the front wall of which corresponds with wall 2073. The engraving also shows what appears to

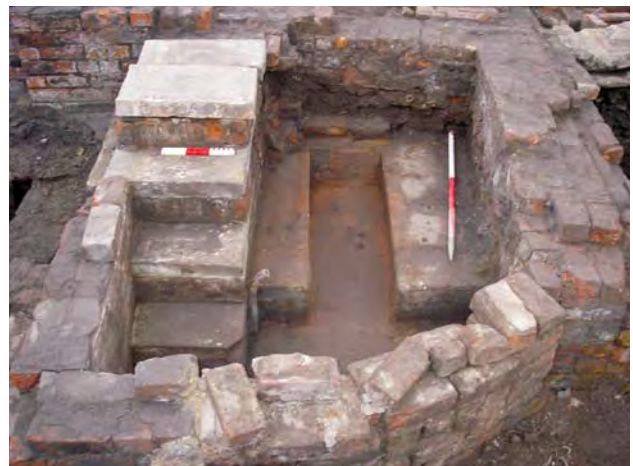
Figure 25 Hoyle Street Works chimney base area, viewed from the south-east

One of the most prominent features in the engraving, however, is the chimney at the northern corner of the range, lying slightly north-west of that on the 1852 map. It had a square base at least as tall as the adjacent buildings, topped by the long, slightly tapering chimney stack. As depicted on the 1890 map (Fig. 21 inset), on which it is labelled, it was 2.1 m square at its base, possible traces of which were recorded abutting (possibly overlying) the end of wall 7001, at a very slight angle. Its north-west and north-east sides are possibly represented by an L-shaped brick wall (7056), and its south-west side by a similarly angled brick foundation (2079) sealed below later floor levels and only partially visible (Fig. 21). There was no trace of a wall on its south-east side, which both the map and engraving show was abutted by the front of the extension (wall 2073).

The area of the chimney base underwent numerous alterations, presumably after its demolition. This included the construction of a concrete structure (2181) comprising a raised shelf around three sides of a rectangular (floor-level) slot, 1 m long and 0.4 m wide, vertical at the sides but steeply angled to the rear (Fig. 25). The shelves, which were 0.2 m high but varied in width, appeared to abut walls 7001 and 7056 to the north-west and north-east, respectively, and a flight of four brick and stone steps (2179/7010), with thick, shaped

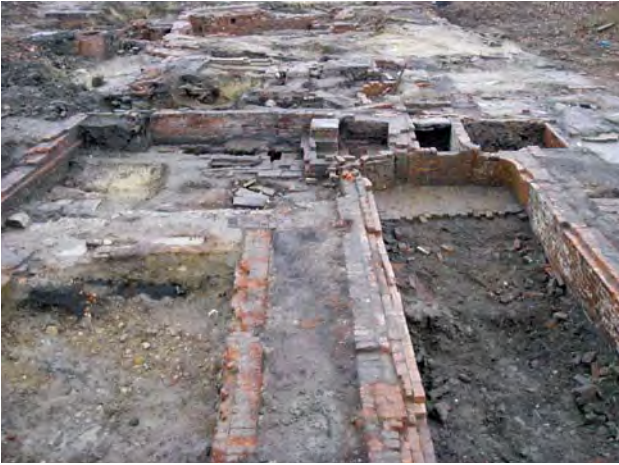
Figure 26 Hoyle Street Works Lancashire boiler base, viewed from the south-east

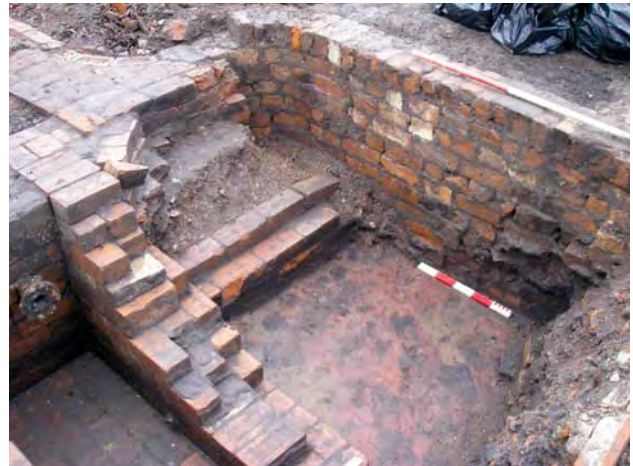
Figure 28 Hoyle Street Works, small boiler base, viewed from the north

Alternatively, the protrusion could be a brick structure adjacent to, and apparently contemporary with, the chimney flue with which it shared wall 2159 (Fig. 28). It may have been the base for a boiler, or perhaps an engine, but this remains uncertain. The structure, 2 m wide internally and surviving to a depth of 0.8 m, was divided into two parts, one being wider and possibly longer than the other. The wider part to the north-east, defined by walls 2159, 2066 and 2063, was 1 m wide internally, but of uncertain length (only 2.3 m of its length was exposed). It had a brick floor, and near its south-east end it was crossed by a wall (2065) surviving to only 0.3 m; the gap behind was not excavated. The north-east wall (2063) had been largely demolished, but its north-

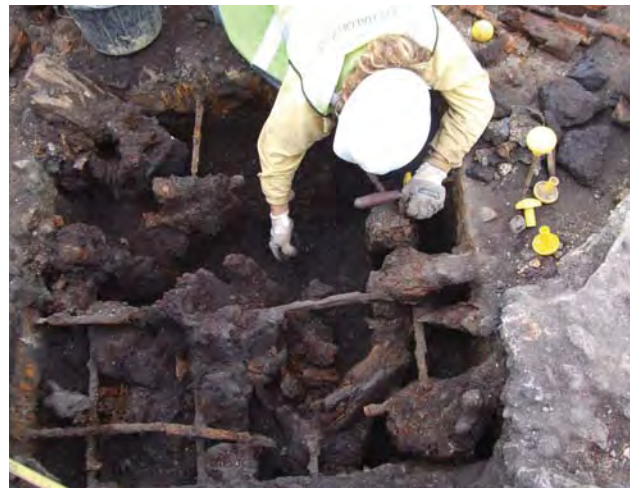
Figure 29 Hoyle Street Works, timber and iron 'crane' structure under excavation

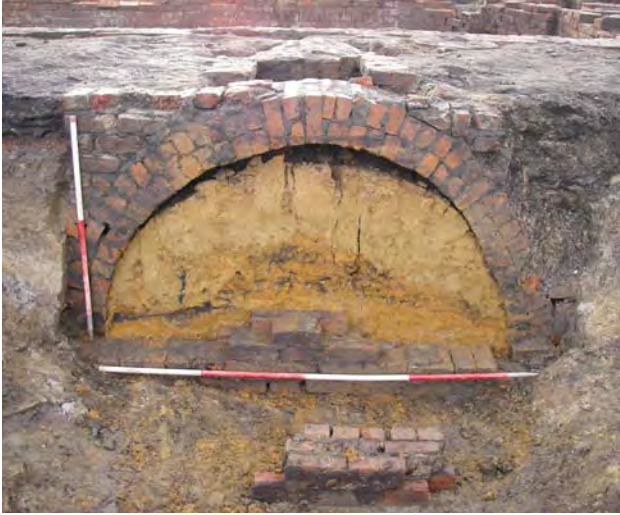
Figure 30 Hoyle Street Works, silt trap with front wall removed, viewed from the north-east

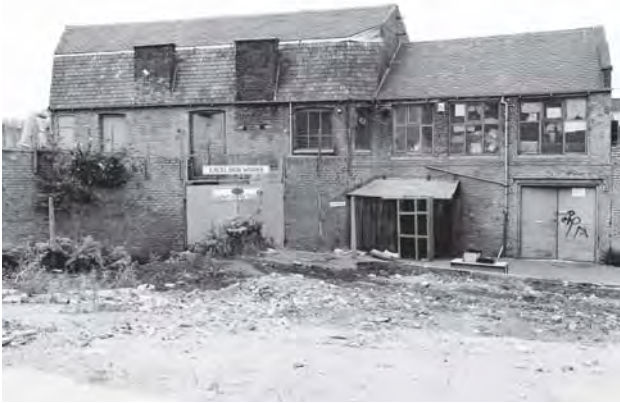
Figure 32 Hoyle Street Works, south-west elevation of buildings B1 and B2

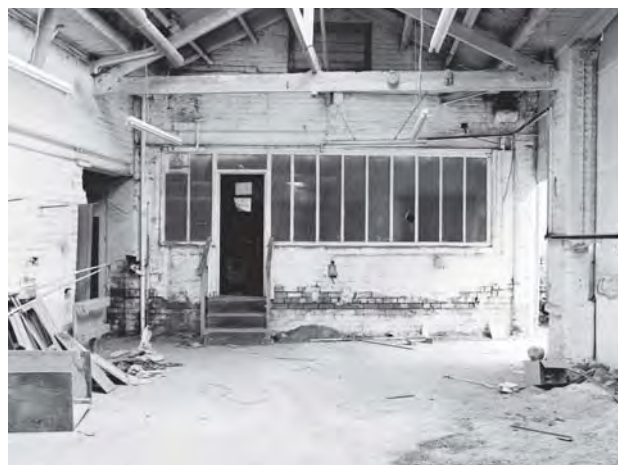
Figure 33 Hoyle Street Works, south-east elevation of building B8, overlooking the works yard

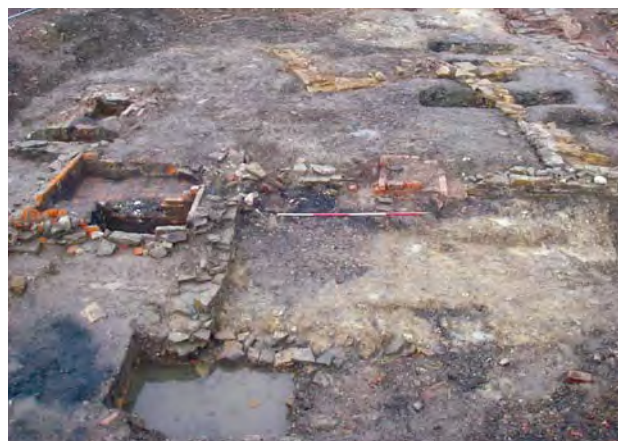
Figure 35 Milton Works/Progress Works, viewed from the south-west

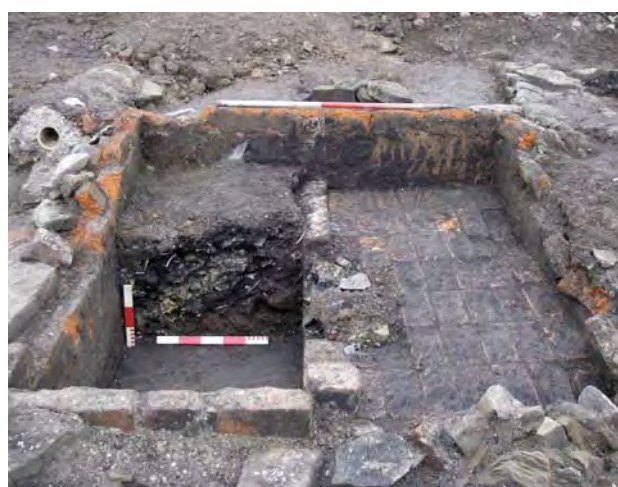
Figure 36 Feature 2010, containing pottery-rich clearance deposit, viewed from the south-west

natural clay) form what appears to be a single, undivided building, measuring 7.3 m by 4.4 m internally, with an internal wall (2017) creating a 0.8 m wide space inside the front (south-western) wall. The rear wall had subsequently been cut for the insertion of a concrete slab on which was square brick chimney base (2015). It is not clear to what uses this building may have been put, but there was a localised spread of clay (2104) in its northern corner, containing pieces of crucible, sandstone and brick, as well as sherds of pottery.

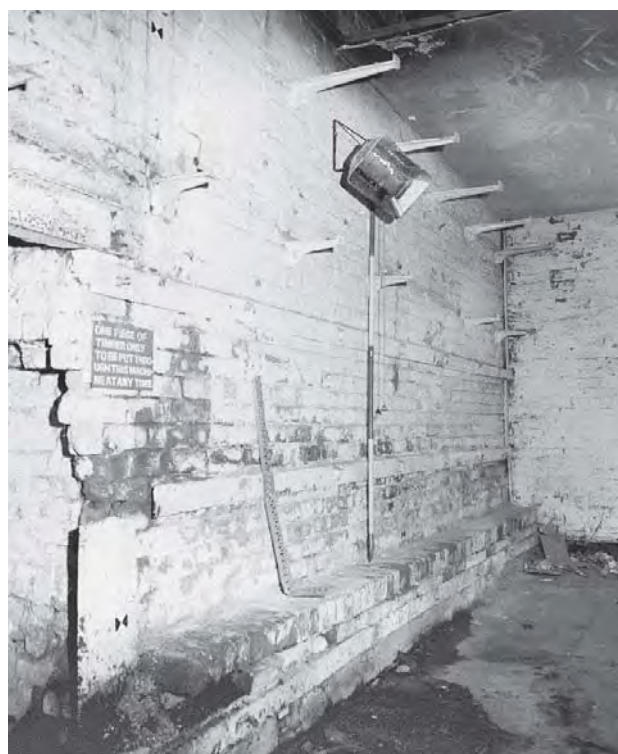
Figure 41 Titanic Works, building F1, detail of south-east crucible stack, showing ledge and shelf brackets

This building was a rare double-stack crucible furnace, constructed in two phases between 1850 and 1890, located at the south-eastern end of the Malinda Street frontage (Fig. 39). Adjacent to it to the north-east was a small workshop with flagstone floor which was most likely a potting room (Room G2), and a further room which was a cart shed (Room G3) (Fig. 37). The furnace building was constructed of red brick with a pitched roof, and with chimney stacks at

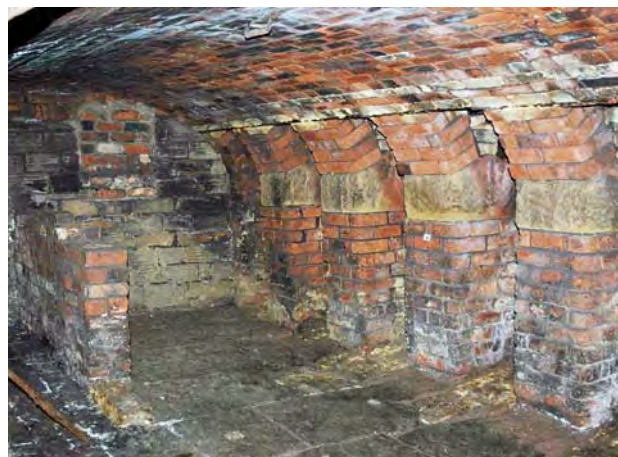
Figure 43 Titanic Works, Cellar 2, north-west half, viewed from the north-east

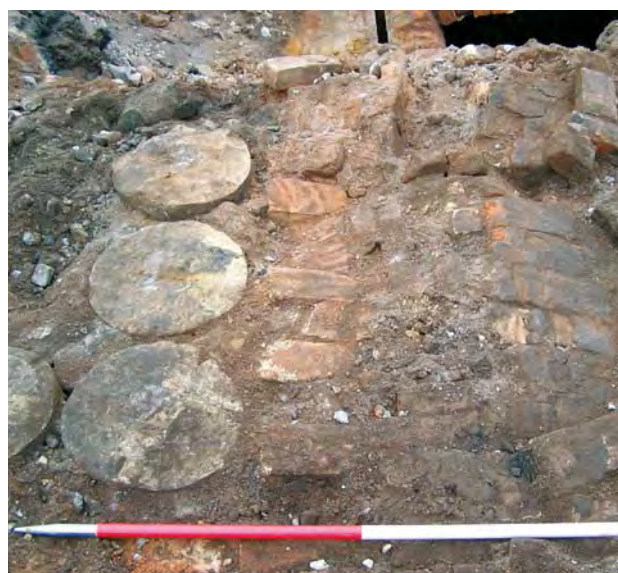
Figure 44 Titanic Works, exposed roof of Cellar 1 with melting holes blocked by grindstones

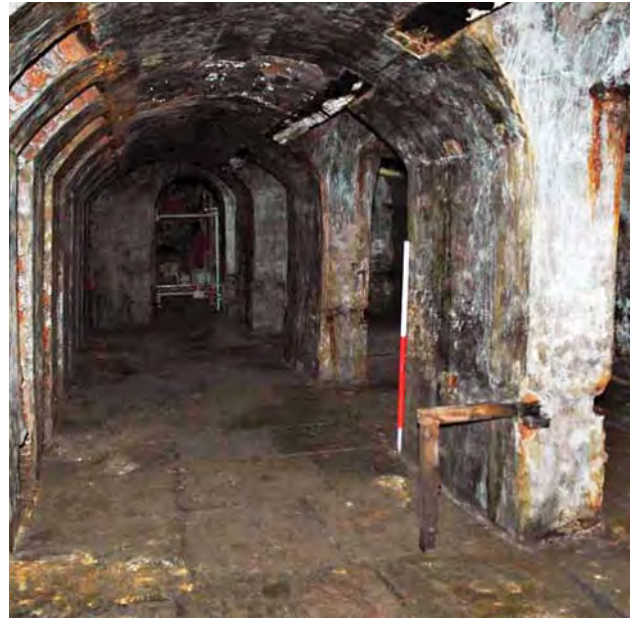
Figure 46 Titanic Works, Cellar 1 viewed from the north-west

clay, on top of a stone floor, held back by a large flagstone set on edge at its entrance. There was also a small recess in the south-east wall, beside the end ash pit, which had a blocked opening through the wall, and a blocked lightwell in the front (south-west) wall. Following the decommissioning of the furnace, probably in the 1950s, a brick base, presumably associated with later machinery in the building above, was built in the main cellar.

The pot shop was accessed by a doorway at the north-west end of the front wall, and had a ceiling of timber joists supporting the floor of the offshot building above, the architectural style of which would suggest that the crucible cellar was constructed during the 1920s or 1930s; one of the joists was stamped *G. R. Jones Co. Ltd Sheffield*, who were listed at the works until the 1930s. The pot shop had a large lightwell (divided in two and half-blocked), and a stone flagged floor at its south-east end, the rest of the floor being covered by an *in situ* iron puddling tray (Fig. 49). Adjacent to the lightwell, against the south-west wall, was an iron-topped table on brick supports,

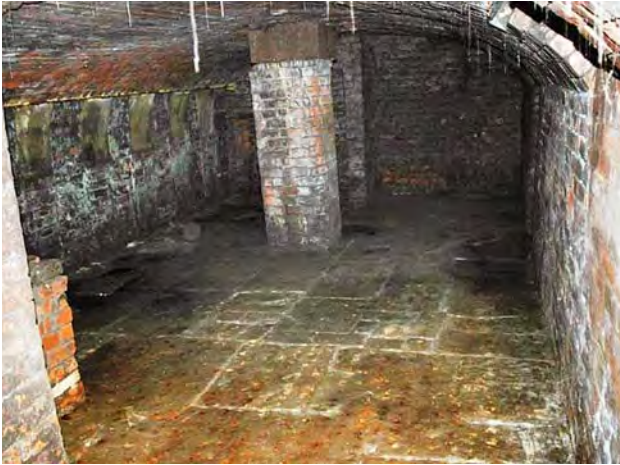
Figure 48 *Titanic Works, Cellar 3 viewed from the north-west*

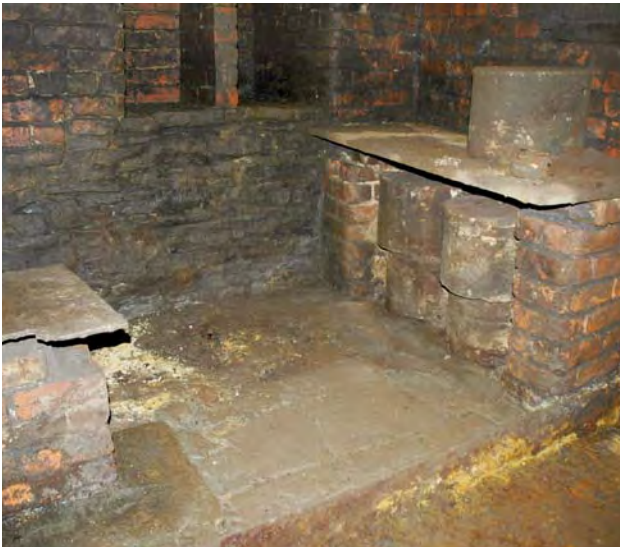
Figure 49 *Titanic Works, Cellar 3 ancillary room with puddling tray and stacked grindstones*

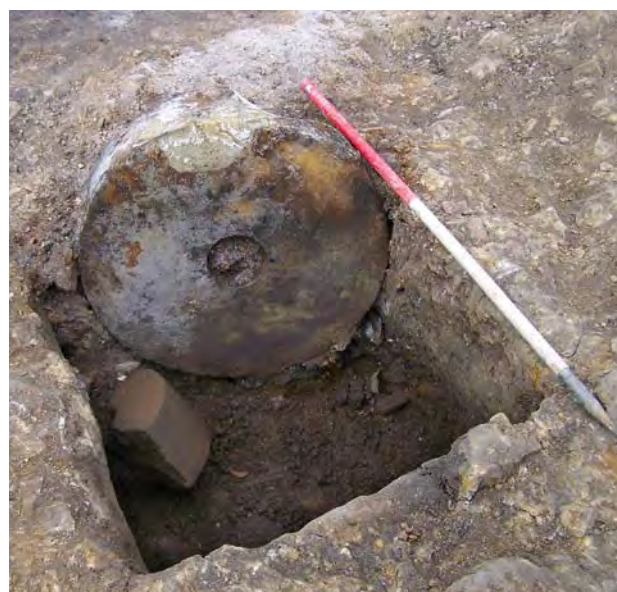
Figure 51 Australian Works, grindstone in pit, Trench

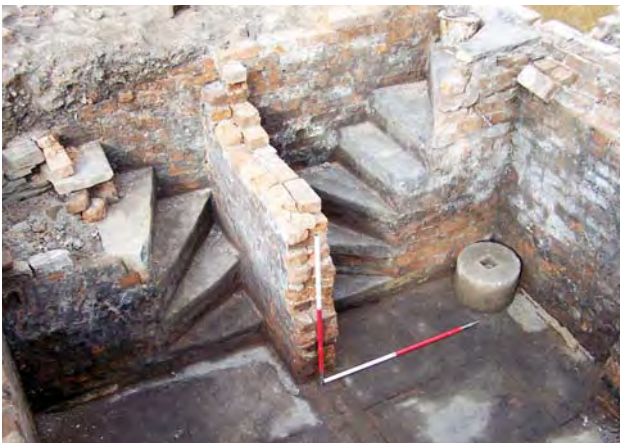
Figure 55 Area A, Trench 9, cellars of back-to-back house on Burnt Tree Lane, viewed from the north-east

cellar to the house at the rear. This arrangement of cellars would have allowed both the front and rear houses to have been supplied with coal directly from the road via chutes. A sondage excavated in the rear house at the north-west end of the trench revealed that it had no cellar.

At some date the dividing wall between the two parts of the cellar had been largely demolished, and the flight of steps from the rear house was blocked with crude stonework, possibly indicating that the front and rear houses had been amalgamated into a single dwelling. A grindstone was found in the

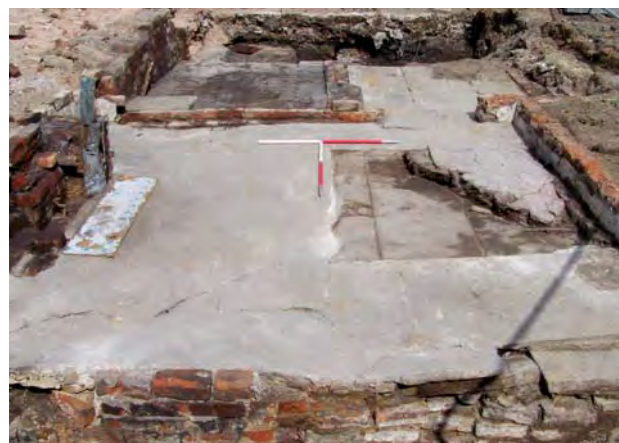
Figure 57 Area A, No. 92 Meadow Street terraced house, viewed from the south-west

The offshot room, which also had stone flags on its floor, had a door in its north-west side giving access to the yard. There was a stone flag in the doorway, flanked by two blocks with doorpost sockets. The yard was surfaced with blockwork of grey tiles with diamond-patterned grooves. Overlying the tiles in the western corner of the yard there was a square stone slab, and there was a drain hole for a downspout in the eastern corner leading into a ceramic drain.

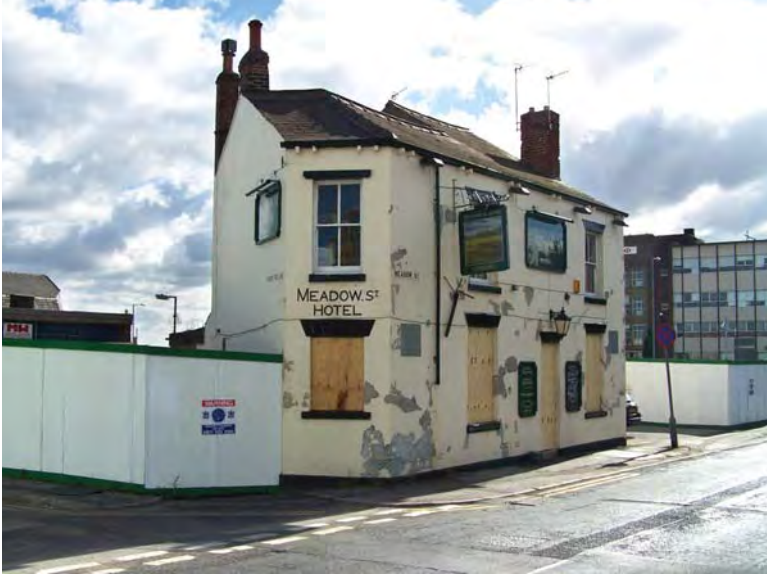
Figure 58 *The Meadow Street Hotel, viewed from the west*

The principal façade of the pub was the south-west elevation fronting Meadow Street (Fig. 58). The north-west corner with Burnt Tree Lane was angled and contained the original raised lettering 'MEADOW. ST HOTEL'. All the windows had retained their original timber hung sashes, stone sills and flat arched lintels; the ground-floor window within the angled north-west corner was

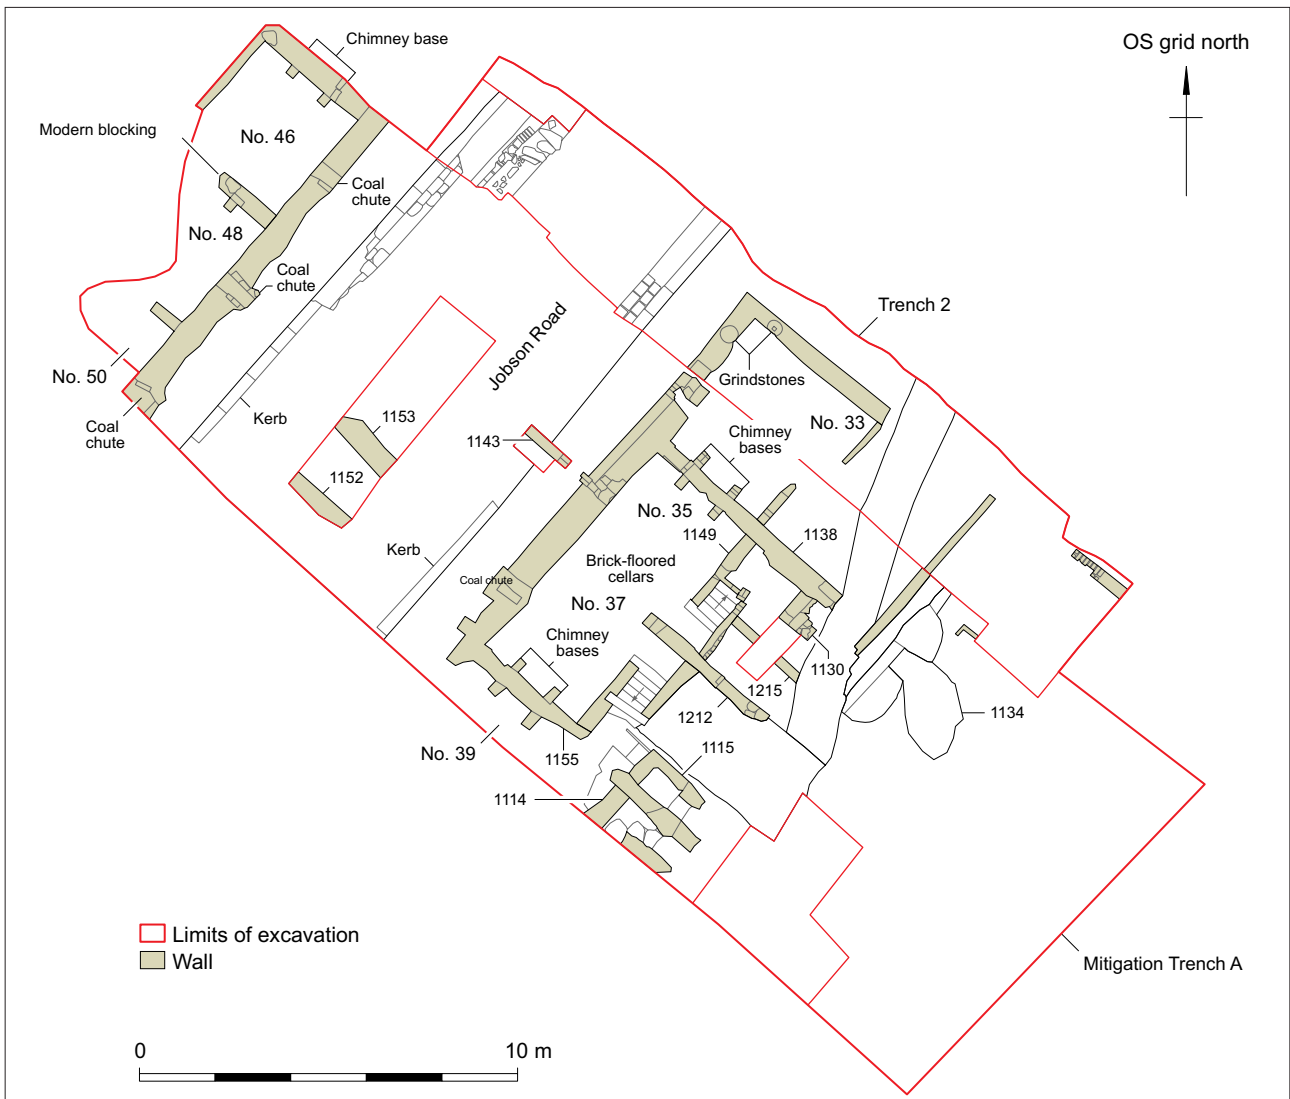
Figure 61 Roscoe Place Works, plan of Trench 2 and Mitigation Trench A, archaeological features referred to in text

(1152 and 1153) (Fig. 61). Wall 1152, 0.23 m wide and surviving to a height of 1.16 m, comprised four courses of red brick on a substantial sandstone foundation, while wall 1153, 0.43 m wide and up to 0.48 m high, consisted only of sandstone blocks; both were bonded with white lime mortar. These walls may be associated with a small building (4.1 m by 5.3 m), shown on the 1816 Fairbank plan (Fig. 10), abutting the south-east side of the central works building at its south-western end, and possibly the adjacent works' boundary wall; no other walls shown on the historic maps match these two features. It is possible that further short lengths of wall (1143 and 1215) may relate to the large building, shown on the same plan, to the north-east.

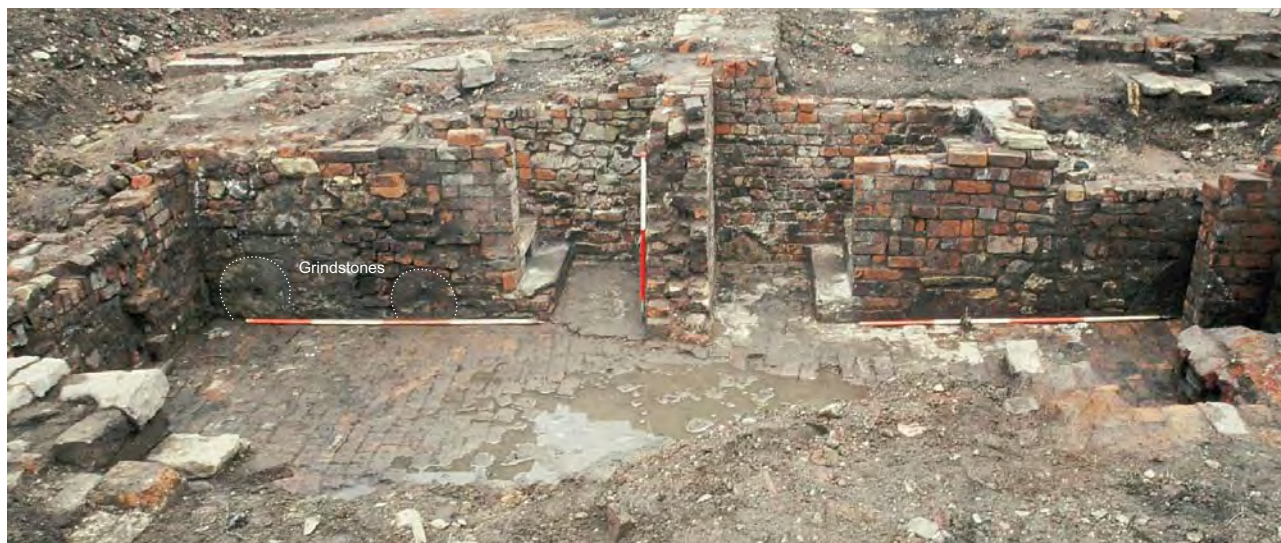
Figure 63 Area H, cellars of Nos 35 and 37 Jobson Road, viewed from the north-west (note grindstones built into wall)

The walls were built of a mixture of largely hand-made red brick, yellow fire-brick and irregular blocks of sandstone bonded with white lime mortar, much of this material probably recycled from the demolition of the earlier works buildings. The main external walls were substantial in their construction, and 0.5 m wide. However, a number of the internal dividing walls were somewhat crudely built; of note were a number of reused grindstones incorporated into the structure, such as two set upright in the back wall (1149) of the cellar of No. 35 (Fig. 63), and others laid flat on the walls of the No. 33 cellar (Fig. 64).

The brick-floored cellars at the fronts of Nos 33, 35 and 37 were exposed. The cellars measured internally 3.2 m square. The brick party wall (1212) between Nos 35 and 37 was only recorded towards the rears of their cellars where it flanked the flights of steps leading down into them (Fig. 63). It is possible that the rest of this wall had been knocked through to create a single, larger cellar; alternatively its demolition was contemporary with the demolition of the houses. The other two party walls, between the cellars of Nos 33/35 (1138) and 37/39 (1155), both had short lengths of brickwork abutting them on both sides, indicating the positions of the fireplaces in the houses' front rooms.

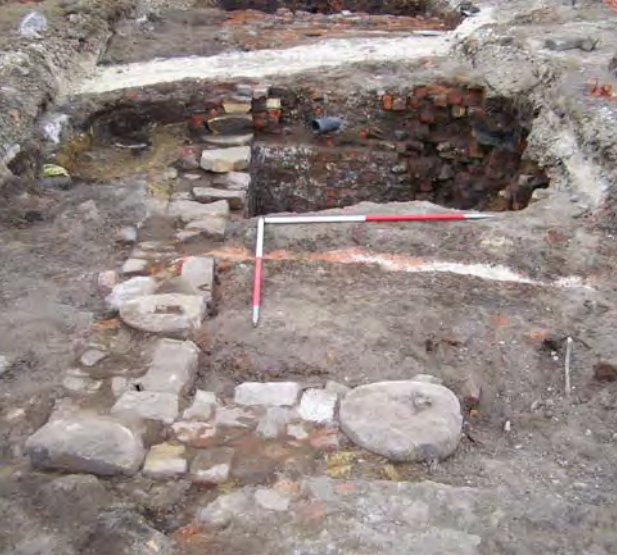
Figure 64 Area H, grindstones in cellar wall of No. 33 Jobson Road

decommissioned. Others, notably, were found reused in the construction of domestic housing on the site of the former Roscoe Place Works (Fig. 64); one was also found in one of the cellars of the back-to-back houses on Burnt Tree Lane (Fig. 55). Grindstones of many different sizes were recorded (Figs 51 and 67), perhaps reflecting the wide range of steel products (such as cutlery, scissors, pocket knives, files etc.) manufactured on the site, although discarded grindstones are commonly found throughout Sheffield.

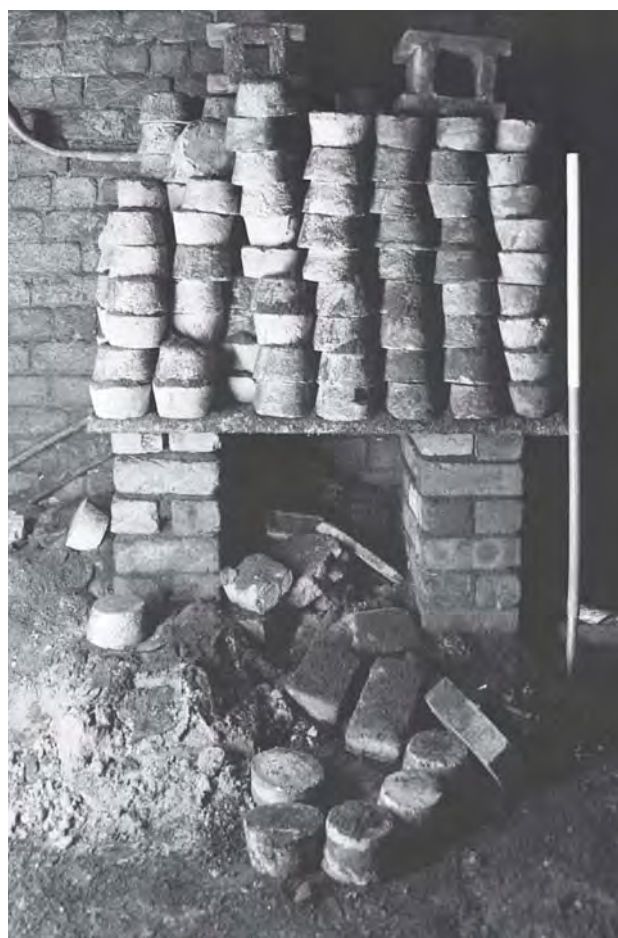
Figure 65 Stacked ‘cheeses’ in Titanic Works Cellar 2

making the crucibles. Other objects found among the debris in Cellar 2 included a crucible lid, and numerous ‘cheeses’ on an iron-topped table at the north-east end (Fig. 65), as well as wooden formers for manufacturing dozzles, and the elliptical templates – looking like oval barrels – around which the ganister linings of the melting holes were rammed (Fig. 66). On the stone-topped table within the ancillary room were an iron ring used to form the rim of the crucible, and a curved iron plate, pairs of which were used to lift the crucible off the stand.

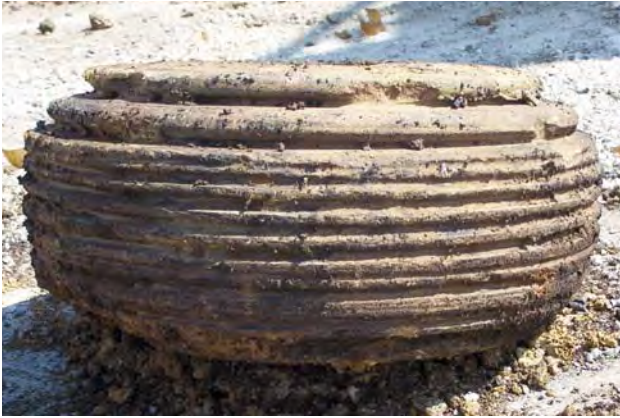
Figure 67 Grooved grindstone
