# Bath Quays Waterside

**The Archaeology of Industry, Commerce and the Lives of the Poor in Bath's Lost Quayside District**

Wessex Archaeology Occasional Paper  
2020

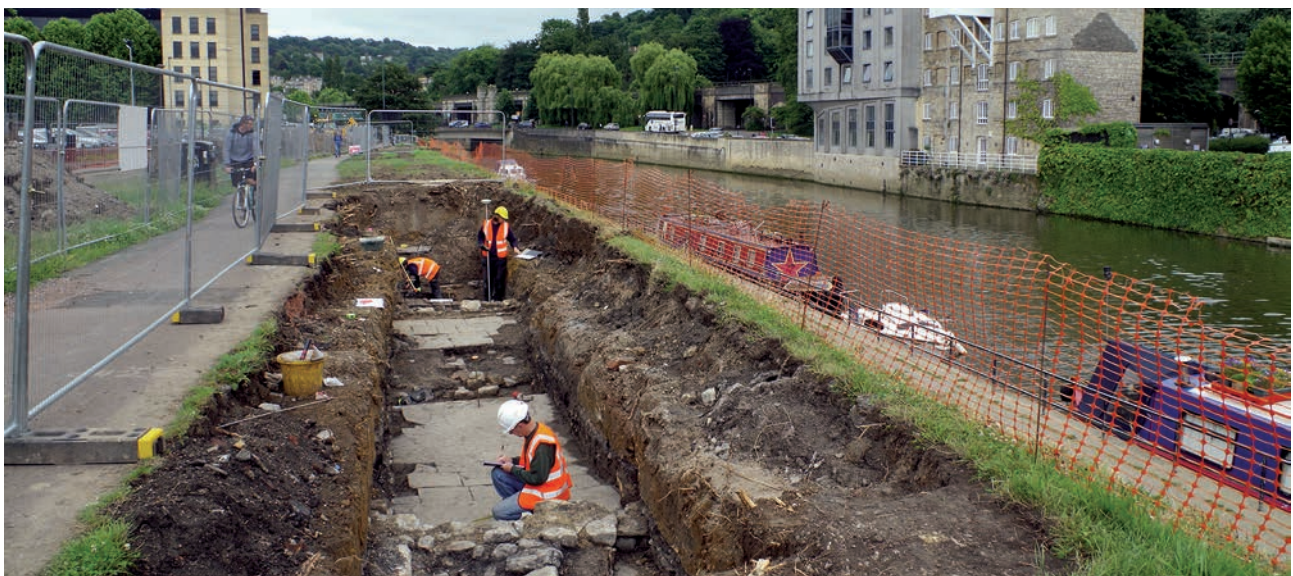
Plate 1.2 Evaluation trench along Green Park Road, from the north-west, showing archaeological remains of 18th-century buildings beneath modern made ground

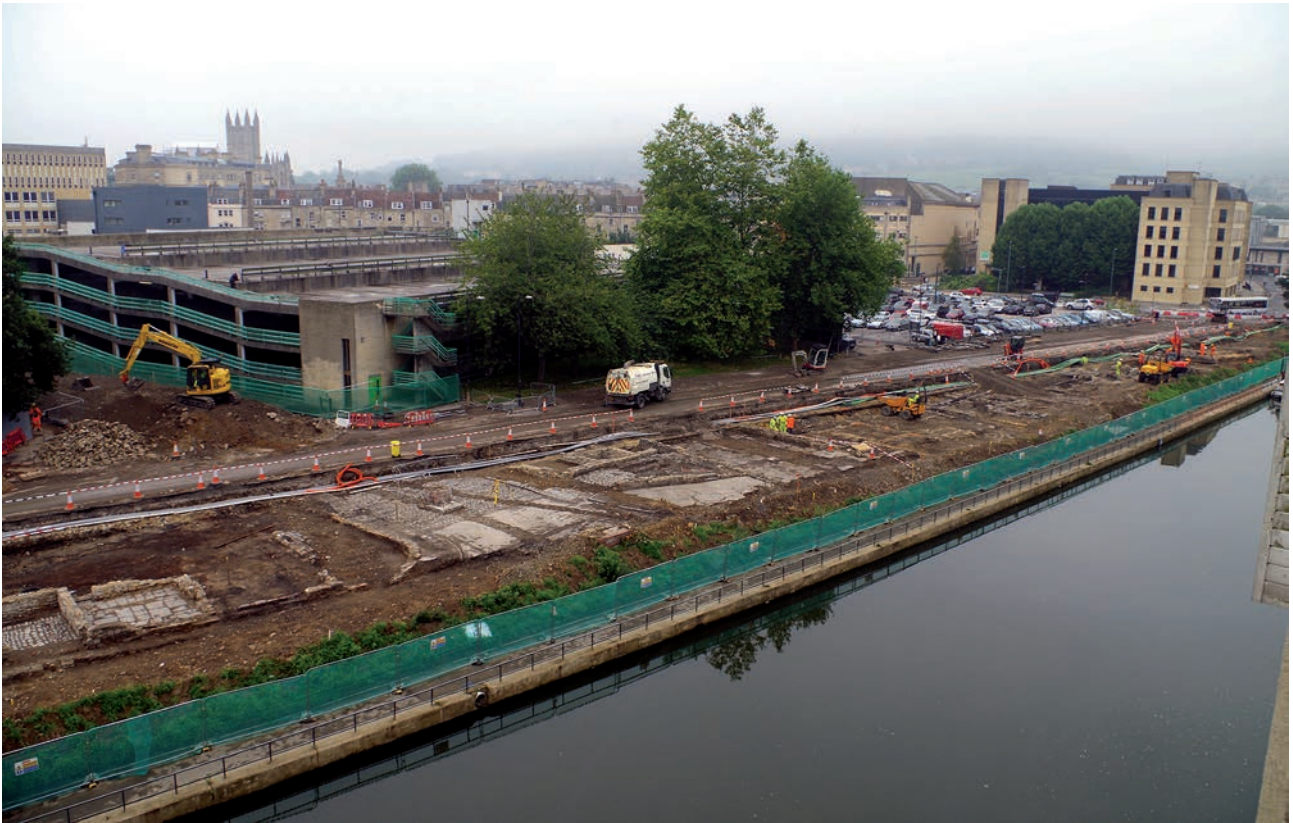
*Plate 1.3 Excavation area from the west, showing the excavated remains of buildings along Avon Street and New Quay, with Avon Street multi-storey carpark in the background*

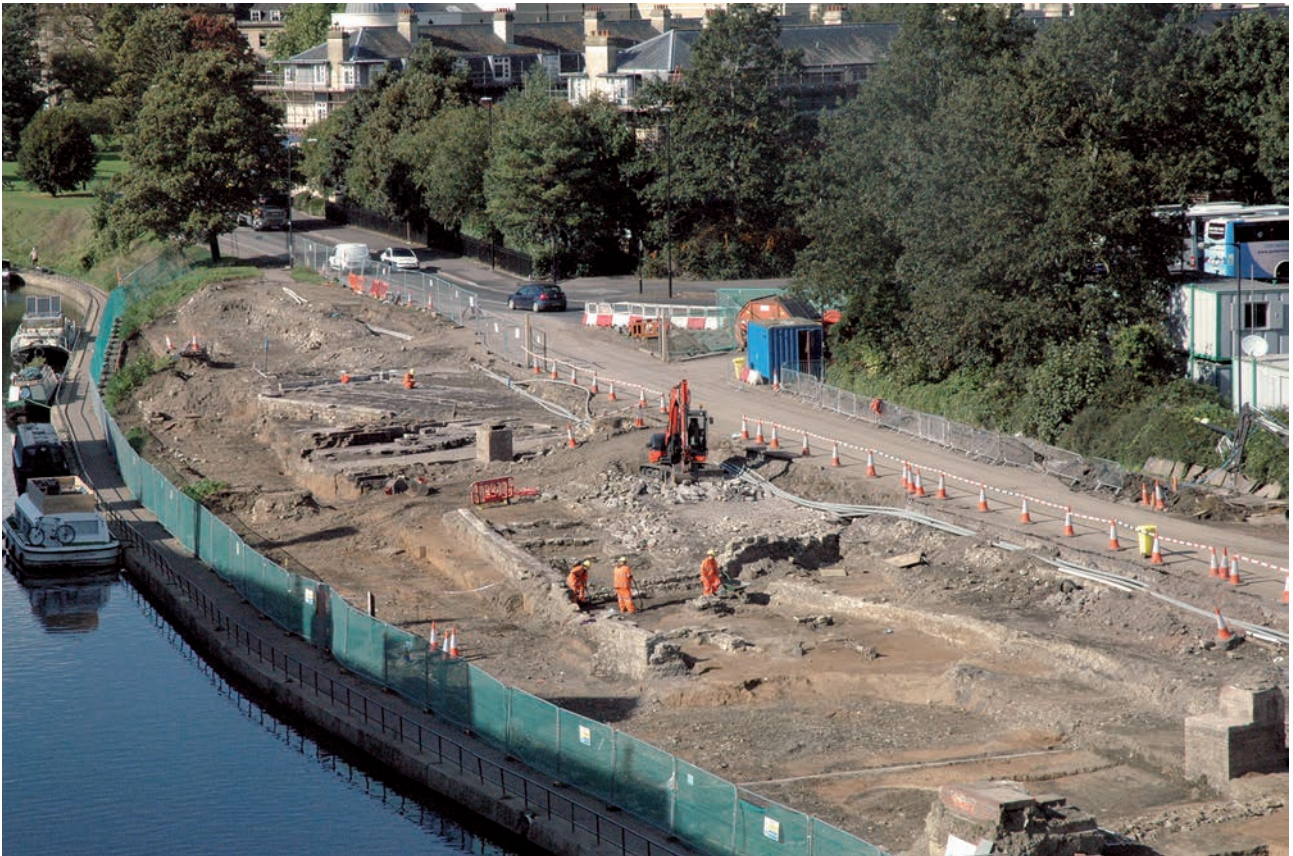
*Plate 1.4 Excavation area from the south-east, showing the excavated remains of buildings along New Quay and Milk Street, with Kingsmead Flats in the background*

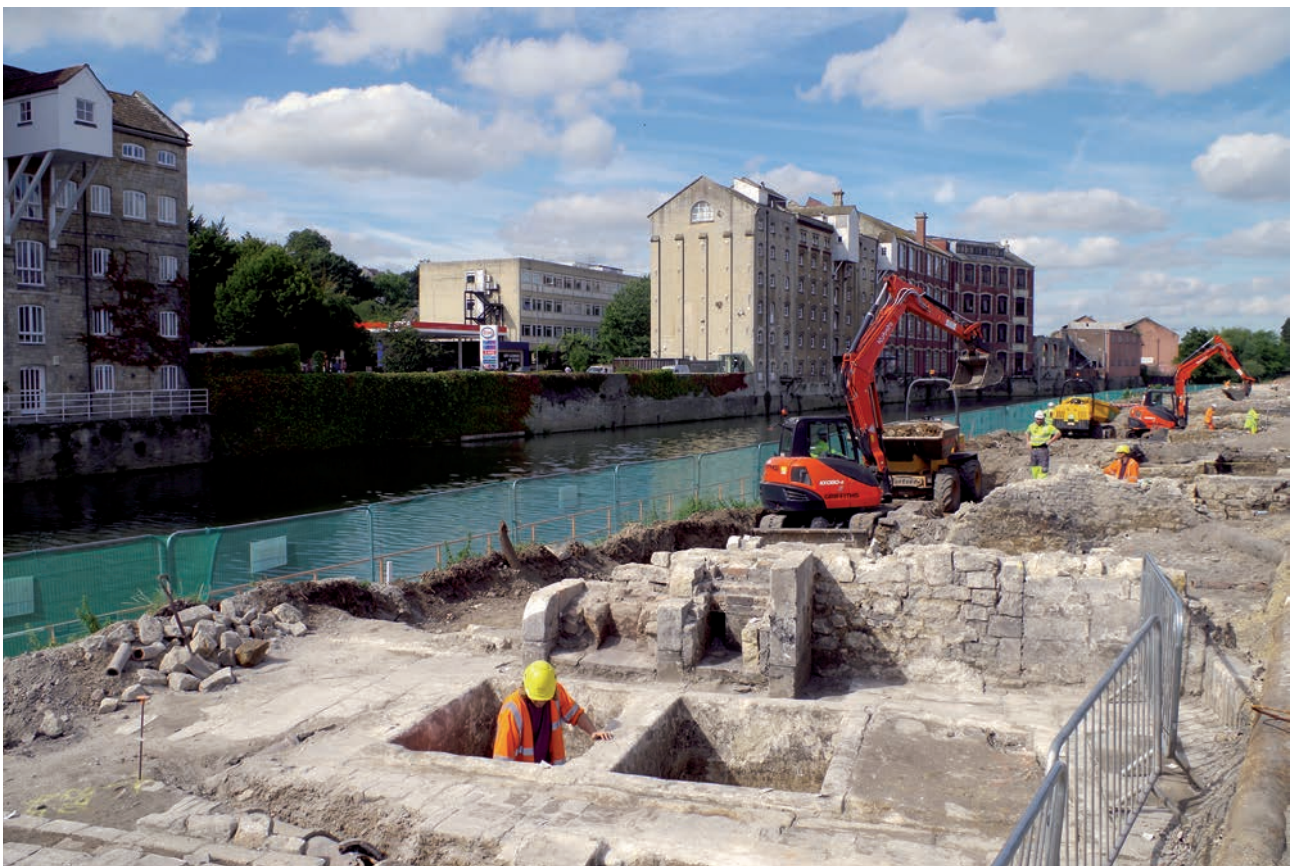
*Plate 1.6 Excavation of stone-lined liming pits within an 18th-century fellmongers and parchment works at 3 New Quay (view from the north-east), with Camden Malthouse, Camden Mill and the Albion Stay Factory in the background*

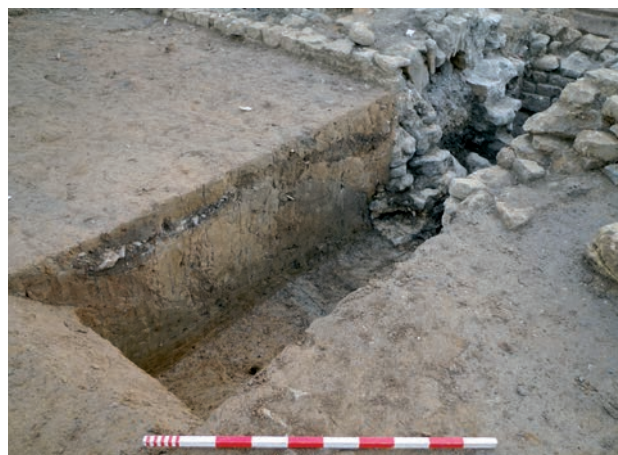
Plate 2.1 Section across the medieval ‘Fosse Dyke’ (S1), culvert S19 and wall S2, from the west

The earliest archaeological feature on the site was a 7.3 m wide ditch (S1; Figs 2.4 and 2.5; Pls 2.1–2.3). This feature, known as the Fosse Dyke, formed the boundary between St John’s Mead/Little Kingsmead (OA1) and Ambury (OA2). The top of the ditch was recorded at 16.6 m OD and it was hand-excavated to a maximum depth of 1.2 m. Hand-augering below this level showed that the ditch was over 2.4 m deep. The lower fills were not excavated, as they were deep enough to be preserved *in situ*. The ditch had steep or undercutting sides and the lower fills (seen during hand-augering) contained organic remains, indicating that the ditch was water-filled when in use. This is consistent with the dyke’s documented use as an outfall from the Hot and Cross Bath springs. The upper ditch fills contained charred grains of wheat (*Triticum aestivum/turgidum*) and barley (*Hordeum vulgare*) derived from domestic crop-processing activities, and the seeds of docks (*Rumex* sp.), trefoil (*Trifoliae*), and

of a revetment wall (S2) on the east side of ditch S1 (Figs 2.4 and 2.6; Pls 2.1–2.3). Wall S2 was 0.8 m wide, 0.6 m high and constructed of rough-hewn Bath Stone blocks bonded with clay. This structure is likely to be the foundations of the crenellated ‘wall between St James’s Ground and Kingsmead’ that was constructed or repaired in 1580.

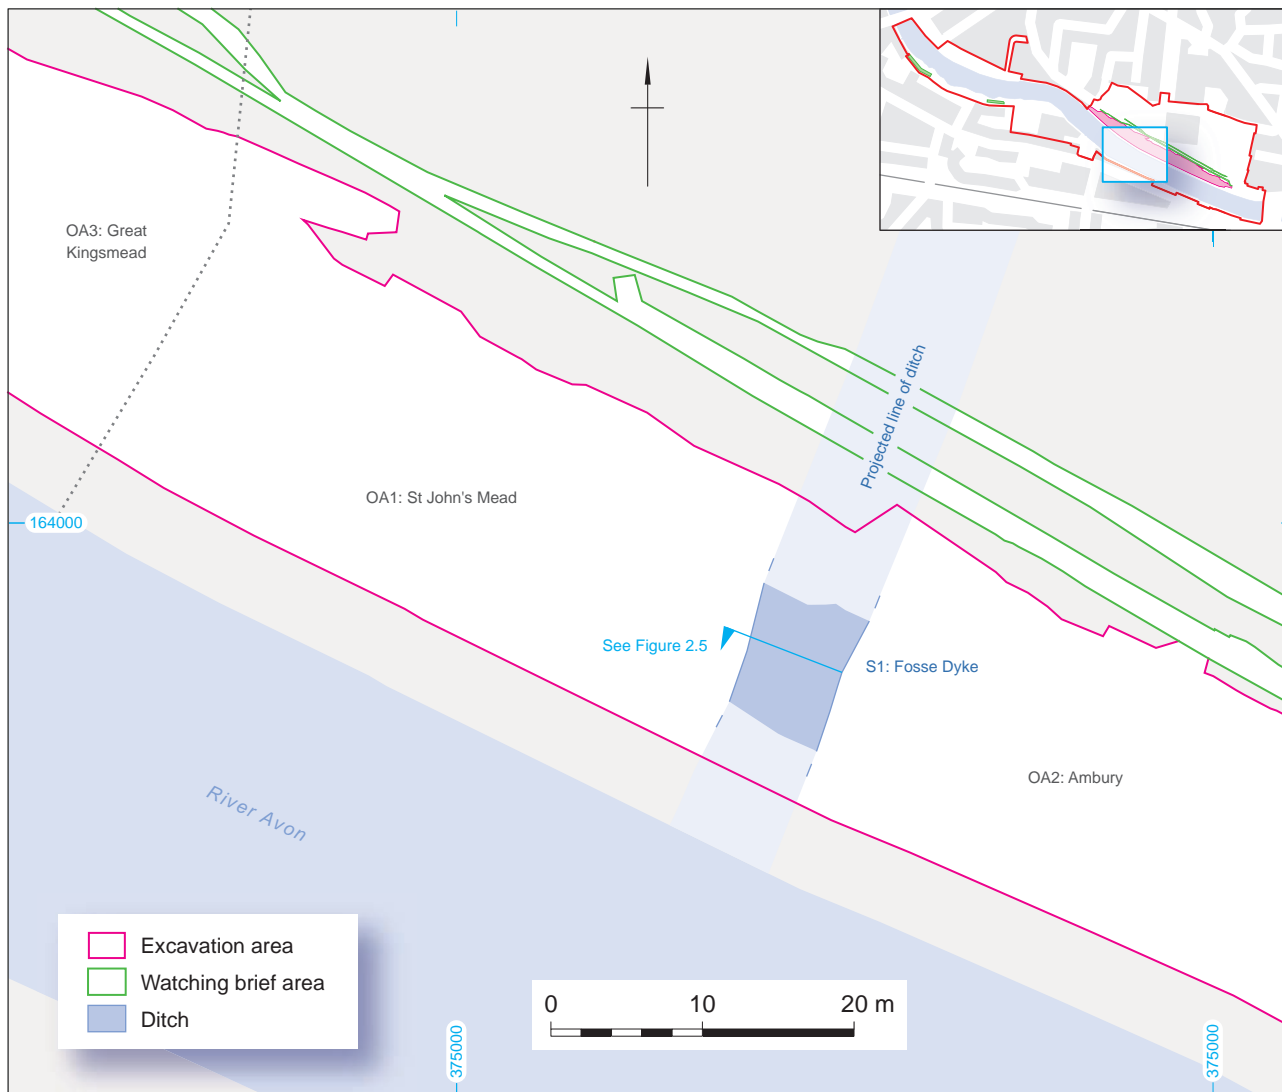
Figure 2.4 Plan of medieval features

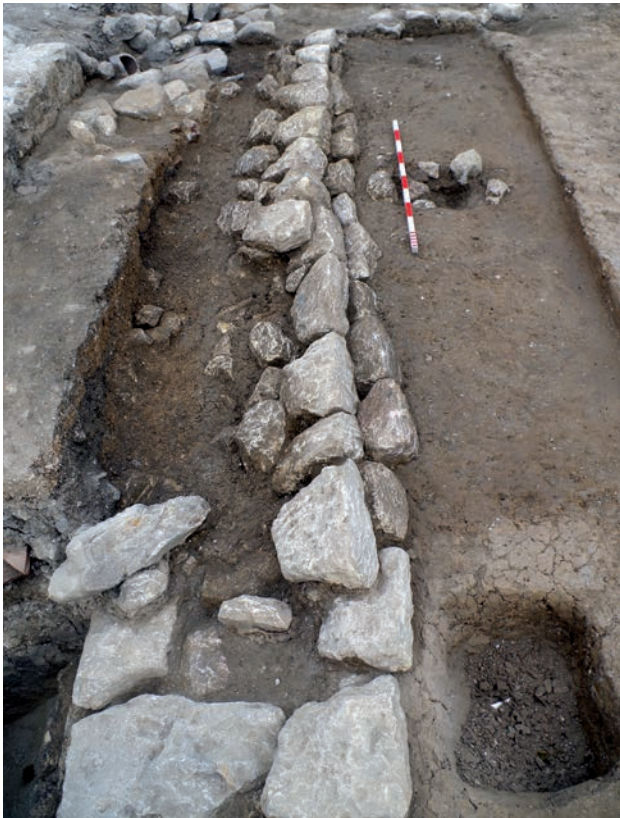
Plate 2.2 Late medieval/early post-medieval wall S2, from the south-west

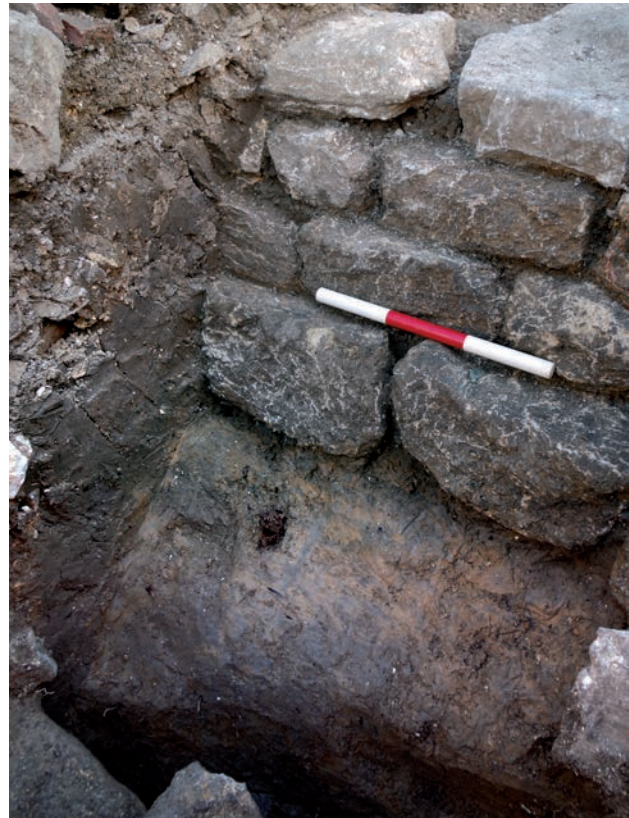
Plate 2.3 Late medieval/early post-medieval wall S2, from the west

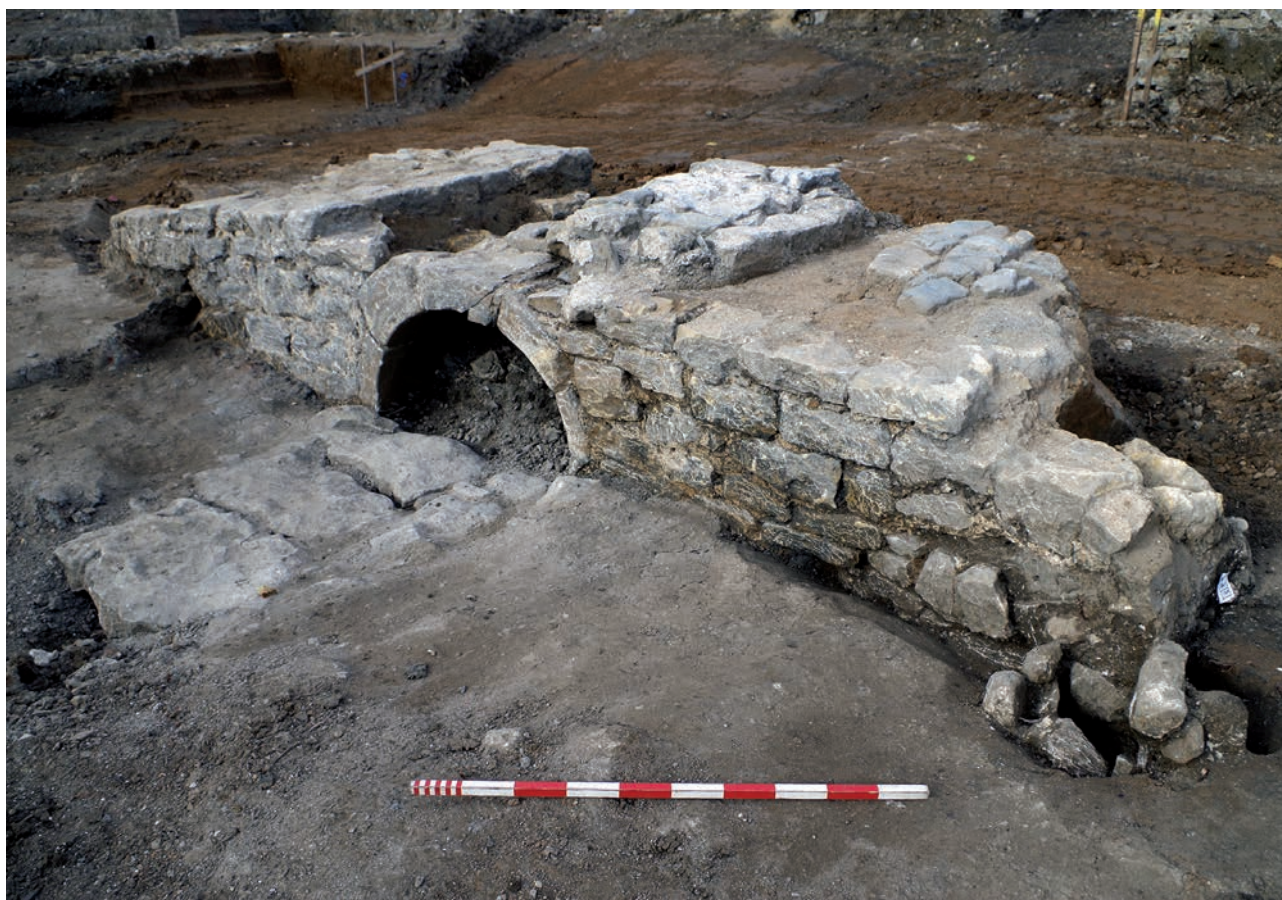
*Plate 2.6 c. 1685–1735 bridge S6, from the west*

The clinker-filled cart ruts were cut by the foundations of a small stone footbridge (S6; Fig. 2.8; Pl. 2.6), which was constructed of roughly-hewn Bath Stone blocks, with cut-stone voussoirs forming a neat, round, 1 m wide arch, with a cobbled footway above. The bridge was 4.7 m long, 2.4 m wide at its

western abutment, narrowing to 1.5 m above the arch. Given that the earlier track (indicated by the cart ruts) would have traversed the water-filled Fosse Dyke, it seems probable that there was an earlier, possibly wooden, bridge in this location. A single stone-packed posthole (S5) recorded adjacent to, and partially below, the bridge’s eastern abutment could potentially have been associated with an earlier bridge, but this could not be confirmed. No direct dating was recovered from the bridge structure itself, but the fact that it truncated the clinker-filled cart ruts indicates that it certainly post-dates 1685. The bridge is not shown on Gilmore’s plan, which may indicate that it was built after 1692, but this is uncertain, as the cartographer may simply have omitted this detail. Bridge S6 was abutted by stone culvert S19, which was probably constructed in the late 1730s, giving the bridge a potential construction date of *c.* 1685–1735.

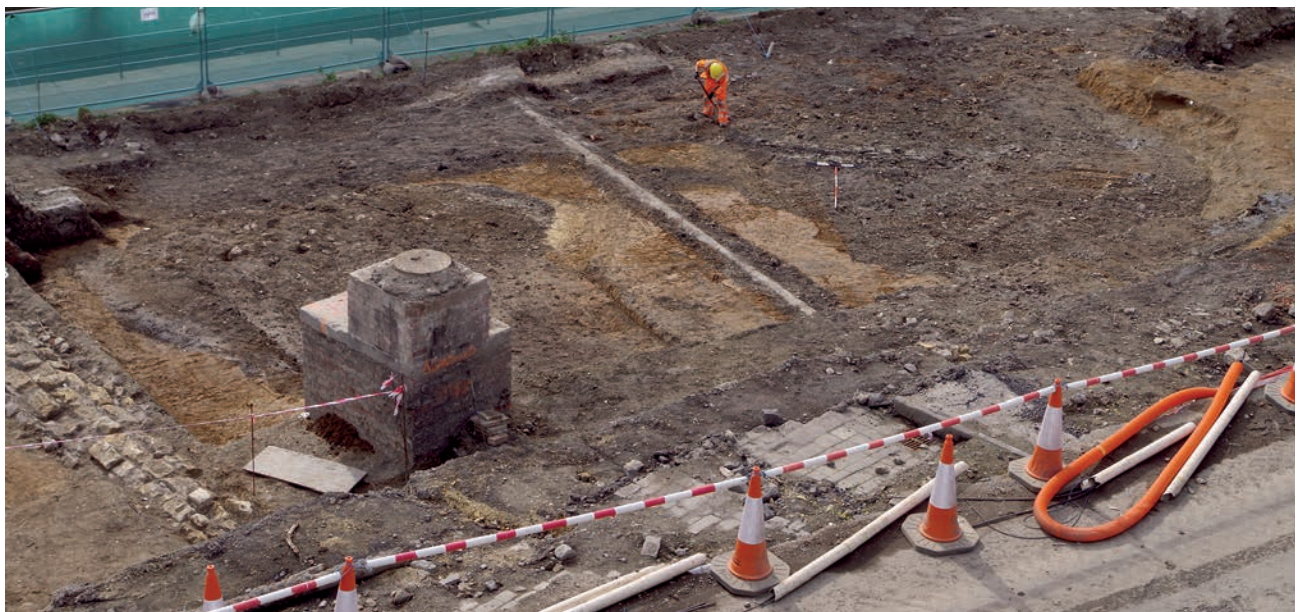
Plate 2.7 Post-medieval quarrying (S7) in St John's Mead/Little Kingsmead, from the north-east

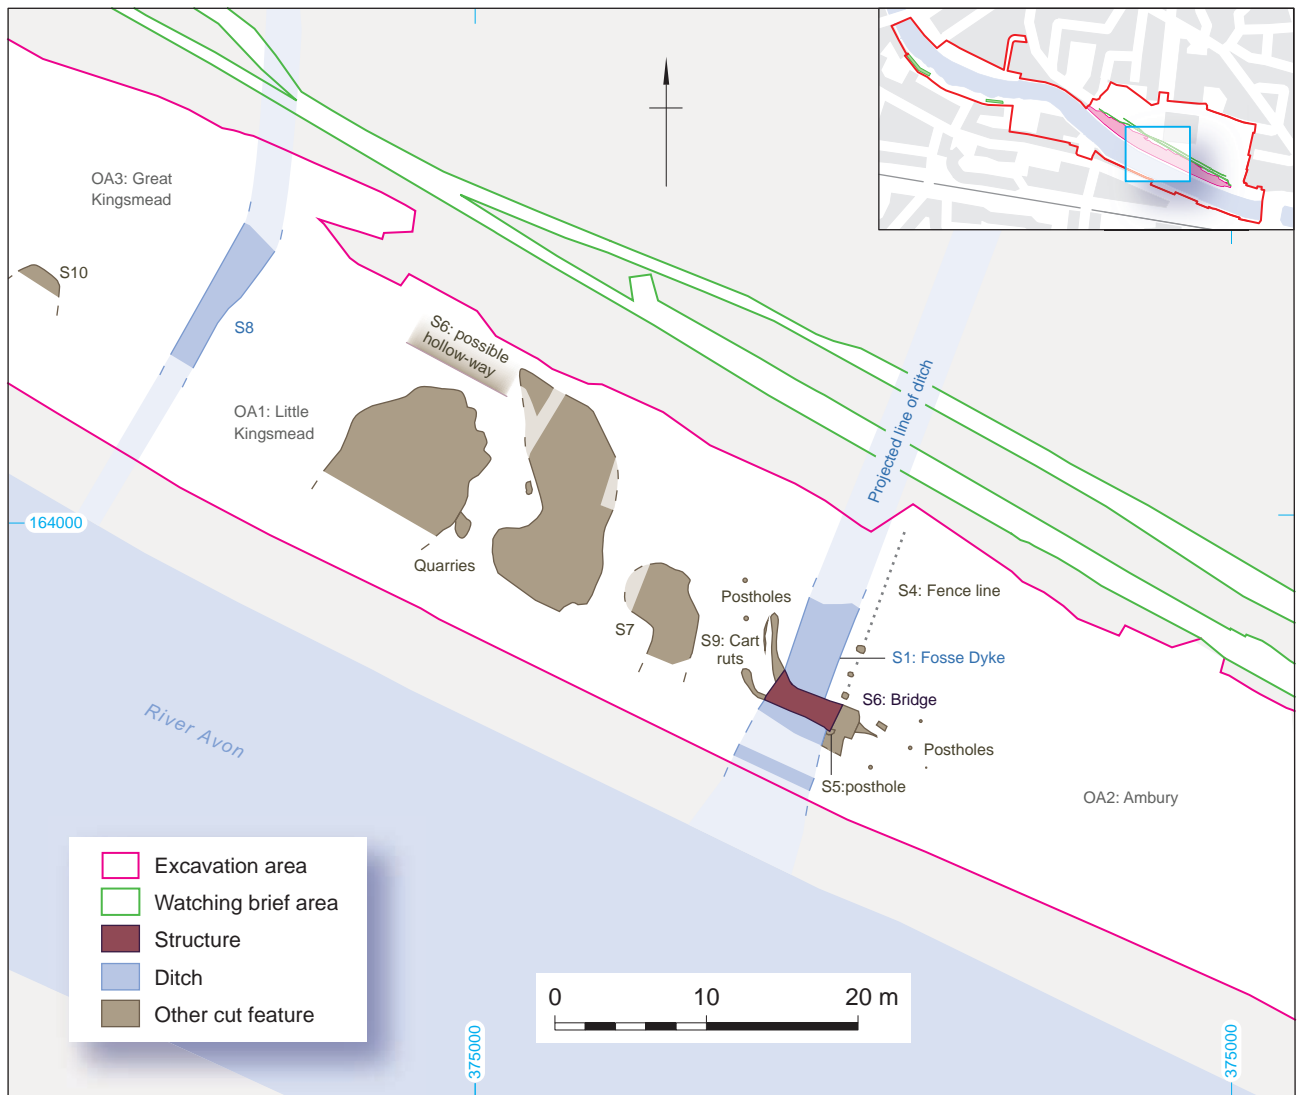
Figure 2.8 Plan of late 17th–early 18th-century features

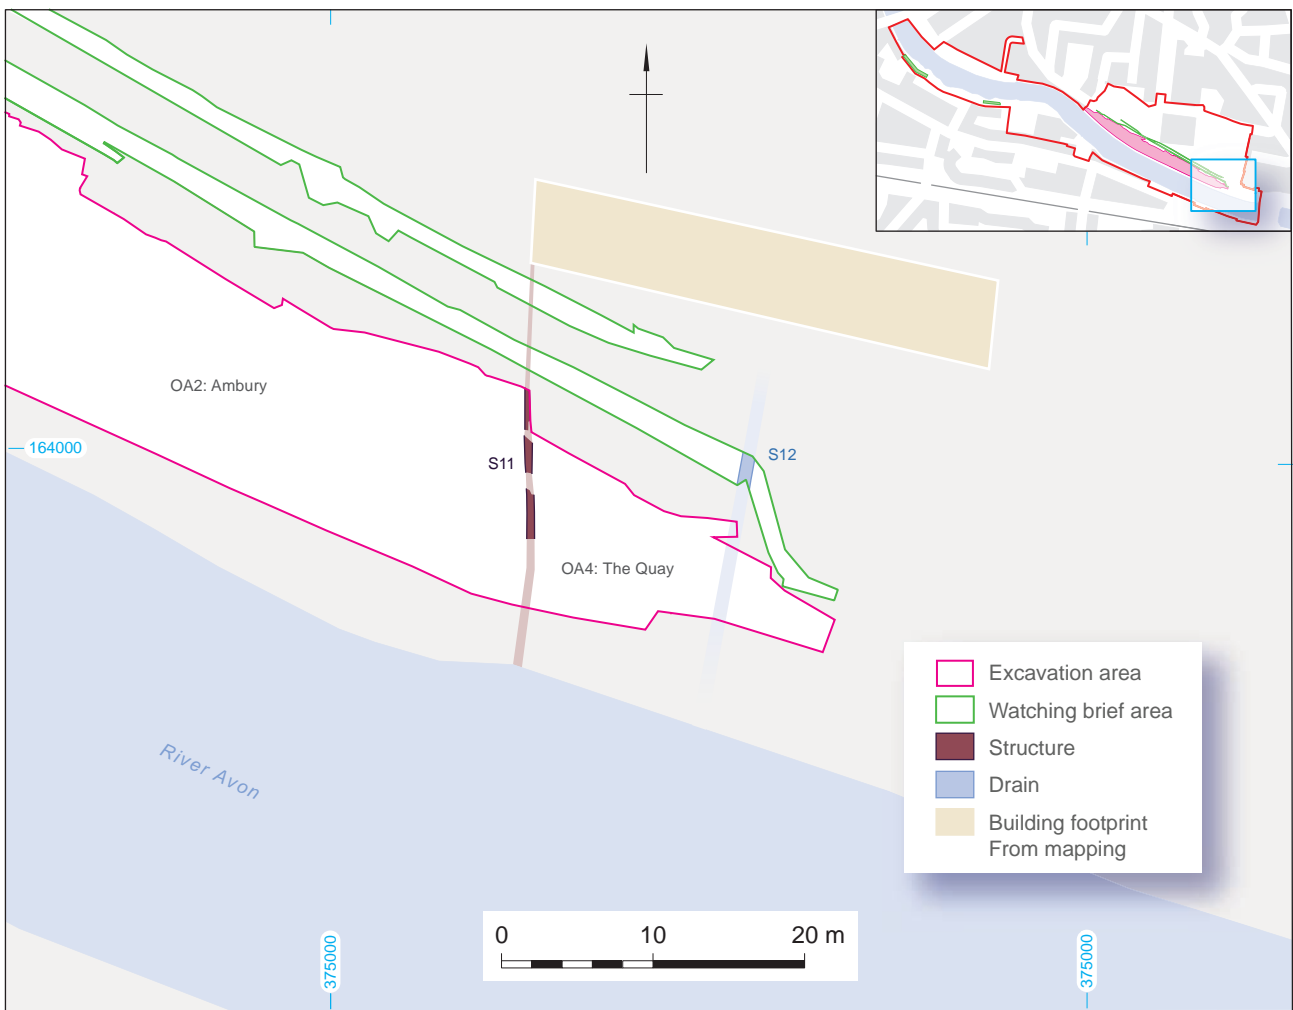
Figure 3.9 Plan of archaeological features around The Quay, c. 1729–60. Building outline based on excavated structures, documentary evidence and 18th-century maps

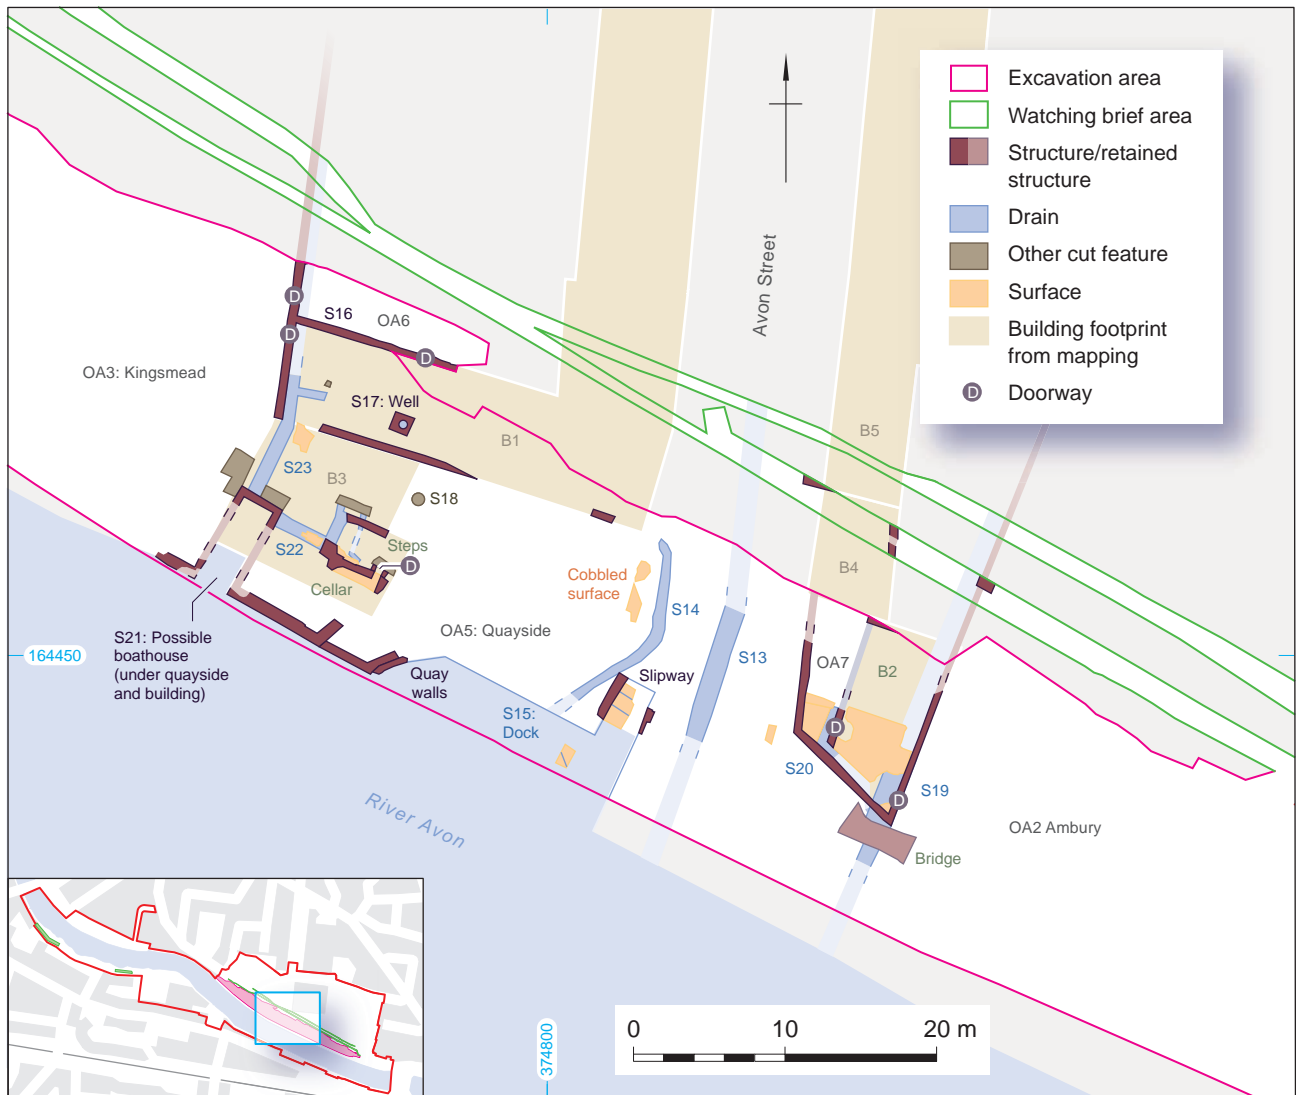
Figure 3.10 Plan of archaeological features at the southern end of Avon Street, c. 1729–60. Building outlines based on excavated structures, documentary evidence and 18th-century maps

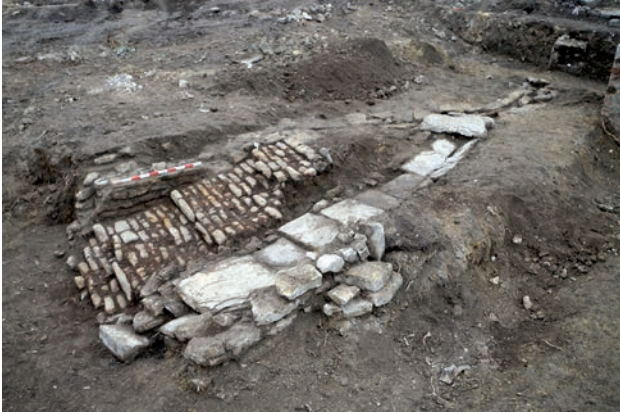
Plate 3.1 Late 1730s slipway S15 at the southern end of Avon Street, cut by 19th-century stone-lined drain, from the south-east

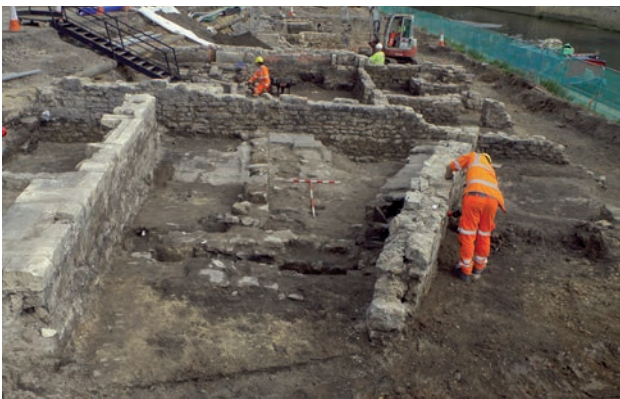
Plate 3.2 Late 1730s building B2 (centre), and mid-18th-century houses B6 (left) and B12 (background), from the north-west

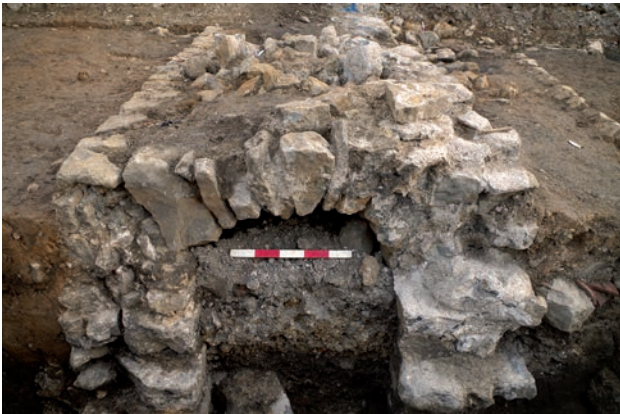
Plate 3.3 Late 1730s culvert S19, from the south-west

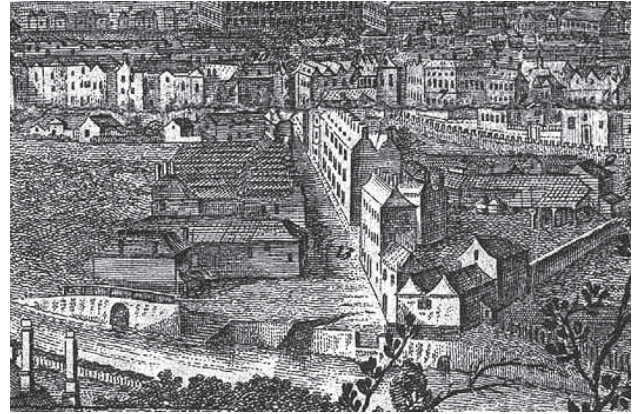
Figure 3.11 Detail of Thomas Robins' A South West Prospect of the City of Bath, 1754 (reissued 1757), including quayside at the southern end of Avon Street, showing slipway S15 and two arched openings to the sides: the smaller of the two (to right) is the outfall for culvert S19; the larger arch (to left) may be a subterranean boathouse (S21) below building B3

access onto the Kingsmead meadow, the other linking B1 to the garden of the house to the north, perhaps suggesting that these properties were related. No internal partitions were evident and there were no surviving floor surfaces. B1 is depicted on Robins' Prospect of 1754 (Fig. 3.11) as a one- or two-storey structure with a hipped roof. This building, which was demolished in 1874, was never given a street number, which suggests that it was probably a non-domestic structure. Stone-lined well S17 was probably contemporary with B1, though the well remained in use long after the building was demolished. A mortar-mixing pit S17, located to the south of B1, was probably associated with the construction of B1, or possibly B3, immediately to the west.

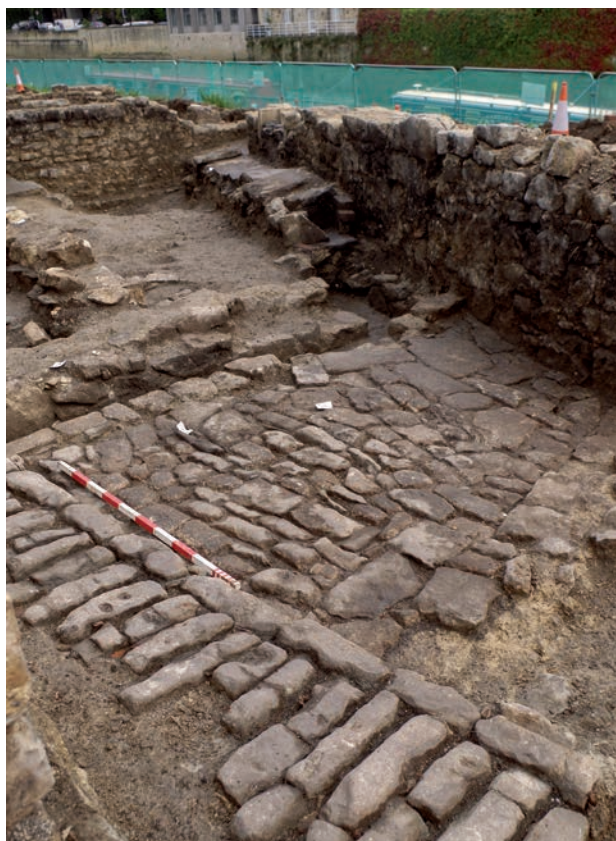
*Plate 3.4 Late 1730s cobbled surfaces OA7 and drain S20, from the north-west*

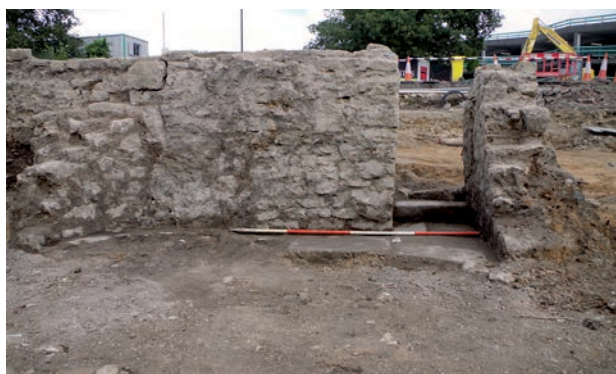
*Plate 3.5 Cellar of 1740s building B3, from the south-west*

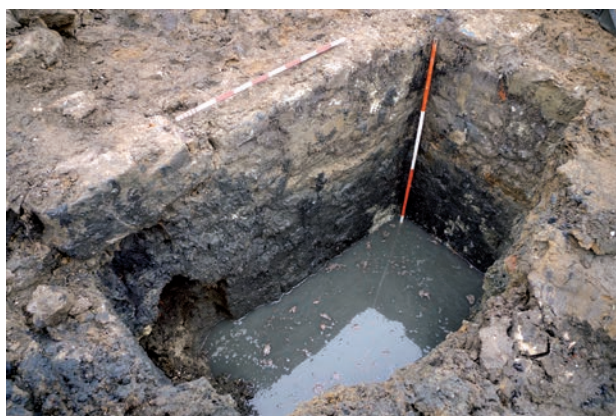
*Plate 3.6 Mechanically-excavated slot at north-eastern end of possible 1740s boathouse dock S21, from the west*

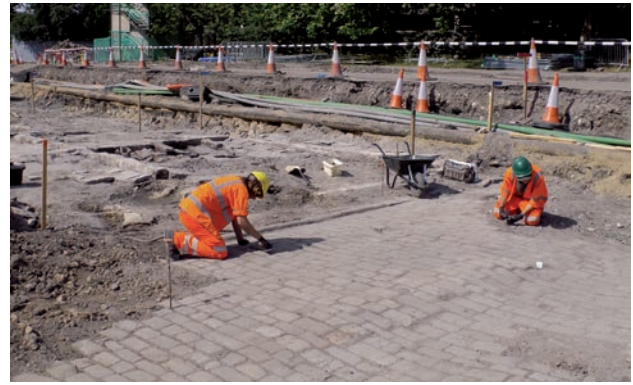
Plate 4.1 Little Corn Street, from the south

Little Corn Street was laid out in 1764. The road was paved with setts and edged with kerbs, and there were flagstone-surfaced pavements on both sides

(Pl. 4.1). Parts of these surfaces had been lifted to allow the insertion of later services (eg, water, gas and drains), but there was no indication that the street was ever completely re-paved. A stone-lined drain (S36) along the east side of the street appears to have been contemporary with the construction of the road.

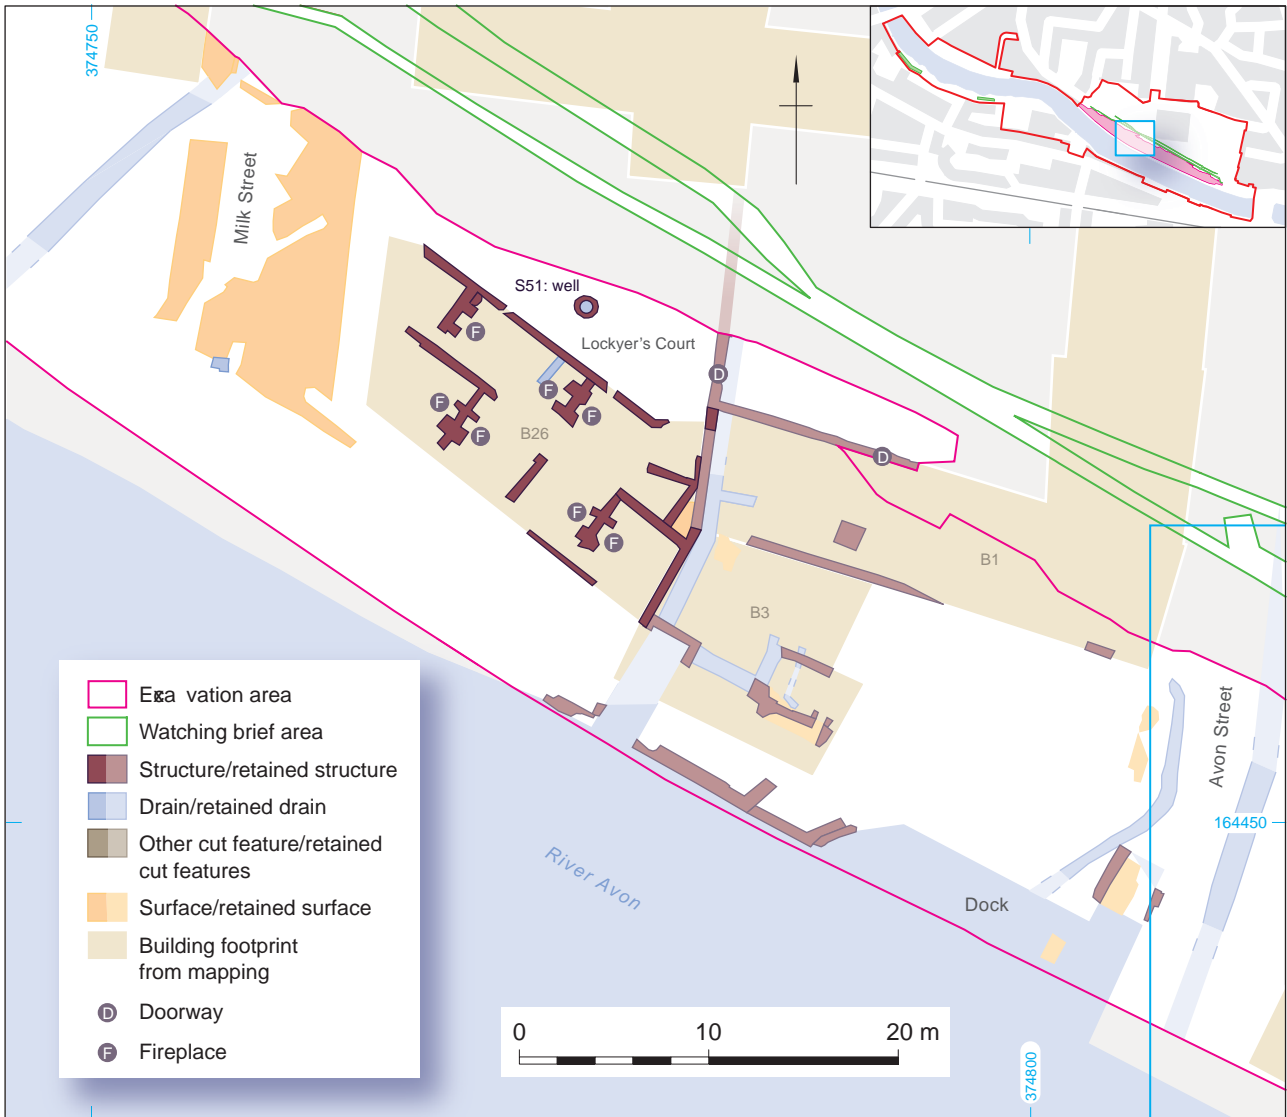
Figure 4.8 Plan of c. 1760–1800 archaeological features along New Quay. Building outlines based on Harcourt Master's plan of 1794

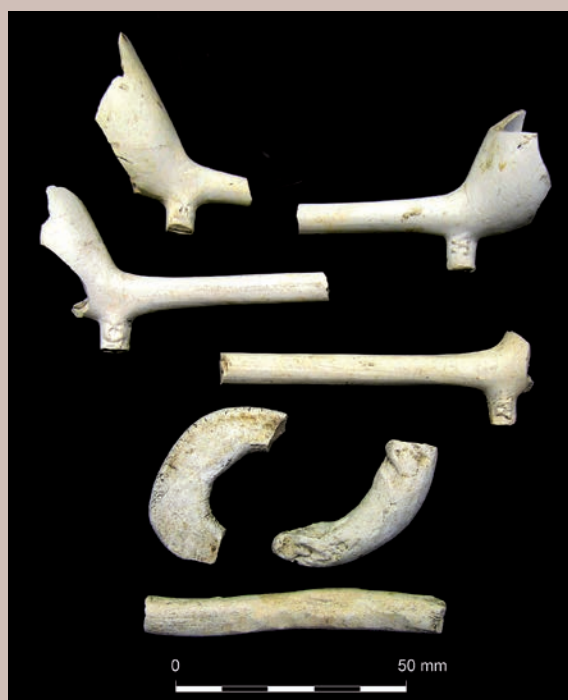
*Plate 4.2 Pipes of Thomas Clarke and Richard Ward, and kiln furniture*

The clinker deposit on which the flagstones of Milk Street's western pavement were bedded contained a dump of clay tobacco pipemaking waste (Pl. 4.2). This is workshop kiln waste from the factory operated under a partnership between Thomas Clarke and Richard Ward at 86 Avon Street between c. 1790 and 1806, though their moulds continued to be used until at least 1811 (Lewcun in prep.). Pipes have been found with their surname initials arranged in the form of either C/W or W/C on the sides of the spur, but this is the first time that the two forms have appeared together in a sealed deposit, and the circumstances conclusively confirm that both types were produced in the same factory. Five mould forms were identified amongst the 46 bowls, four with the initials embossed as C/W and one as W/C. Three items of kiln furniture were recovered: two rolls and one fragment of wad, each made of pipeclay. Rolls were used to separate groups of pipes in the firing chamber, while wads were cemented together the series of props which formed the central spine of the kiln (Peacey 1996, 68–70).

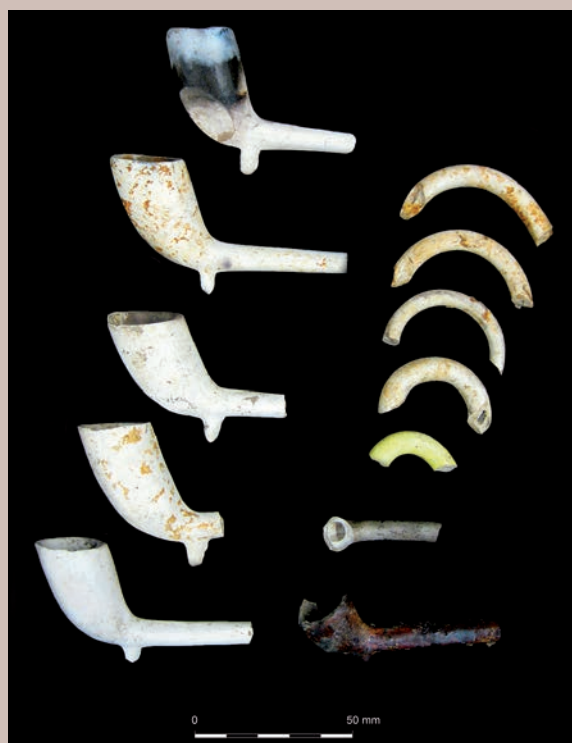
*Plate 4.3 Clay pipes and kiln furniture*

The ash-rich deposit used to infill the dock probably derived from kiln flue rakings and produced 69 clay pipe bowls from six moulds dating to somewhere between 1810 and 1840 (Pl. 4.3). The pipe bowls are all plain, and none of the mouthpieces or tips of the stems are glazed. Only one pipe is marked, with the initials W/C of Clarke and Ward (see above *Clay Pipemaking Waste from Milk Street*), but this is earlier in date. In the absence of the marks of any other makers, the remainder of the pipes are probably products of John Laffar, who is documented as having taken over the factory and purchased the working tools and moulds, probably including that for the W/C pipe, from the Clarke family in 1811 (Lewcun 1994, 135), in which case this is the first group of pipes in the city which can be attributed to him. Among the pipes were 41 items of kiln structure and furniture, as well as a small finger-ring and a fragment of green-glazed figurine, both made of pipeclay.

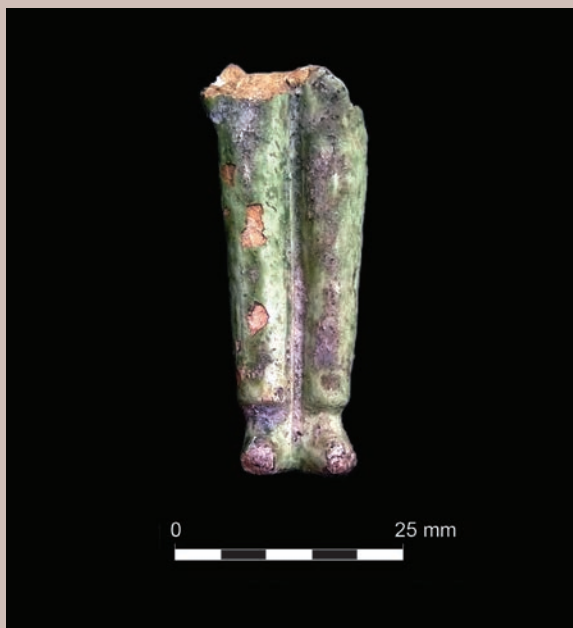
Plate 4.4 Pipeclay figurine

The fragment of pipeclay figurine is of particular interest, as no parallel has been found in published literature (Pl. 4.4). The example from Bath Quays is incomplete, and consists only of the legs and feet, hand-made rather than in a mould, and is coated with a pale green glaze. There is a conical indentation at the top of the fragment, but in the absence of the other remains of the figurine the purpose of this is unclear. The size and simplicity of the figurine suggest that this particular example was a child's toy, which presumably broke during the manufacturing process. In the 19th century there was a big growth in the mass production of toys for children, with many items being imported from Germany, but this did not gain much momentum until after 1850. The manufacture

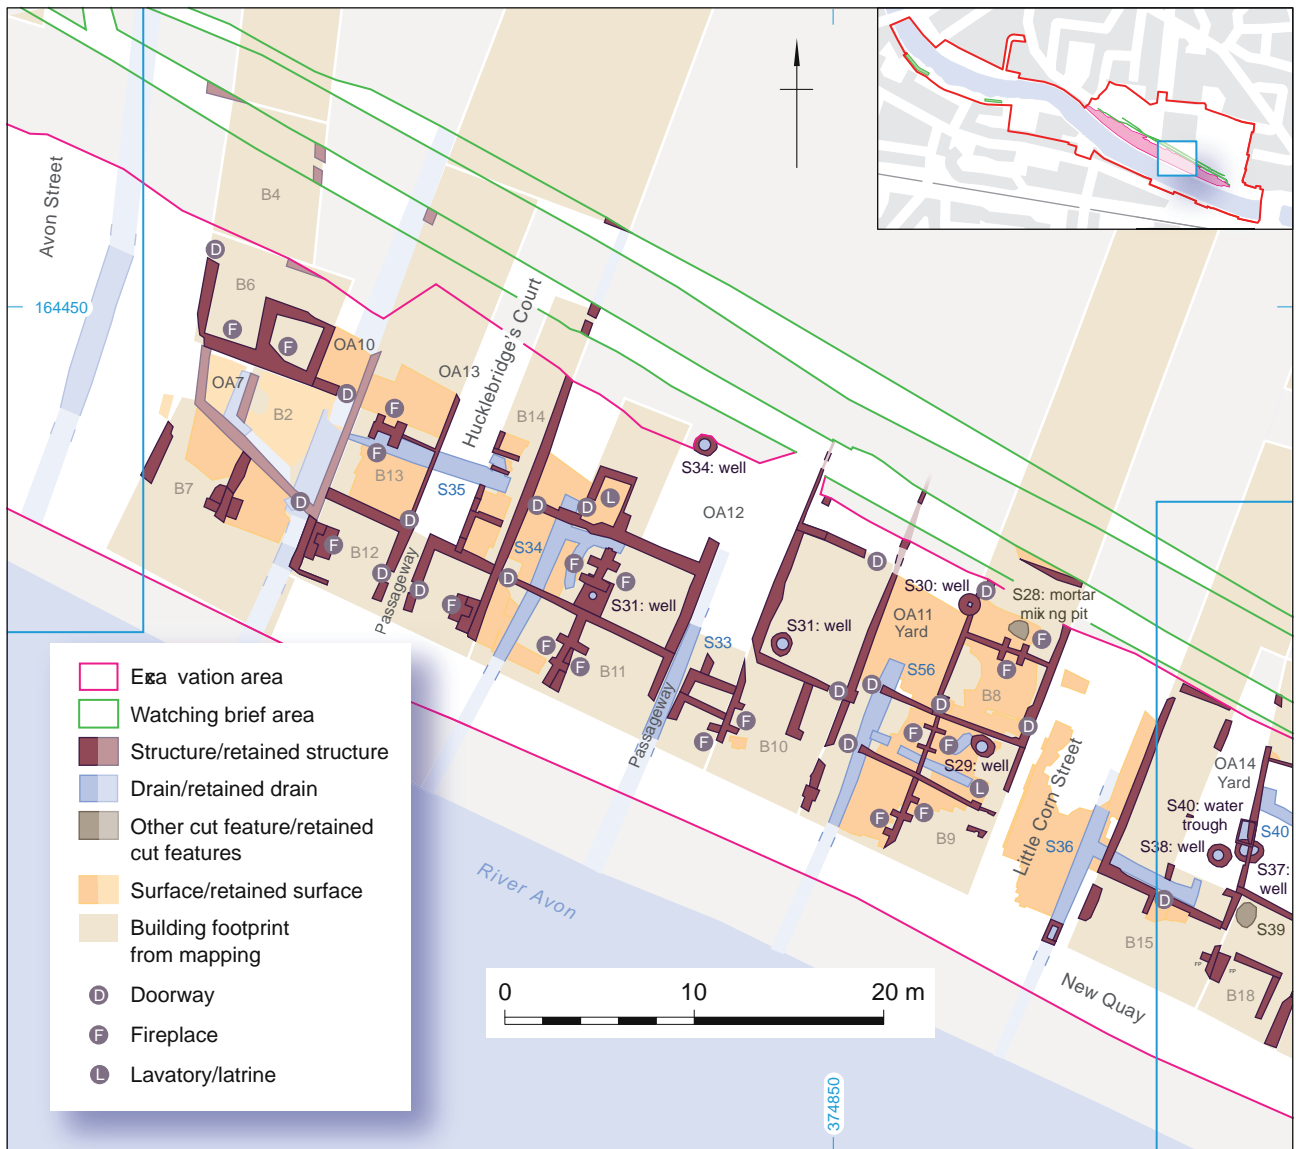
Figure 4.9 Plan of c. 1760–1800 archaeological features along New Quay. Building outlines based on Harcourt Master's plan of 1794

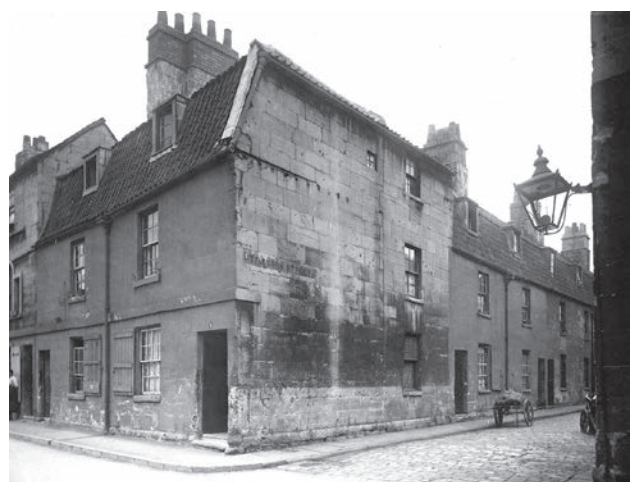
Plate 4.6 c. 1930 view from the same position as Pl. 4.1, showing 8–9 New Quay (B8) and 1–4 Little Corn Street (B9) from the south © B&NES Council

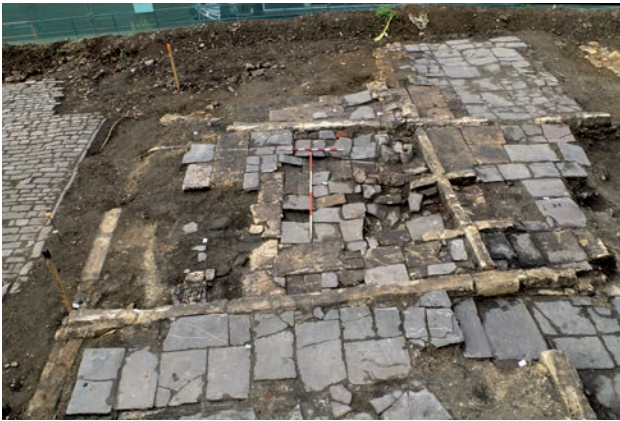
*Plate 4.7 8–9 New Quay (B8) and 1 Little Corn Street (B9), from the north-east. Note the uneven and subsiding floor surface caused by leaking drains*

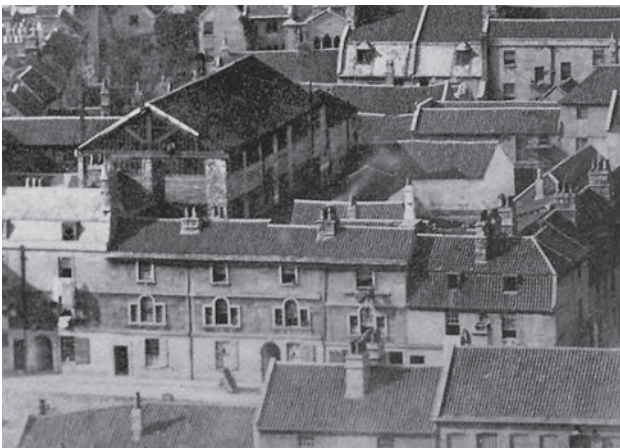
*Plate 4.8 8–15 New Quay (B8 and B10–B12) and 1–4 Little Corn Street (B9), from the south, taken between 1880 and 1885. Note the roof of Hucklebridge’s Court and the Bath City Brass and Iron Foundry (large barn-like building to the rear of 14–15 New Quay) © B&NES Council*

Late 19th-century photographs show that B12 (Pls 4.8 and 5.8) was a three-storey structure with a mansard roof over a fourth-floor garret. Apart from the roof, the building was built in the same style as the near-contemporary houses (B10–B11) to the east.
