# Bath Quays Waterside

**The Archaeology of Industry, Commerce and the Lives of the Poor in Bath's Lost Quayside District**

Wessex Archaeology Occasional Paper  
2020

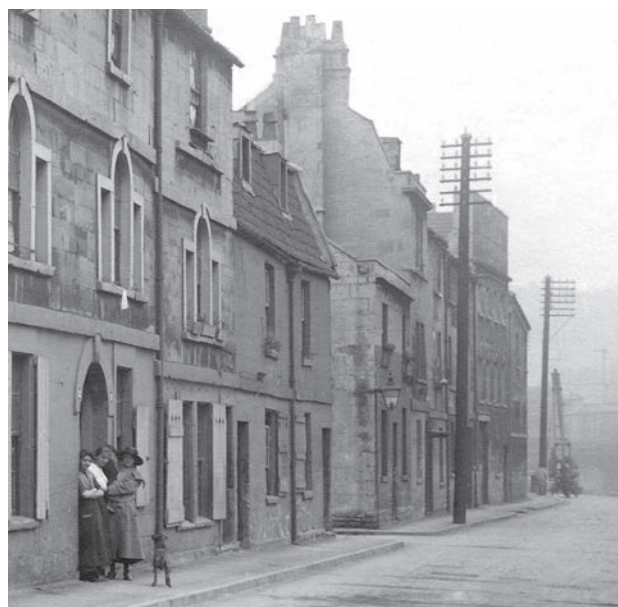
*Plate 4.10 c. 1930 view of 1–11 New Quay, from the west, showing (left to right) B11, B10, B9, B15, B16, B18, B19, B35 and B37. The women and dog are standing at the entrance to the covered way through B10*  
© B&NES Council

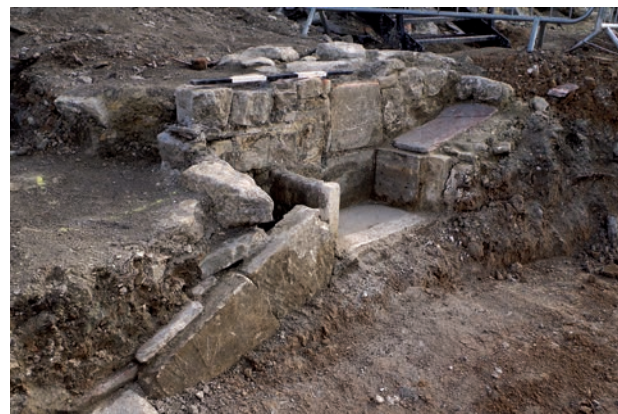
*Plate 4.11 Late 18th-early 19th-century drain to the rear of 13 New Quay (B11), incorporating a sewer gas trap, view from the west*

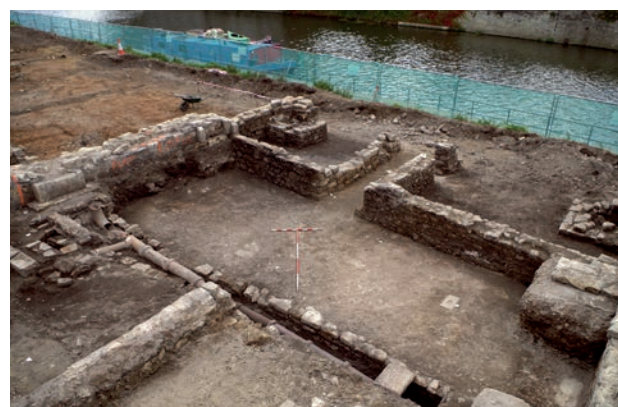
*Plate 4.12 Foundations of 1–2 Hucklebridge's Court/14–15 New Quay (B12), from the north, with partially excavated foundations of 3–4 Hucklebridge's Court (B13) and drain S35 in the foreground*

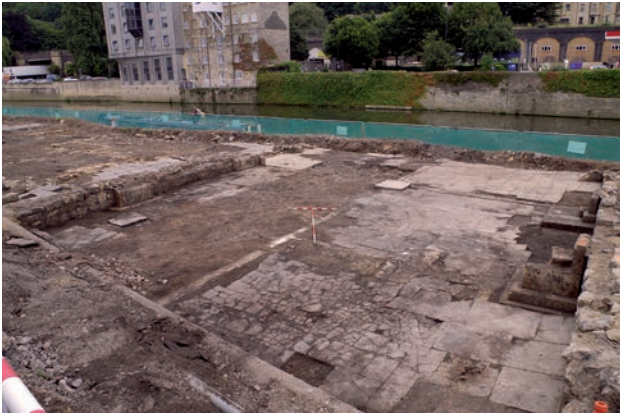
Plate 4.13 1–2 Hucklebridge’s Court/14–15 New Quay (B12) and 3–4 Hucklebridge’s Court (B13), from the north. Note the inserted pillar bases for an 1893 extension to Walker’s Firewood Mill

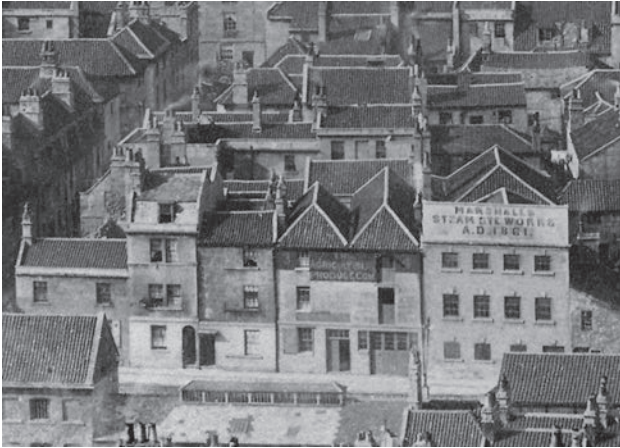
Plate 4.17 View from the south, showing 3–7 New Quay (right to left B35, B16, B19, B18 and B15), taken between 1880 and 1885 © B&NES Council

the property; the building was occupied by the end of the year (BRO DP 667; BC/5/70/8). Historic photographs (Pls 4.17 and 4.20) show that B18 was a three-storey double-pile house with a garret. The ground floor measured 7 m by 4.8 m externally and was divided into two rooms (Pl. 4.21). The front room had a fireplace against the north-west party wall. Later modifications and modern truncation had removed all traces of the original floor surfaces.

B19 (5 New Quay; Fig. 4.10) was a house that infilled the gap between B16 and B18. Historic photographs (Pl. 4.17) show that B19 abutted B18, and was therefore later. This is confirmed by documentary evidence, which indicates that the plot was vacant until 1773 (BRO BC/5/70/10). B19 was a simple three-storey structure with a pitched roof. A ground floor had a passageway providing access to a shared rear yard (OA15), with a single 4 m by 3 m wide room to the south-east (Pl. 4.21). The room

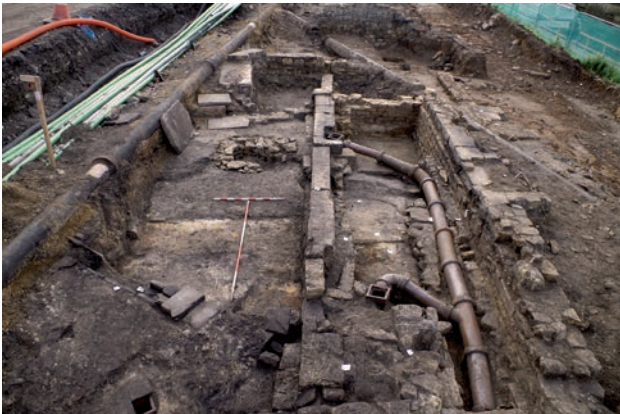
Plate 4.19 Foundations, yard surface (OA14), drains (S36 and S70) and wells (S37 and S38) to the rear of 7 New Quay (B15), from the north-west

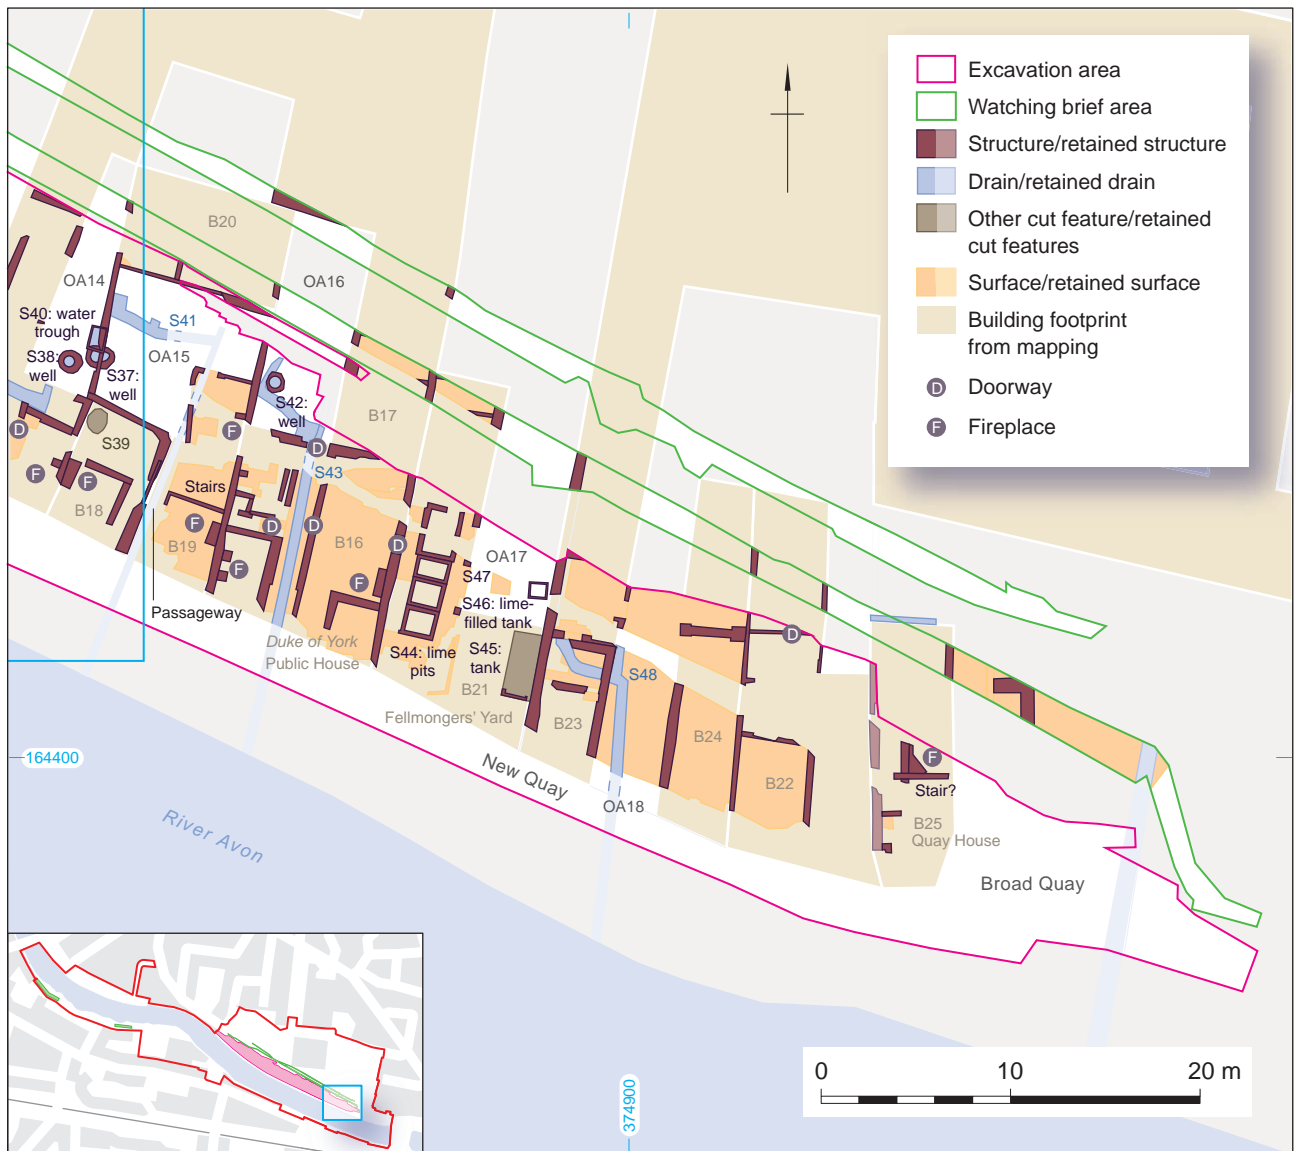
Figure 4.10 Plan of c. 1760–1800 archaeological features along New Quay. Building outlines based on Harcourt Master’s plan of 1794

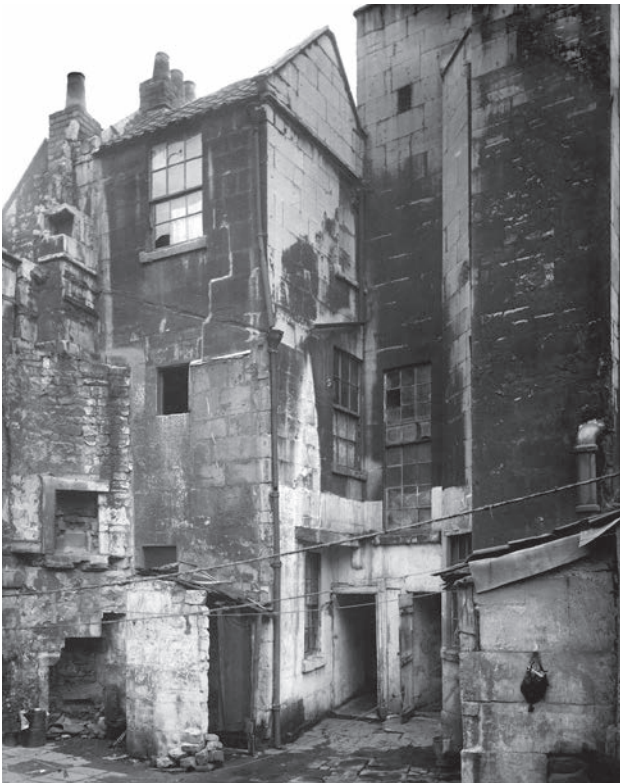
Plate 4.20 c. 1930 view of 5–6 New Quay, from the north  
© B&NES Council

Between 1794 and 1852, several small extensions were added to the rear of B18 and B19 (see Figs 4.18 and 4.19), one of which (to the rear of B18) appears to have been for a bay window. A c. 1930 photograph (Pl. 4.20), taken from the rear yard, shows that the first extension to the rear of B18 was three storeys high; later additions were one or two storeys high. The extensions and yard (OA25) were all paved with flagstones.

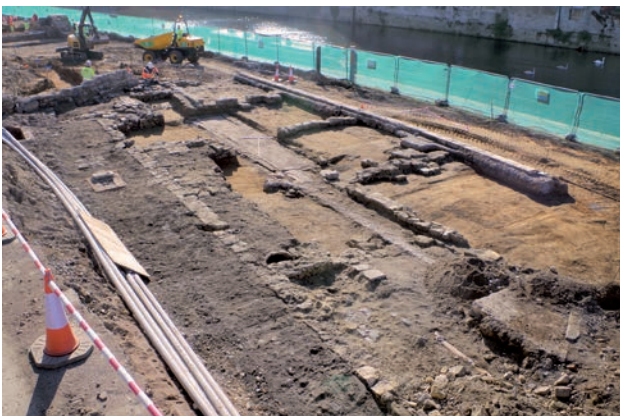
Plate 4.22 Heavily truncated foundations of Lockyer's Court (B26), from the north-west

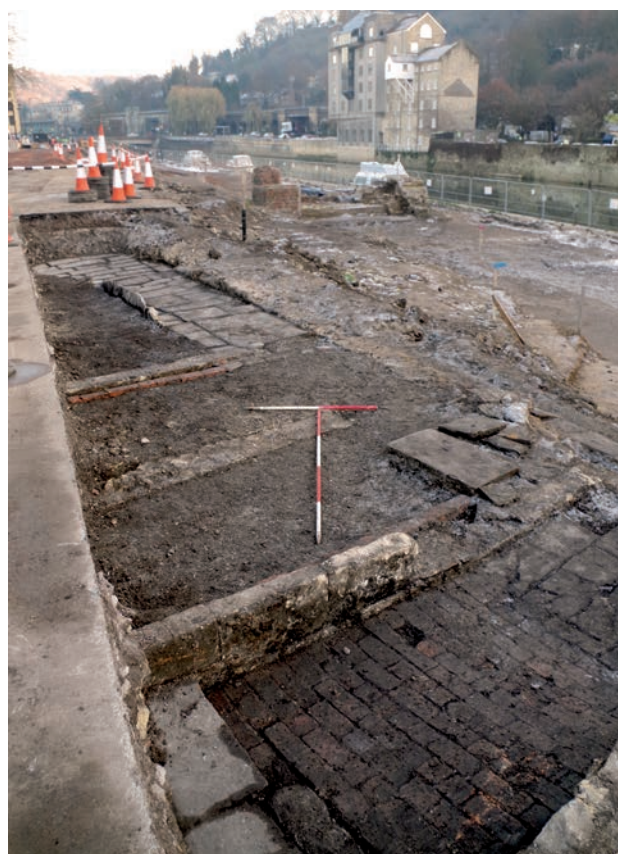
B28 (see Figs 4.16 and Fig. 4.17; Pl. 4.23) was a small one-up one-down two-storey cottage, which was constructed in the rear garden of 49 Avon Street between 1808 and 1852. The cottage had a small paved yard to the rear (OA22) and a garden and paved path to the east (OA23). There were three parallel brick-built dwarf walls in the ground-floor room, indicating that it had a suspended wooden floor.

Plate 4.23 Early 19th-century cottage (B28) to the rear of 49 Avon Street, from the north-west

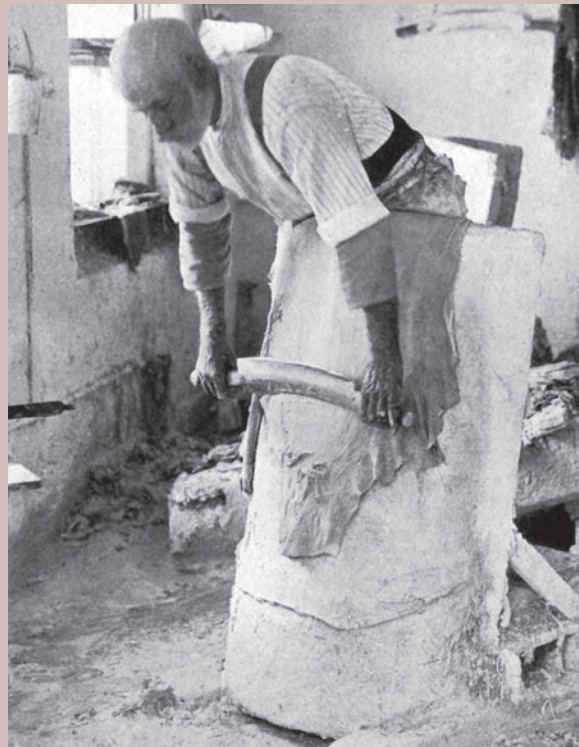
*Plate 4.25 Working sheepskins on a 'beam' to remove fat and lime. Image of the Homewell Parchment Works, Havant, published in The Sphere, 28 September 1928, 208 © Mary Evans Picture Library*

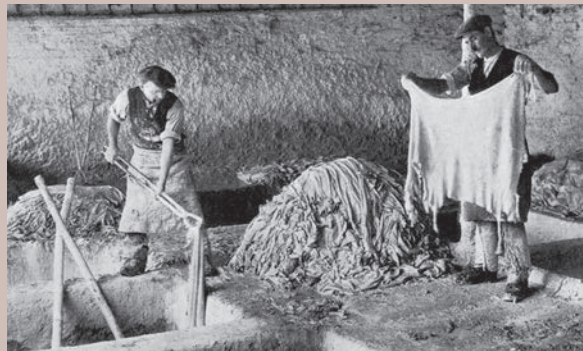
*Plate 4.26 Soaking sheepskins in liming pits to arrest putrefaction and remove fat. Image of the Homewell Parchment Works, Havant, published in The Sphere, 28 September 1928, 208 © Mary Evans Picture Library*

off by some of the processes described under leather [see above], the skin is put into a lime pit, and when the fat has completely combined with the lime, the skin is stretched upon a stout wooden frame or horse, consisting of 4 bars perforated with holes, each of which is occupied by a peg. By means of these pegs the skin is stretched in the frame, for which purpose a number of pieces of twine are tied firmly to the edges of the skin, and to prevent

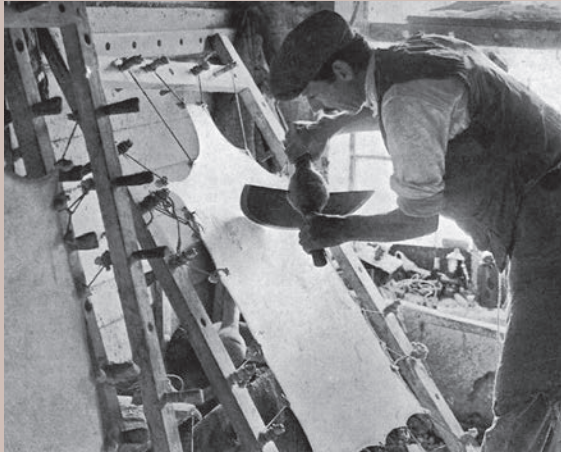
*Plate 4.27 Worked sheepskins fixed to a frame then scraped with a half-moon knife to remove excess flesh, dirt and slime after soaking in liming pits. Image of the Homewell Parchment Works, Havant, published in The Sphere, 28 September 1928, 208 © Mary Evans Picture Library*

the skin from slipping when strained tightly, each string is tied round a small wad or ball, formed by making a small fold at the side of the skin, and rolling up a shred of skin in this fold. In some cases skewers are stuck into the edges of the skin and the string is tied to them. In either case the other end of the string is passed through a hole in the side of the peg, and in turning this the string is wound round it, and thus the skin is gradually and equally strained, great care being taken to prevent the formation of wrinkles. The horse is then set up against a wall, and the surface is scraped with a double edged knife, (called from its shape a half moon knife) attached to a double handle (Pl. 4.27). The skinner uses this knife with both hands, and pressing the edge against the skin, first on the flesh side and then on the grain side, thus gets rid of fleshy substances, dirt, slime, &c.

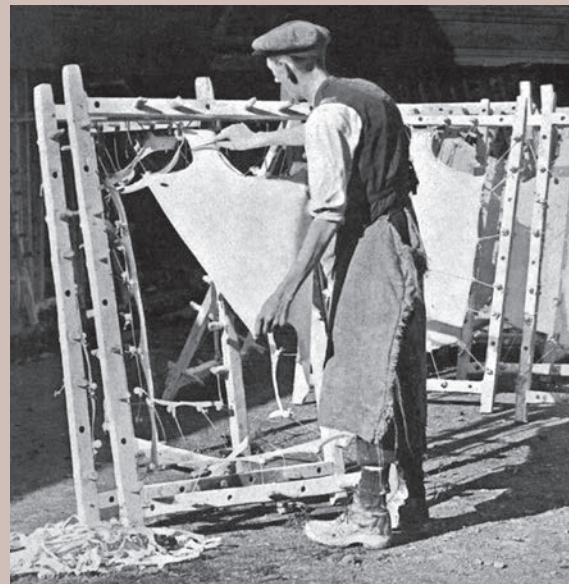
*Plate 4.28 Finished parchment being cut from a frame. Image of the Homewell Parchment Works, Havant, published in The Sphere, 28 September 1928, 208 © Mary Evans Picture Library*

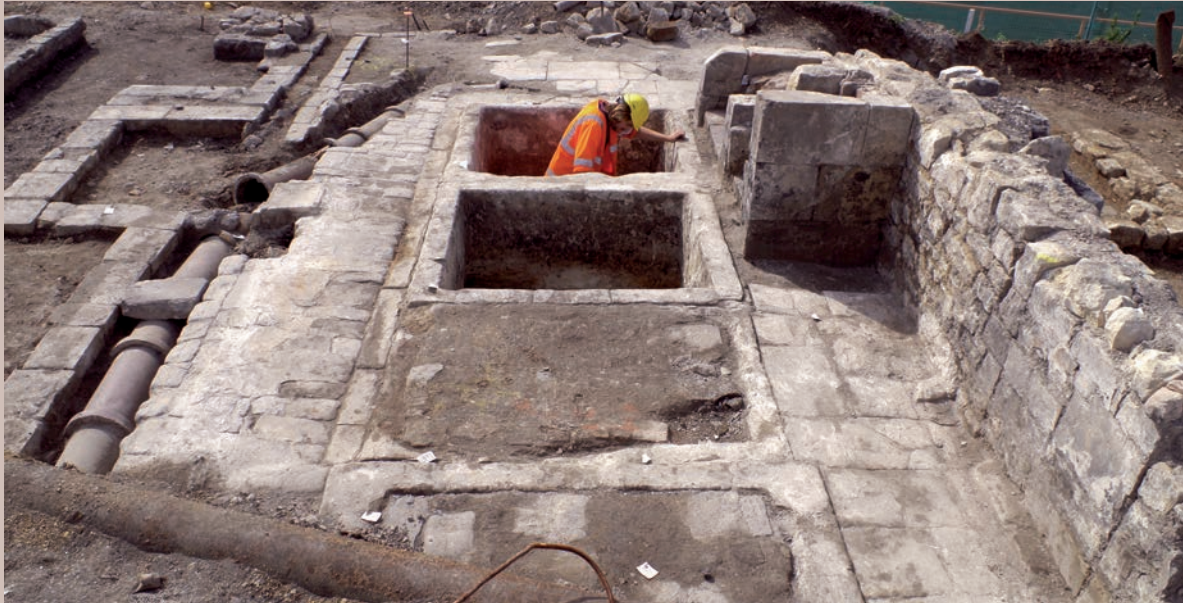
*Plate 4.29 Liming pits (S44) within a late 18th-century fellmongers' yard, leather-dressers and parchment works (B21) at 3 New Quay, from the north-east, showing late 19th-century drains (S72) and walls of Marshall and Banks' Steam Dye works (left) and early 20th-century forge of N S G Wilcock's engineering works (right)*

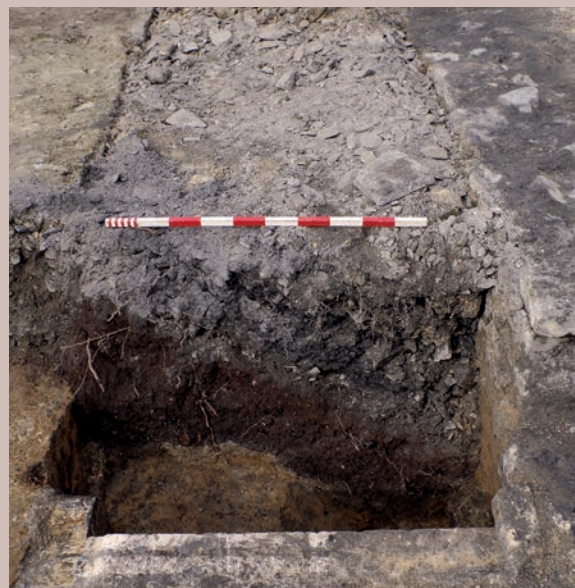
*Plate 4.30 Infilled and partially robbed late 18th-century stone-lined tank S45 within B21, from the south-west*

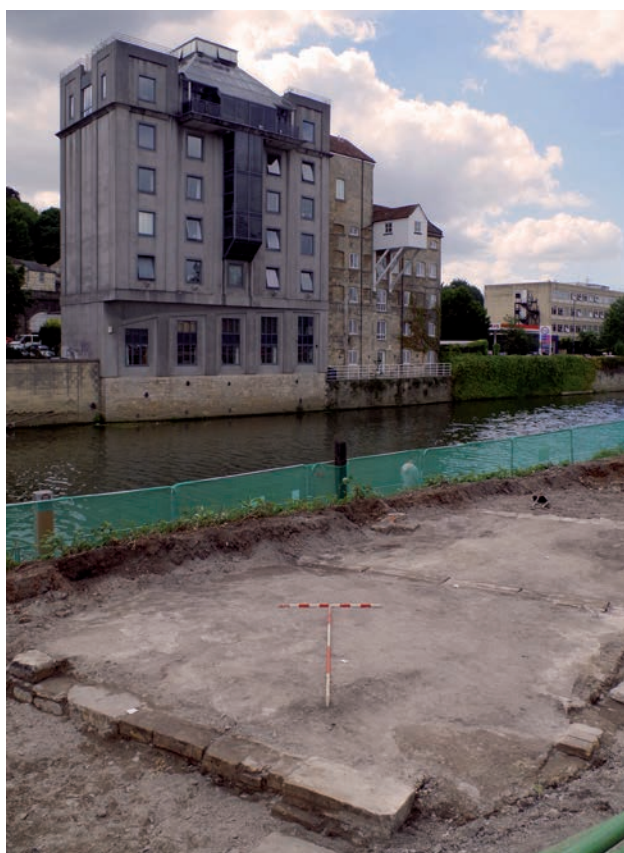
Plate 4.31 Late 18th-century non-domestic building (B22) at 1 New Quay, from the east, with Camden Malthouse and Silo in the background

There were three late 18th-century non-domestic buildings (B22–B24; Fig. 4.10) within the excavated part of 1–2 New Quay. B22 (1 New Quay) was a two-storey double-pile warehouse that was occupied by the 'tenants of W R Liddard' in 1786–1809. Earlier references to William Smith's warehouse (c. 1766–75) and Miss Bleek's warehouse (c. 1779–81) may relate to this building, but this cannot be confirmed. In

The walls of B22 (Pl. 4.31) were constructed using a single skin of Bath Stone ashlar, founded on a rammed-gravel surface, which was possibly an earlier yard surface, or a pad for the construction of the building. There were two internal partition walls in the western half of B22; these are absent from a late 18th-century plan of the building (Fig. 4.12), indicating that they are later additions to the building. A c. 1880 photograph of B22 (Pl. 4.32) shows that there were four doors on the New Quay frontage: a possible goods entrance, a small door that provided access to the first floor via an internal stair, and two stable doors, the latter perhaps indicating a use of the eastern half of the building.

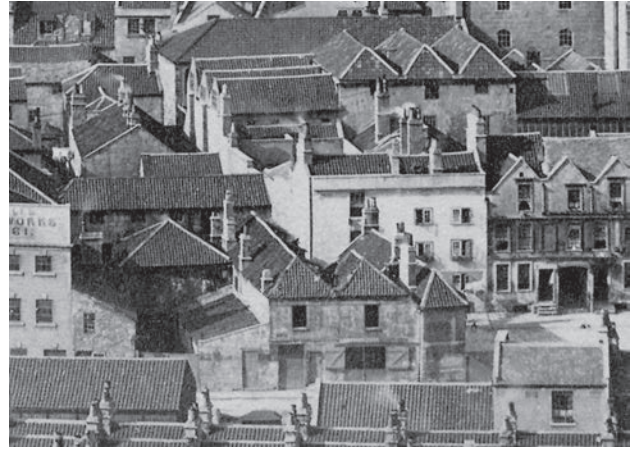
Plate 4.32 7 Broad Quay and 1–3 New Quay (right to left B25, B22, B24, B23 and B35), from the south, taken between 1880 and 1885 © B&NES Council

On the east side of OA18, there was a small building (B24) that abutted B22. B24 is depicted on Harcourt Masters' 1794 plan (Fig. 4.6) and a late 19th-century photograph (Pl. 4.32), which shows that it was a single-storey lean-to structure, with a doorway on the New Quay frontage. B24 had an entrance onto OA18, which suggests that B23 and B24 were part of

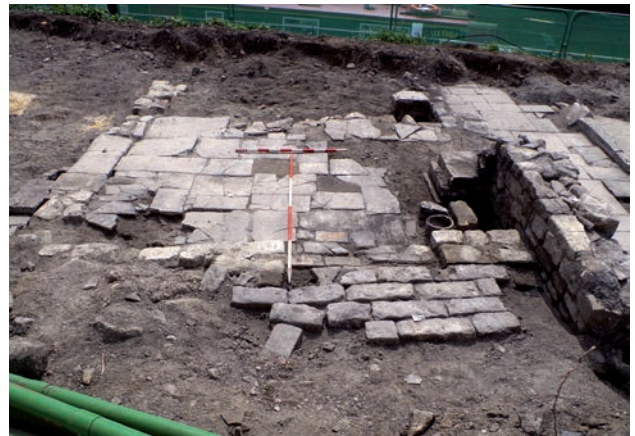
Plate 4.33 Late 18th-century non-domestic building (B23) at 2 New Quay, from the north-east

B23 (2 New Quay; Fig. 4.10; Pl. 4.33) was the southernmost end of a long narrow L-shaped building, to the west of yard OA18. This building may have been King's and subsequently John Yeoman's stable, which is recorded in 1766 and 1767–75 respectively. In about 1779, the property was acquired by Thomas Ettrick Cary, who established a short-lived fellmongers' yard on the site (see *Fellmongers, Leather-dressers and Parchment Makers at 2 and 3 New Quay*, c. 1774–1869).

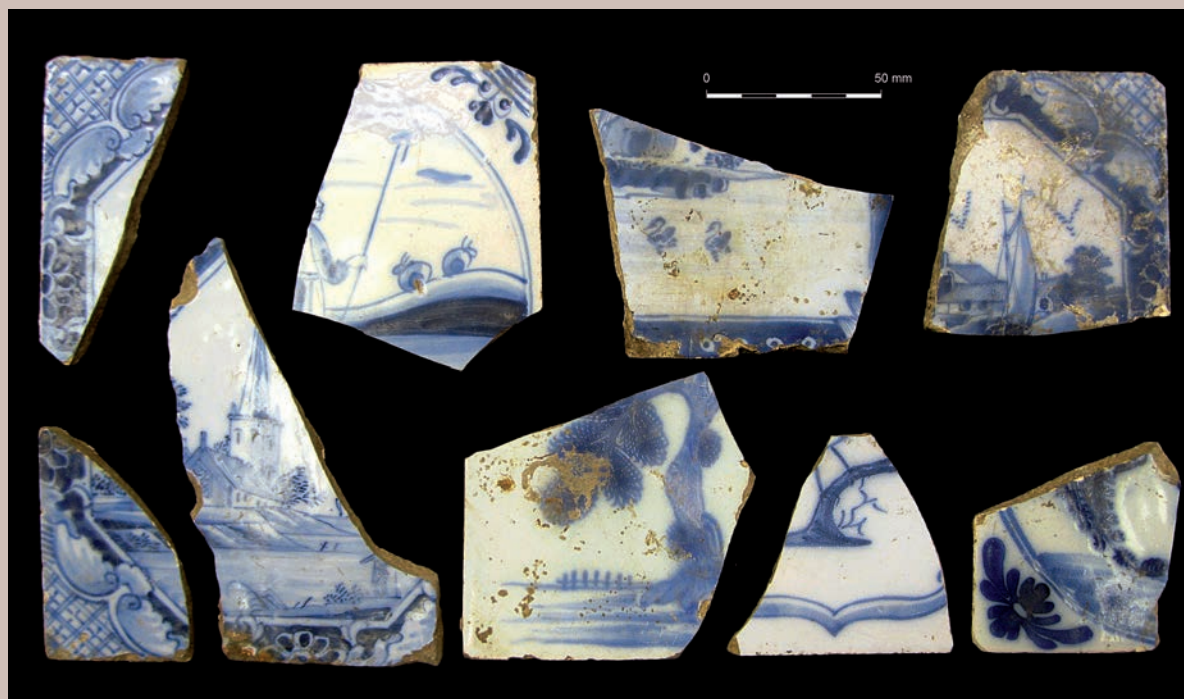
Plate 4.34 Tin-glazed wall tiles

Eight fragments of wall tile were found in a make-up layer below the floor of B23 and appear to date to the third quarter of the 18th century; two further fragments came from an underlying layer of made ground (Pl. 4.34). Four of them share the same octagonal Louis XV floral border with diaper corners and represent at least two tiles: two fragments show parts of the central design, both landscapes, one featuring a church spire, and the other a harbour scene. The border design is Dutch in origin, appearing in the first half of the 18th century, but was also used in the Liverpool tileries and at the Mortlake pothouse in London in the second half of the century; a good parallel for the simple diaper design seen here is

provided by a Liverpool tile dated 1750–80 (Betts and Weinstein 2010, cat nos 288–9, 496). Two other possible Liverpool products are represented by a tile with a barbed medallion border, and another featuring a tamarisk tree; both are dated 1750–75 (*ibid.*, cat nos 499, 502). Another fragment is from the corner of a landscape scene in a circular medallion with barred ox-head corner motifs, probably English and again possibly from Liverpool (*ibid.*, cat nos 258–62).

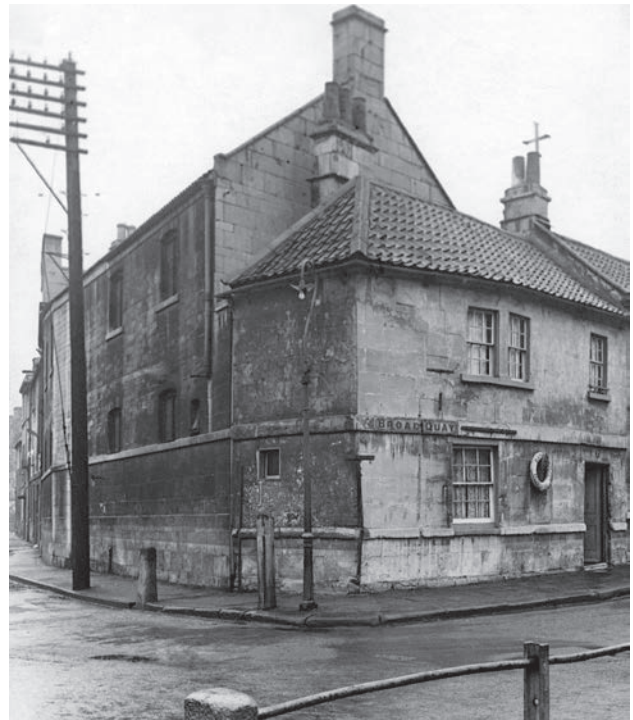
*Plate 4.35 1937 view of Quay House (B25), from the south-east, showing the level of a recent flood © B&NES Council*

B25 was very heavily truncated by modern disturbance associated with the construction of a temporary bridge in the late 1960s. The surviving remains included a corner fireplace, a corridor and a small area of flagstone flooring. A narrow passage to the west of the fireplace may indicate the position of a stair. Historic photographs (Pls 4.32, 4.35 and 7.10) show that B25 was two-storey, slightly irregular structure with a hipped roof at the south end. The

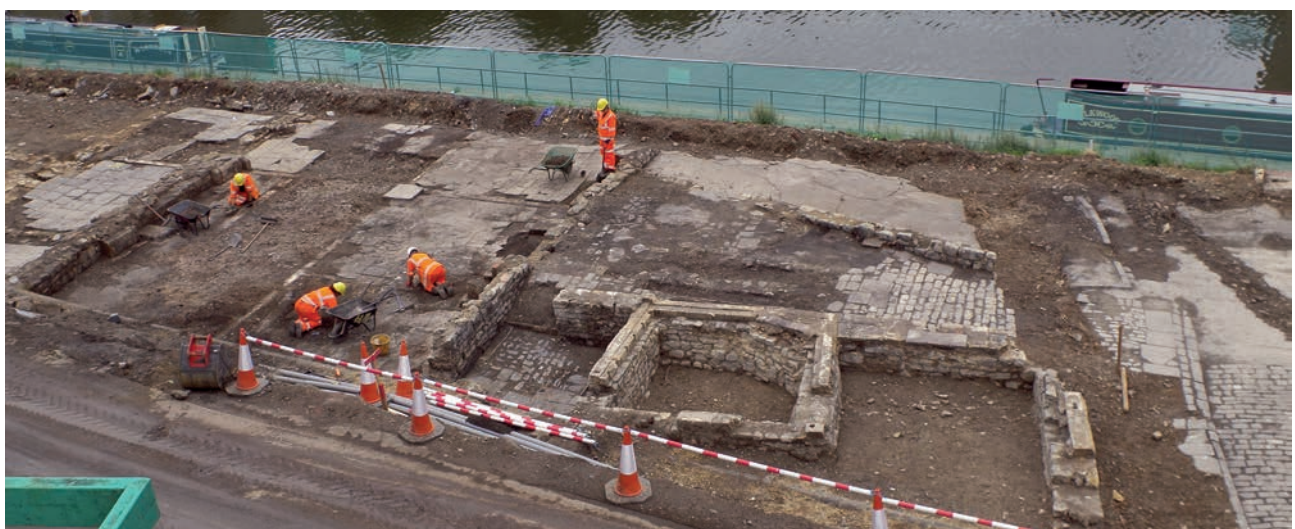
*Plate 4.36 18th-century buildings along New Quay and Avon Street, from the north, showing 14–15 New Quay/1–2 Hucklebridge’s Court (B12), 3–4 Hucklebridge’s Court (B13), and 48 Avon Street (B2/B6)*

In the mid-18th century, the northern half of B2 was demolished and replaced by a modest two-storey house (B6; Fig. 4.9; Pl. 4.36), which is depicted in an early 20th-century drawing (Fig. 3.12). The ground floor of B6 was divided into three rooms: a hallway and stair, a parlour/living room and a kitchen. To the rear there was a small paved yard (OA10) at a slightly lower level than the house. The ground floor had suspended wooden floors throughout and there were fireplaces in the parlour and kitchen. A cast-iron grille in the rear wall provided ventilation to the underfloor void. Cotterell's plan of 1852 (see Fig. 5.1) shows a privy in the rear yard.

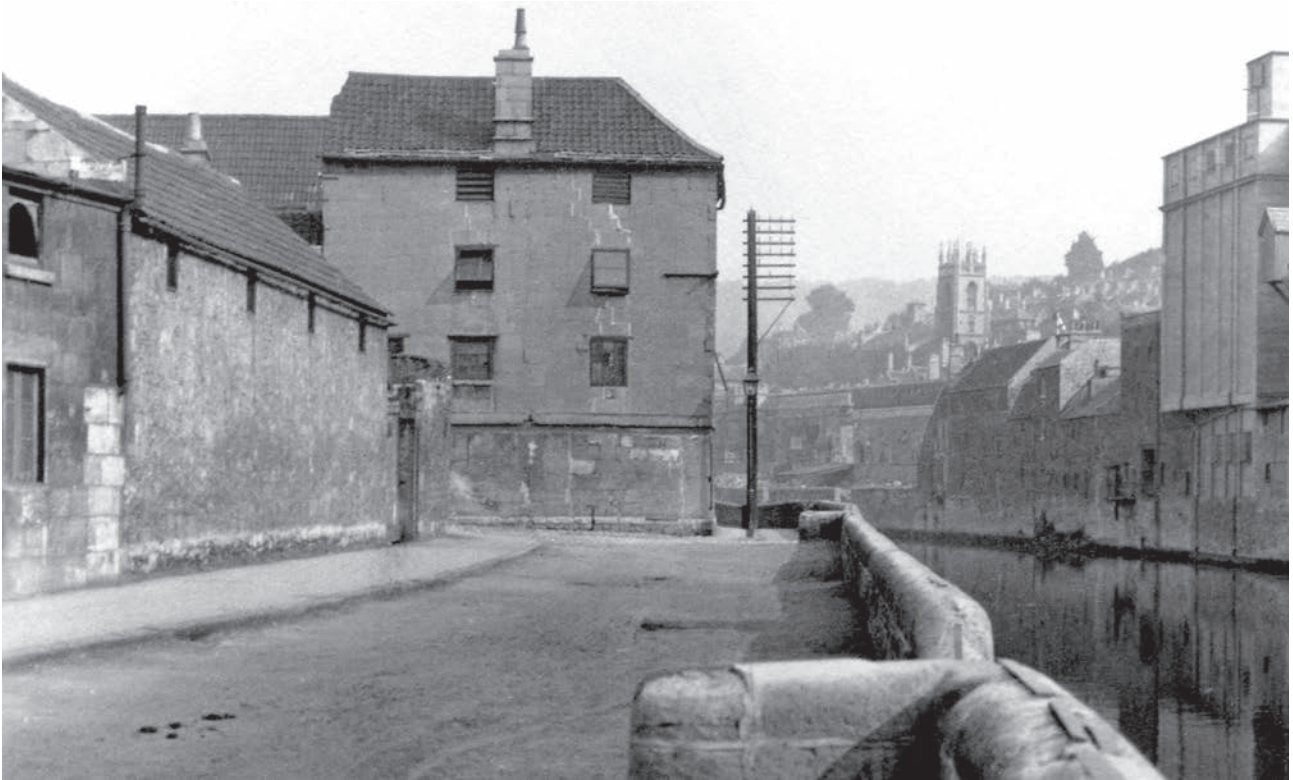
Plate 4.37 c. 1930 view of New Quay, from the north-west, showing late 18th-century warehouse B7 (centre) and c. 1874 stable B33 (left) © B&NES Council

Warehouse B7 was divided in two by a substantial wall that was abutted by further stone structures, possibly the foundations for a chimney or stair. Fragments of Pennant Sandstone paving survived in the east room; the other had a mortar floor. In 1900, the building was described as 'arranged on four floors and for many years used as a leather warehouse' (BCWG, 22 November 1900).

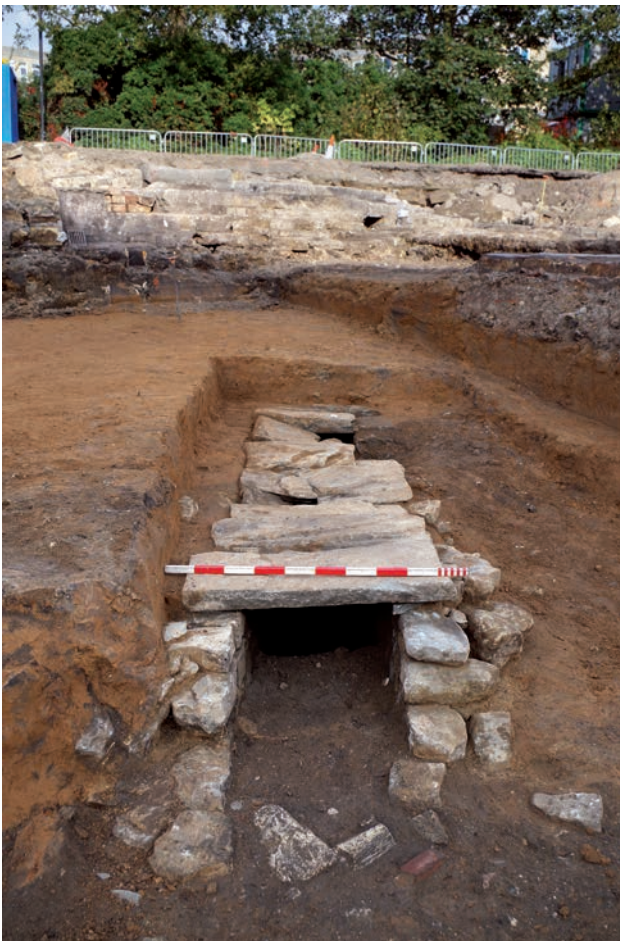
Plate 4.38 18th-century culvert S49, from the south-west

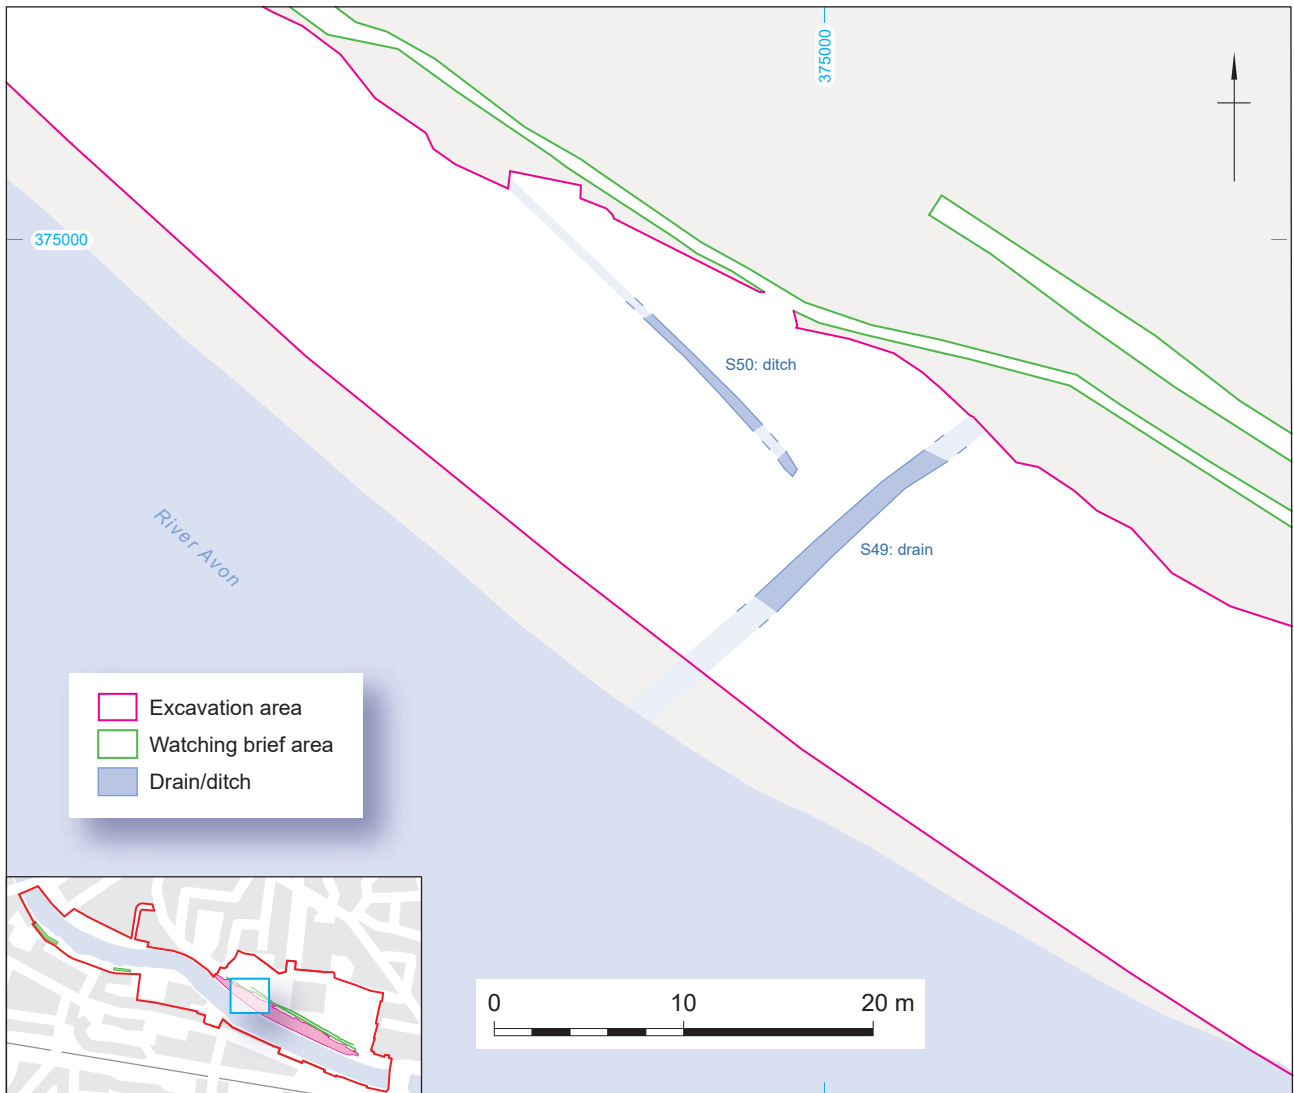
Figure 4.13 Plan of mid-/late 18th-century archaeological features in Great Kingsmead

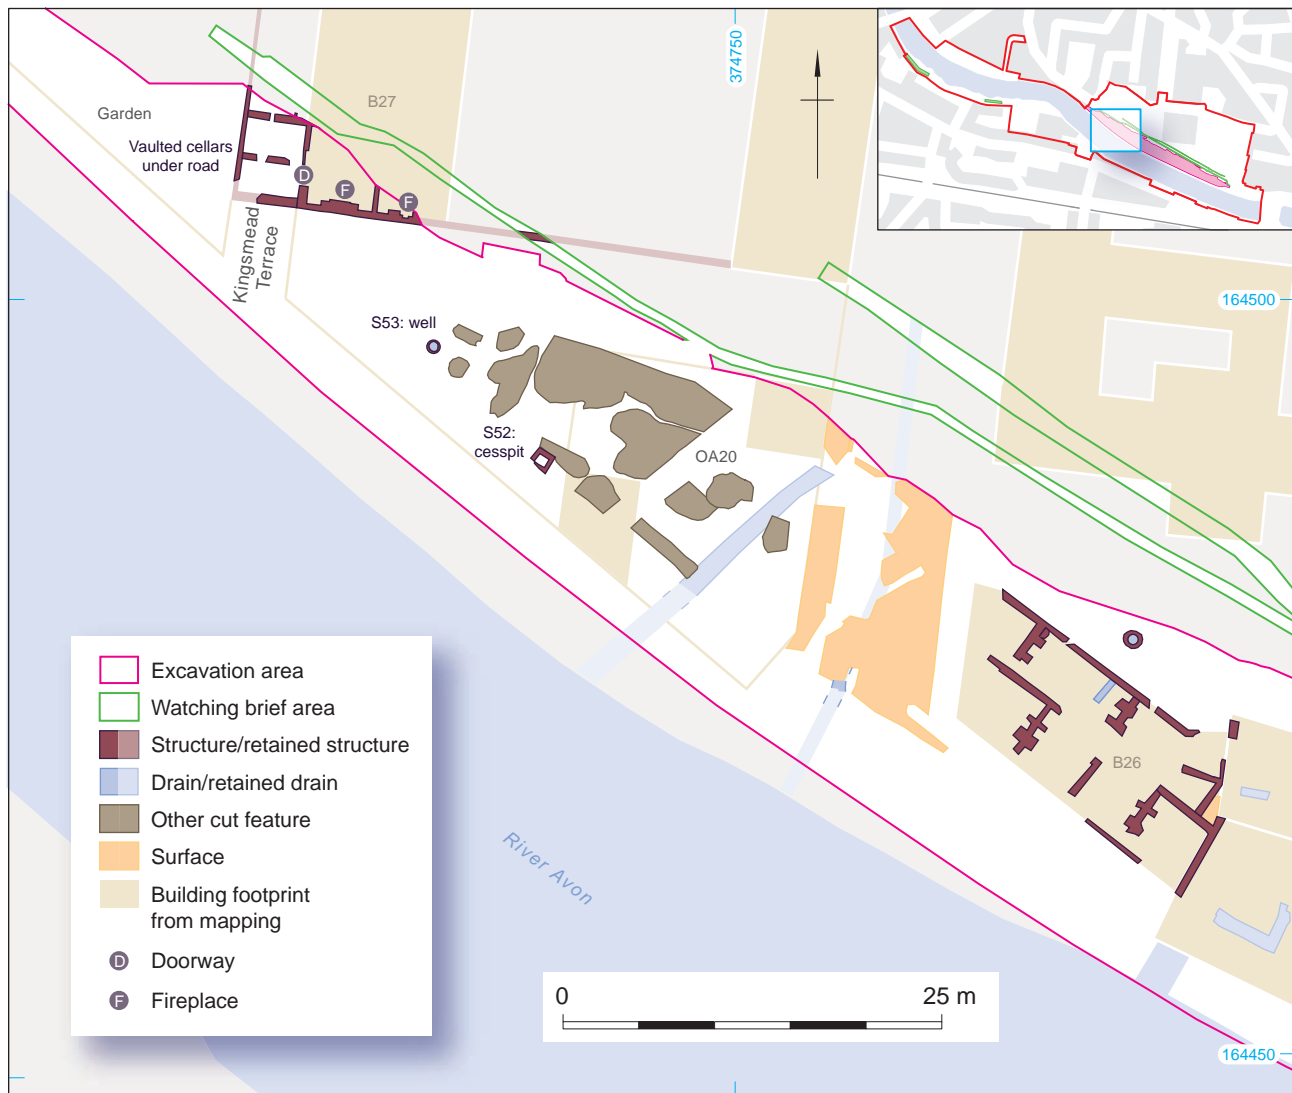
Figure 4.14 Plan of archaeological features to the west of Milk Street, c. 1780–95. Building outlines based on Harcourt Master's plan of 1794

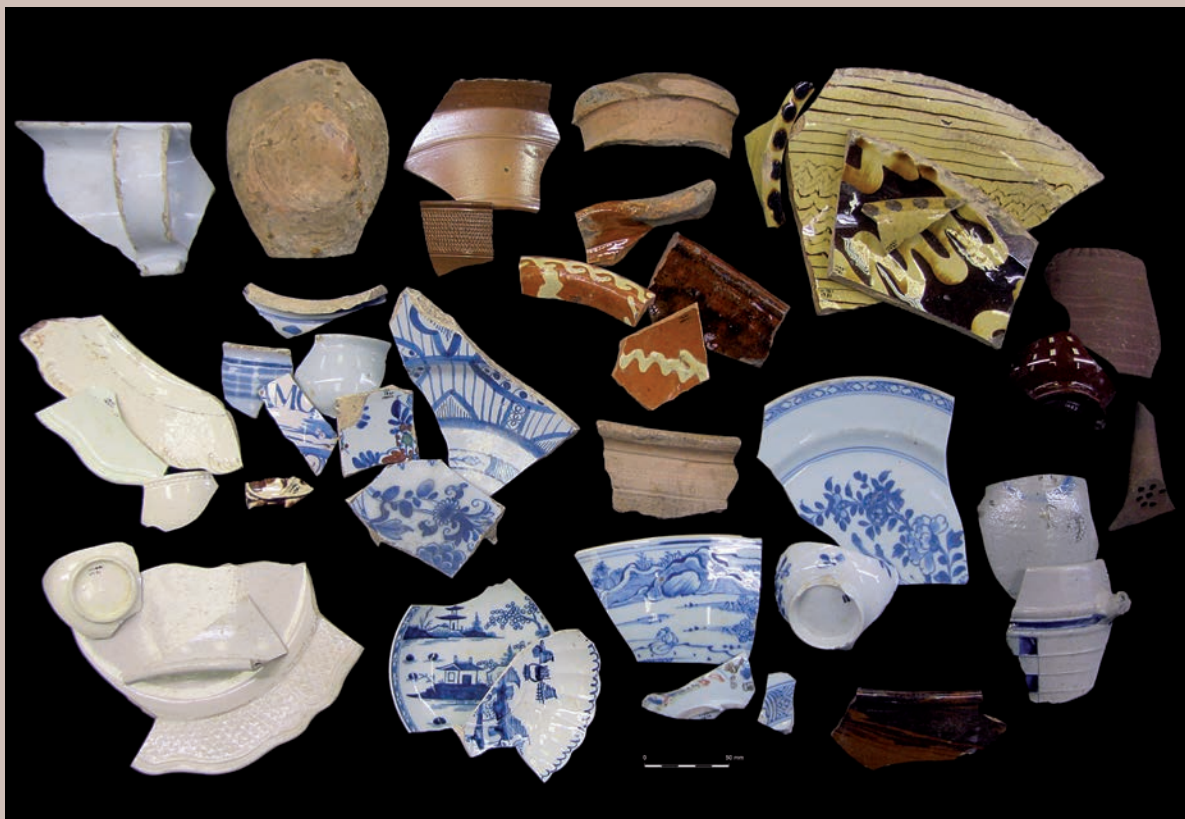
Plate 4.39 Selection of pottery from dumping layers

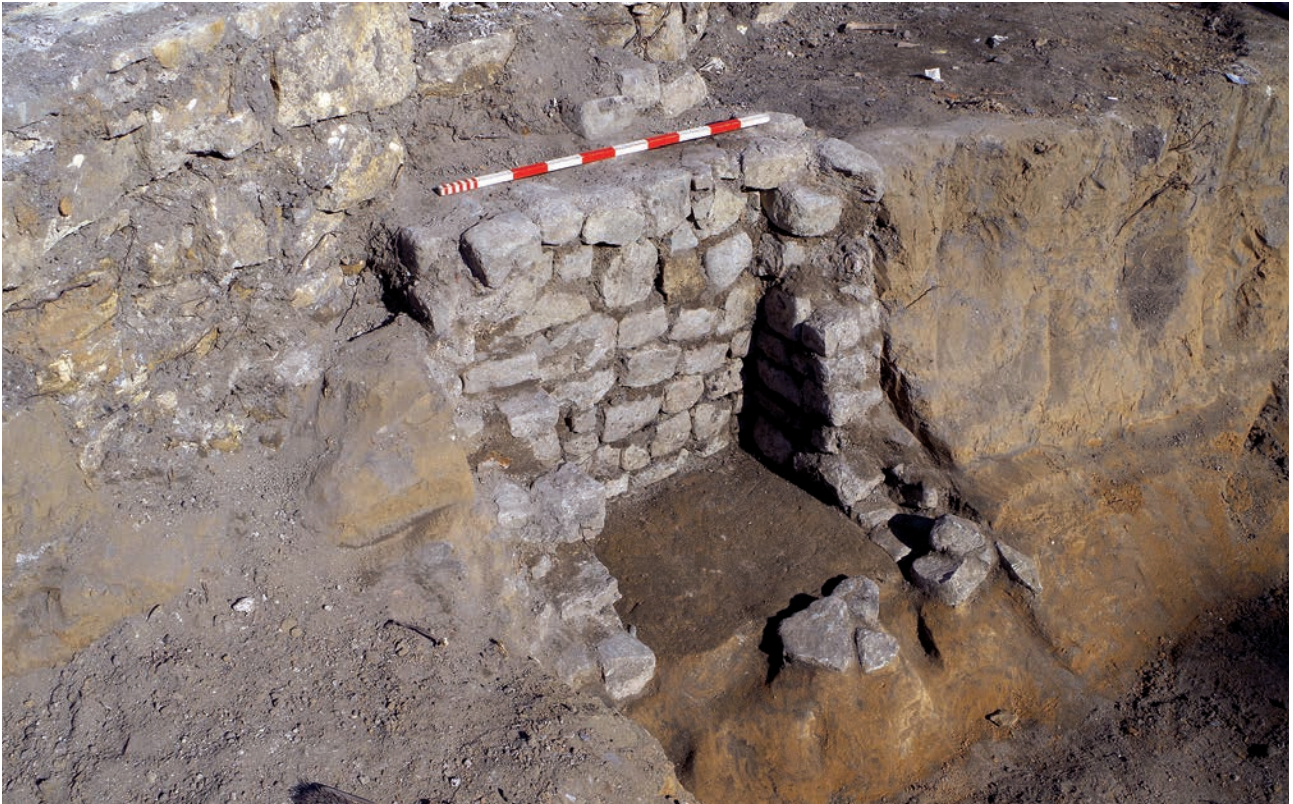
Plate 4.40 Cesspit S52, from the south-west

The dump deposit in OA20 was cut by a small (1.35 m by 1.2 m wide and 1.05 m deep) stone-lined cesspit (S52; Fig. 4.14; Pl. 4.40), which was backfilled with a dump of sandy silt, ash and clinker. Finds from the infill of the cesspit (see *Fill of Cesspit (S52) at 30 Kingsmead Terrace*), suggest that it was probably backfilled in the 1780s or early 1790s. Stone-lined well S53 (Fig. 4.14) is likely to be broadly contemporary with the cesspit, but this could not be confirmed.

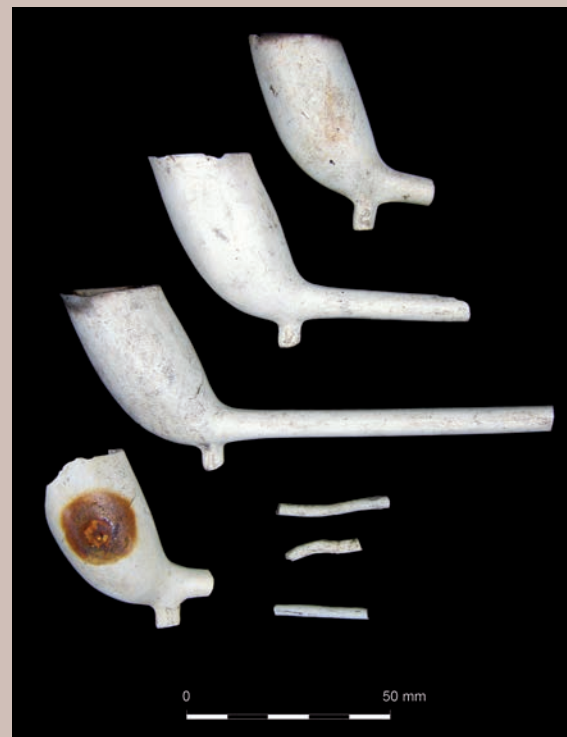
Plate 4.41 Clay pipes and pipeclay strips from cesspit S51

The group of pipes in the truncated fill of the cess pit are all early products by Joseph Smith of 10 Bridewell Lane, Bath, c. 1780–90 (Pl. 4.41). Very few of these have been found elsewhere, and certainly not in such numbers, and there is one previously unrecorded mould form among them. In addition to 174 stem fragments, 15 bowls and fragments of 10 others were recovered. Three mould forms are present, and in each case the S is embossed in reverse, an error on the part of the mould cutter. On two of the forms, the initials are arranged in the traditional way, by which the Christian name initial is on the left side of the spur, while on the third form the initials are embossed the other way around. Amongst the other material in the deposit were three thin strips or wires of what appeared to be pipeclay. In the absence of any identifiable kiln debris, these do not seem to indicate that the pipes were brought in as workshop waste, and they presumably relate to some other process or function.

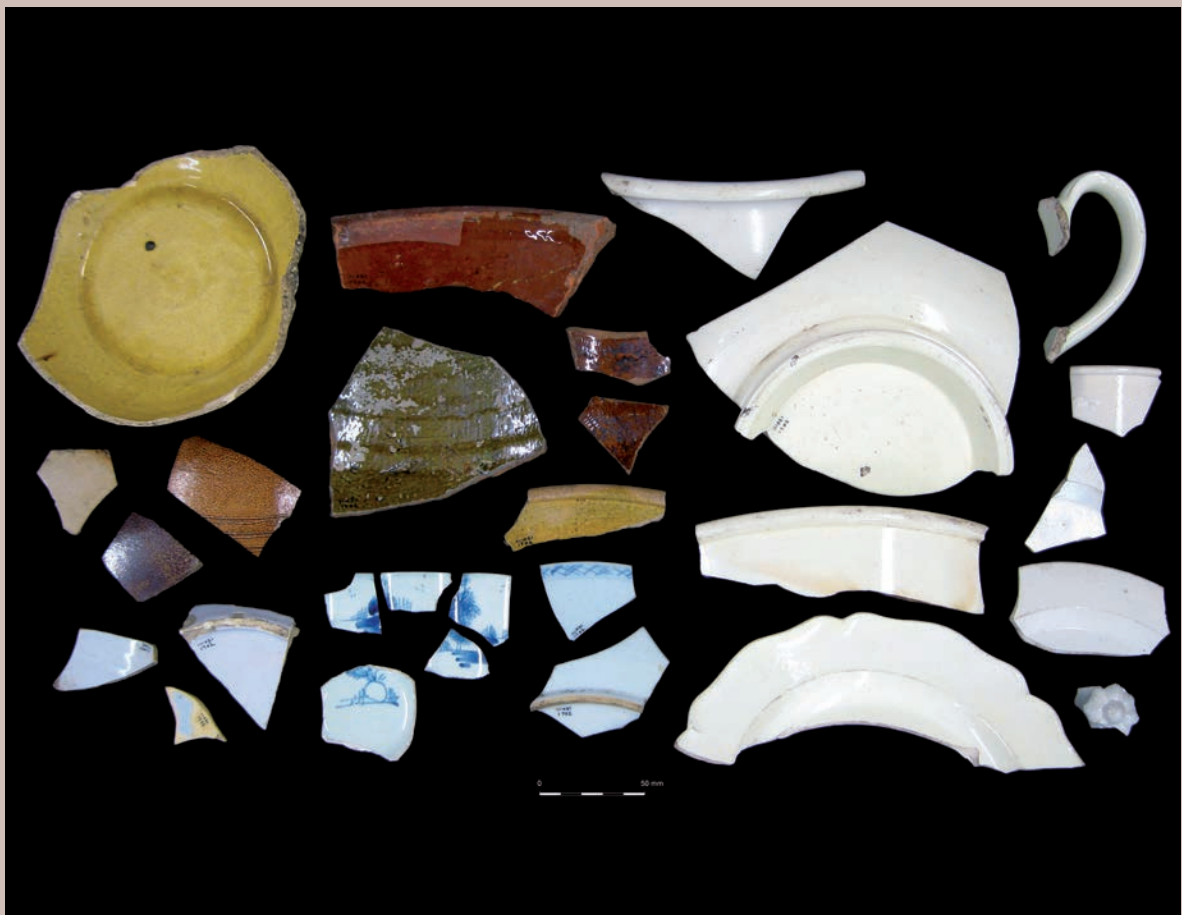
Plate 4.42 Pottery from cesspit S51

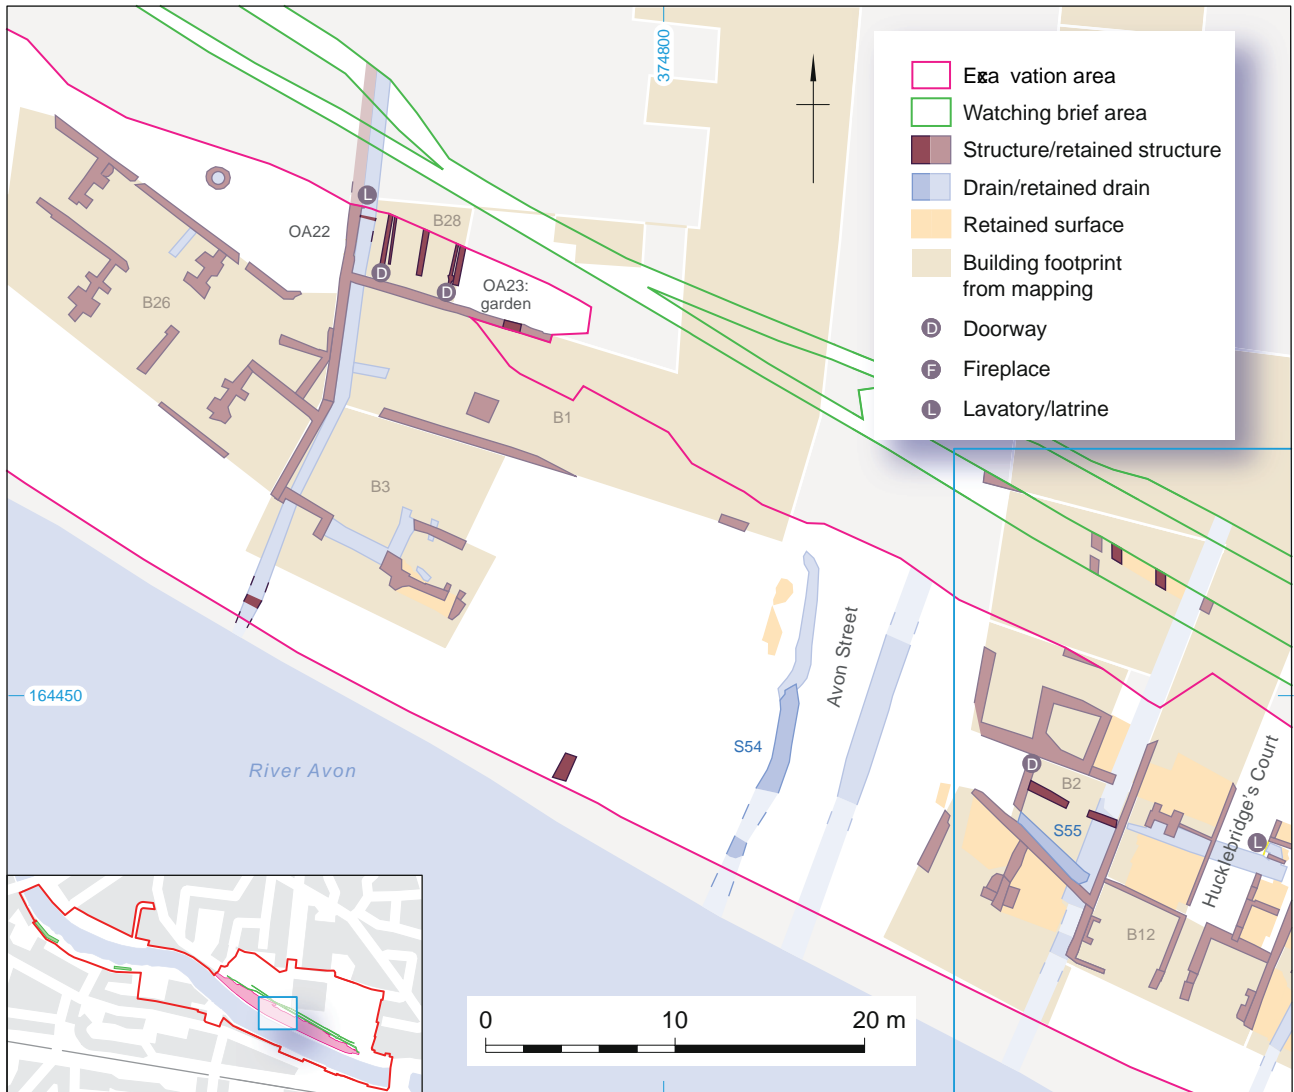
Figure 4.17 Plan of archaeological features along New Quay, c. 1800–39: west end. Building outlines based on Cotterell's plan of 1852
