# Bath Quays Waterside

**The Archaeology of Industry, Commerce and the Lives of the Poor in Bath's Lost Quayside District**

Wessex Archaeology Occasional Paper  
2020

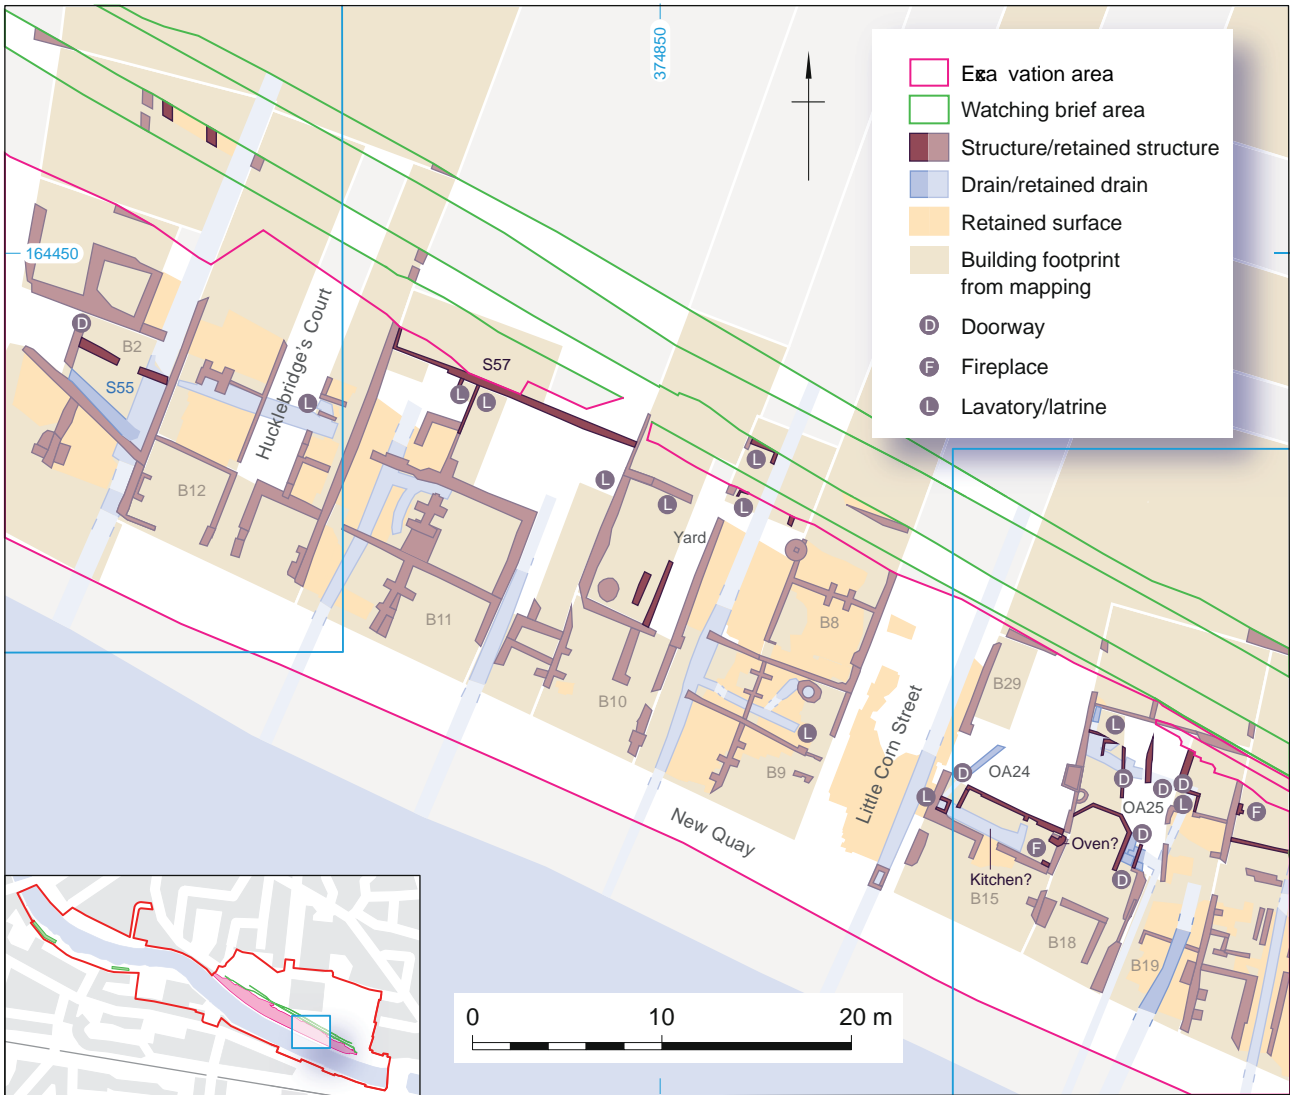
Figure 4.18 Plan of archaeological features along New Quay, c. 1800–39: central area. Building outlines based on Cotterell’s plan of 1852

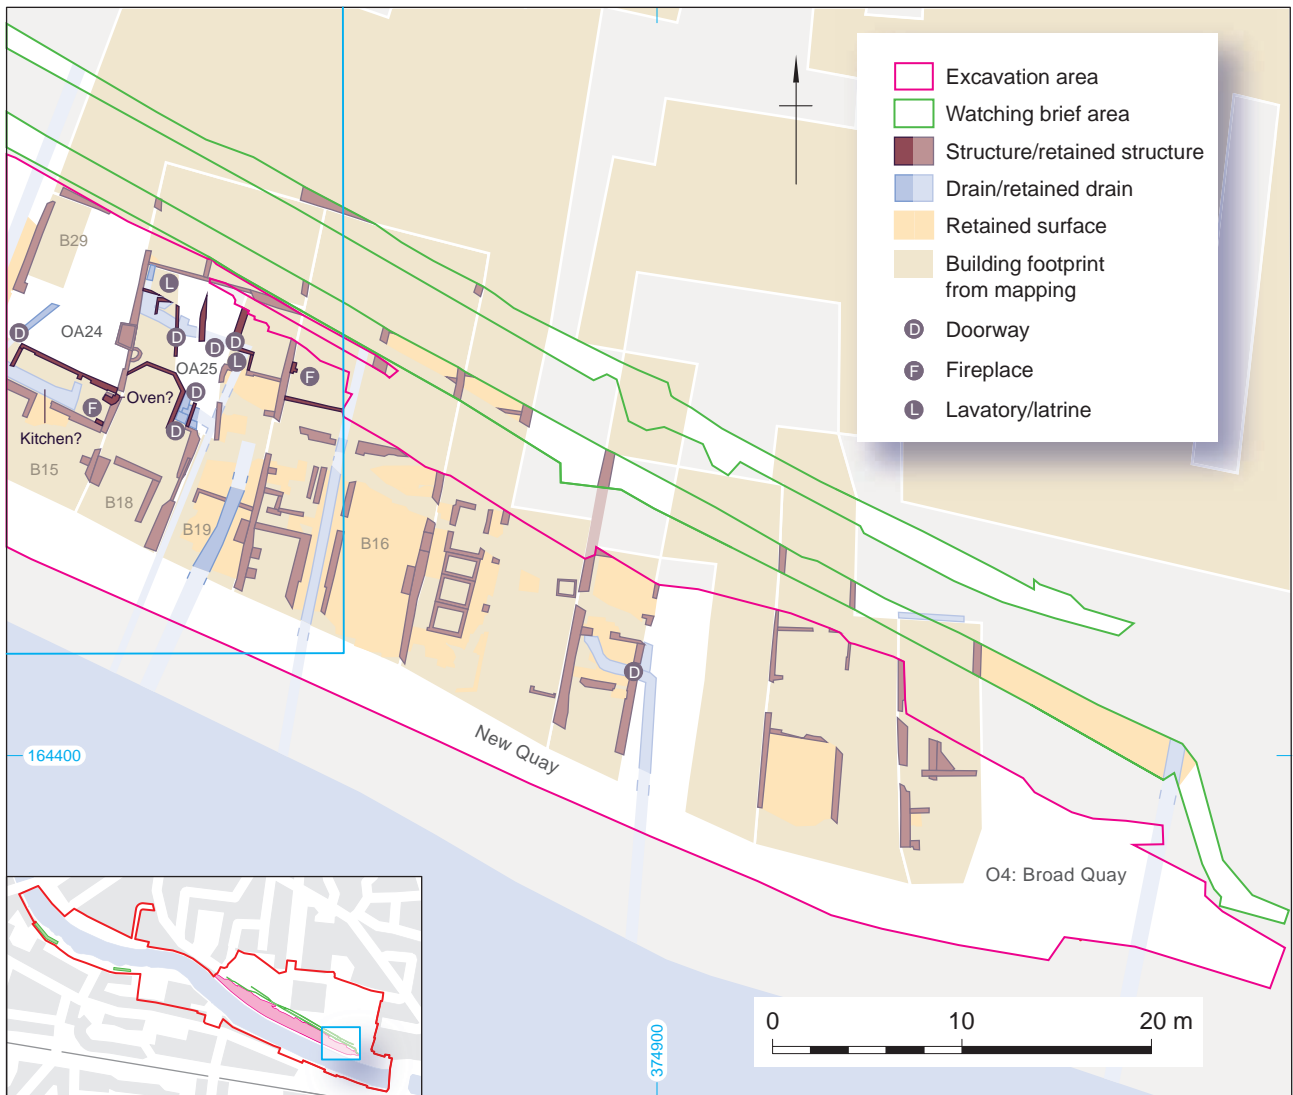
Figure 4.19 Plan of archaeological features along New Quay, c. 1800–39: east end. Building outlines based on Cotterell's plan of 1852

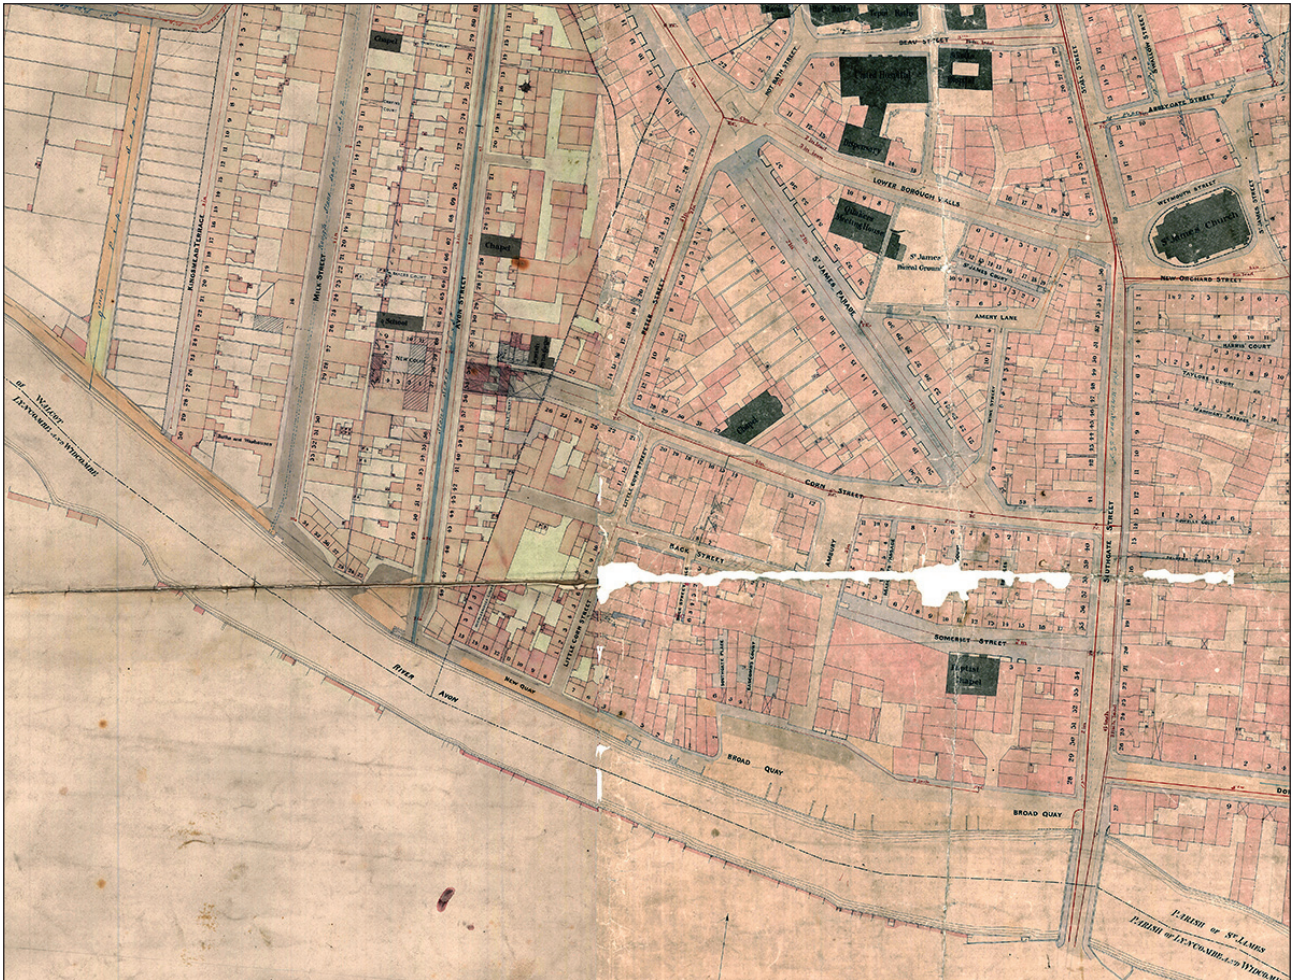
Figure 5.1 Detail of Jacob Henry Cotterell's Plan of the City and Borough of Bath, 1852

There were only a few civic buildings in the Avon Street district: a public washhouse, constructed in 1847, a school on Avon Street and a Sunday school on Milk Street. Religious institutions were similarly sparse: Cotterell's plan of 1852 (Figs 5.1–5.2) depicts two chapels of unknown denomination on Avon

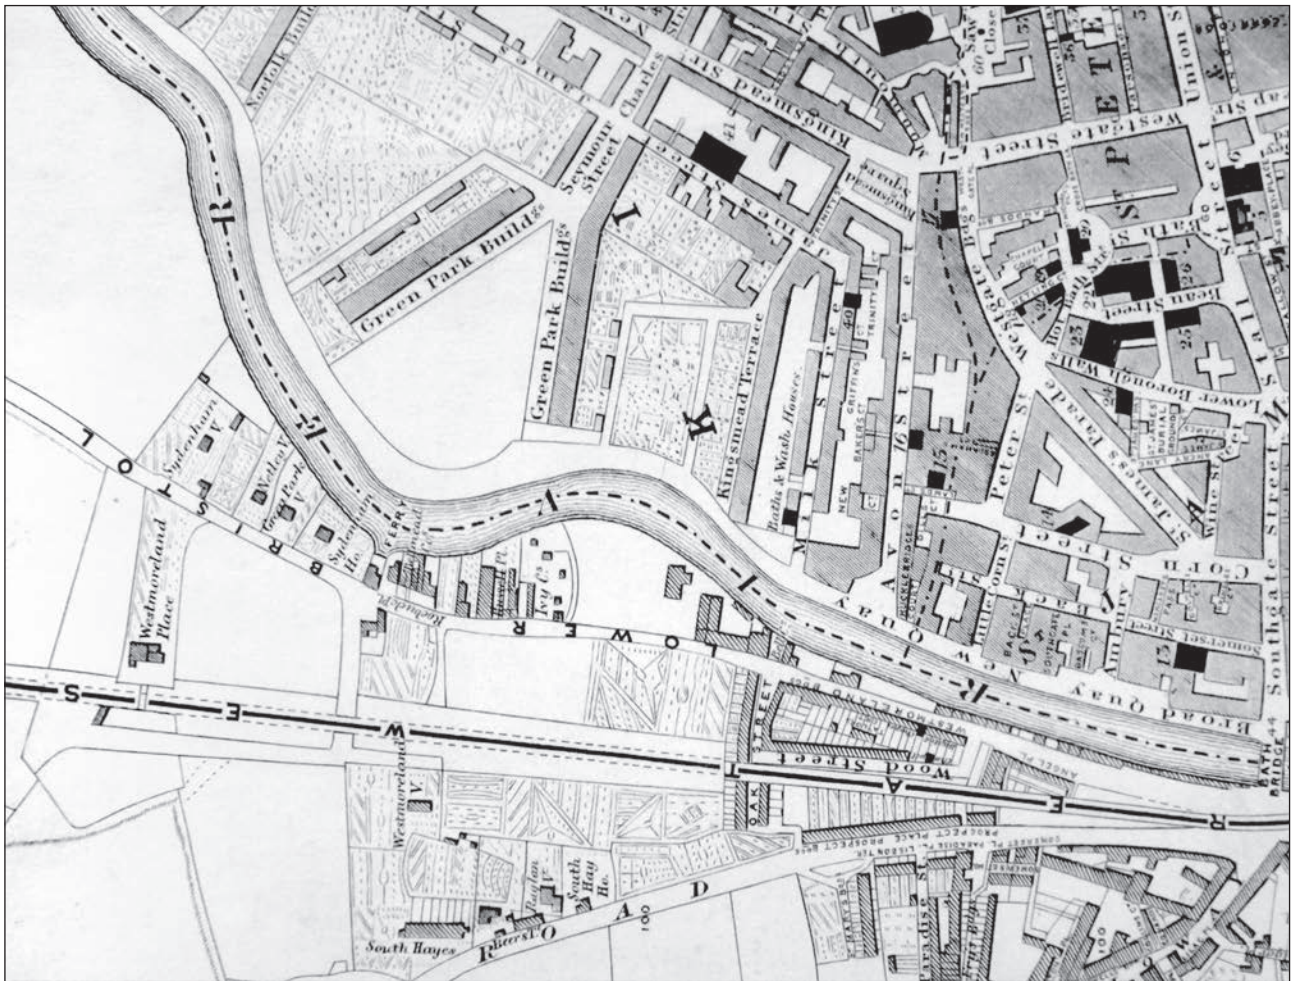
Figure 5.2 Detail of Jacob Henry Cotterell's Plan of the City and Borough of Bath, and its suburbs, 1852

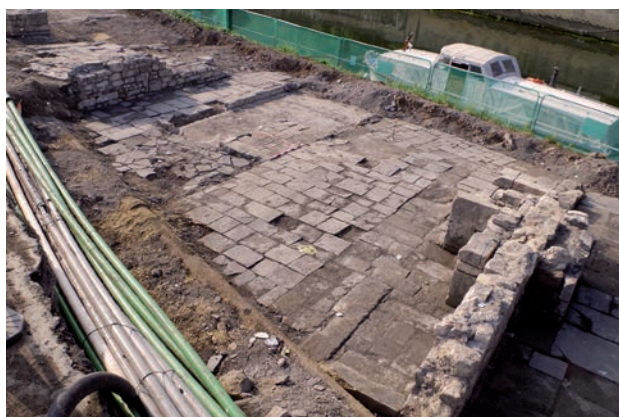
Plate 5.2 Bath and West of England Steam Power Dye Works (B35), from the north-west. Converted for use as N S G Wilcocks' Bath City Foundry and Engineering Works in 1898

After the dye works closed, the property was acquired by a 30-year-old engineer and aerated water-bottling equipment manufacturer named Nathaniel St George Wilcocks, who converted the building for use as the 'Bath City Foundry and Engineering Works'. Wilcocks' firm was a family business that was established *c.* 1818 by his great-grandfather George Weedon. His company, Weedon & Co, specialised in the manufacture of gas lamps, chandeliers and beer pumps. The opening of the Bath Gas Light and Coke Company's gasworks in 1819 provided a market for their gas fittings, which were one of the company's main products until the 1880s. Weedon & Co became Weedon & Wilcocks *c.* 1836, N G Wilcocks in 1862, and N S G Wilcocks *c.* 1889. The company was initially based at 5-6 Upper Borough Walls, but by 1861 it had relocated to 15 Westgate Buildings, and in 1865, Nathaniel George Wilcocks acquired 46 Avon Street and converted it and a former bone mill backing onto Back Street for use as the 'Bath City Brass and Iron Foundry' (BRO BC/6/2/9/665). During the 1880s, N G Wilcocks became a specialist manufacturer of

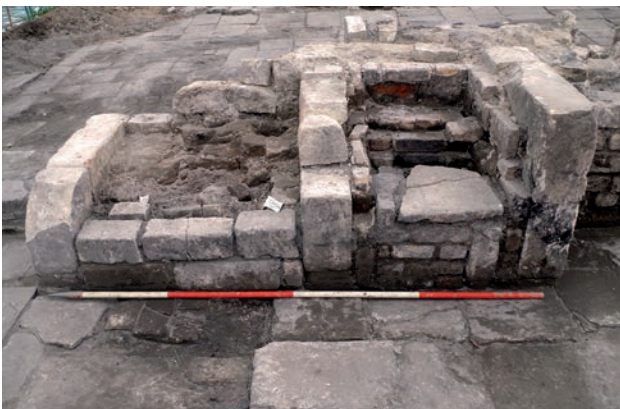
Plate 5.3 Detail of possible forge base within B35

The only features that could be directly related to the building's use as an engineering works was a pair of fireplaces (S73; see Fig. 5.12; Pl. 5.3) built against the west party wall. The fireplaces had elevated hearths, which suggests that they may have been small forges. The only other significant post-1898 changes were the insertion of an additional goods doorway on the New Quay frontage, and some minor alterations to the internal layout of the building.

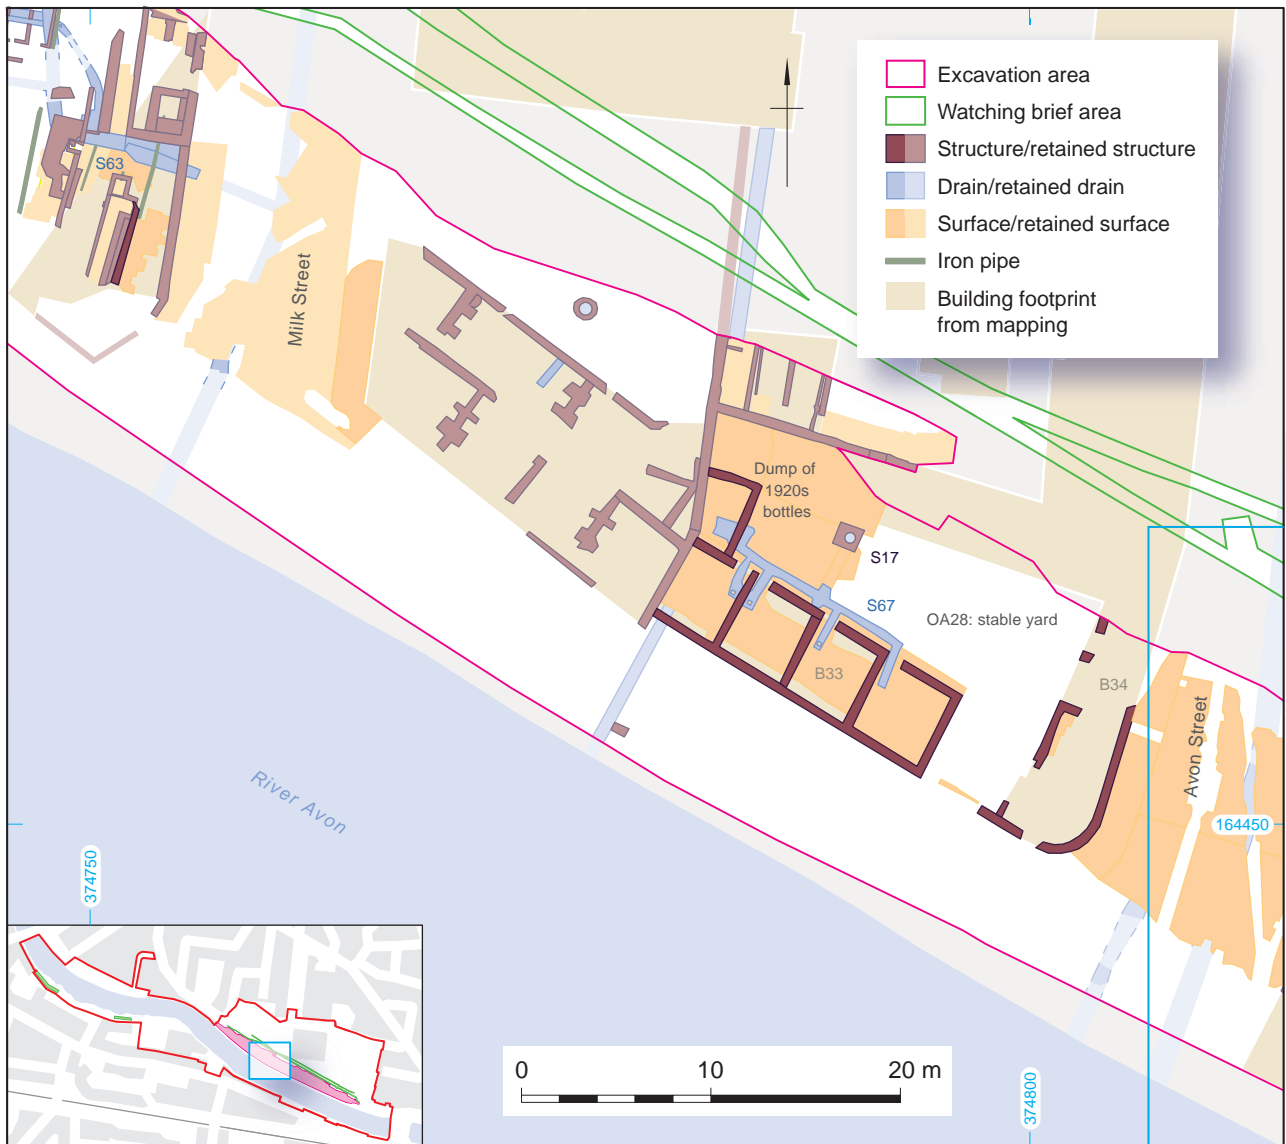
Figure 5.10 Plan of archaeological features, 1870–1930: west end. Building outlines based on 1904 OS plan

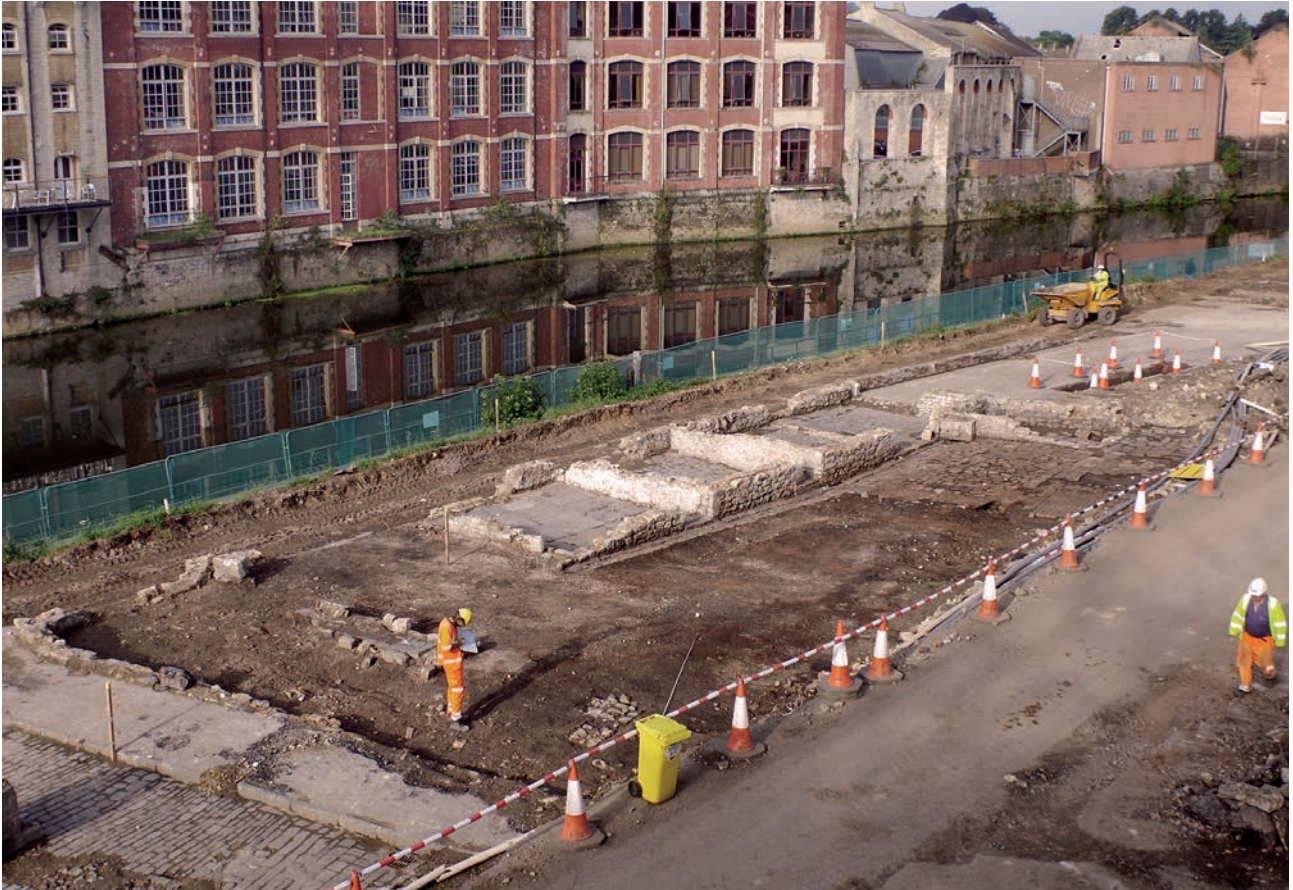
*Plate 5.4 Commercial stables (B33, B34 and OA28) at the southern end of Avon Street, view from the north-east, with the Albion Stay Factory and the Newark Works in the background*

The western half of yard OA28 was paved with sandstone setts, with sunken strips of sandstone setts and flagstones forming surface gutters; the eastern half of the yard was surfaced with compacted clinker. Iron-grated drainage gullies were set into the gutters, which fed into a network of ceramic pipes (S67) that drained waste and surface water towards the main sewer. Eighteenth-century well S17 remained in use and is marked on contemporary plans as a pump (Fig. 5.3).

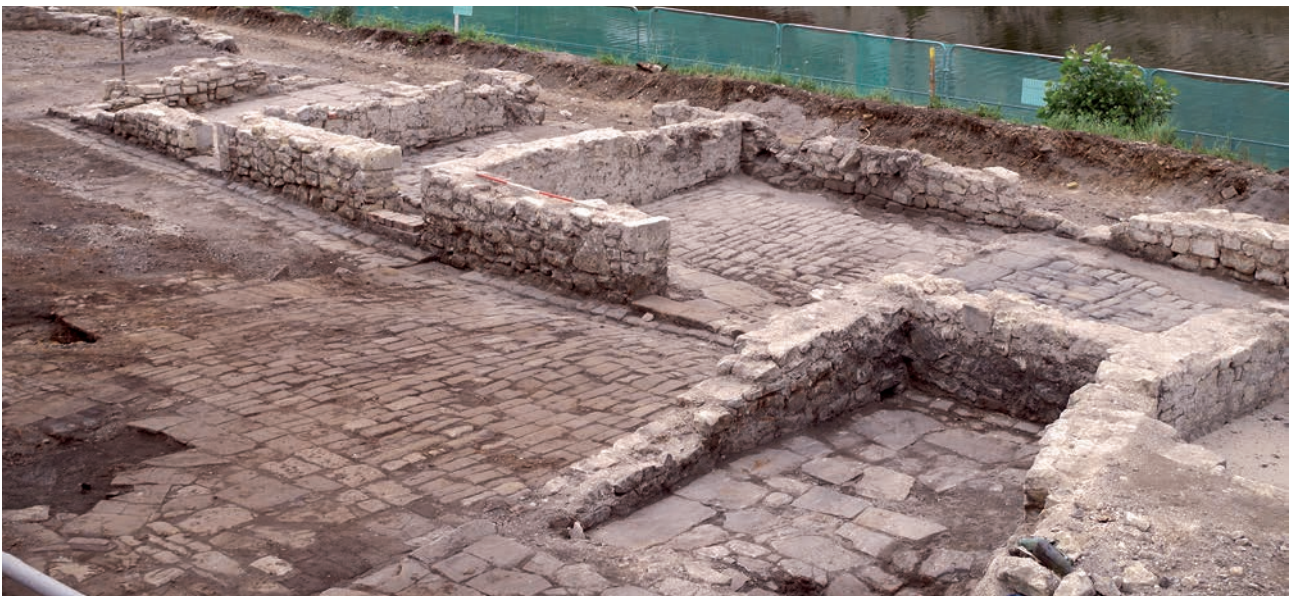
*Plate 5.5 Commercial stables (B33, B34 and OA28) at the southern end of Avon Street, from the north-west*

The stables themselves comprised a walled yard (OA28) with single-storey buildings (B33 and B34) ranged around the sides (Figs 5.9–5.10; Pls 5.4–5.6). B33 was a purpose-built stable block, constructed in 1874. The walls, which survived up to 1 m high, were of uncoursed Bath Stone rubble. The stable block was divided into four 4 m-square rooms, each with a doorway opening on to the yard (OA28). The room at the eastern end of the building was paved with flagstones and was probably used as an office or tack store; the other rooms were paved with sandstone setts, which suggests that they were horse stalls. Unsurfaced parts of these rooms indicate the positions of fodder racks. The floors sloped towards drainage gullies near the doors, no doubt to facilitate mucking out.

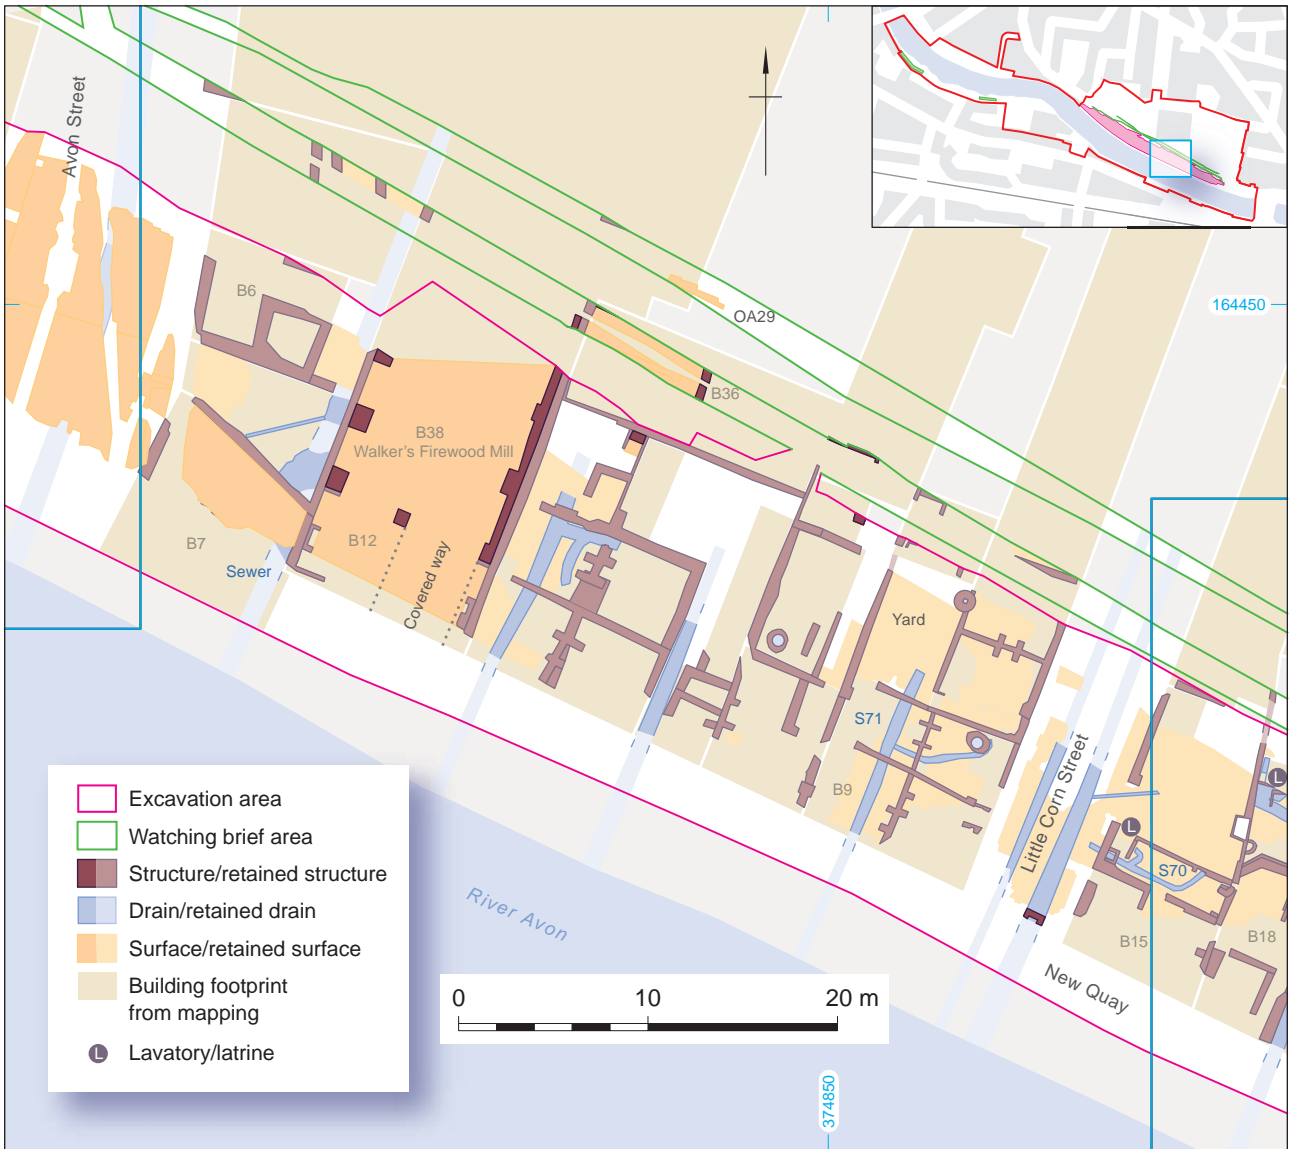
Figure 5.11 Plan of archaeological features, 1870–1930: central area. Building outlines based on 1904 OS plan

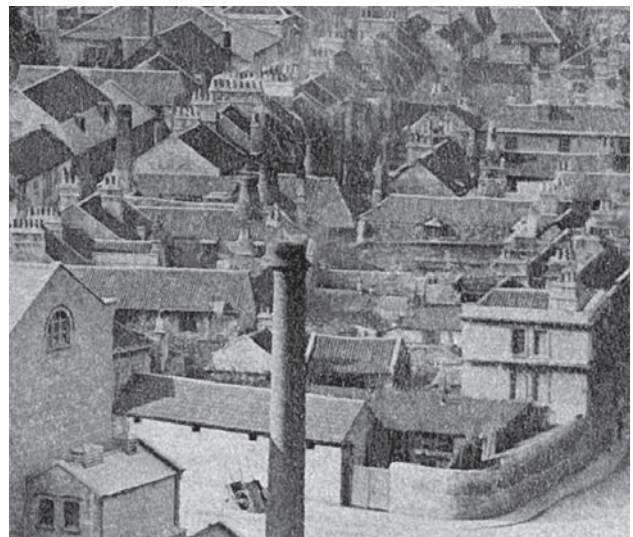
Plate 5.6 Commercial stables (B33, B34 and OA28) and 49 Avon Street, from the south, taken between 1880 and 1885 © B&NES Council

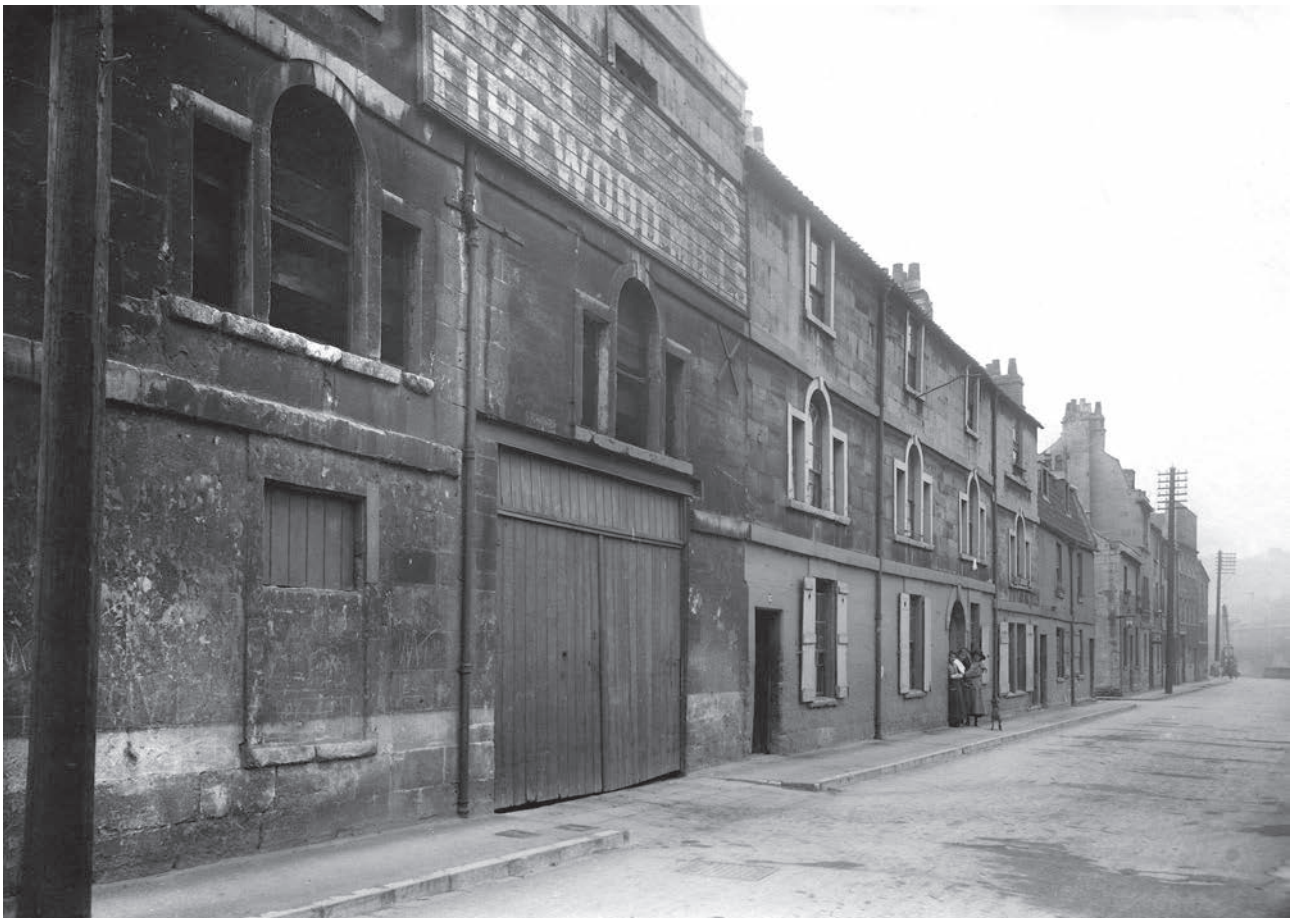
Plate 5.8 c. 1930 view of *14–15 New Quay (B12)*, which was incorporated into *Walker's Firewood Mill (B38)* in 1893 © B&NES Council

In 1893, Walker purchased Hucklebridge’s Court and 14–15 New Quay (B12–B13). Hucklebridge’s Court was demolished and replaced by a large extension to his firewood mill (B38; Fig. 5.11). The

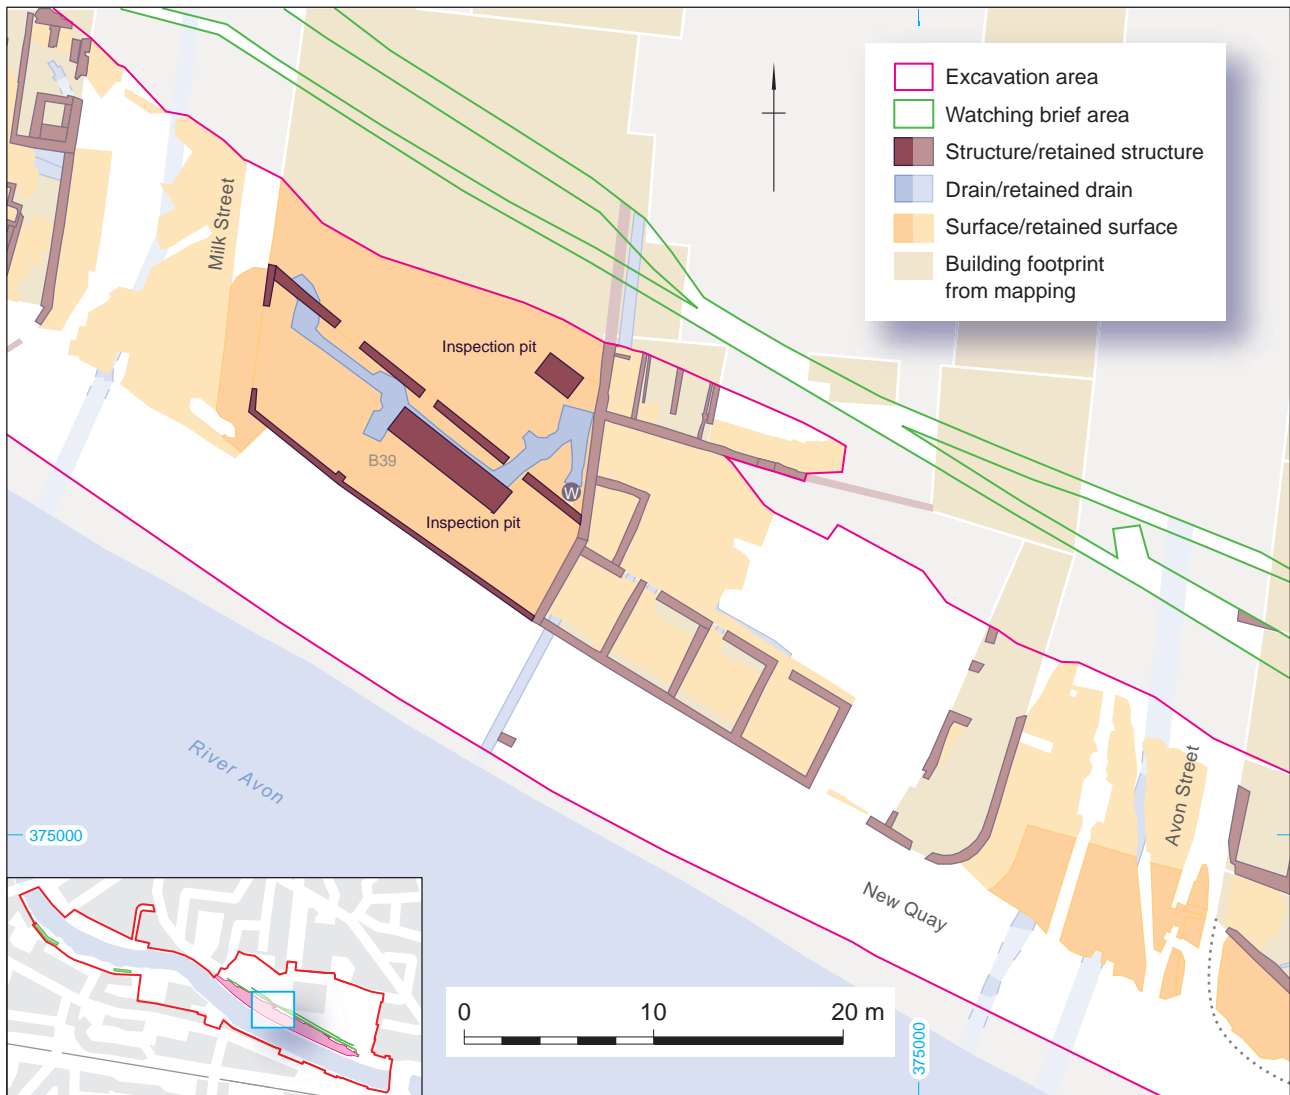
Figure 5.13 Plan of Narrow Quay Garage, 1920s–40s. Building outlines based on 1932 OS plan

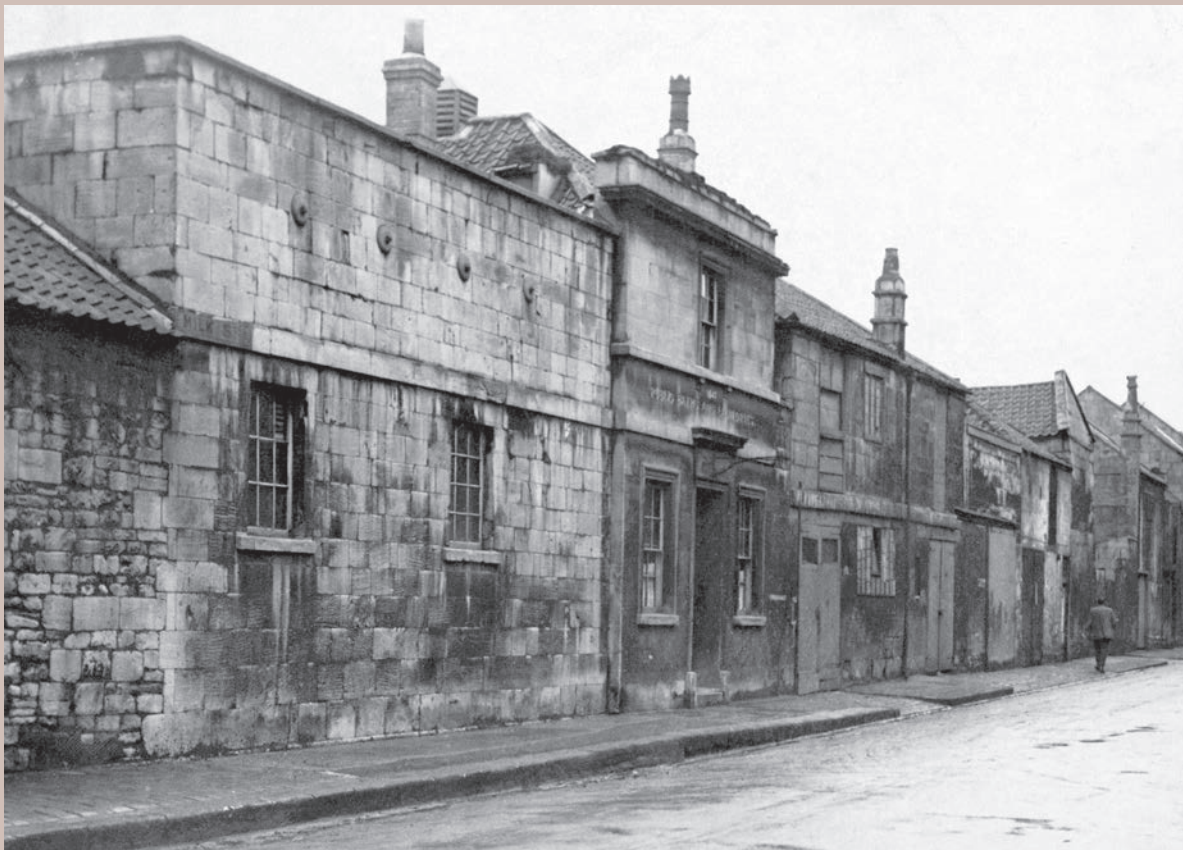
*Plate 5.9 c. 1930 view of the Milk Street Baths and Laundry, from the south-east © B&NES Council*

The new washhouse was a two-storey structure with an entrance facing Milk Street (Pls 5.9 and 5.10). It was fitted with 14 laundry tubs, five baths, and a steam engine and boiler to pump water from the river and heat the water. Each of the laundry tubs had a hot and cold water supply and a pipe that supplied steam for boiling it. The laundry cost one penny for four hours' use and half a penny for every hour thereafter. Cold baths cost a penny, warm baths were tuppence (BCWG, 30 September 1847). It quickly became apparent that the demand for washing facilities was far larger than originally anticipated, and in January 1848, William Sutcliffe, president of the BLSCB, proposed raising an additional £300 to pay for an extension (BCWG, 27 January 1848). In November 1848, Sutcliffe was appointed as Mayor of Bath, but despite holding this prestigious position, funds for his proposal did not materialise until c. 1852. The extension, which included a large laundry block and two additional steam boilers, was completed in 1853. The total cost of building and equipping the washhouse was approximately £3000 (BCWG, 8 December 1853; BCWG, 3 March 1881; SRO D\P\wal.sw/2/1/42).

otherwise stated, all elements of the building were constructed of Bath Stone ashlar, founded on rubble foundations, and bonded with a hard grey lime mortar. The building was divided into three principal elements: a two-storey ‘master’s house’ which served as the entrance to the institution; a two-storey west wing that housed the bathing and laundering facilities and a single-storey south wing that contained the heating and pumping equipment, with a water reservoir above (see Pl. 5.9).

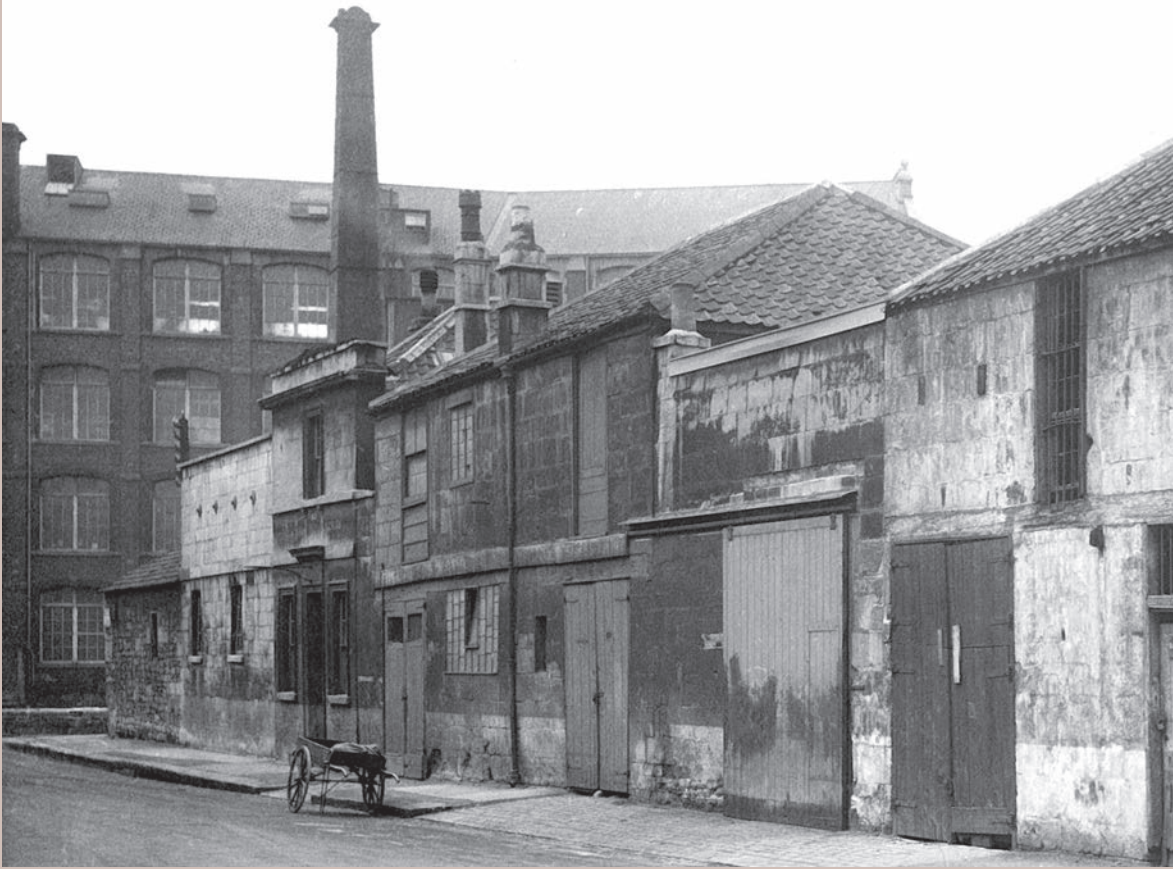
*Plate 5.10 c. 1930 view of the Milk Street Baths and Laundry, from the north-east, with the Albion Stay Factory in the background © B&NES Council*

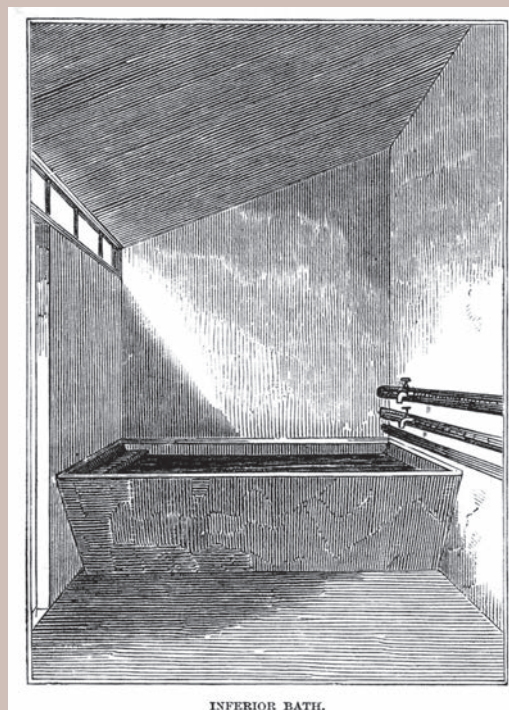
Figure 5.14 'Inferior bath', extract from an engraving of *St Pancras Baths and Washhouse*, *The Illustrated London News*, 3 January 1846 © Mary Evans Picture Library

Contemporary descriptions of the enlarged baths state that there were 16 men's baths on the ground floor and eight women's baths on the first floor. The baths were supplied with hot and cold running water and a private closet for changing. The cheapest (second-class) baths cost tuppence and included the use of a towel (Fig. 5.14). First-class baths were available for threepence; these had more ornate closets, a floor-grate to stand on, a chair and cushion, a wash-stand and a mirror (Fig. 5.15). Second-class women's baths were better appointed than

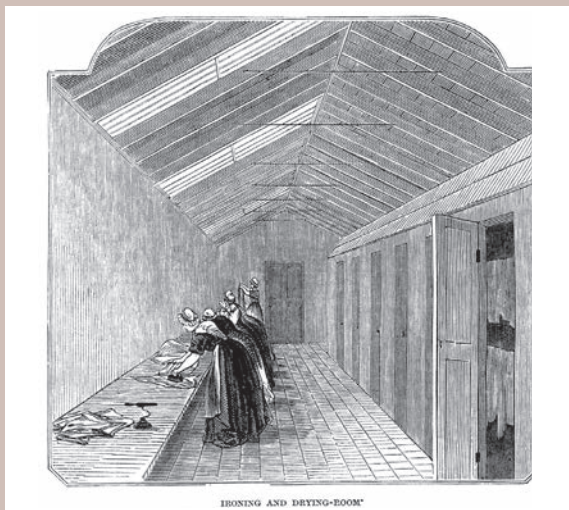
Figure 5.17 'Ironing and drying room', extract from an engraving of *St Pancras Baths and Washhouse*, in *The Illustrated London News*, 3 January 1846 © Mary Evans Picture Library

washhouse laundry. Clothes were dried in hand- or steam-powered drying machines, and there were 15 'drying horses' and 'a large and cheerful ironing room, well supplied with flats [irons], and a [heated] drying closet'. Figures 5.17–5.18 show a typical ironing room layout and the types of machinery used to wring and dry clothes in mid-19th-century public washhouses. Hot water and steam was provided by three coal-fired boilers: two to heat water and a third that provided steam for a three-horse-power engine to 'pump river water into a well, where it is filtered, and from thence into a reservoir, where it is filtered

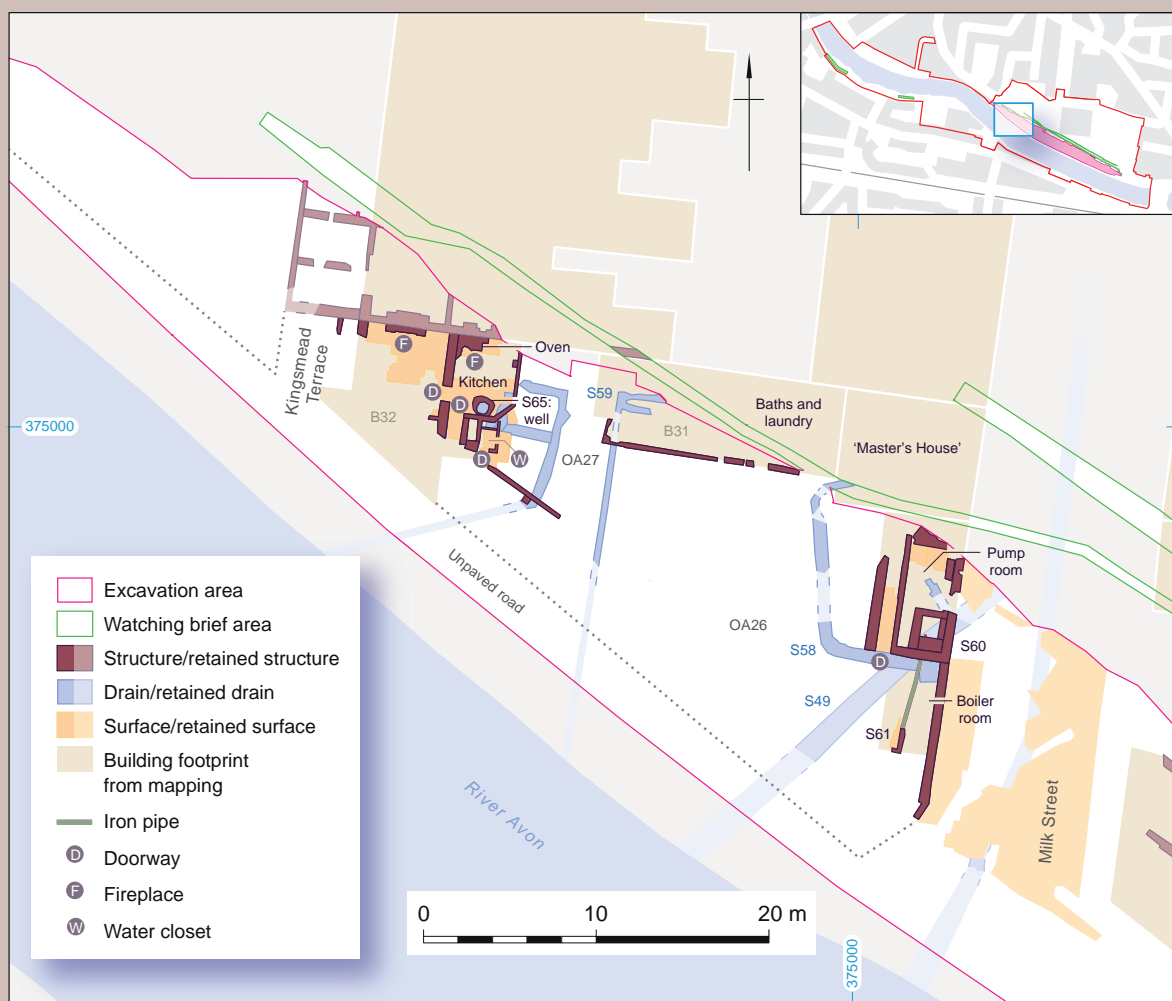
Figure 5.20 Plan showing the development of the Milk Street Baths, 1847–52. Building outlines based on Cotterell's plan of 1852

The earliest part of the washhouse (Fig. 5.20), which was constructed in 1846–7, comprised an L-shaped building with an entrance facing Milk Street. Unless

B32 (Fig. 5.20) was a substantial, 11.5 m by 10 m wide, end-of-terrace townhouse. Cartographic evidence suggests that the building was constructed between 1810 and 1852, which concurs with the date of the finds from beneath the building (see *Finds from Ground-raising Deposits Beneath 30 Kingsmead Terrace*).

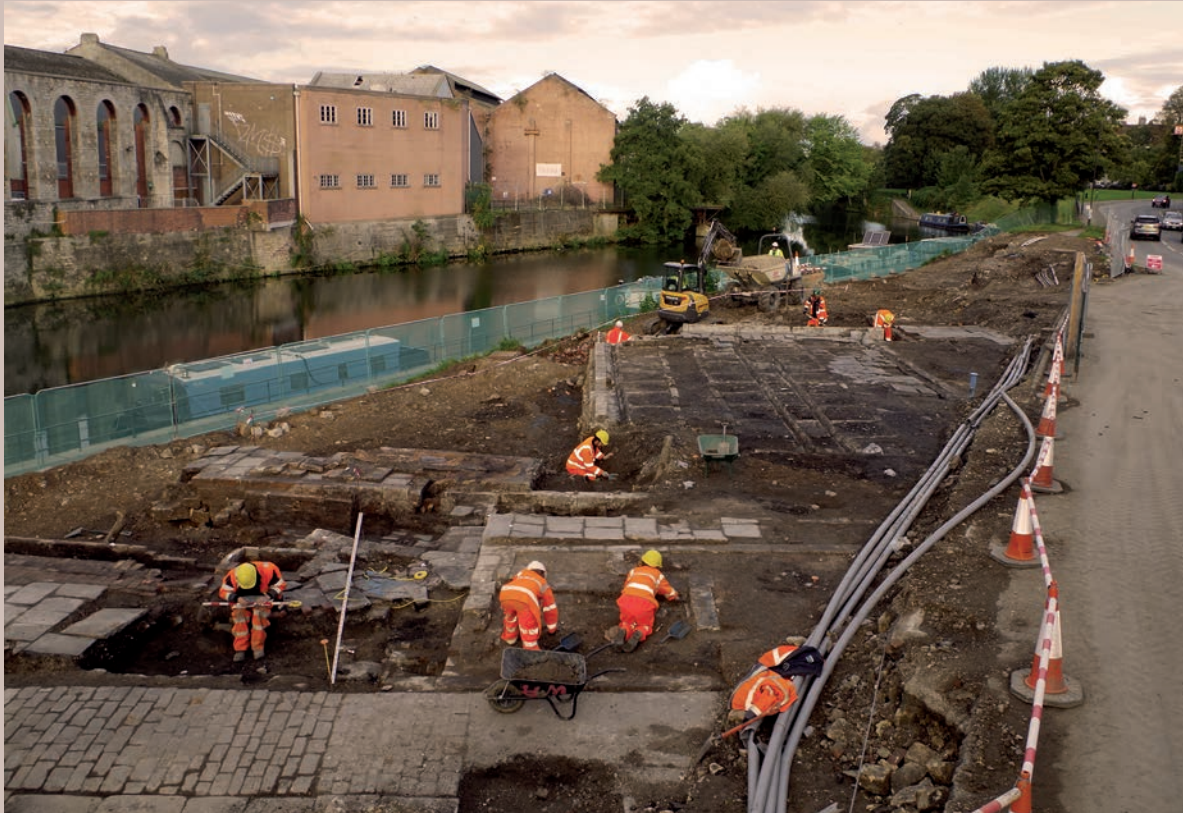
*Plate 5.12 The Milk Street Baths and Laundry, from the east, with the Newark Works foundry in the background*

The south wing (Pl. 5.12), which measured 8.1 m by 5 m, had a north-south aligned corridor along its west side, with a single room to the west. This room contained a large sub-surface tank (S60; Pl. 5.13), measuring 2 m by 1.45 m and over 1 m deep internally, constructed of large Bath Stone blocks.

The second phase of construction within B31, undertaken in 1853, involved adding a 16 m by 8 m laundry block (Pls 5.12 and 5.14; Fig. 5.21) to the

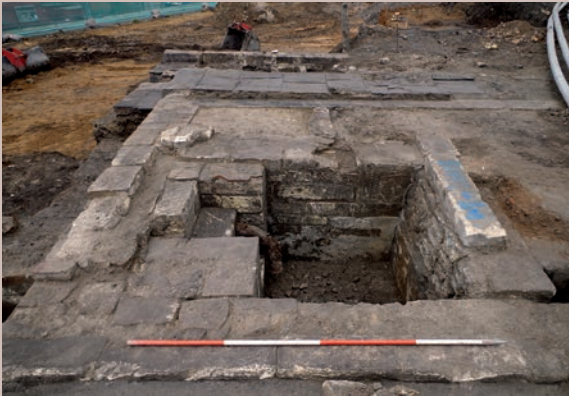
*Plate 5.13 'Well' for pump and filter within the Milk Street Baths and Laundry pump room, from the east*

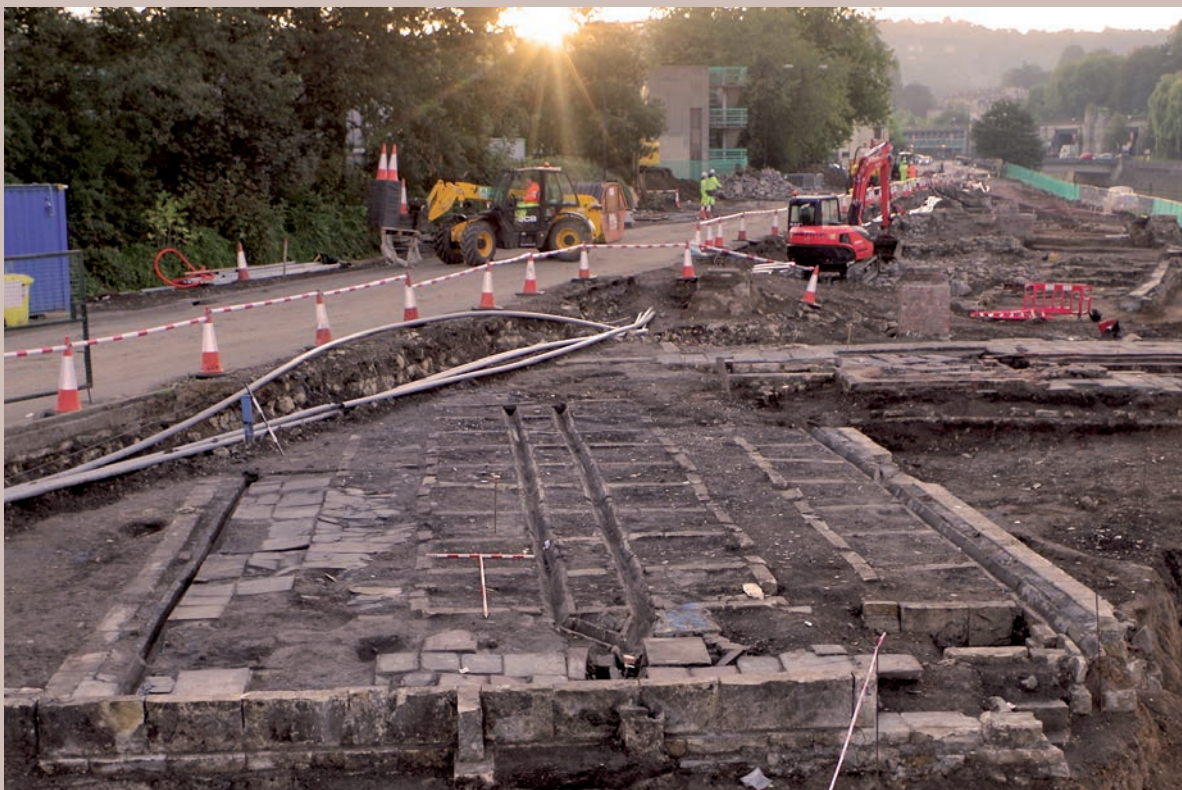
*Plate 5.14 1853 laundry block, from the west*

south-west of the original building and substantially enlarging the boiler room to accommodate three steam boilers (Pl. 5.15). The laundry contained 41 washing cubicles, each separated by Bath Stone
