# Bath Quays Waterside

**The Archaeology of Industry, Commerce and the Lives of the Poor in Bath's Lost Quayside District**

Wessex Archaeology Occasional Paper  
2020

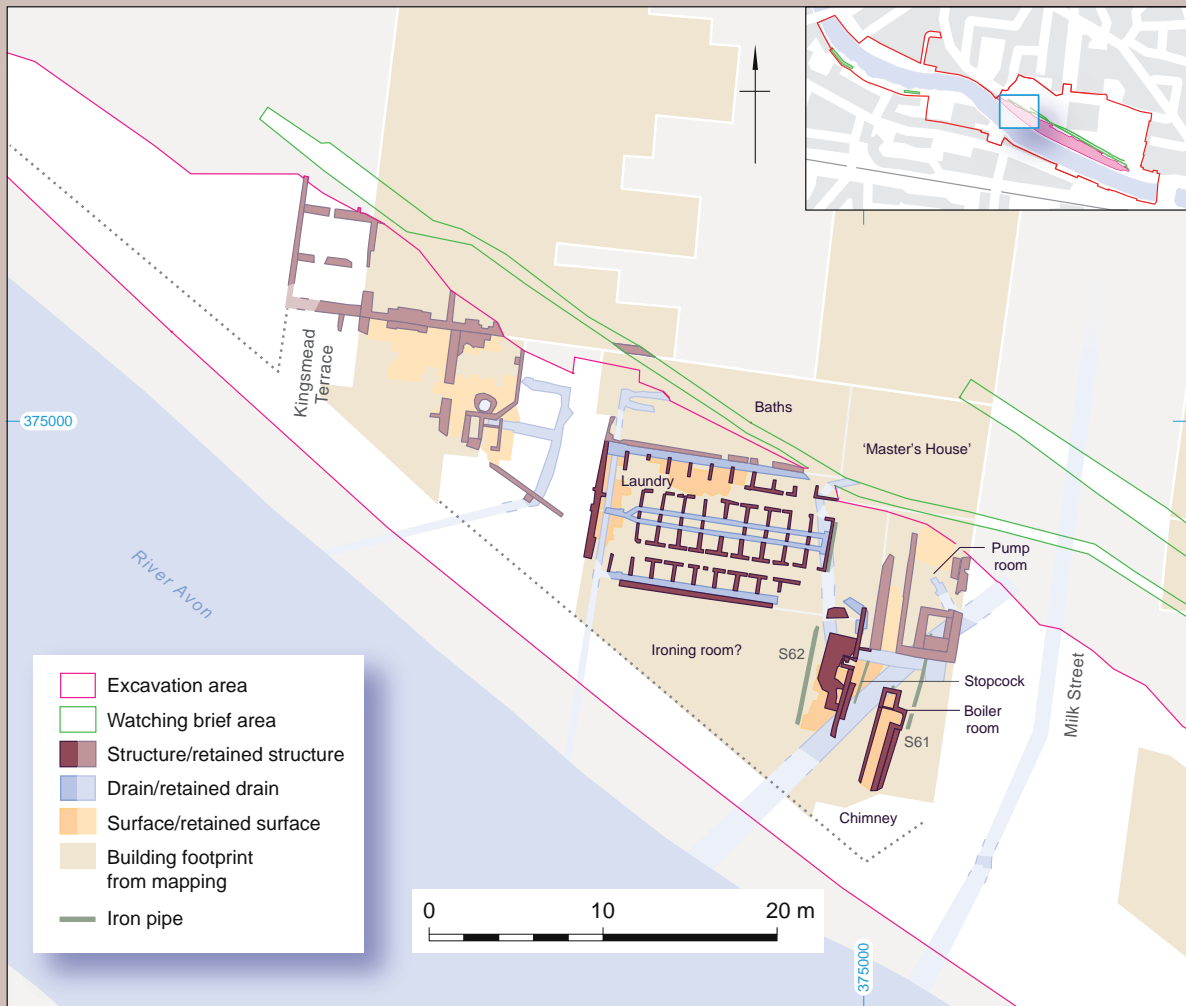
Figure 5.21 Plan showing the development of the Milk Street Baths, 1853–73. Building outlines based on 1885 OS Town Plan

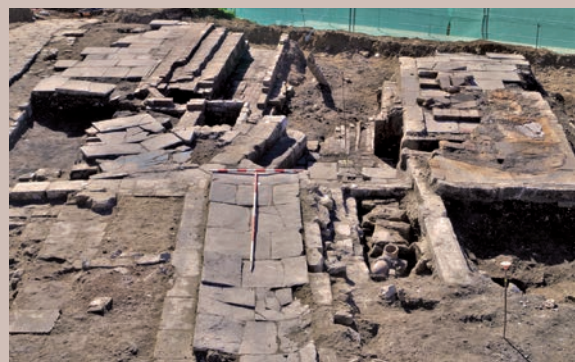
Plate 5.15 1853 Lancashire boiler bases S61 and S62, from the north

The block at the southern end of the south wing is likely to have housed a coal store and the steam boiler that provided steam for the engine and hot water for the baths. Fragmentary remains of a brick- and stone-built boiler base (S61), likely to date from 1847, were recorded in this area.

south-west of the original building and substantially enlarging the boiler room to accommodate three steam boilers (Pl. 5.15). The laundry contained 41 washing cubicles, each separated by Bath Stone

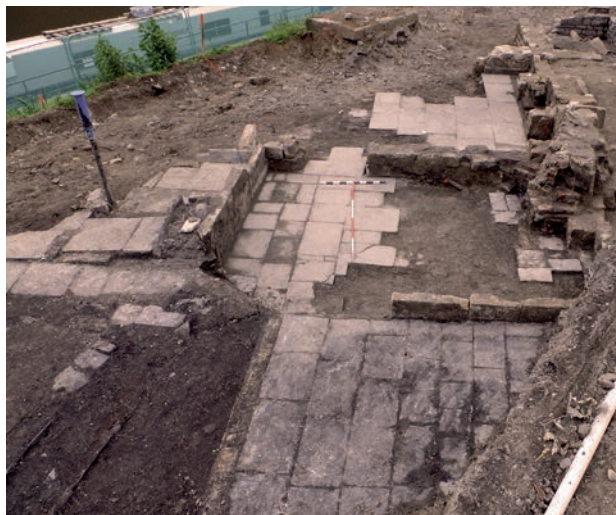
Plate 5.16 30 Kingsmead Terrace (B32), from the east, with kitchen and garden in the foreground

B32 (Fig. 5.20) was a substantial, 11.5 m by 10 m wide, end-of-terrace townhouse. Cartographic evidence suggests that the building was constructed between 1810 and 1852, which concurs with the date of the finds from beneath the building (see *Finds from Ground-raising Deposits Beneath 30 Kingsmead Terrace*).

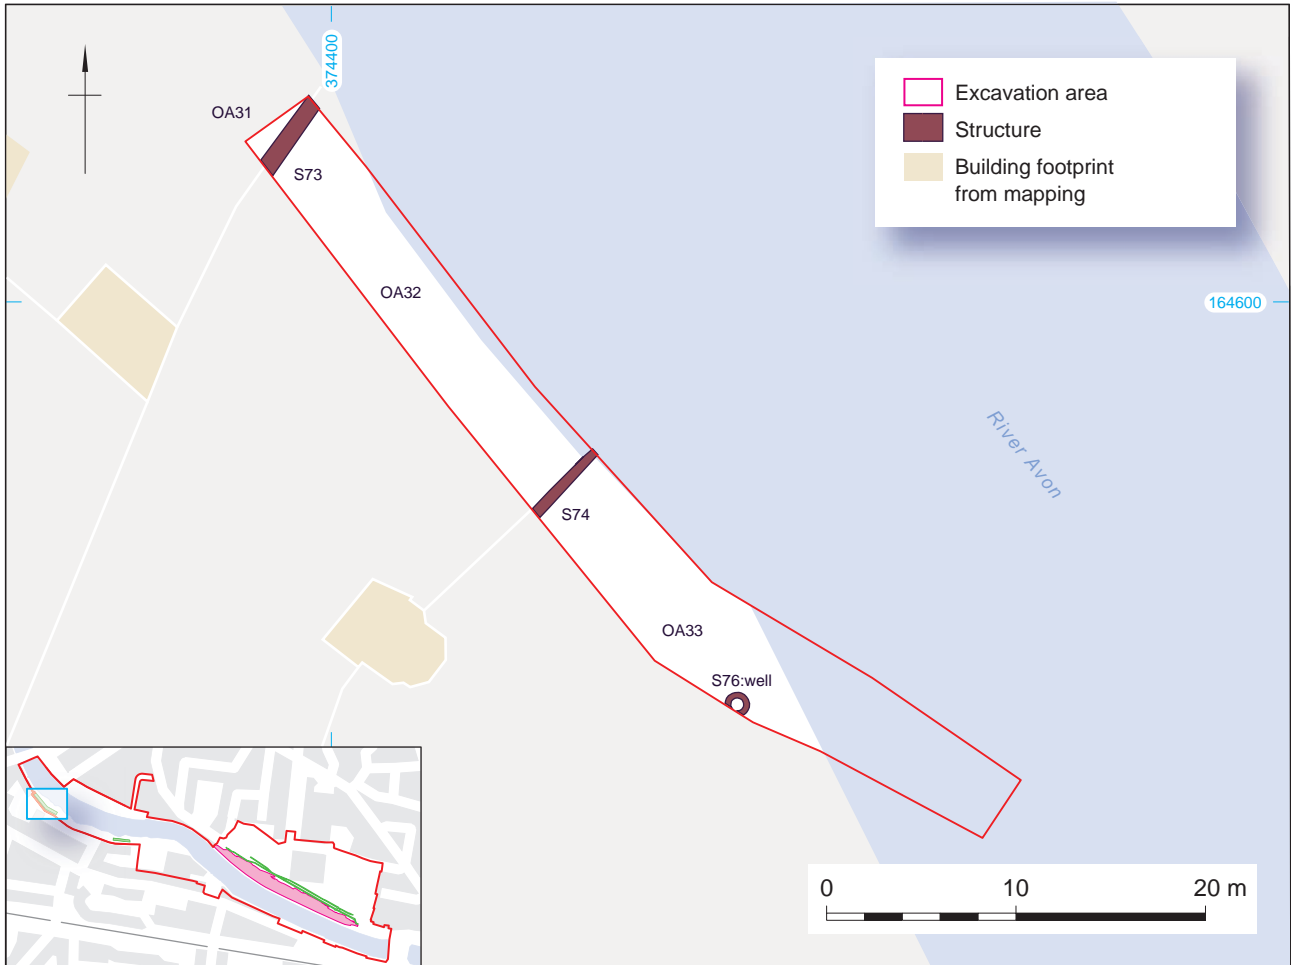
Figure 5.23 Plan of archaeological features on the south side of the river, c. 1830–90. Building outlines based on the 1885 OS plan

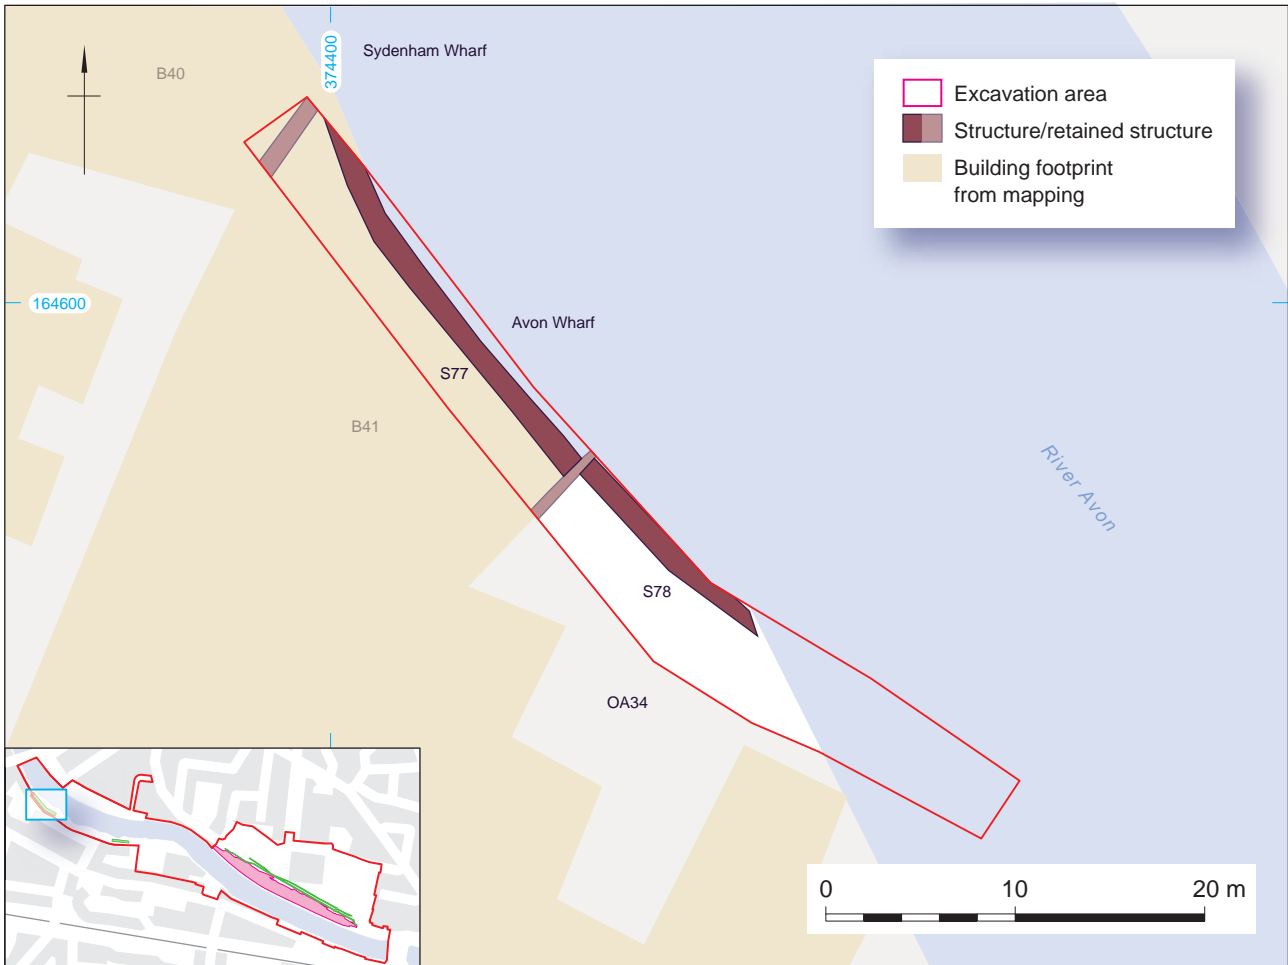
Figure 5.24 Plan of archaeological features on the south side of the river, c. 1890–1930. Building outlines based on the 1932 OS plan

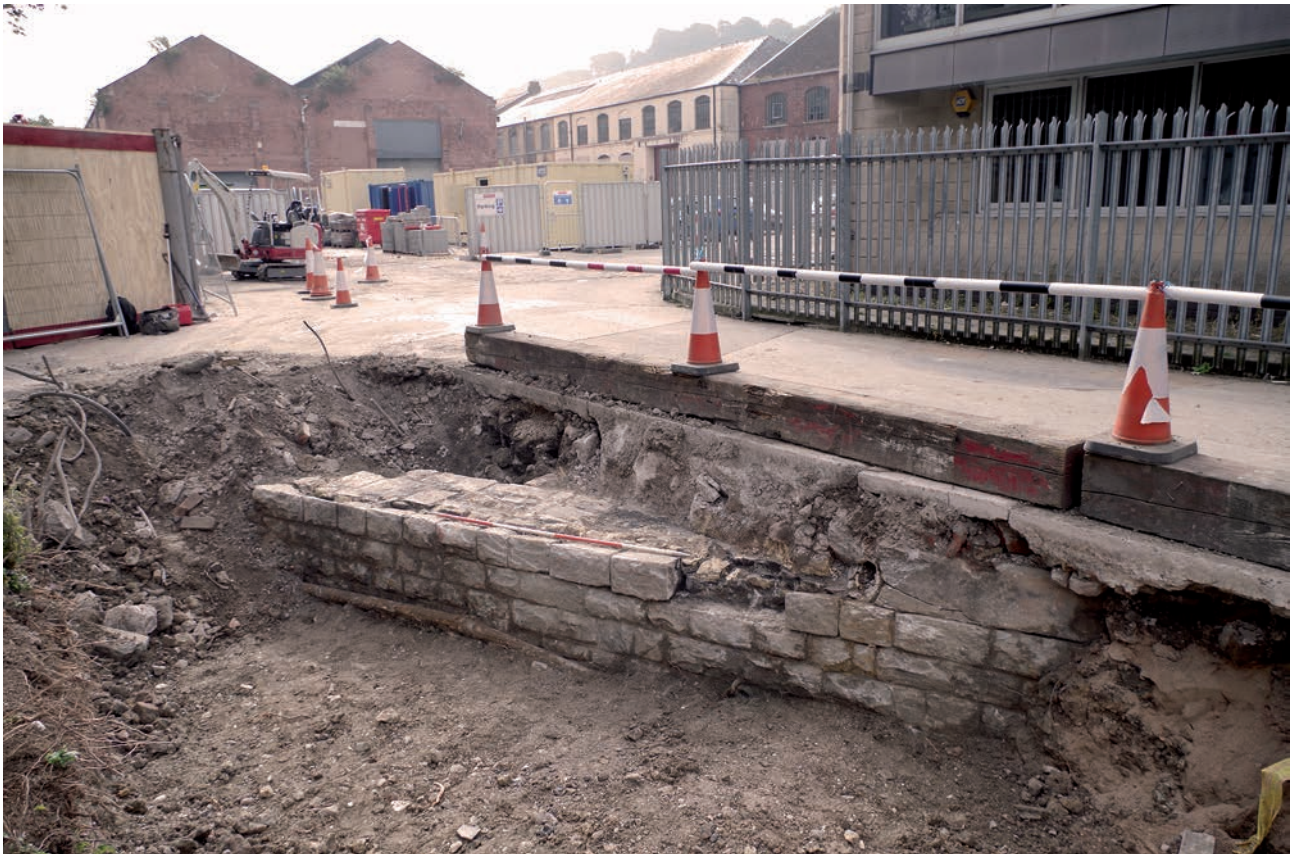
Plate 5.19 Mid-19th century wharf (S79), from the north-west, with the remains of the Newark Works foundry in the background

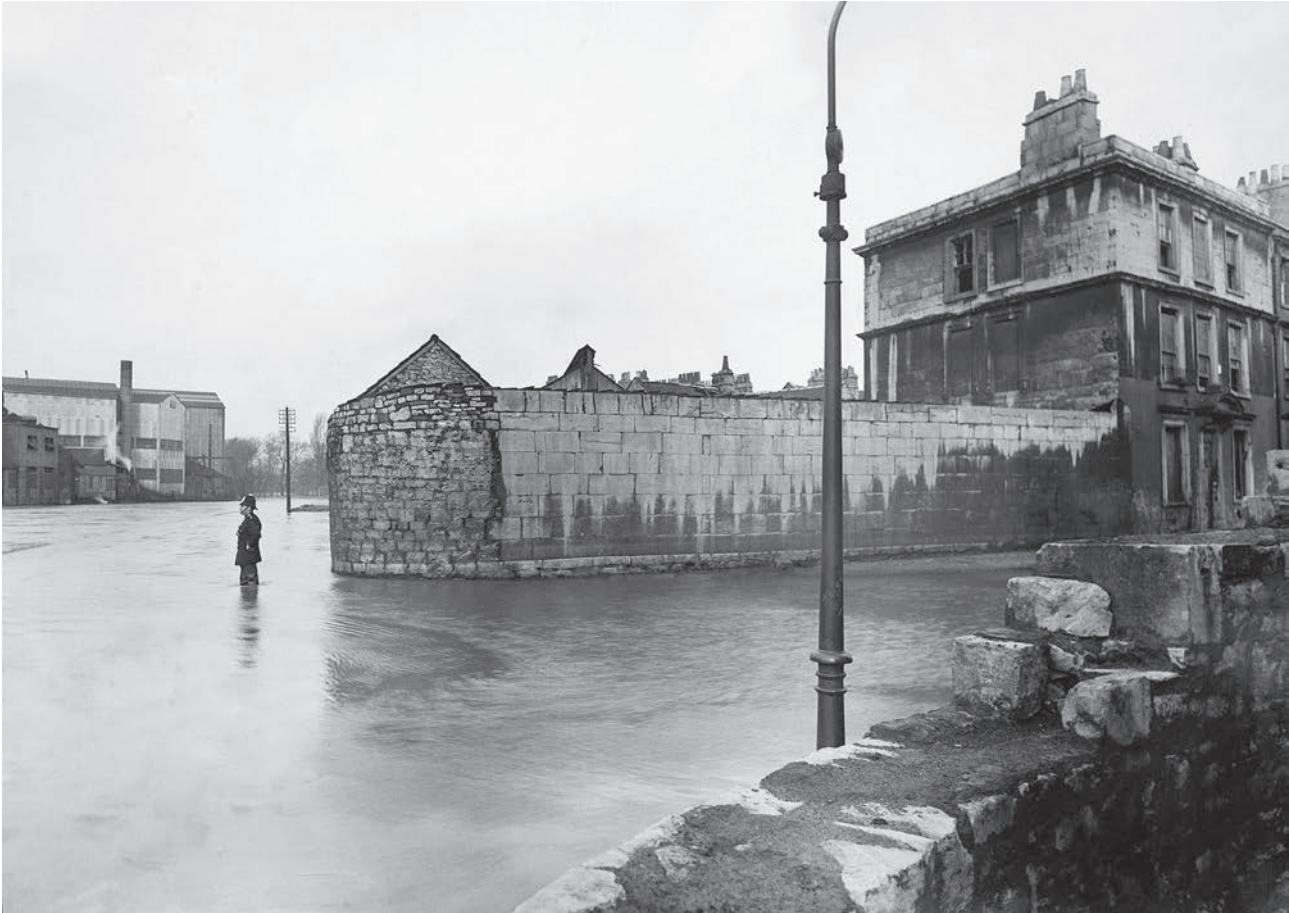
*Plate 7.1 Flooding at the southern end of Avon Street on 27 February 1937, from the east, showing 49 Avon Street (constructed in the 1730s) and adjacent stables (B34), which were constructed c. 1874 © B&NES Council*

The Avon floodplain is, as the name implies, subject to seasonal flooding. This was both an impediment to development and a hazard for the district's 18th–20th-century inhabitants. In the 19th century, there were particularly severe inundations in 1809, 1821, 1823, 1841, 1882, 1894 and 1899, the last being the most serious (Buchanan 1998, 175). Part of the reason for the severity of the 19th-century floods was the fact that as the town expanded, the river became constrained by high walls that narrowed the channel, which forced floodwaters to rise upwards rather than outwards. There were further severe floods in 1937 (Pl. 7.1) and 1960, and it was the latter that finally spurred the council into action. Work to deepen and straighten parts of the river and remove obstructions began in the winter of 1964/5. Medieval St Lawrence's Bridge was demolished, as were most of the 18th-century riverside walls along Broad Quay and New Quay. By 1965, a new single-span concrete road bridge (Churchill Bridge) and a footbridge were constructed in its place. New steel and concrete walls were subsequently constructed along the

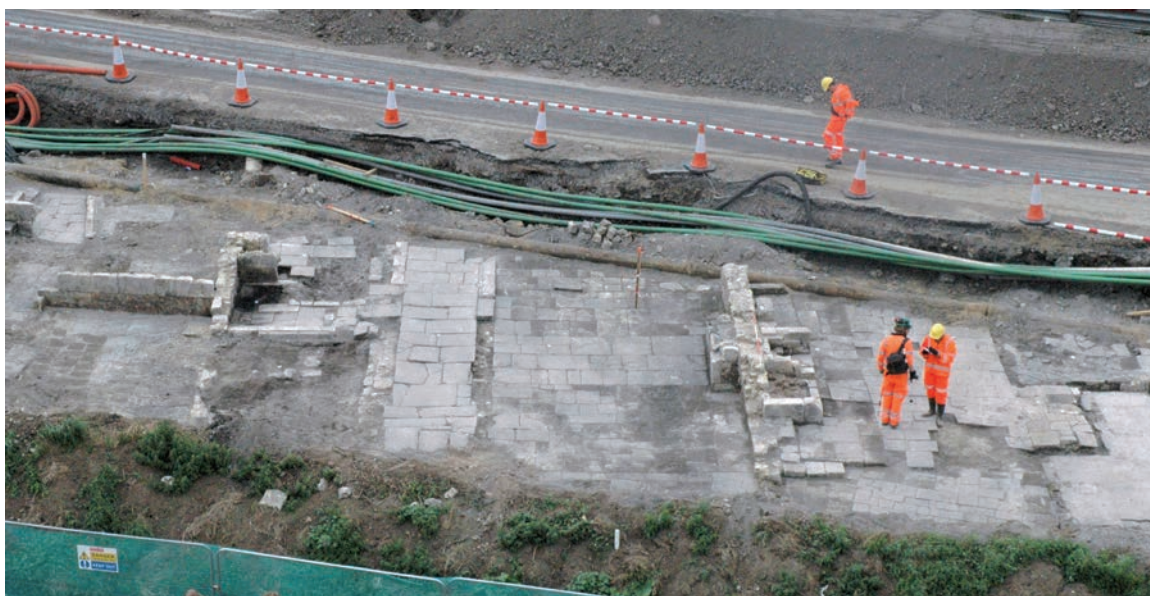
The buildings of Bath's wealthy 18th- and 19th-century inhabitants are, quite rightly, world-famous for their architecture, but those of the city's poorer inhabitants – the workers who built and provided the basic needs of the city – are less well known. This is largely due to the extensive and deliberate demolition
