Capper Pass & Son's Bedminster Smelting Works

EXCAVATIONS AT DALBY AVENUE AND WHITEHOUSE LANE
BEDMINSTER GREEN, BRISTOL

Cai Mason

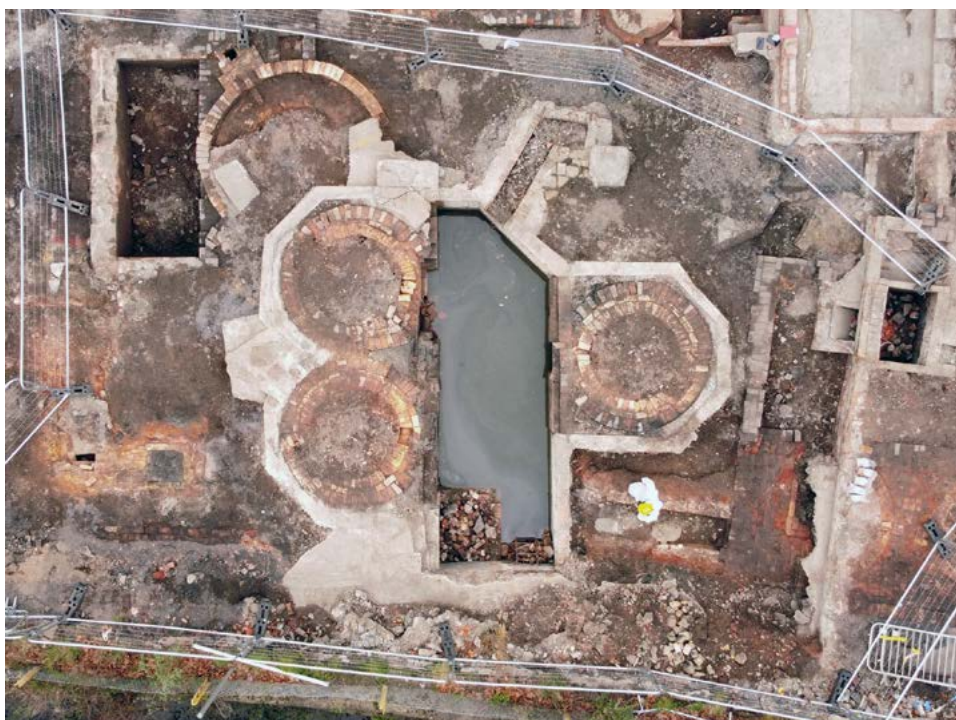
Figure 1.10 Aerial view of the northern part of Plot A, showing solder pots S50 (photograph reproduced with the permission of Bristol & Bath Heritage Consultancy Ltd)

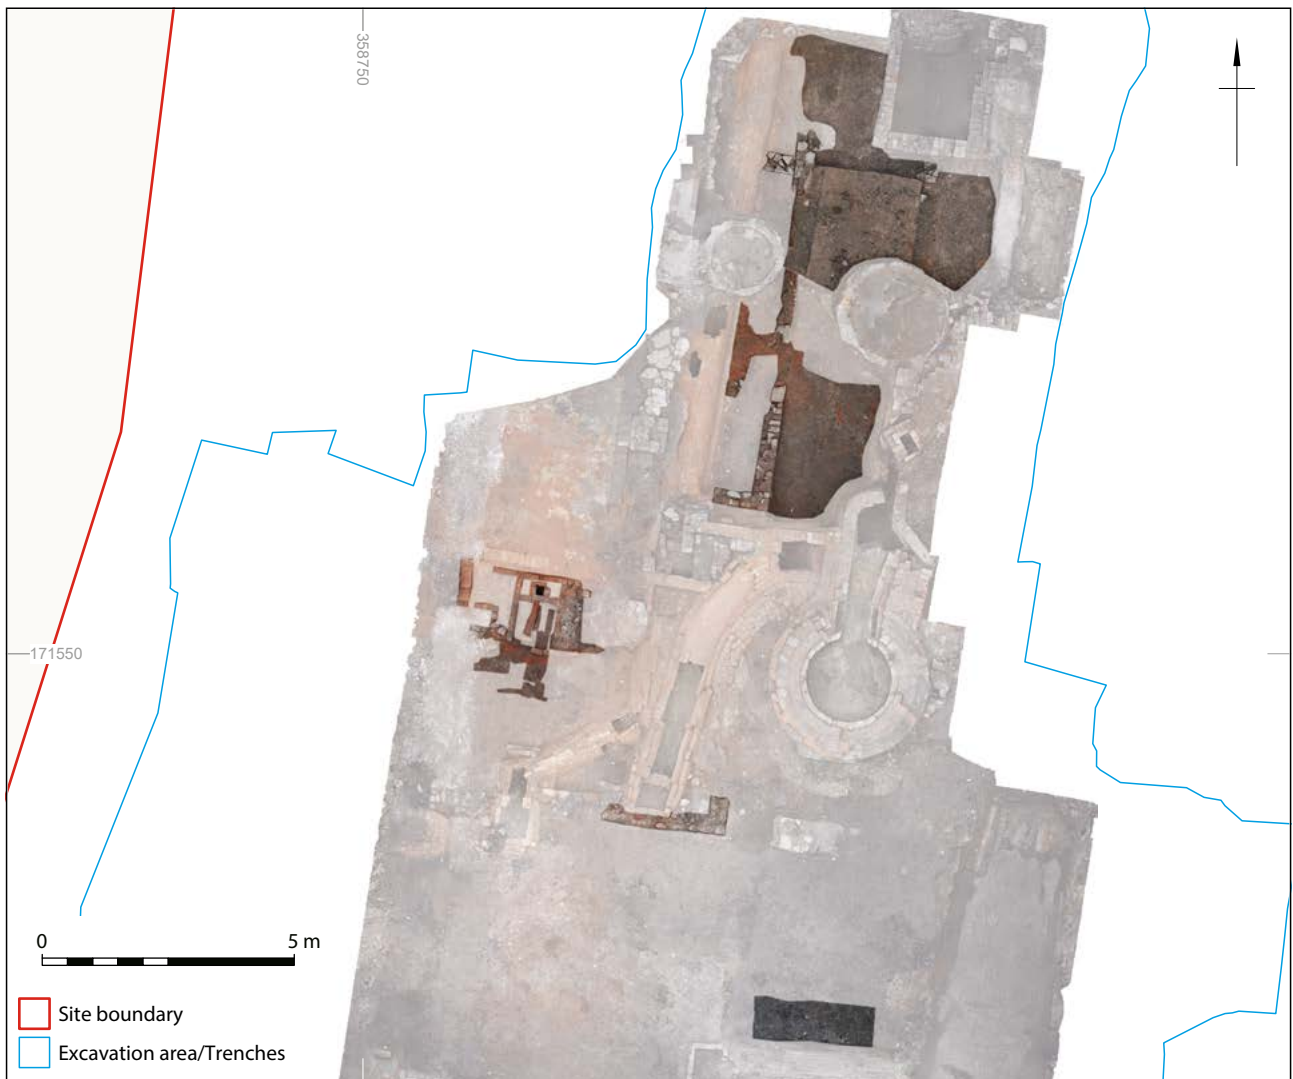
Figure 3.3 Orthographic plan from photogrammetric model, showing archaeological features, 1832–9

The earliest archaeological features comprised the foundations of outbuildings and other structures to the rear of 7–10 Coronation Street (Figs 3.2 and 3.3). These structures, which were heavily truncated by later features, included an outhouse (B1) and associated brick-lined drainage system and garden wall to the rear of 7 Coronation Street; the walls of another outhouse (B2) behind No. 8; and an extension (B3) and outbuilding (B4) to the east of No. 9. The 1830s buildings were predominantly constructed of stone, with some brick details, all bonded with pale grey lime mortar. The buildings were aligned east–west and north–south.

Brick- and stone-built outhouse B1 measured 2.5 x 1.9 m wide and incorporated a contemporary stone-lined drainage system, probably for a primitive water-flushed privy and/or washhouse sink. There were no indications of any paved surfaces within the building. Building B2, which measured 2.5 x over 1 m, was built of stone and was probably also used as outhouse. There were unpaved yards (OA1 and OA2) to the south of these buildings.

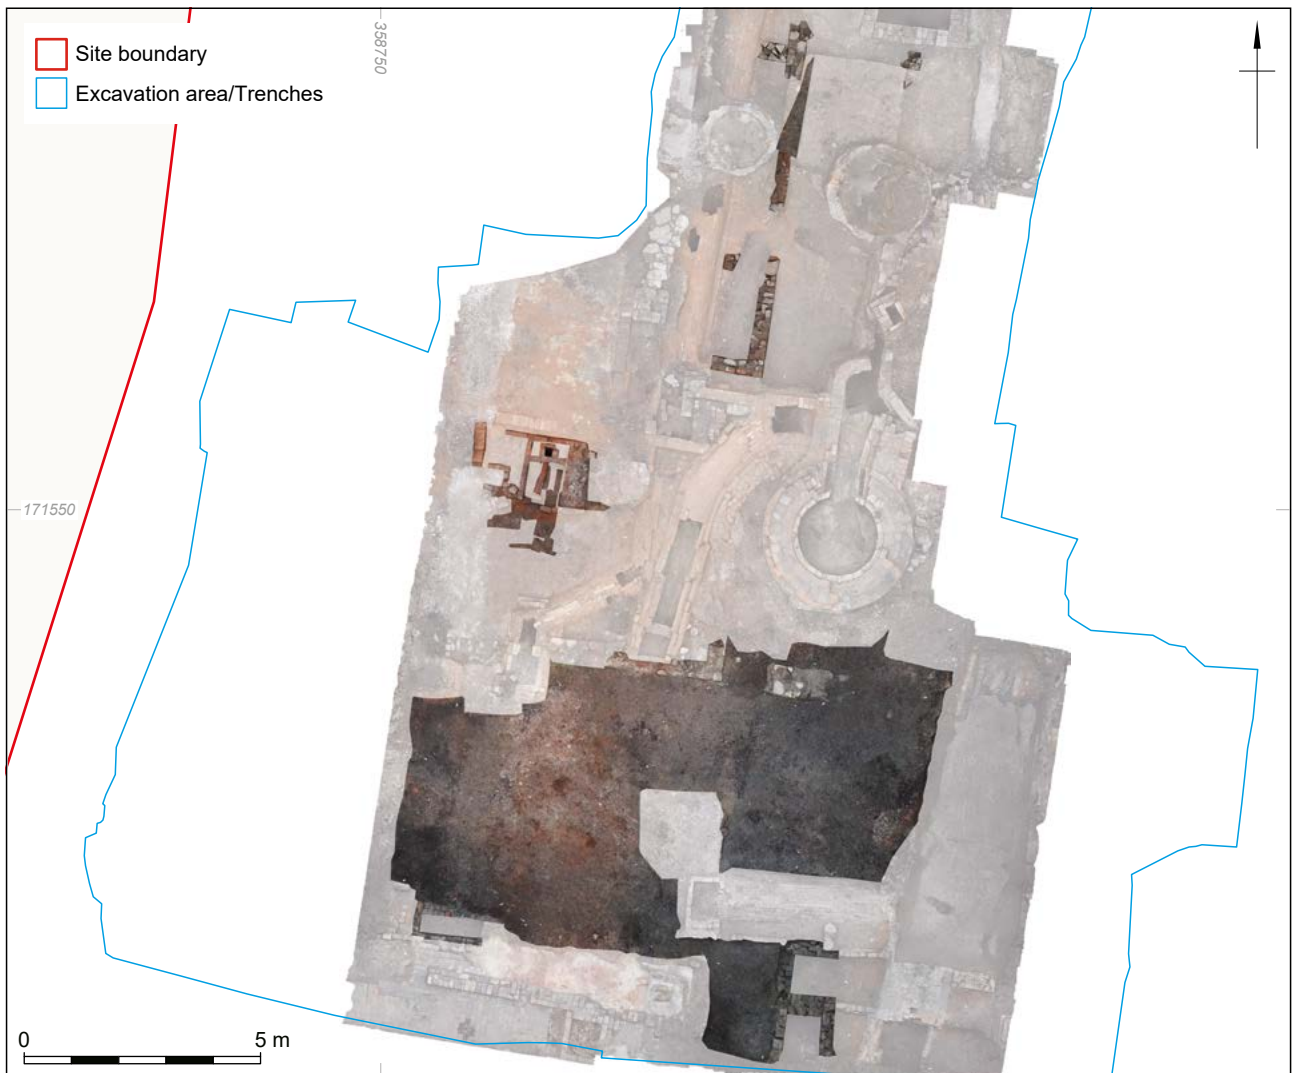
Figure 4.6 Orthographic plan from photogrammetric model, showing 1840–54 archaeological features

By 1854, Pass had erected a small workshop (B5) within yard OA5. The fragmentary remains of this building comprised a shallow and insubstantial line of brickwork: possibly a plinth for a timber-framed wall. The north-west corner of the building was defined by a narrow (0.4 m wide by 1.75 m long internally) trough-like brick structure (S2), which had single-skin brick walls along its north, west and south sides, but none at the east end. The base was unlined. The function of this trough is unknown.

The only other structure within building B5 was a 0.6 m deep stone-lined pit (S3; Fig. 4.7), which was split into two cells, both of which measured approximately 1 x 0.8 m wide internally. The northern cell was open to the east; it is unknown if the southern compartment was open to the south, as its edge lay beyond the limits of excavation.

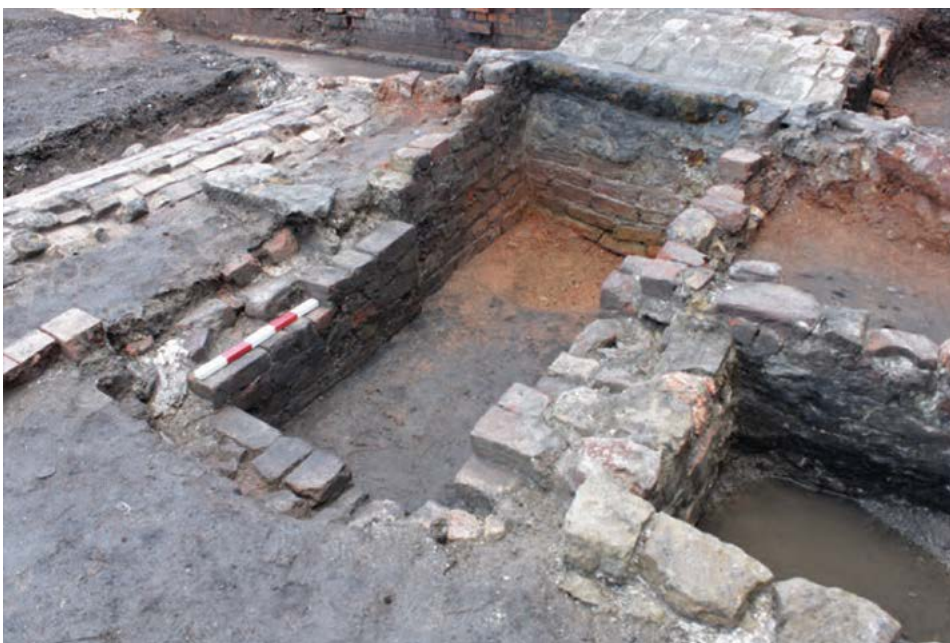
Figure 4.7 Twin-cell structure S₃, with flue S₄ to the rear, looking north-east. Scale: 0.5 m

The function of this structure is uncertain, but it is possible that the two cells were ash pits for small, above-ground crucible furnaces. This interpretation is supported by the presence of an accumulation of ash within structure S₃. Analysis of the ash (see Chapter 8, sample 13), showed that it predominantly comprised particles of clinker, coal dust and partially burnt coal.

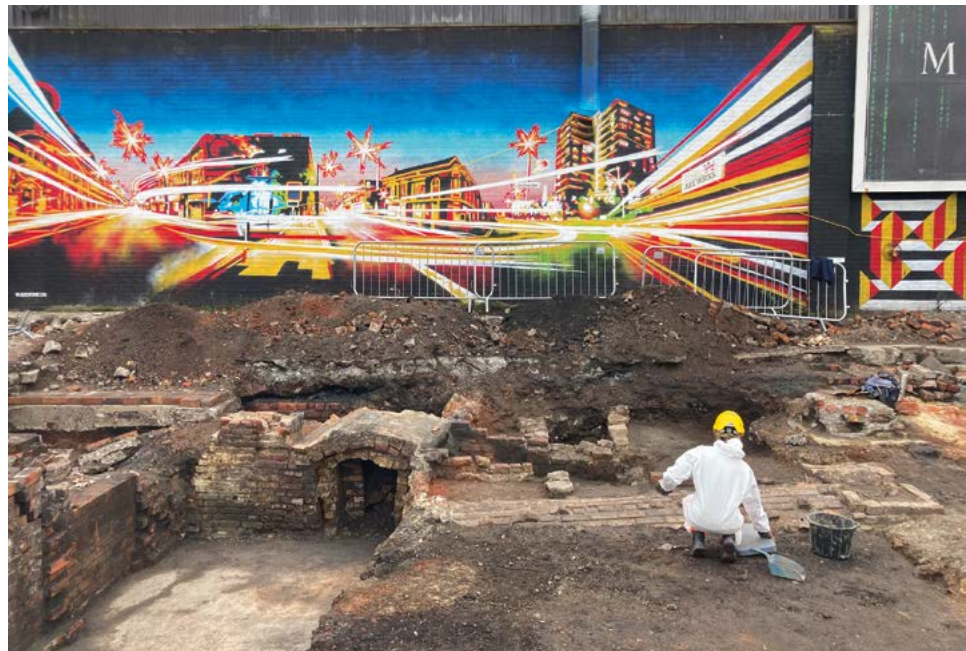
Figure 4.10 Flue system S₄, looking south

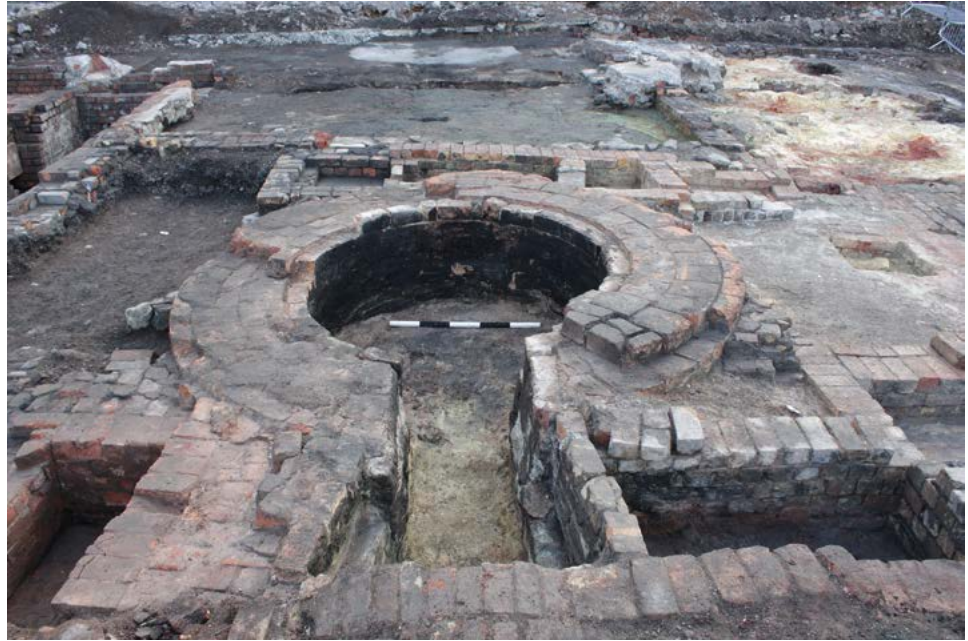
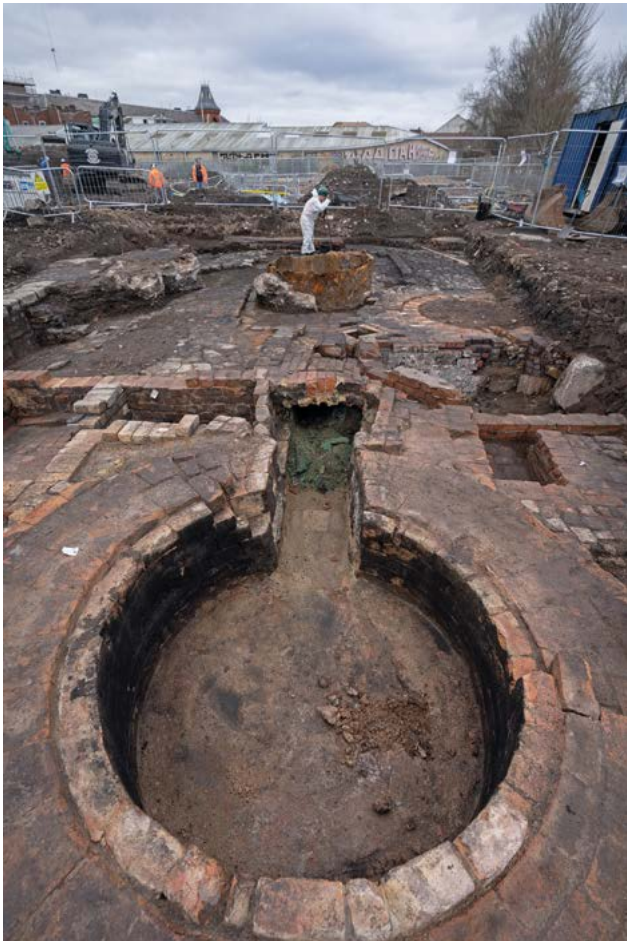
Figure 4.12 Chimney base S6 and flues S5 and S22, with yard OA7, solder pot S30 and iron tank S43 in the background. Looking north

Figure 4.11 Chimney base S6, flues S5 and S22 and structure S31, looking south. Scale: 1m

To the north of building B₆, there was a substantial circular chimney base (S₆; Figs 4.11 and 4.12). An annotation on the 1896 Goad Fire Insurance Plan (Fig. 5.4) shows that this chimney was 120 ft (36.6 m) high. The surviving elements comprised a 4.4 m wide circular foundation that supported the 3.2 m wide chimney, all built of curved red bricks bonded with grey lime mortar. The internal shaft had a diameter of 1.7 m and there was a single opening for a 0.53 m wide by over 0.5 m high flue (S₅) on the north side. The east side of the chimney was partially cut by a sub-rectangular pit (S₁₀) that measured over 3.7 m by over 1.8 m wide. The depth and purpose of this pit are unknown.

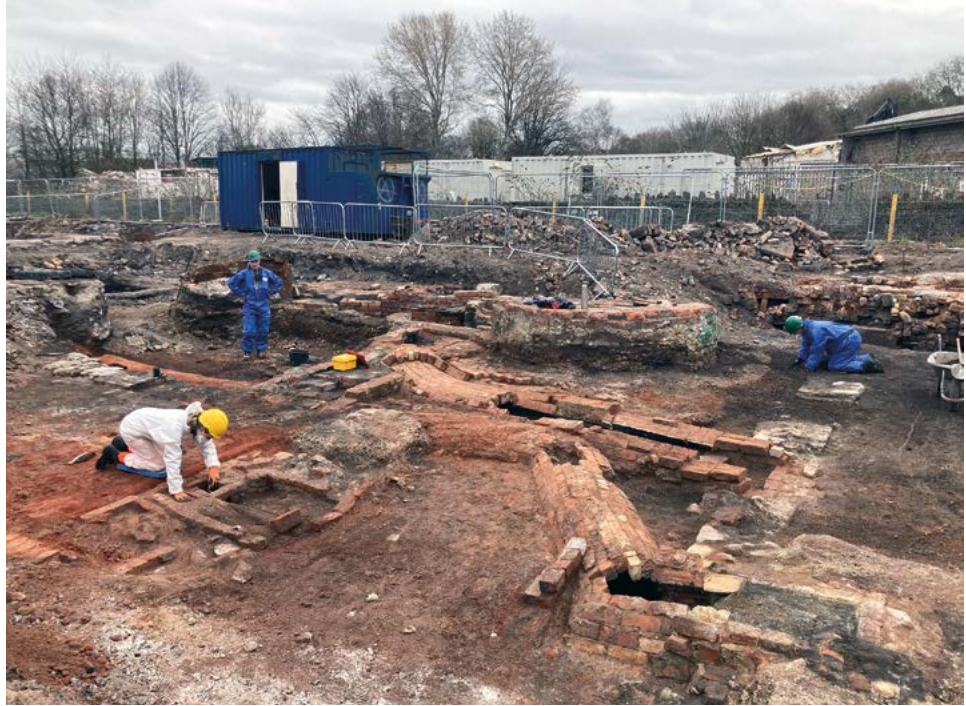
Figure 4.13 Buildings B1 and B6 and flues S11 and S21, looking north-east

To the west of chimney S6, there was another subterranean flue (S11; Figs 4.13 and 4.14), with an opening on the northern edge of building B6. Flue S11, which measured 0.56 m wide and over 0.6 m high internally, would have channelled smoke northwards. The flue was probably originally linked to chimney S6 via a manifold, but the link between the two was truncated by later activity. There was a slight dog-leg at the southern end of flue S11, probably to avoid the outhouse (B1) to the rear of 7 Coronation Street. Documentary evidence indicates that this property was demolished c. 1873, which suggests that flue S11 and its associated furnace were constructed before this date. Flue S11 was partially truncated by flue S21 (see Chapter 5).

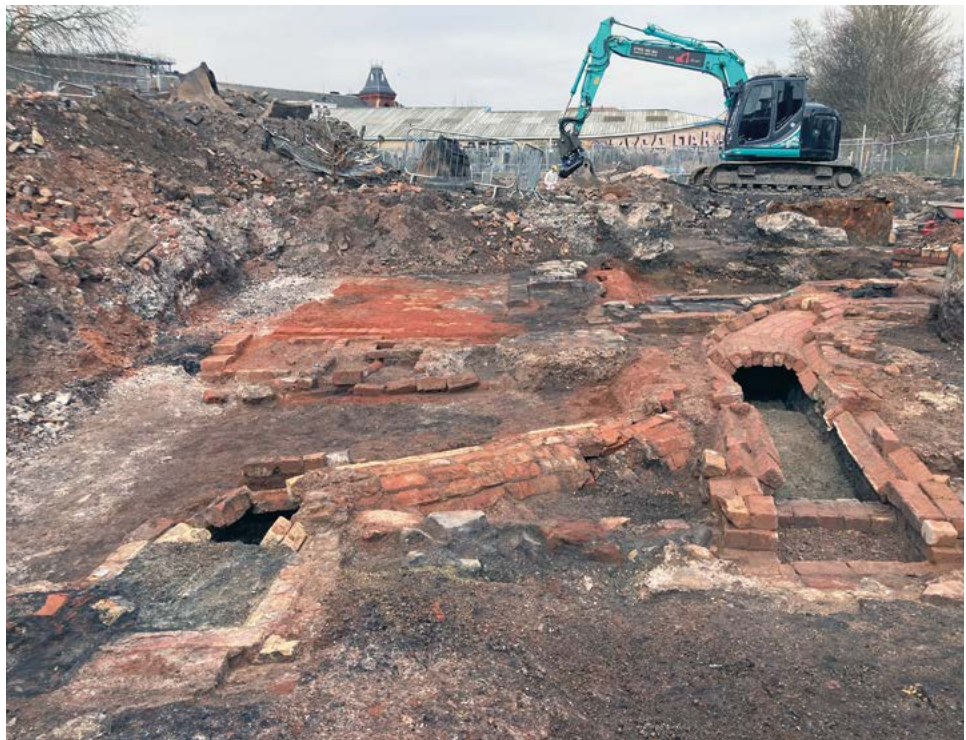
Figure 4.14 Outhouse B1 and flues S11 and S21, looking north

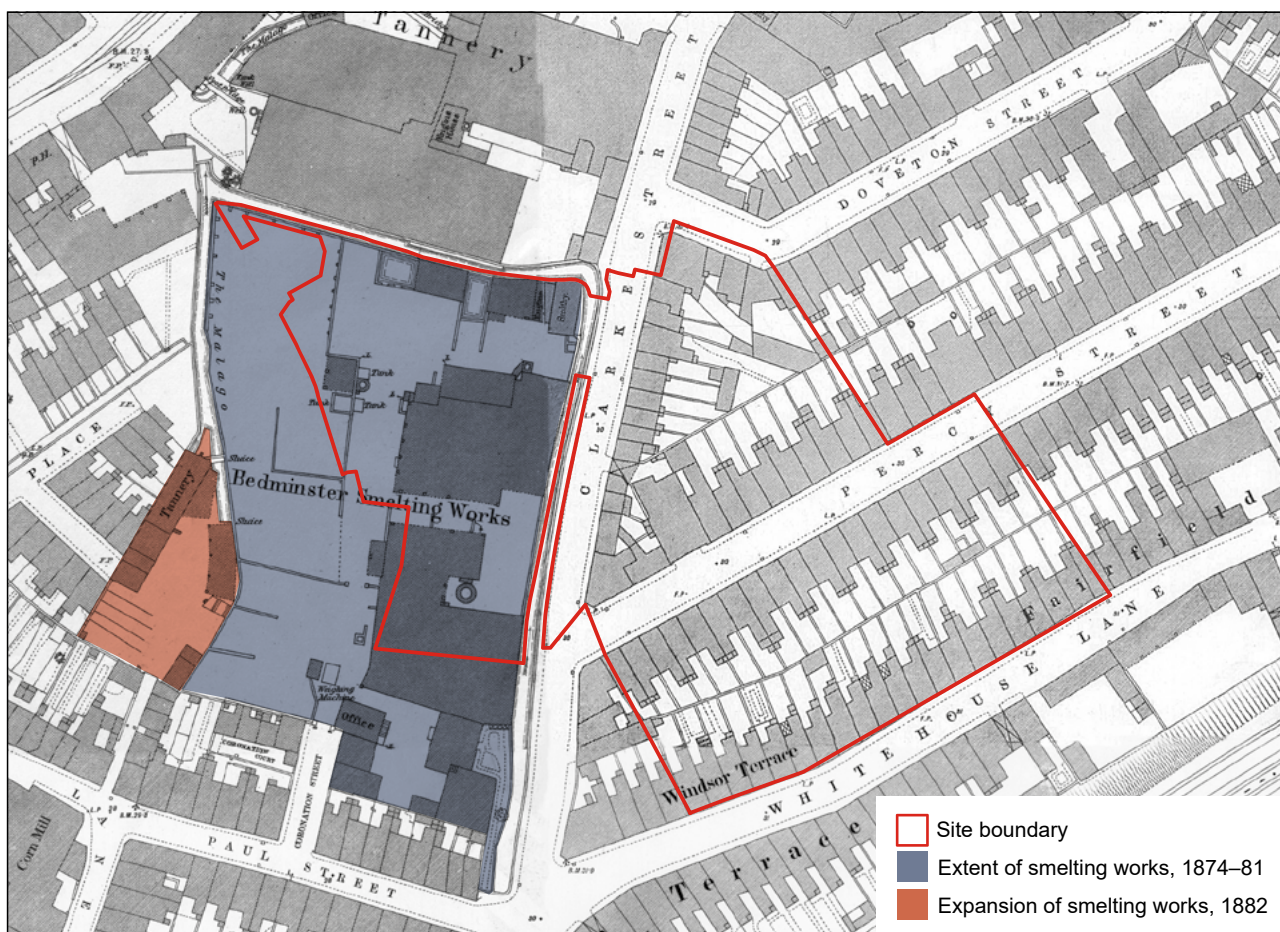
Figure 5.2 1885 OS Town Plan (surv. 1883). Reproduced with the permission of National Library of Scotland and British Library. <https://maps.nls.uk>

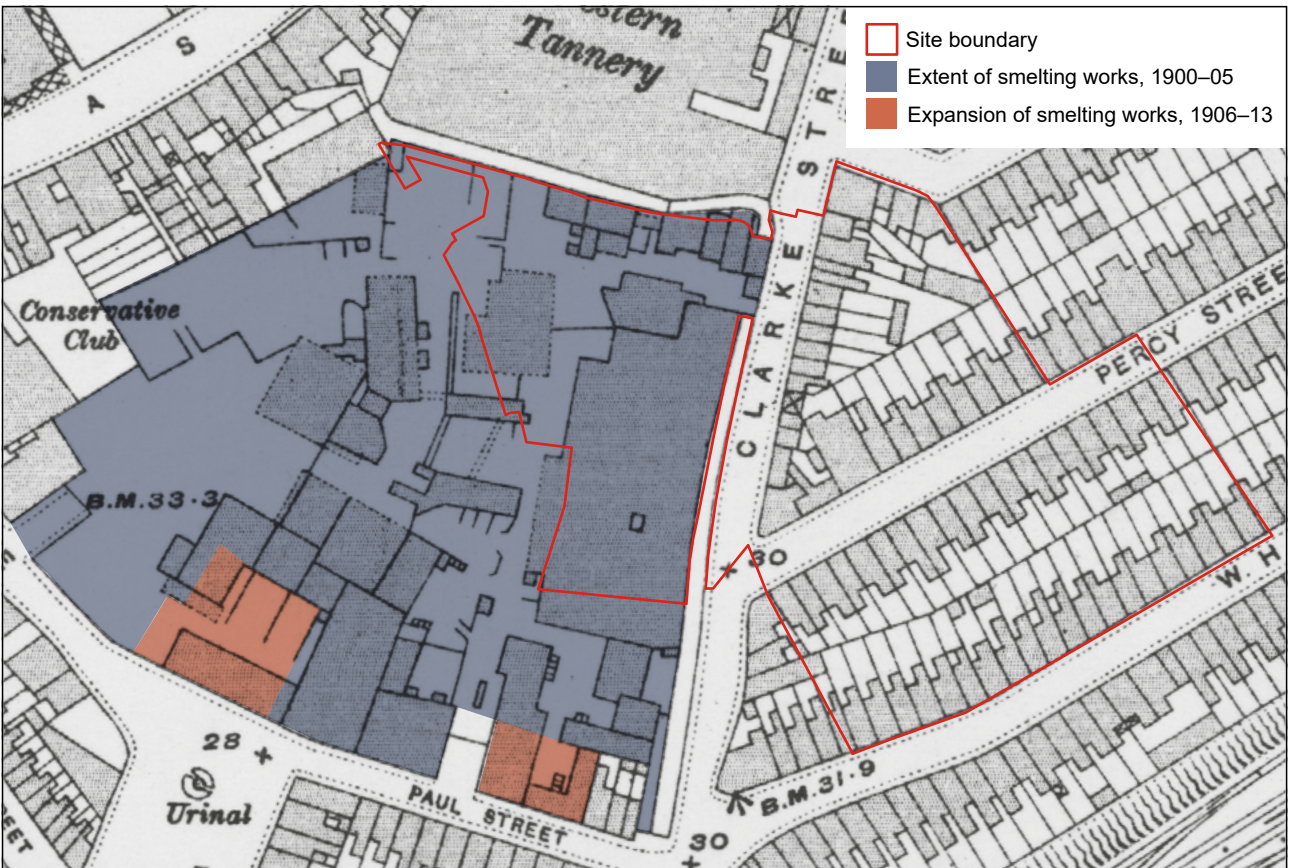
Figure 5.6 1918 OS plan (revised 1913). Reproduced with the permission of National Library of Scotland. <https://maps.nls.uk>

There were further investments in 1912: a new blacksmith's shop and a two-storey mill shed were built, and all the timber buildings were replaced with iron-framed structures clad in corrugated iron to reduce the risk of fire (Little 1963, 24–5). The 1918 OS plan, which was surveyed in 1913, (Fig. 5.6) shows the extent of the smelting works on the eve of World War I.

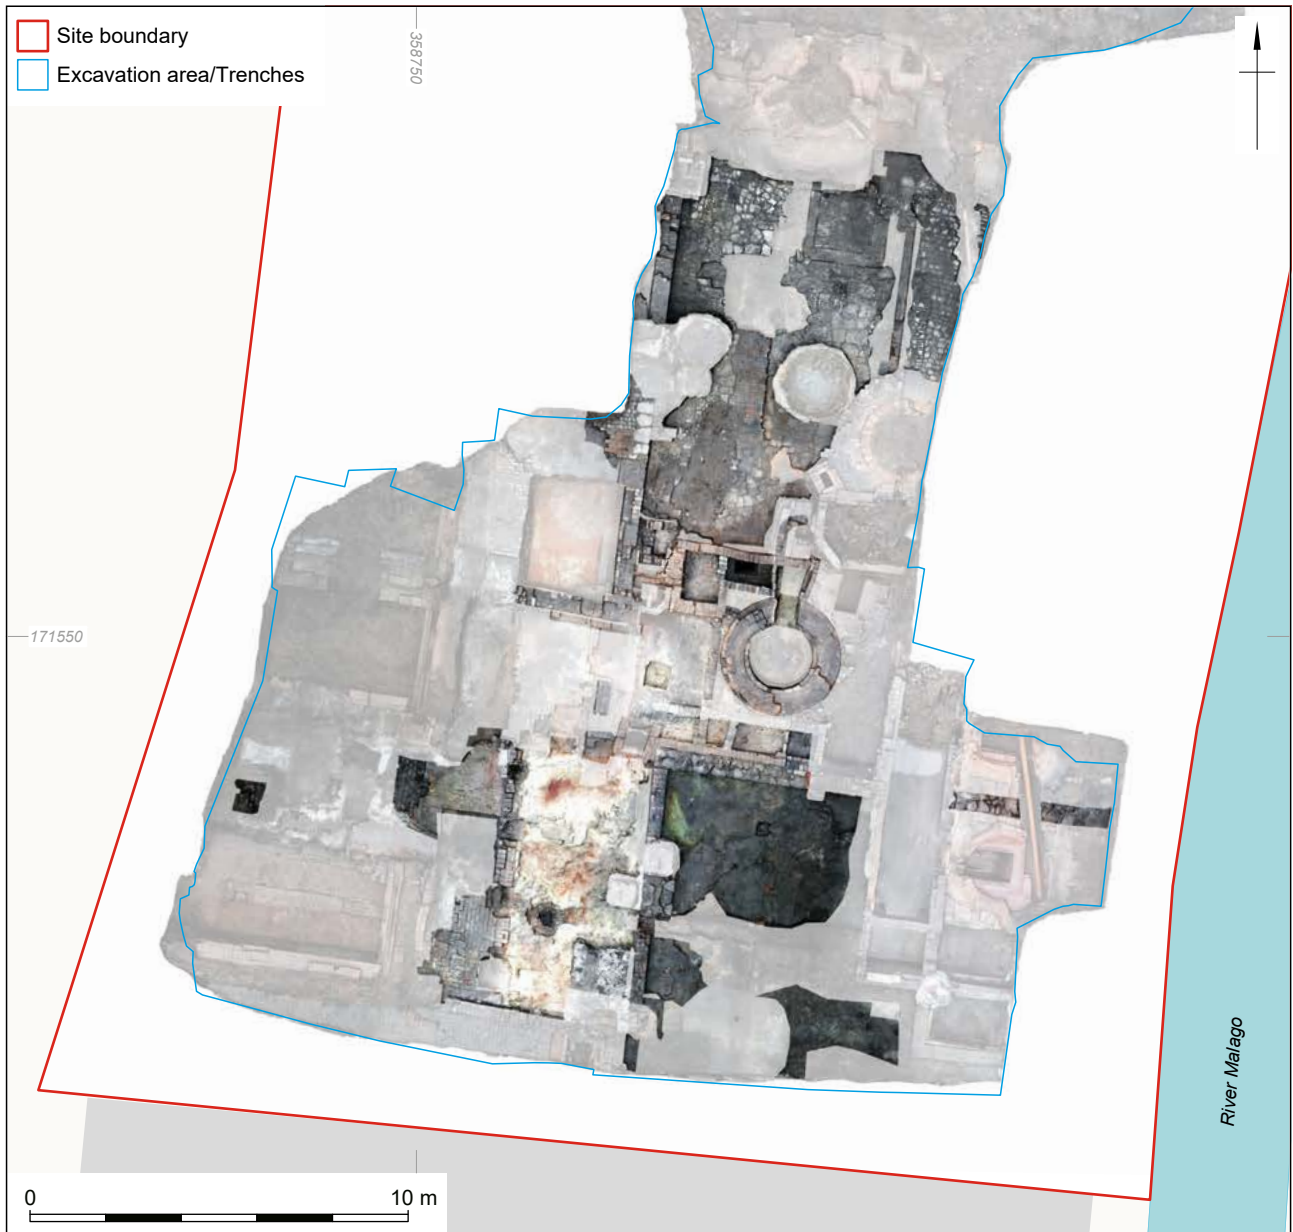
Figure 5.12 Orthographic plan from photogrammetric model, showing 1871–83 archaeological features, phase 2

The second phase of expansion comprised the construction of a north–south-aligned, 9.4 × 6.2 m, brick shed (B10; Figs 4.12, 5.11, 5.12 and 5.16) and a manifold flue system (S22; Figs. 4.11 and 4.12). The east side of building B10 was defined by a brick wall, which had a series of internal bullnose-cornered buttresses that mirrored the pillars of building B9. Within building B10, there was a brick-built cellar (S23; Figs 5.11, 5.12 and 5.17), with a flight of steep steps on the east side. The cellar, which was 1.44 m deep, 1.5 m wide and over 2.7 m long, corresponds with a structure shown on the 1885 OS plan (Fig. 5.2). Cellar S23 was infilled with a deliberate dump of fine black granular slag; the function of the cellar is unknown. The purpose of manifold flue system S22 was to gather various flues together, so that they could be channelled into a single opening at the base of chimney S6. This was done to preserve the structural integrity of the chimney, which would have been compromised if it was pierced by multiple flue holes.

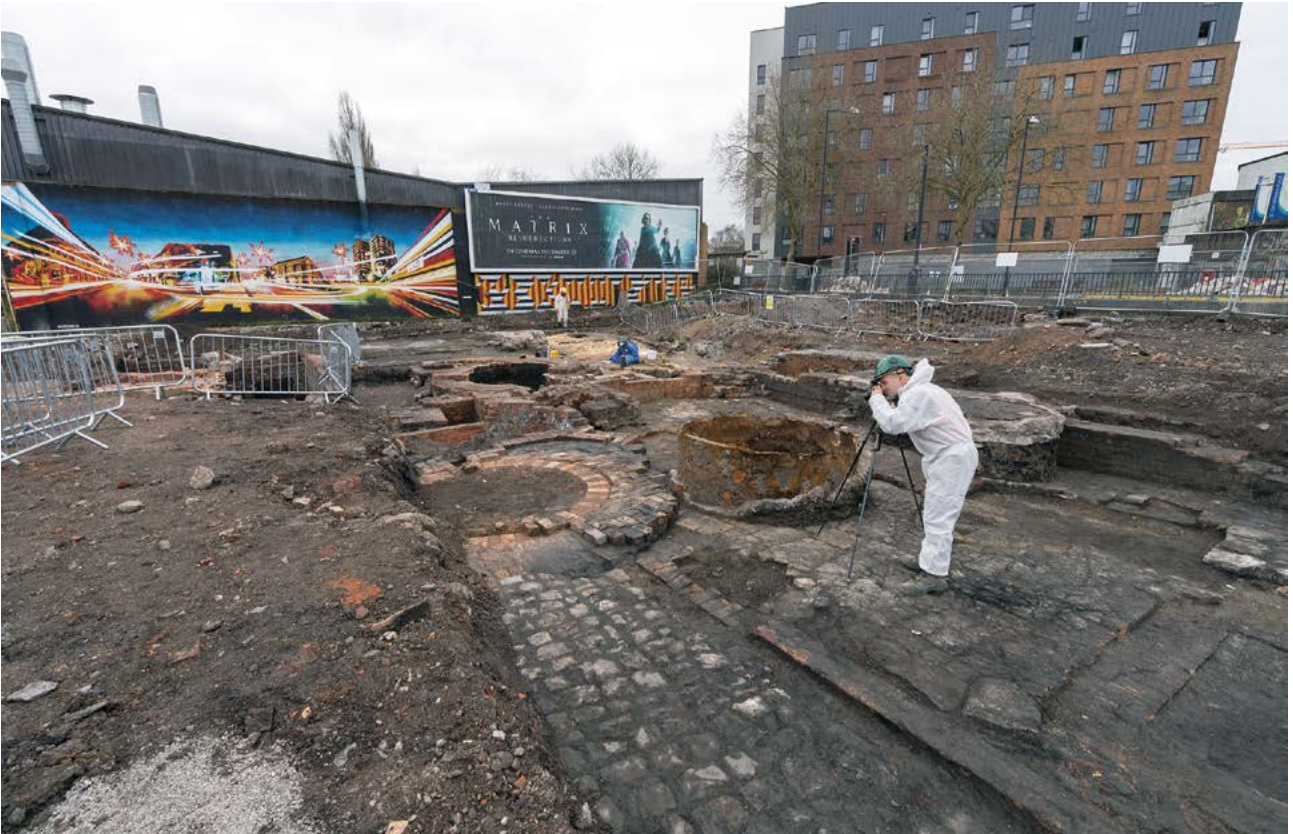
Figure 5.16 Yard OA7, building B10, solder pot S30 and iron tank S43. Looking south-west

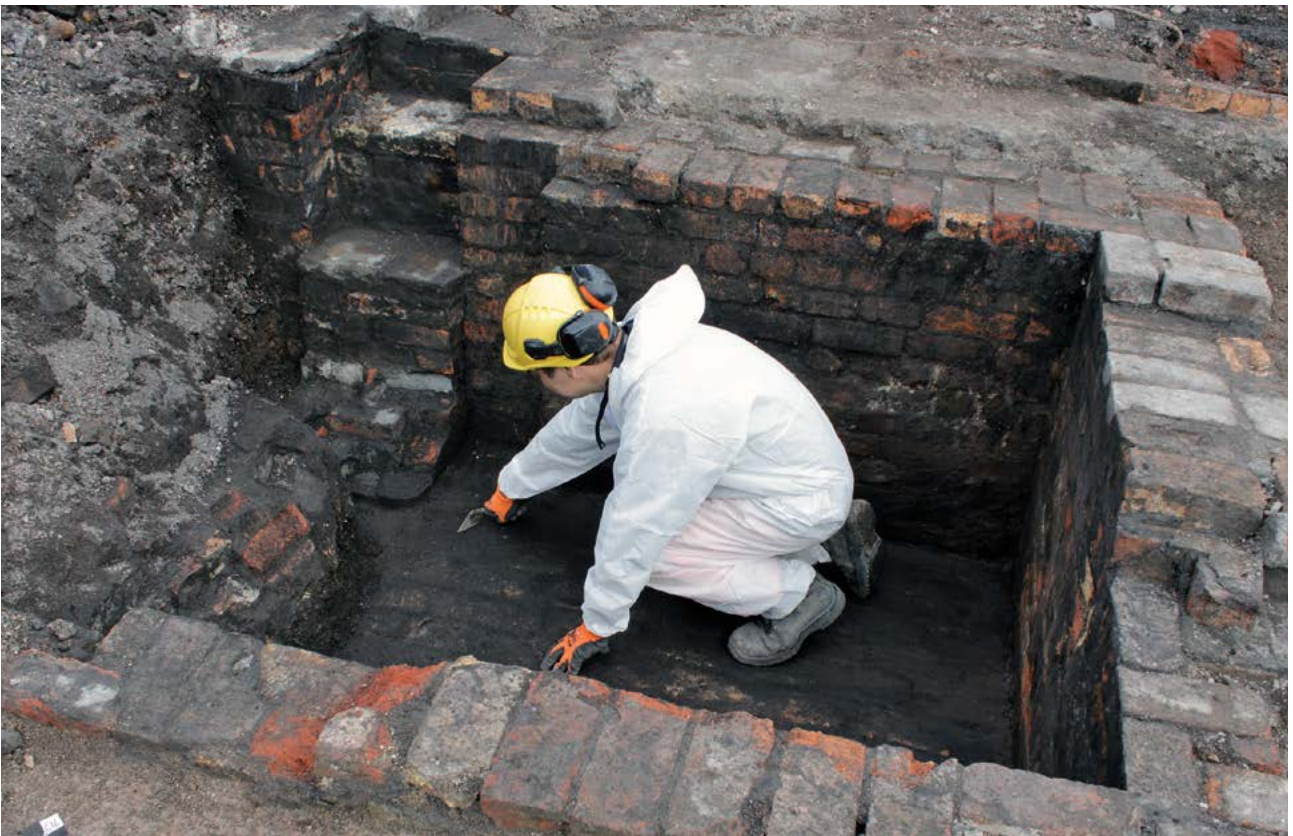
Figure 5.17 Cellar S23, looking east

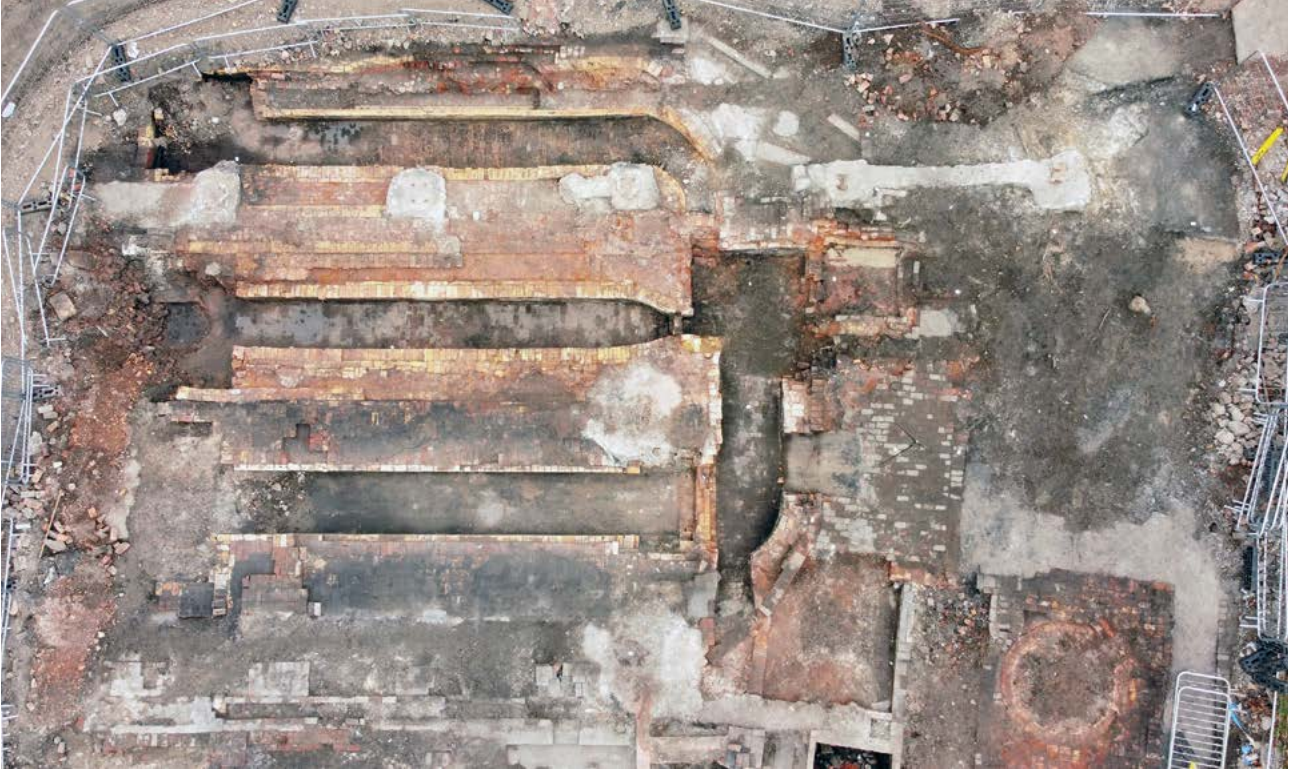
Figure 5.18 Aerial photograph of boiler houses B12 and B14 and boiler bases S27 and S36 (photograph reproduced with the permission of Bristol & Bath Heritage Consultancy Ltd)

These are likely to have been mounts for a steel- or iron-framed building that housed a large Lancashire steam boiler (S27; Figs 5.9, 5.10, 5.18 and 5.19). The 1896 Goad Fire Insurance Plan (Fig. 5.4) depicts building B12 as a timber structure with a tiled roof. However, given that the plan states that the surveyors were denied access to the works, it is possible that there are inaccuracies in the plan. Steam boiler base S27 (Fig. 5.18) was aligned east-west and measured over 10.1 x 3.9 m. There was a blowdown pit for wastewater at the west end of the boiler base, and the mounts for a flue damper at the east end. A detailed examination of the western end of the boiler base was hindered by the presence of degraded asbestos fireclay. This substance, which was removed by specialist contractors, was probably used to seal up gaps between the boiler and the surrounding brick flues and may also have been used to seat the boilers (R. Smith, pers. comm. 2024). The boiler flues were lined with yellow firebricks from the Dykehead Fire Brick Works and the Glenboig Union Fireclay Co. The core of the structure was built using press-moulded red bricks from the Malago Brick & Tile Works. The latter company was marketing its 'well-known pressed bricks' by 1877 and continued to do so until the company closed in 1908 (Hammersley 1992, 19; WDP, 23 October 1877, 4). Cartographic evidence suggests that boiler S27 was built between 1874 and 1883.

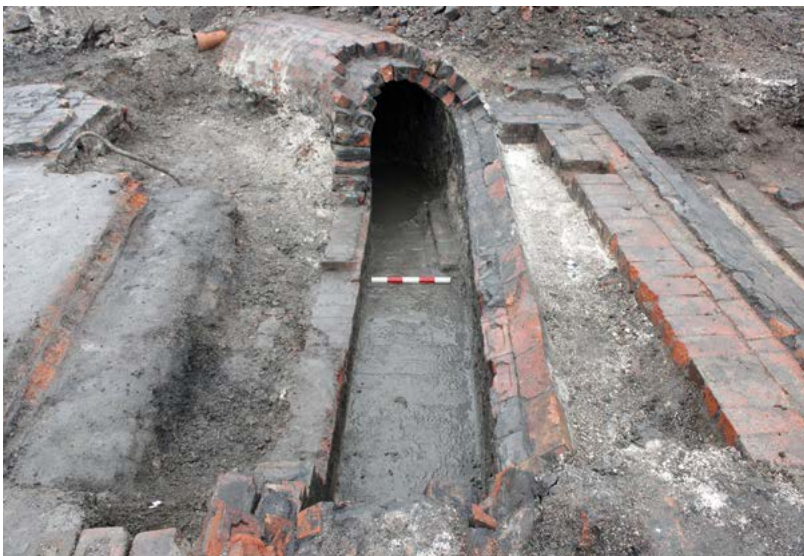
Figure 5.22 Flue S25, with possible blast furnace base S24 to the left, and the north wall of building B11 to the right, looking west. Scale: 0.5 m

To the north of structure S24, there was a large brick flue (S25; Fig. 5.22) that was constructed of red press-moulded bricks bonded with black ash mortar. Flue S25 abutted and respected the north wall of the building B11. Analysis of the dust coating the interior of the flue (see Chapter 8, sample 7), showed that it comprised gypsum, brick dust, lead and calcium sulphates, and tin oxides derived from solder and lead smelting.

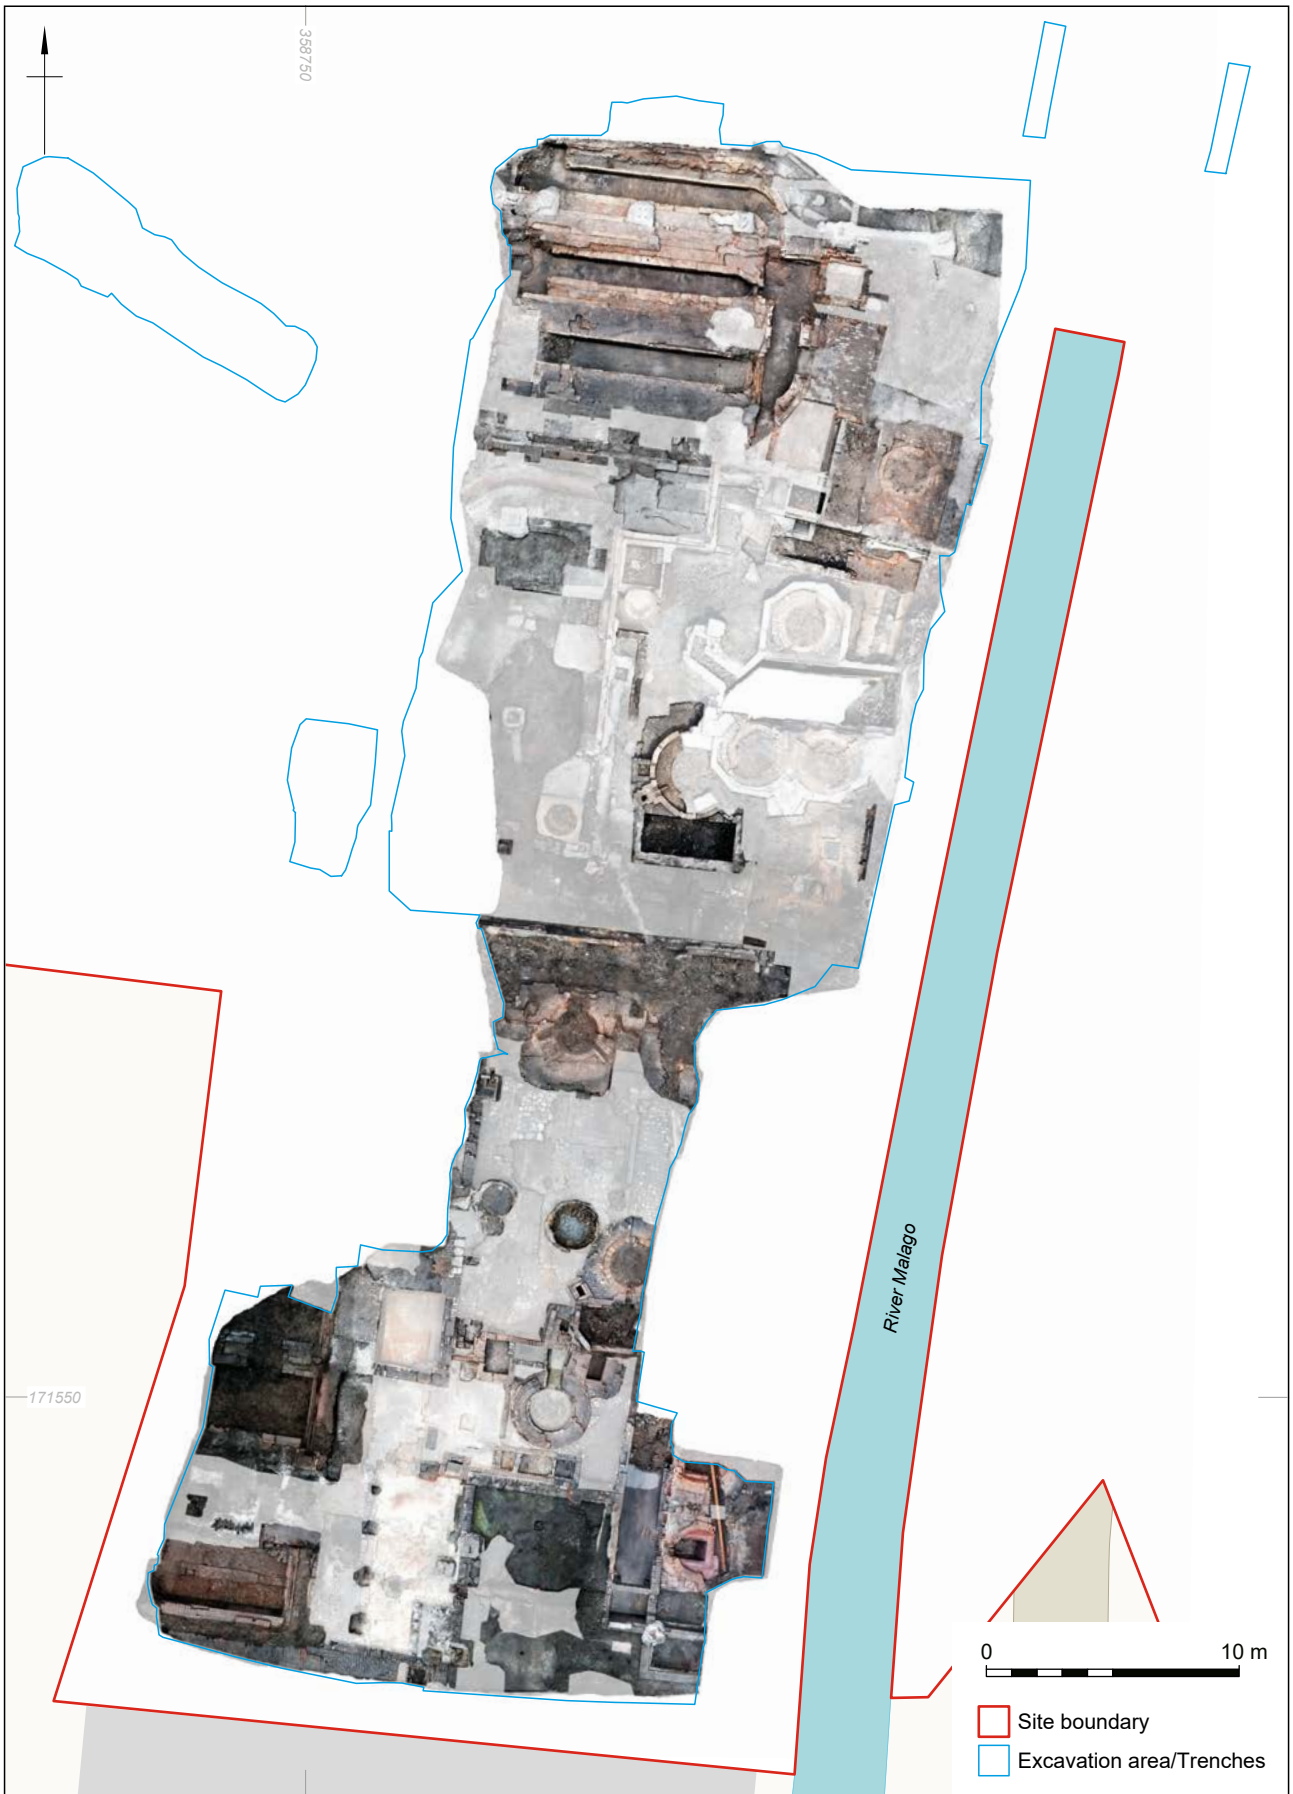
Figure 5.24 Orthographic plan from photogrammetric model, showing 1884–1913 archaeological features

The cellar of solder pots S28 (Figs 5.23–5.28) was fully excavated. Its floor was paved with bricks bedded on concrete. The furnaces were built of red brick bonded with black ash mortar, with unmarked yellow firebricks lining the fireboxes: the latter were bonded with red sand. The upper parts of the furnaces were circular and had an internal diameter of 1.7 m. The furnaces had thick cast-iron doors and cast-iron grates

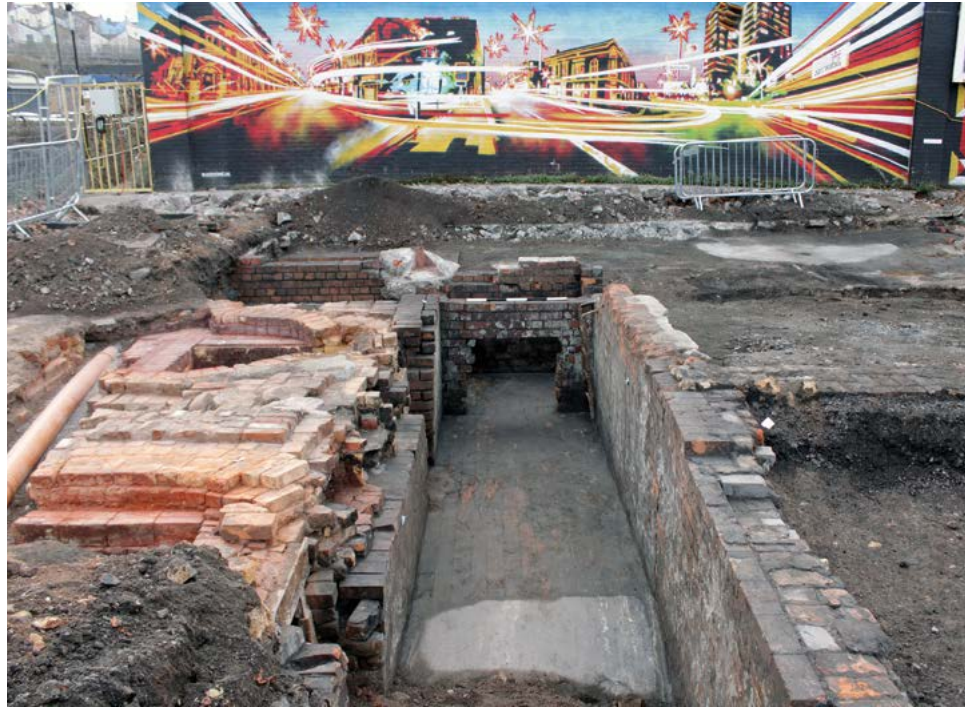
Figure 5.27 South furnace of solder pots S28, looking east

with ash pits below. Oxygen was provided via air inlet holes to the sides of the doors: these were fitted with iron dampers that allowed the furnaceman to regulate the airflow, and therefore the heat, of the furnaces. The grates were overlain by concreted clinker and greyish purple ash from the final firing of the furnaces. Access to the stoking cellar was provided by a fixed iron ladder in the south-west corner of the structure. A chamber at the south end of the cellar was half-filled with coal dust, which suggests that this was the fuel store. The furnace flues vented upwards and would presumably have fed into overhead metal ducts. Although furnaces S28 are marked on a 1962 Goad Fire Insurance Plan (Fig. 6.4) as 'solder pots', their position within the smelting works would be more appropriate for lead melting pots, and they may have been used for this rather than solder mixing (R. Smith, pers. comm. 2024).

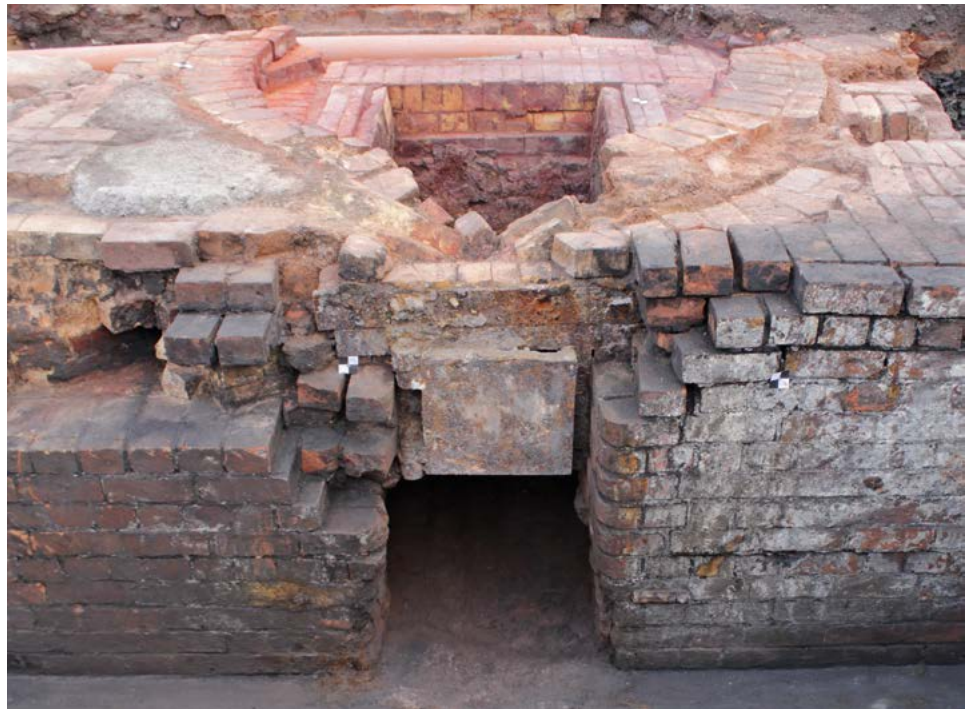
Figure 5.28 South furnace of solder pots S28, looking west. Scale: 0.5 m

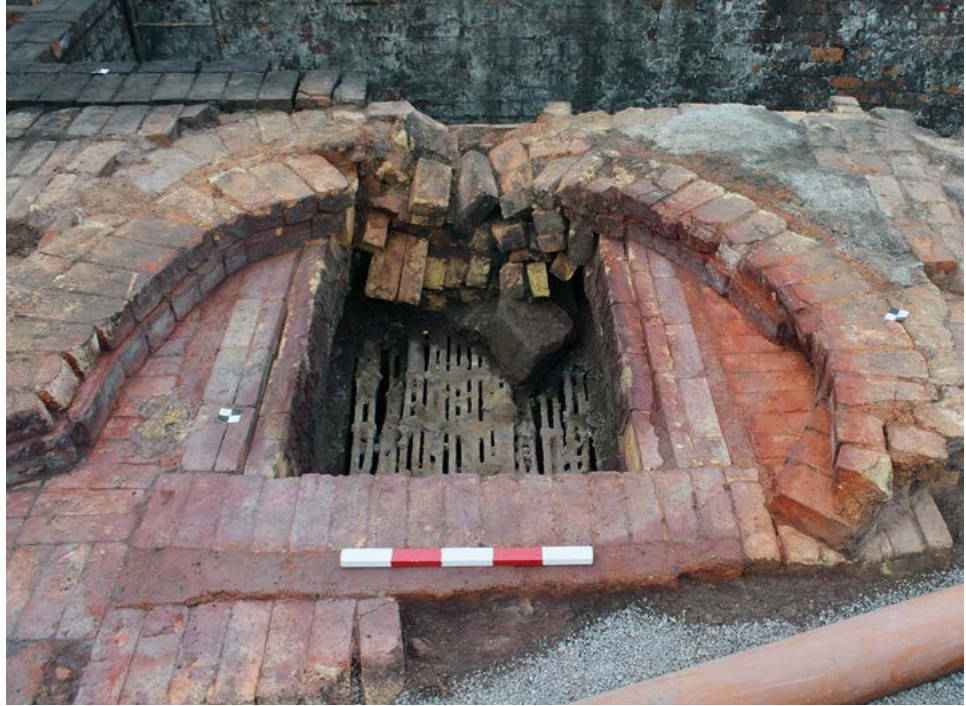
Figure 5.29 Structure S31 and building B6, looking south-east. Scale: 0.5 m

To the west of solder pots S28, and immediately to the south of chimney S6, there was a row of box-like brick compartments (S31; Figs 4.11, 5.23, 5.24 and 5.29). The western end of structure S31 was abutted by a contemporary construction make-up layer composed of clinker and crushed Morgan Crucible Co. assaying crucibles (see Chapter 9, 'The Science of Smelting: Assaying and Analysing'). The compartments within structure S31 were partially filled with grey and bright green ash, identical in composition to the ash in flues S5 and S21. This suggests that structure S31 was probably associated with the flue system. The purpose of structure S31 is uncertain, but the compartments may have been settling chambers intended to collect flue dust, or the bases of primitive fume scrubbers. Alfred Pass experimented with 'steam boxes' for this purpose in the mid/late 19th century and S31 could be the base of these structures (R. Smith, pers. comm. 2024; Wright 1966, 182).
