Capper Pass & Son's Bedminster Smelting Works

EXCAVATIONS AT DALBY AVENUE AND WHITEHOUSE LANE
BEDMINSTER GREEN, BRISTOL

Cai Mason

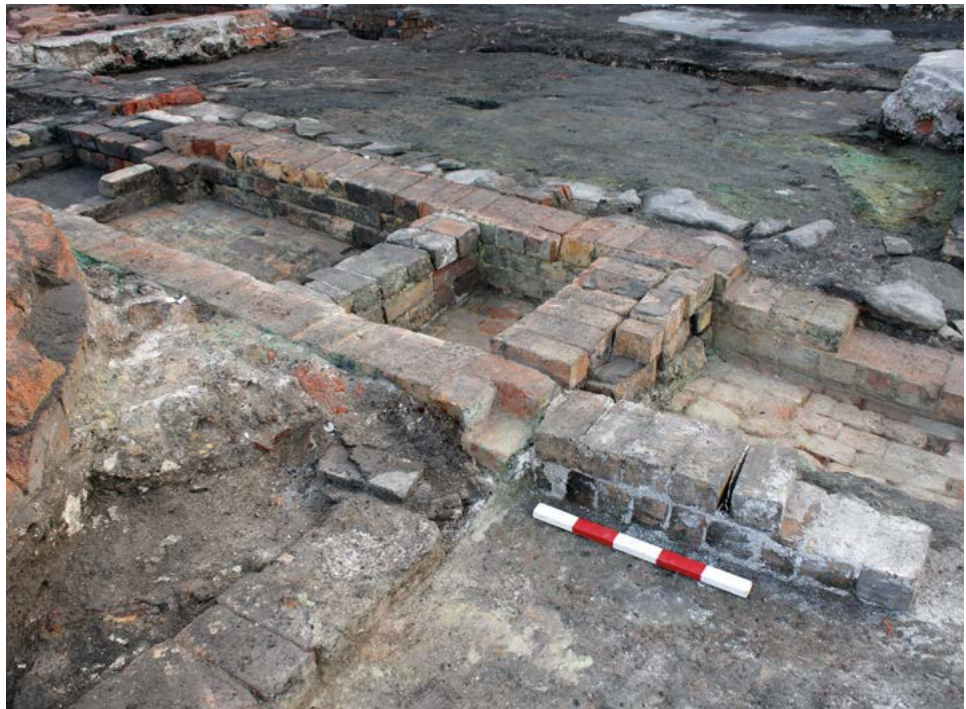
Figure 5.30 Furnace S35,
looking north-west

Within building B11, there was a much larger furnace (S35; Figs 5.23, 5.24 and 5.30), of similar design to the smaller solder pots. Furnace S35 measured 6.6 x 4.6 m externally and had a stoking cellar on the south side, with a circular furnace to the north. The circular part of the furnace had an internal diameter of 3.15 m. Excavation of the stoking cellar was halted due to the presence of asbestos. The exposed northern elevation of the stoking cellar revealed an arched furnace doorway constructed of red bullnose bricks. The north-eastern half of furnace S35 was truncated by later activity (see Chapter 6). The width of the furnace suggests that it may have been a casting pot, used to make ingots of solder for sale. The wide pot would have allowed moulds to be arranged around it without the need for water cooling (R. Smith, pers. comm. 2024).

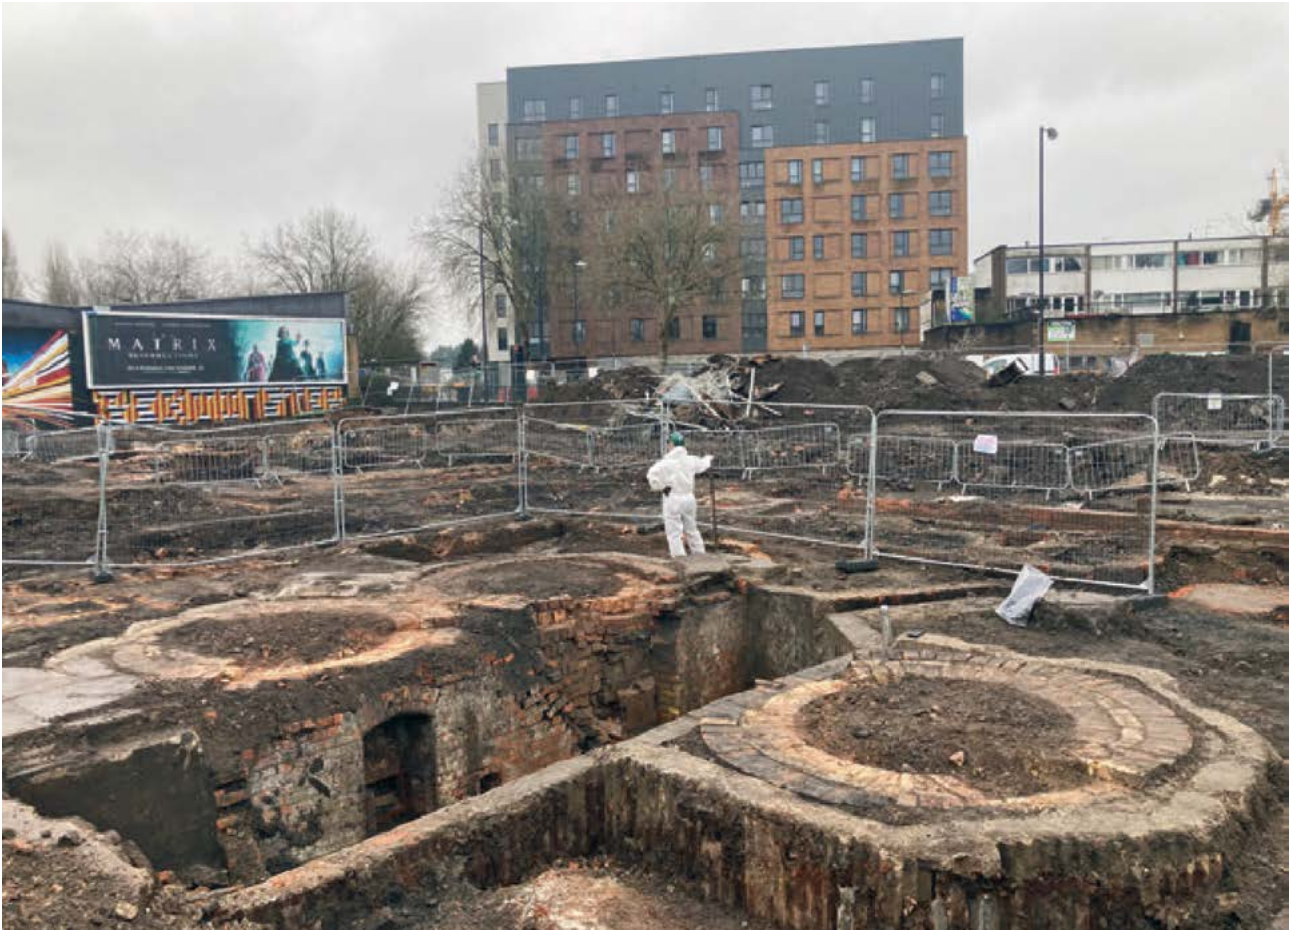
Figure 6.8 Solder pots S50, looking south-west

to the same design as the earlier solder pots, with arched firebox openings edged with bullnose bricks, and thick cast-iron doors to the furnaces (see Fig. 6.8). The flow of oxygen to the furnaces was regulated by air inlets to the sides of the fire doors. The stoking cellar was accessed via a fixed iron ladder. To the south of the ladder, there was a small square chamber that contained a coil of thick steel cable: this appears to have been the base of a hoist or lift. At the west end of the stoking cellar, there was a concrete duct capped with corrugated iron and concrete. The duct probably contained pipework, which was removed by asbestos removal contractors without archaeological supervision.

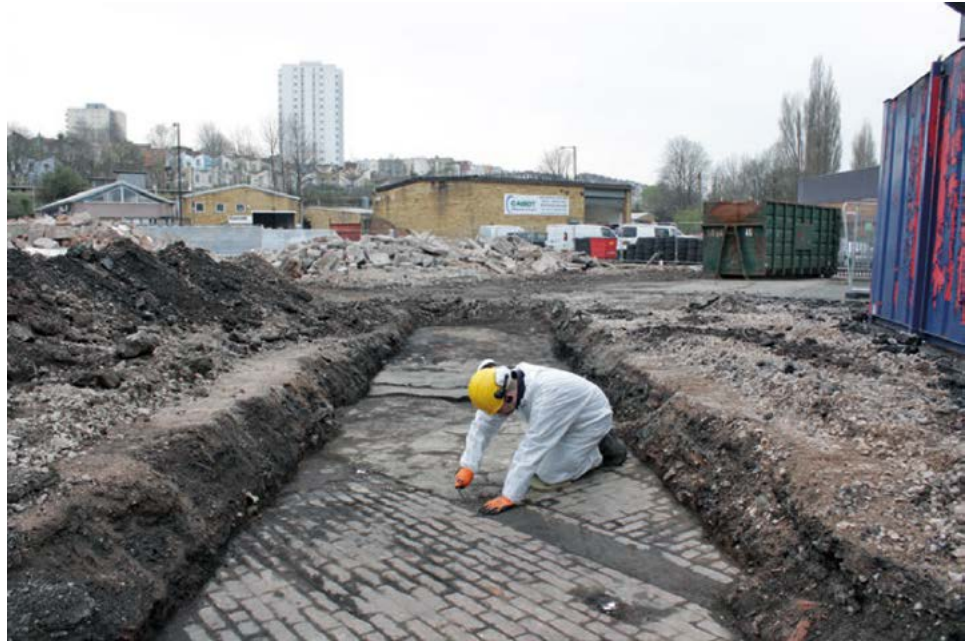
Figure 7.4 Floor of the Bedminster Iron Tomb Railing and Iron Foundry (B23), looking south

The remains of the Bedminster Iron Tomb Railing and Iron Foundry (B23; Fig. 7.4) comprised the external walls, which were one brick thick, and a brick floor that extended throughout the building. There were two parallel brick gullies running north-west to south-east down the centre line of the building. These might have been guides for the wheels of a travelling crane, or they may simply have been drainage gullies.

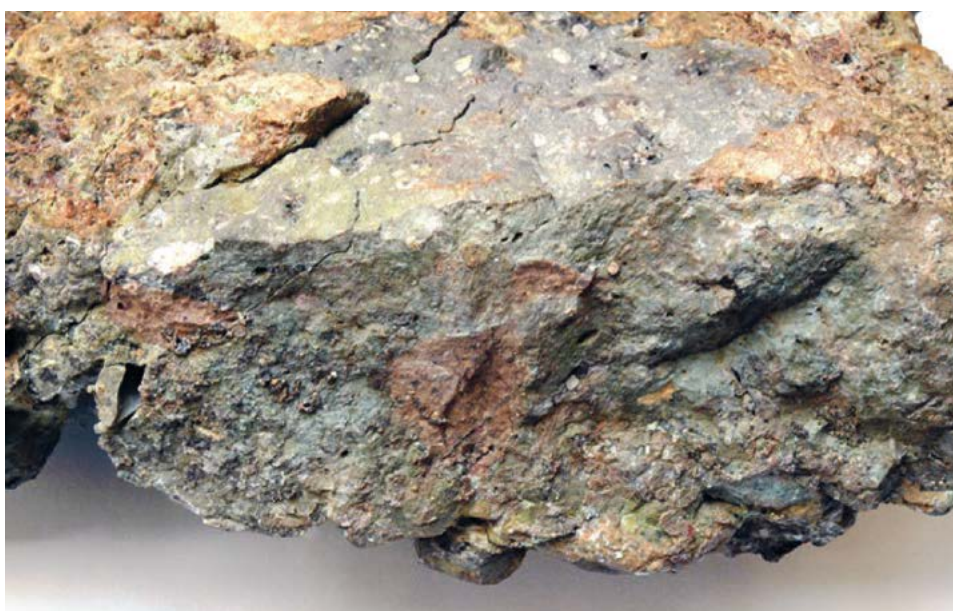
Figure 8.3 Sample 7 flue deposit (as received)

To the north of structure S24, there was a large brick flue (S25; Fig. 5.22) that was constructed of red press-moulded bricks bonded with black ash mortar. Flue S25 abutted and respected the north wall of the building B11. Analysis of the dust coating the interior of the flue (see Chapter 8, sample 7), showed that it comprised gypsum, brick dust, lead and calcium sulphates, and tin oxides derived from solder and lead smelting.

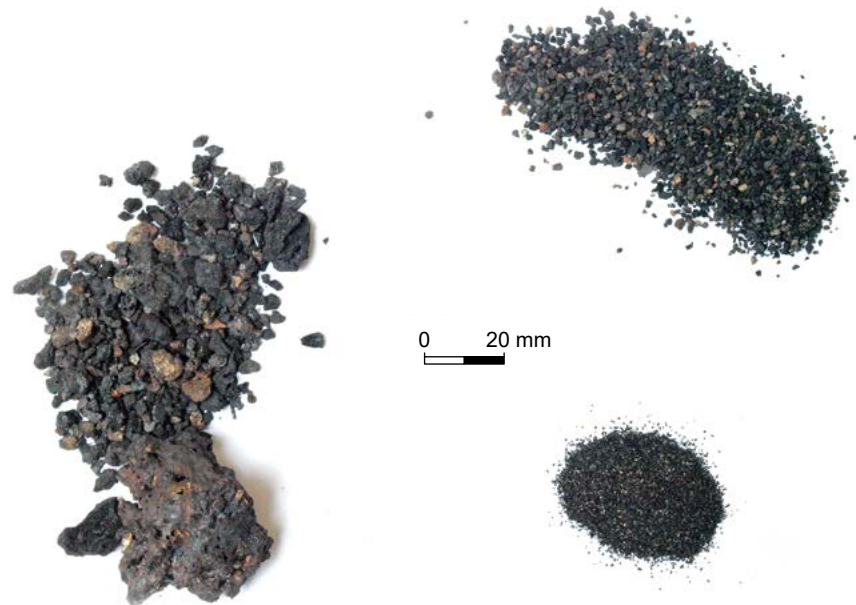
Figure 8.4 Sample 11 flue deposit (sieved into >2mm, 2–0.5mm, and 0.5–0.2mm fractions)

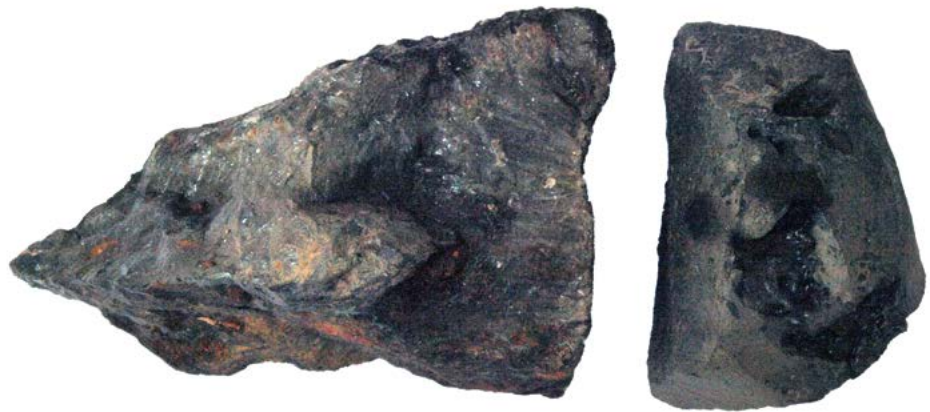
Figure 8.12 Sample 15 before preparation

Sample 15 was taken from a dump of slag forming a surface within building B7 and adjacent to a possible blast furnace base S24. The sample was taken to identify the type of slag and its origin, i.e., is it from the blast furnace, and what metal was being refined? The slag is black in colour and all the surfaces appear to be fracture surfaces (Fig. 8.12).

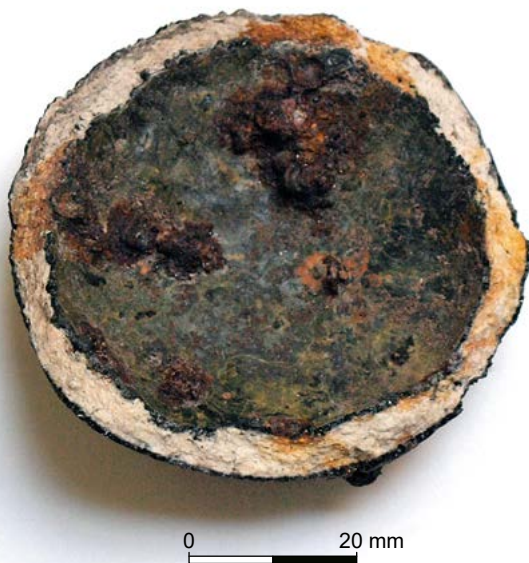
Figure 8.21 Sample 18 prior to sampling

Sample 18 comprises the base of a small crucible with black vitrified surfaces (interior and exterior). The interior surface also contains a large white metal inclusion (Fig. 8.21). The mounted cross-section (Fig. 8.22A–B) shows that the ceramic fabric is almost white (indicating a low iron content) with numerous quartz inclusions. The SEM examination confirmed the presence of fire-cracked quartz (or high-temperature polymorphs of quartz) in a vitrified matrix which contains numerous irregular cracks (Fig. 8.23A–B). The vitrified ceramic matrix also contains recrystallised mullite.

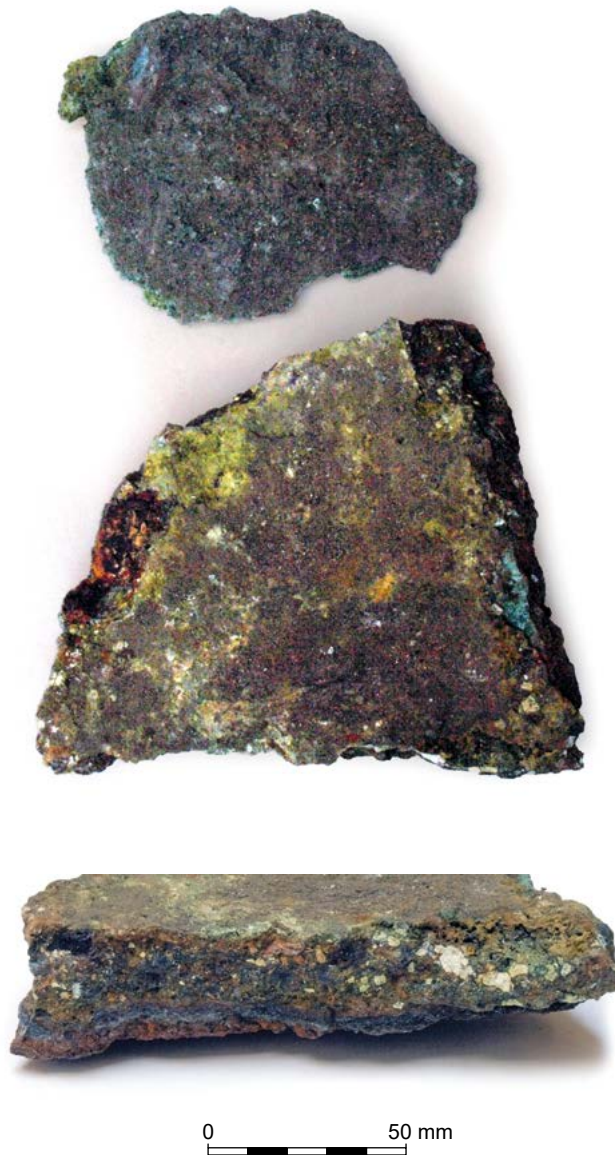
Figure 8.24 Sample 4 before preparation

Sample 4 comprises greyish green copper and other metal slag material forming a rough internal floor within building B6. This sample (Fig. 8.24) was taken to determine the origin of the material from which the surface was made. The cross-section shows a wide range of slag fragments within a matrix concreted by iron compounds (Fig. 8.25A–B).

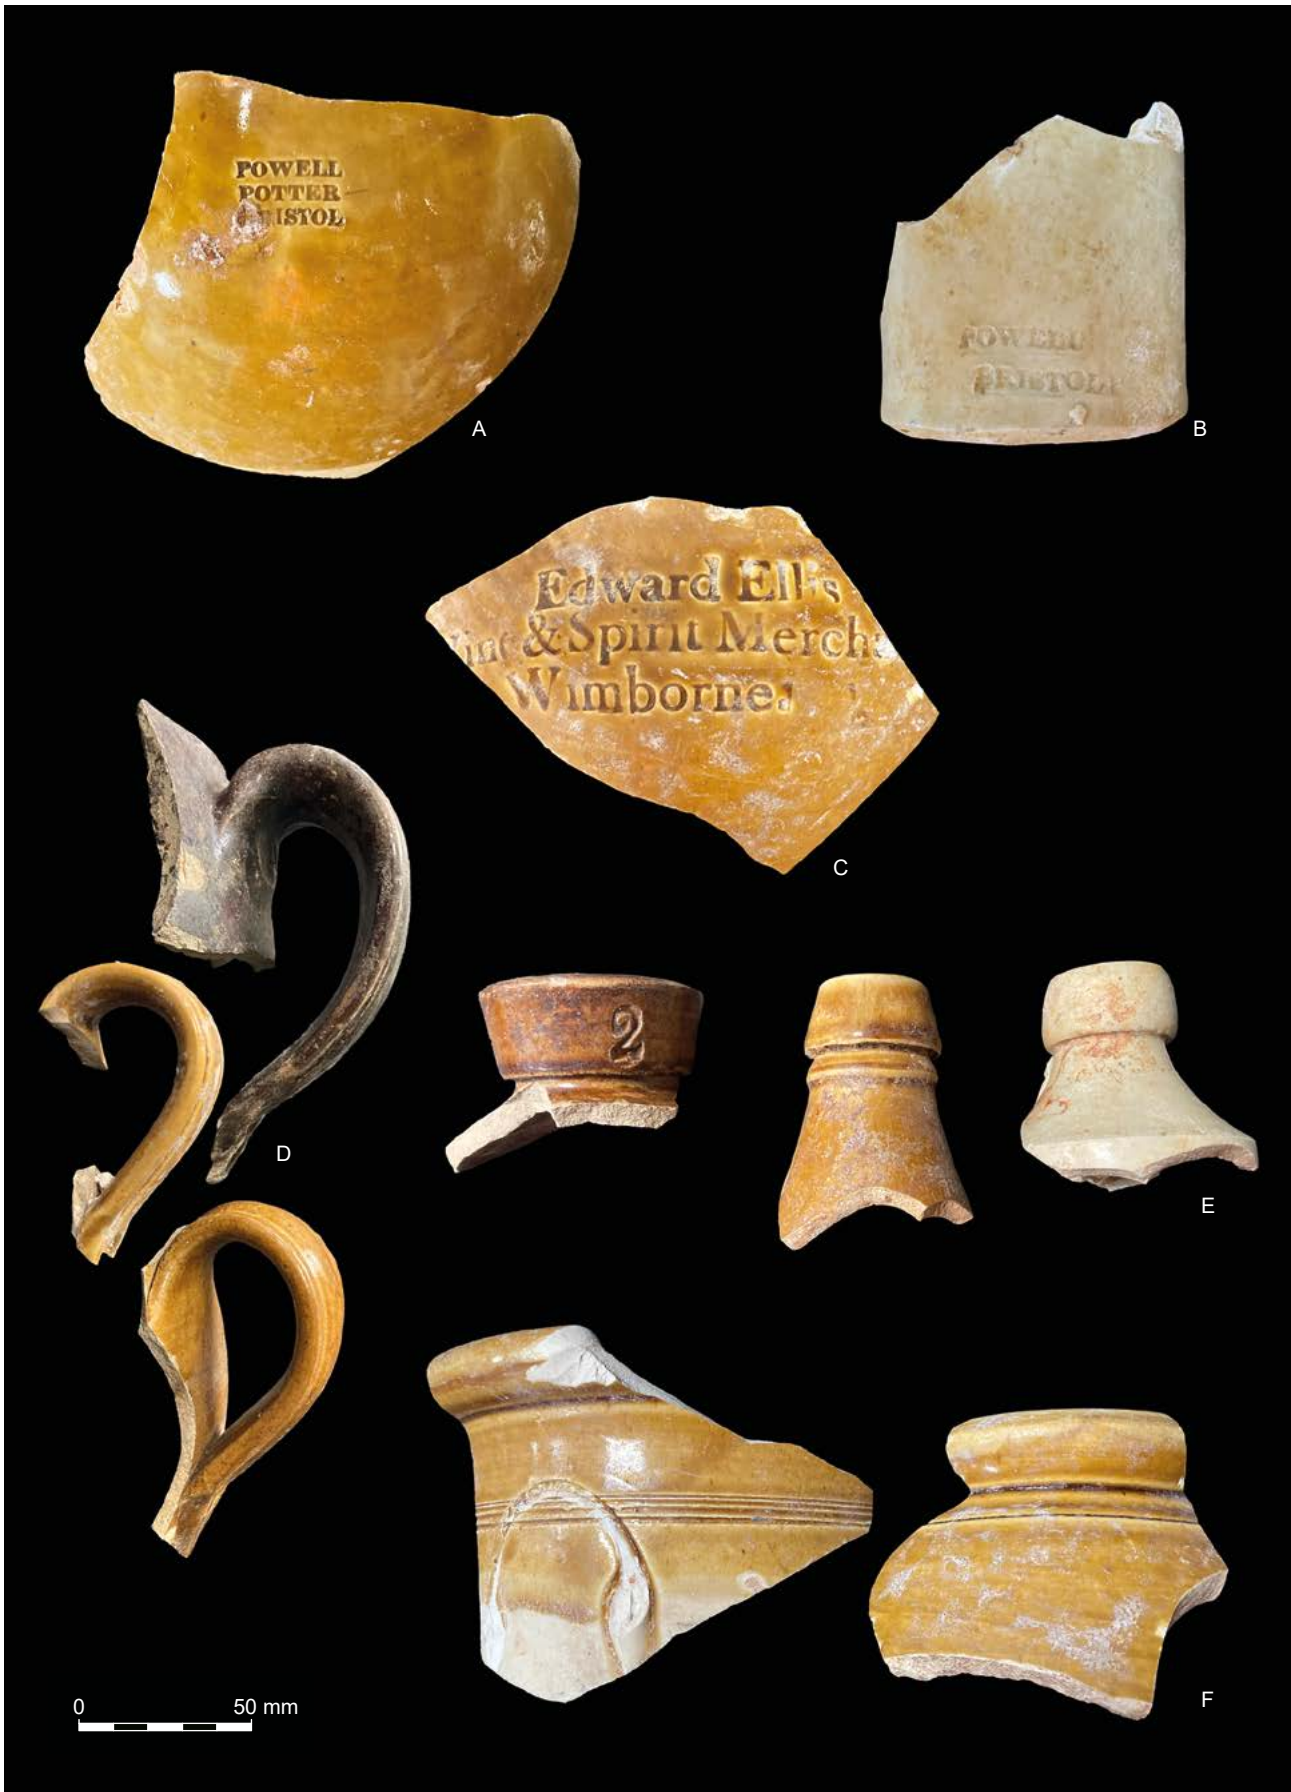
Figure 9.1 Powell's Pottery wasters: A–B) maker's marks; C) proprietary mark; D) flagon handles; E) flagon, beer and ginger beer bottle lips; F) jar rims

During the 1840s or early 1850s, a large quantity of industrial waste was dumped on Plot A to raise the ground level and create a firm, dry, yard surface. This material contained a dump of crushed 'wasters' (misfired and broken pottery) from Powell's Pottery in Temple Gate, Redcliffe. A sample of this pottery (104 sherds) was collected, some of which is marked with the impressed backstamp 'POWELL / BRISTOL' and 'POWELL / POTTER / BRISTOL' (Fig. 9.1). A single large piece of kiln furniture was also recovered. This can be identified as part of a circular sagger that would have protected vessels from direct contact with flames and smoke during firing.

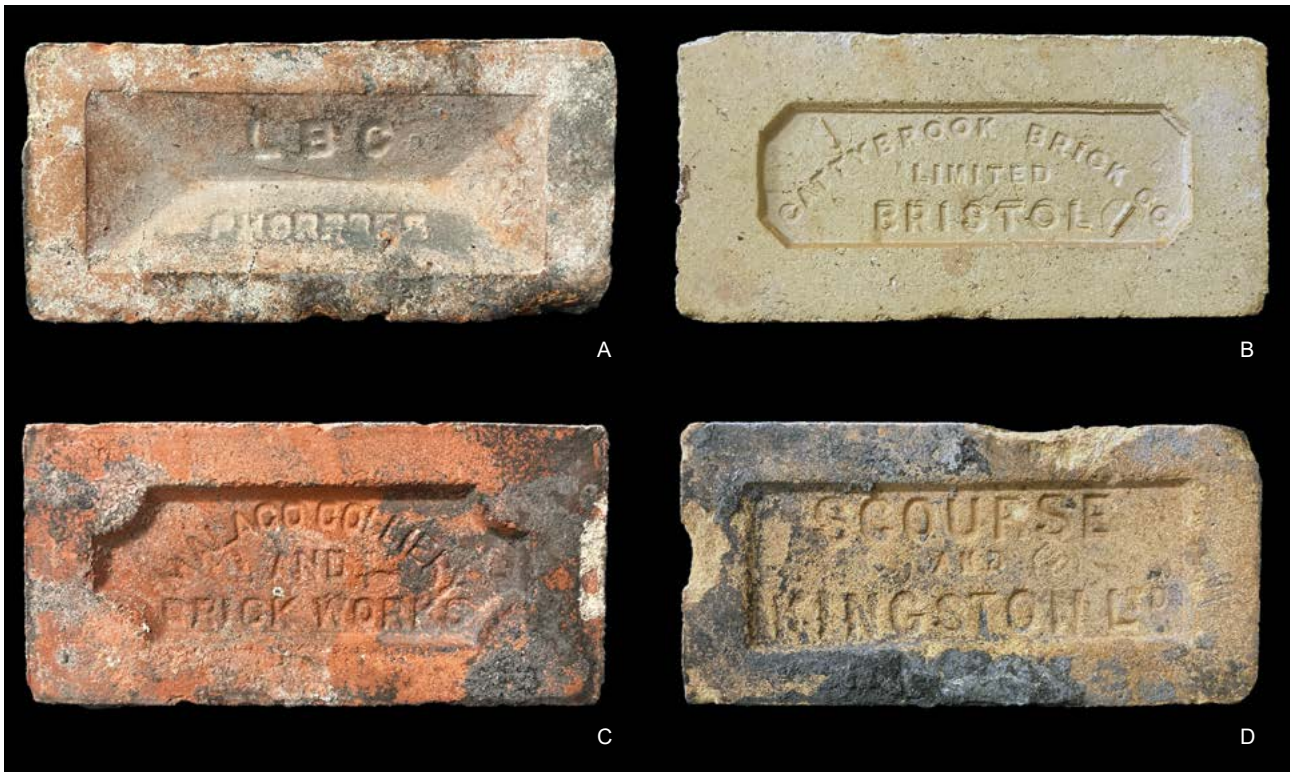
Figure 9.3 Marked bricks manufactured by: A) London Brick Company; B) Cattybrook Brick Co. Ltd; C) Malago Vale Colliery & Brick Works; D) Scourse and Kingston Ltd

One of the ordinary bricks (Fig. 9.3A) was made in Fletton, Cambridgeshire; the others are local products from Bristol and South Gloucestershire.

The local bricks comprise three from the Cattybrook Brick Co. Ltd of Almondsbury, Gloucestershire; three from the Malago Brick & Tile Works of Shene Road, Bedminster; and one made by Scourse & Kingston Ltd of Parson Street, Bedminster.

Malago Vale Colliery was established in 1844 (BM, 17 August 1844; Taylor and Shapland 2012, 33). The pithead was located on the south side of West Street. Ashmead's plan of 1874 shows a large brickworks between the colliery and Shene Road; this is identified on later plans as the 'Malago Vale Works' (1885 OS plan) and the 'Malago Brick & Tile Works' (1904 and 1916 OS plans). It was also known as the Malago Vale Colliery & Brick Works, a name first documented in 1877 (WDP, 23 October 1877). Malago Vale Colliery closed in 1895 following an acrimonious industrial dispute, but the brickworks remained operational until 1908 (Hammersley 1992, 19). The bricks, which are red and have impressed frogs marked with a 'MALAGO COLLIERY / AND / BRICK WORKS' incuse on the bed, were used in the construction of steam boiler base S27 and solder pot S30.

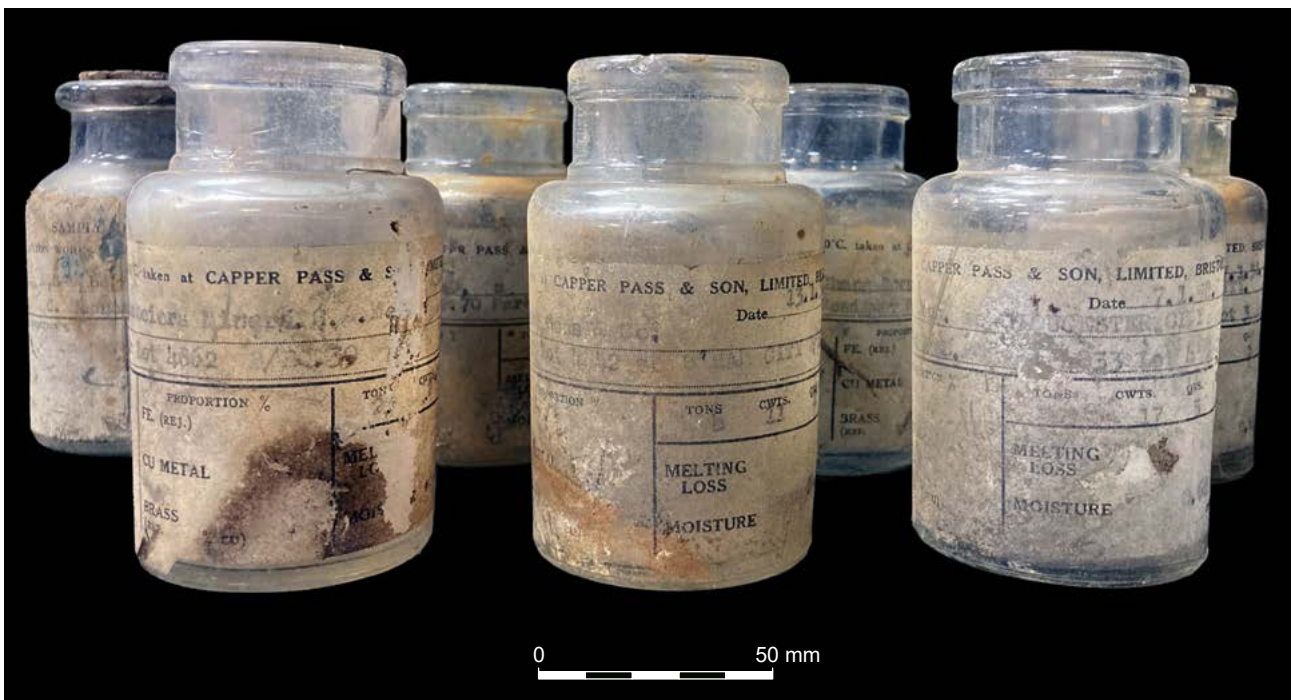
Figure 9.6 Late 1950s Capper Pass & Son Ltd ore sample jars from the backfill of softening pans S40

The jars (Fig. 9.6) are 75–90 mm high and 26 have complete or partial paper labels marked 'CAPPER PASS & SONS LIMITED, BRISTOL', along with various typed details identifying the jars' contents and origin. The jars were all empty, but one had a surviving cork closure. Some have small pieces of straw adhering to the outside; this likely to have been a packing material used to prevent them smashing in transit. The labels show that most of the samples were taken in Bedminster or Gloucester (the port of arrival); one was taken at Melton. The labels indicate that the jars originally contained dried ores or secondaries that were sampled between 1955 and 1958. They came from a variety of sources, and probably represent samples taken to assess the metal content of raw materials prior to purchase. Identifiable contents include tin residue and hearth absorption from the Wah Chang Corporation; tin ore from Financiers Miners S. A.; tinning residues from A. E. Milner (Metals) Ltd; tin dross and flue dust from H. Hales Ltd; lead slag from Watson & Co. Ltd, and unidentified samples from C. Tennant Sons & Co. and *Corporación Minera de Bolivia* (COMIBOL); the latter is likely to have been tin ore. Three jars contained zinc oxide, tinning dross and solder residue from unknown sources. Three of the companies were British: H. Hales Ltd was a Swansea tinplate broker (*Western Mail*, 5 November 1943); A. E. Milner (Metals) Ltd was a Birmingham-based dealer in non-ferrous metals and residues (*Birmingham Weekly Post*, 5 July 1957); and C. Tennant Sons & Co. was a merchant bank that traded in metals and minerals (C. Tennant Sons & Co., 1961). Two were foreign: the Wah Chang Corporation of Oregon, USA, was founded by Kuo-Ching Li, a Chinese-American mining engineer who started out refining tungsten and antimony and later diversified into a wide range of speciality metals and alloys (*The Oregonian*, 11 May 1957 and 9 March 1961). In 1958, the Wah Chang Corporation purchased the Texas City tin smelter and adapted it for the manufacture of tungsten products and tin alloys (Anon 2024). COMIBOL was a state-owned company formed from three of Bolivia's largest tin mining companies after the National Revolution of 1952 (Burke 1987, 3).
