Survey of Timber Marks and Fabric Analysis on HMS *Victory*

Technical Report

Ref: 88310.02

June 2014

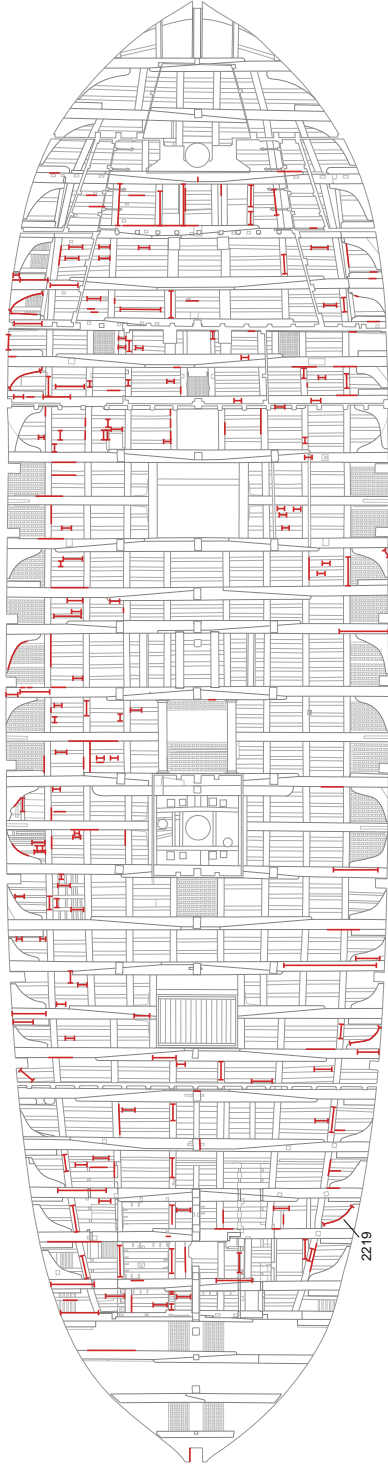
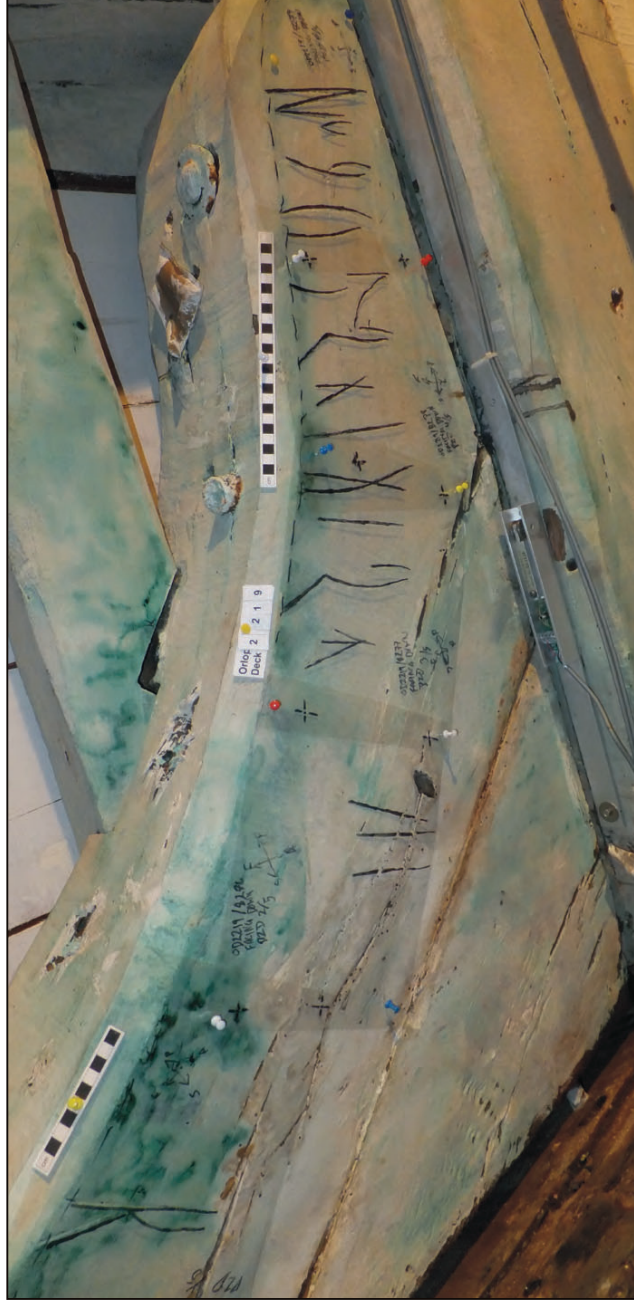
Figure 9

- 6.7.3 One of the more exciting discoveries during the on-board survey was the presence of stamps noted on timber mark 1100, 1101, 2007 and 2043, located on lodging knees (2007 and 2043) and bulkhead planks (1100 and 1101) in the area of the Grand Magazine in the hold (Figure 9). Both stamps comprised the capital letters **RMD** and are likely to relate to the initials of Richard Mosebury, the Timber Master at Portsmouth between 1801 and 1824, as already indicated in the arisings survey described above. This discovery confirms the presence of such stamps on *in situ* components on-board *Victory* and offers tangible insights into the individuals responsible for the works in Portsmouth Dockyard in

Rase marks and stamps on bulkhead planking - 'RMD', probably Richard Mosebury, Timber Master, 1801-24

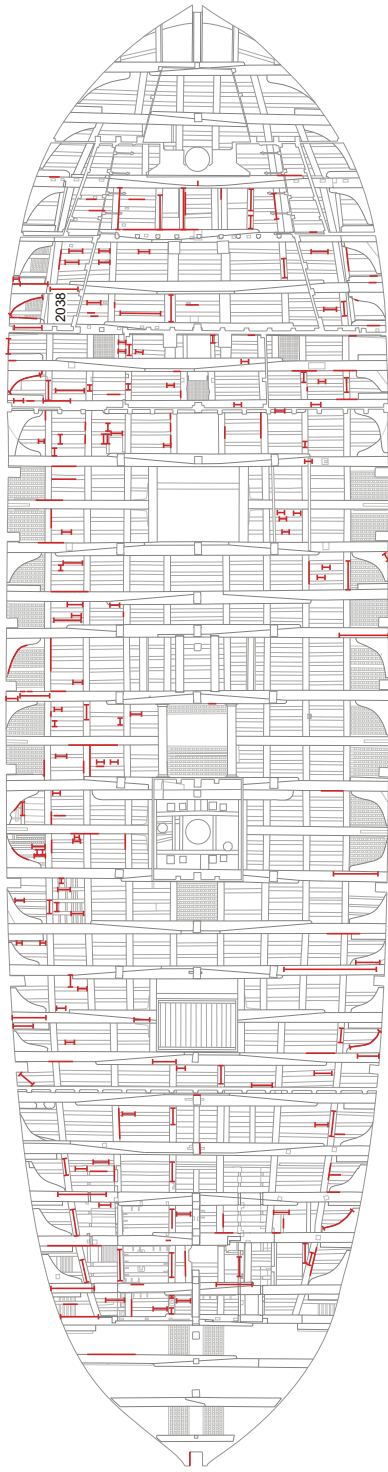
Rase mark on a lodging knee from the Orlop Deck - No. 9052, 1812 date; shown with OHP tracing in place

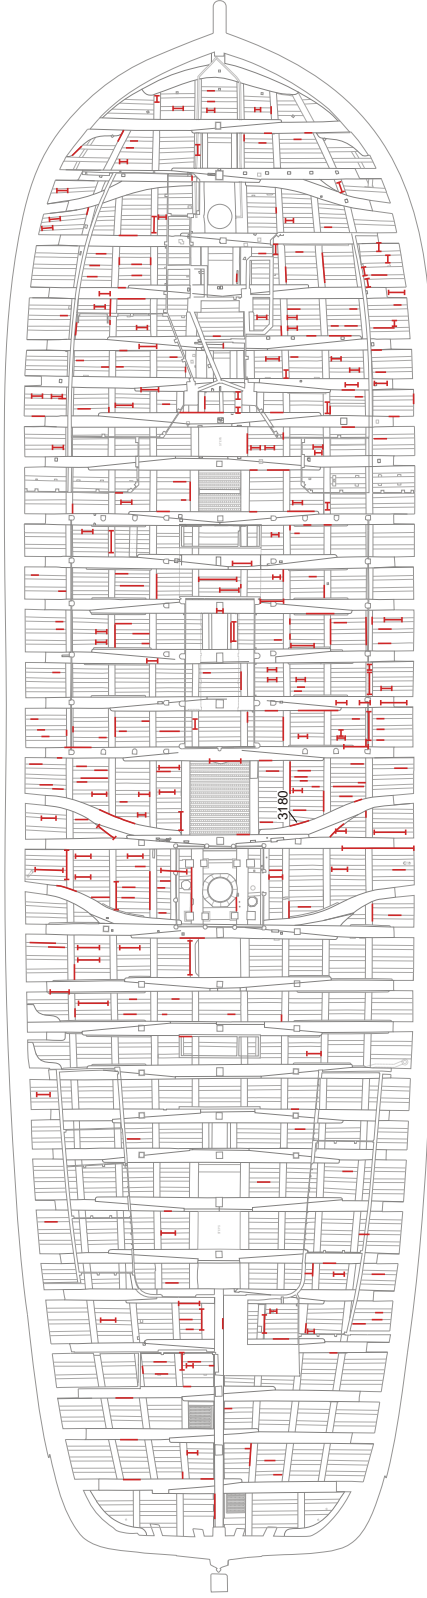
Figure 12

- 6.7.6 Further interesting observations relate to the groups of letters, or initials, associated with the syntax. As outlined above, these almost certainly relate to the individuals who marked the timbers during the various working processes within the dockyard. What is clear is that a spatial analysis of the initials show dominant forms (also noted in the arisings survey); particular examples include **YC** or **YCC**, and **BA**, all of which are represented throughout the deck structure on the Orlop and Lower Deck in particular (Figure 12).

Underside of carling from the Lower Gun Deck showing the standard syntax including the 1815 date and the common letters YC. The syntax has been struck through, indicating that the information given was perhaps incorrect at the time the timber was received into the dockyard.

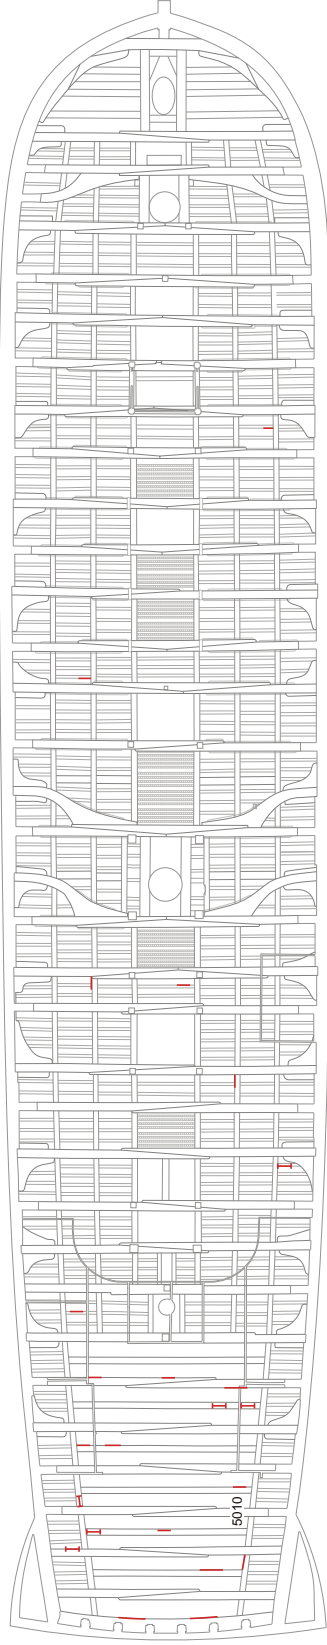
Figure 13

- 6.7.8 The evidence for timber marks containing plain language within the on-board assemblage is well represented. The majority of the plain language relates to deck structure such as carlings and ledges (in addition to the abbreviated marks for elements such as deck beams). In addition to beams, carlings and ledges, examples were noted on other elements. A particularly nice example was noted on a beam arm (Fork) from the forward end of the Lower Deck which read **Victory Fork** (Figure 13).

Lower deck rase mark on a beam arm - 'Victory Fork'
